LEVEL 1 DOWNSTREAM ANALYSIS

Addition for Morgan-Hornsby Residence

6405 West Mercer Way

April 24, 2022

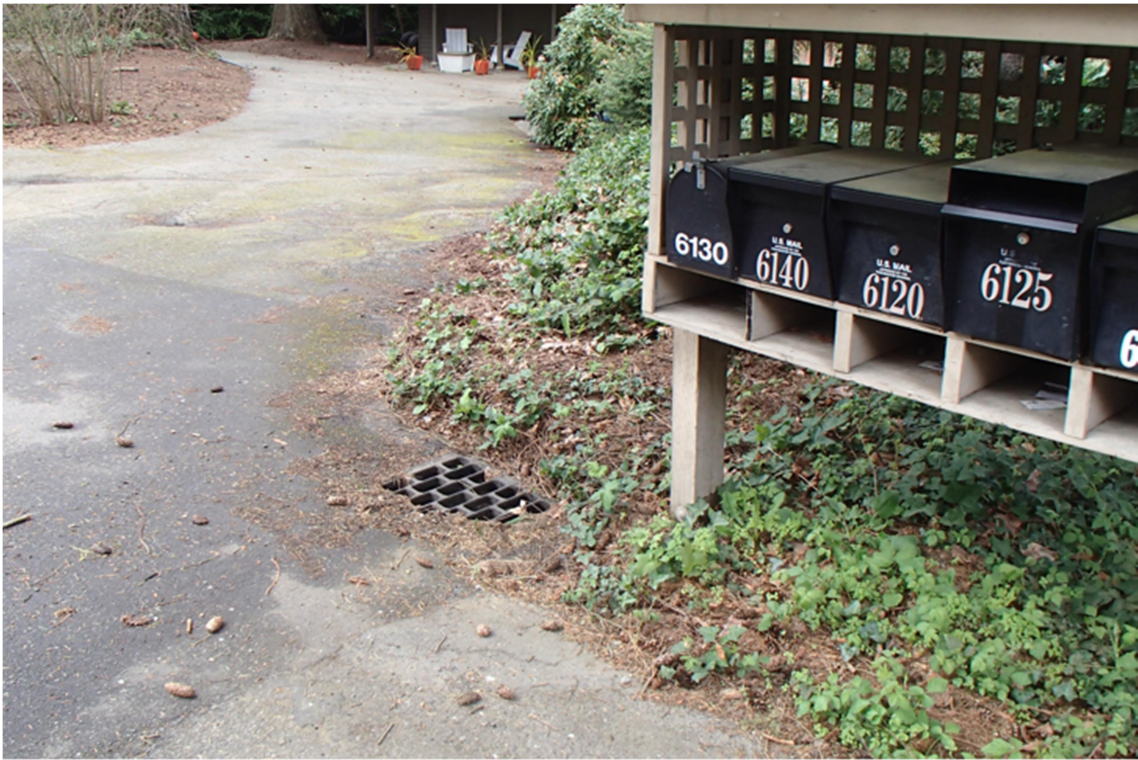
Photo No. 3 Looking northeast at CB 30a-9 between House #6130 and #6140

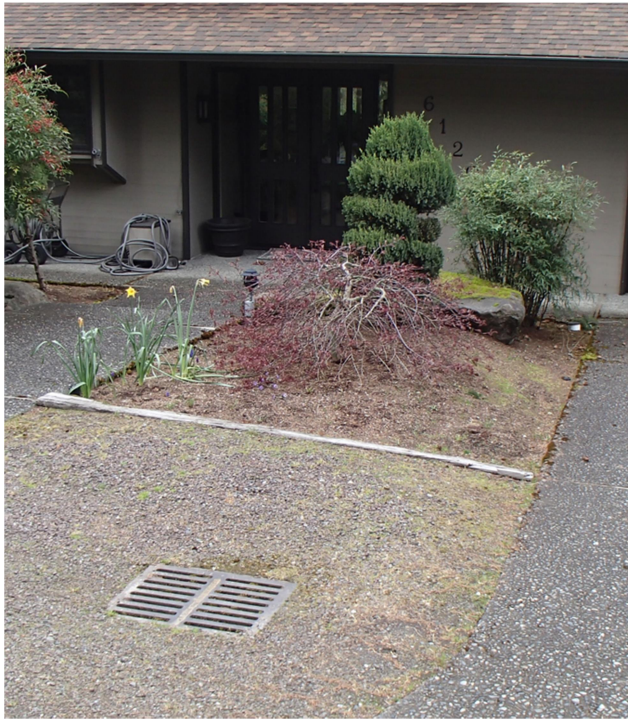
Photo No. 4 Looking easterly at CB 30a-11 in front of House #6120.

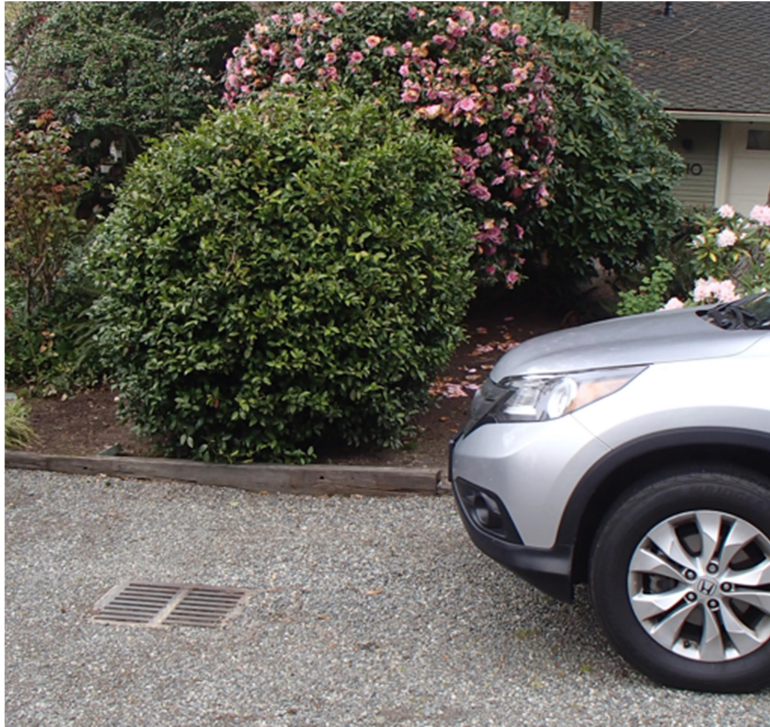
Photo No. 5 Looking east at CB 30a-24 at House #6110.

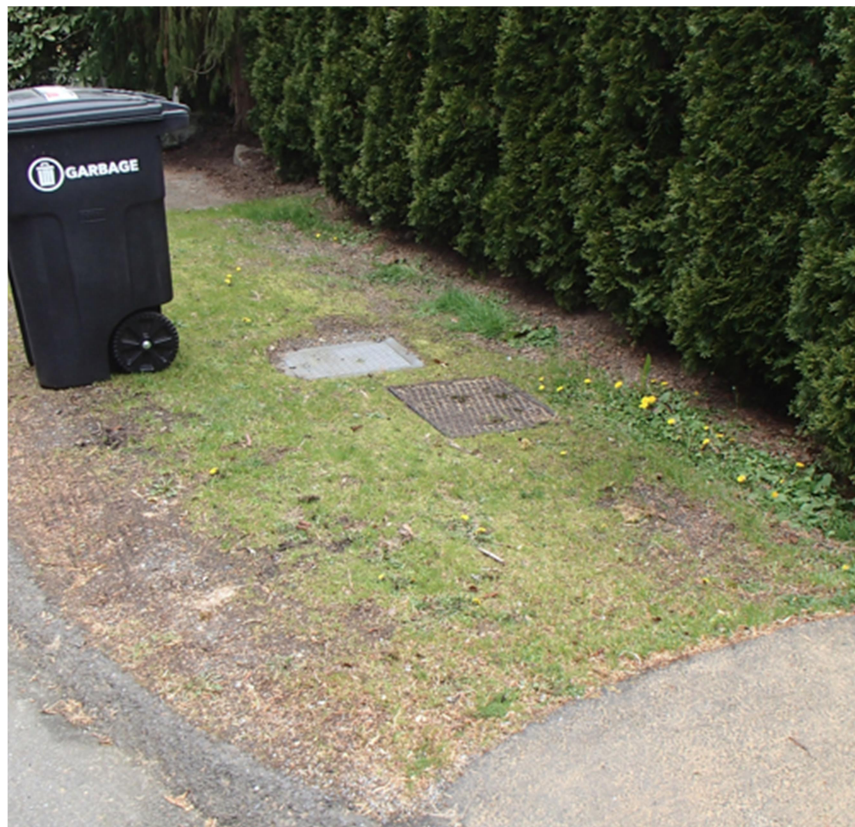
Photo No. 6 Looking northwesterly at CB 30a-25 (solid cover) where the SD crosses to the south side of the street and connects to CB 30a-34.

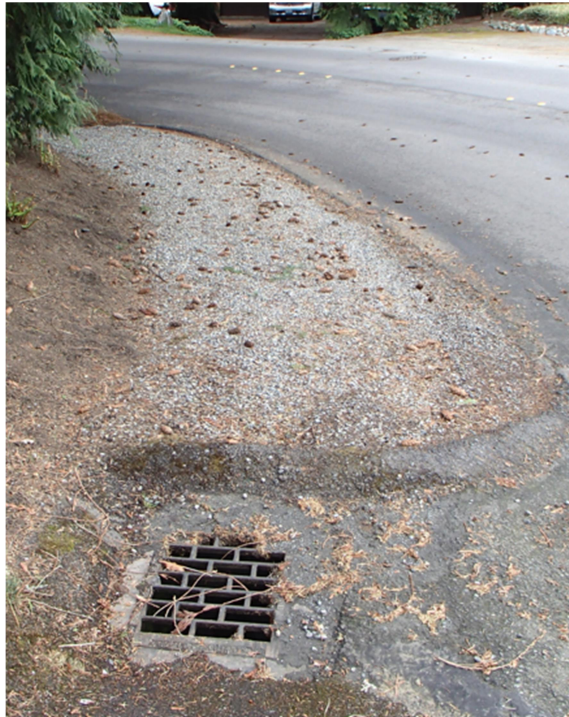
Photo No. 7 Looking southwesterly at CB30a-52 opposite House #6019 and #6017. Note gravel lip and vaned grate to catch runoff down steep road grade.

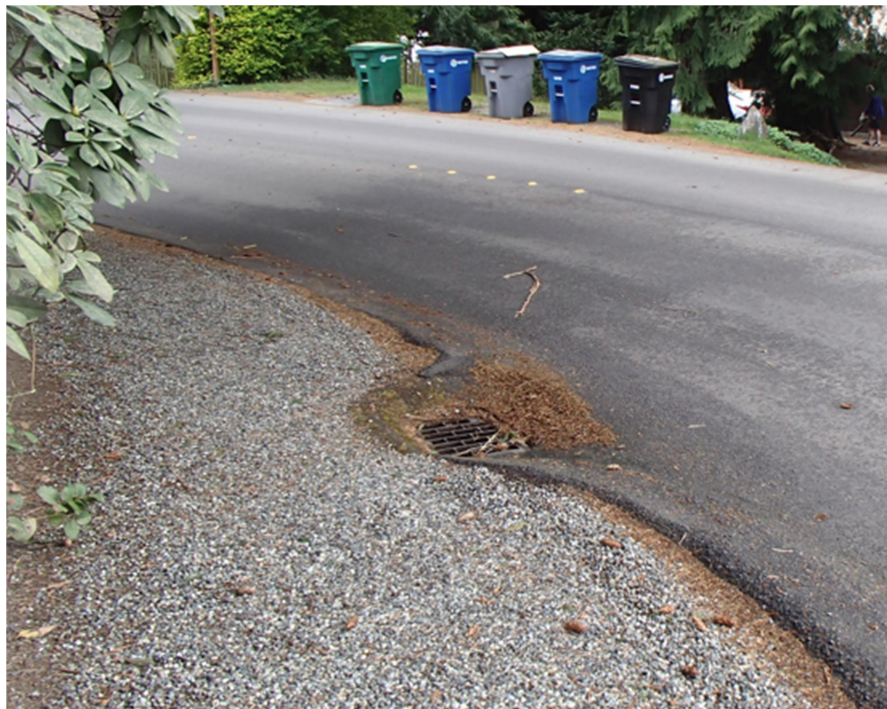
Photo No. 8 Looking southerly at CB #30a-51 opposite House #6035. Note accumulation of fir needles, but still appears to be draining well.

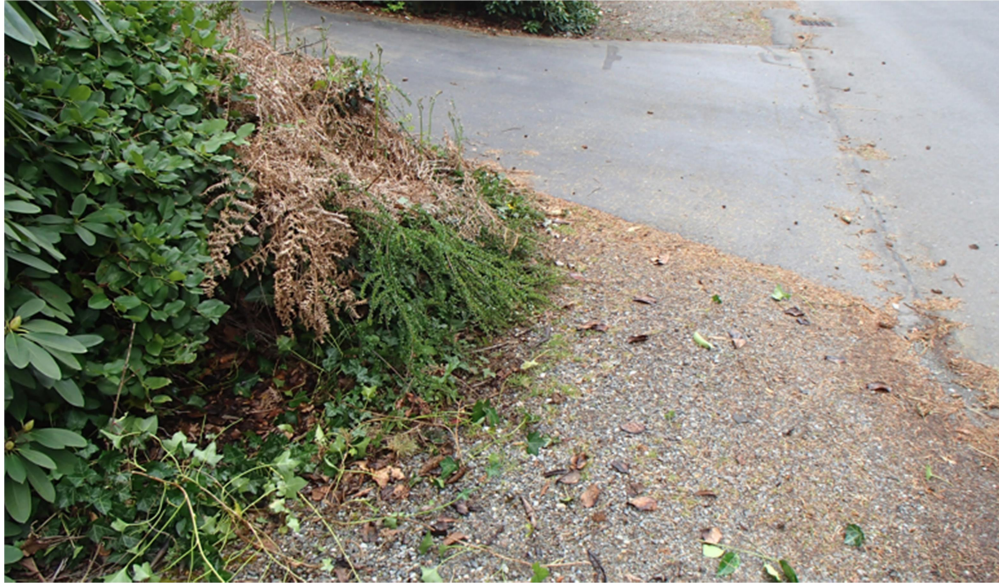
Photo No. 9 Looking southerly at CB #30a-17 adjacent House #6030. Note ivy growing over grate, but it appears to be draining and not signs of surface bypass flow. Photo is past end of ¼ mile Downstream Analysis. Further review downstream completed to confirm outfall to Lake Washington.

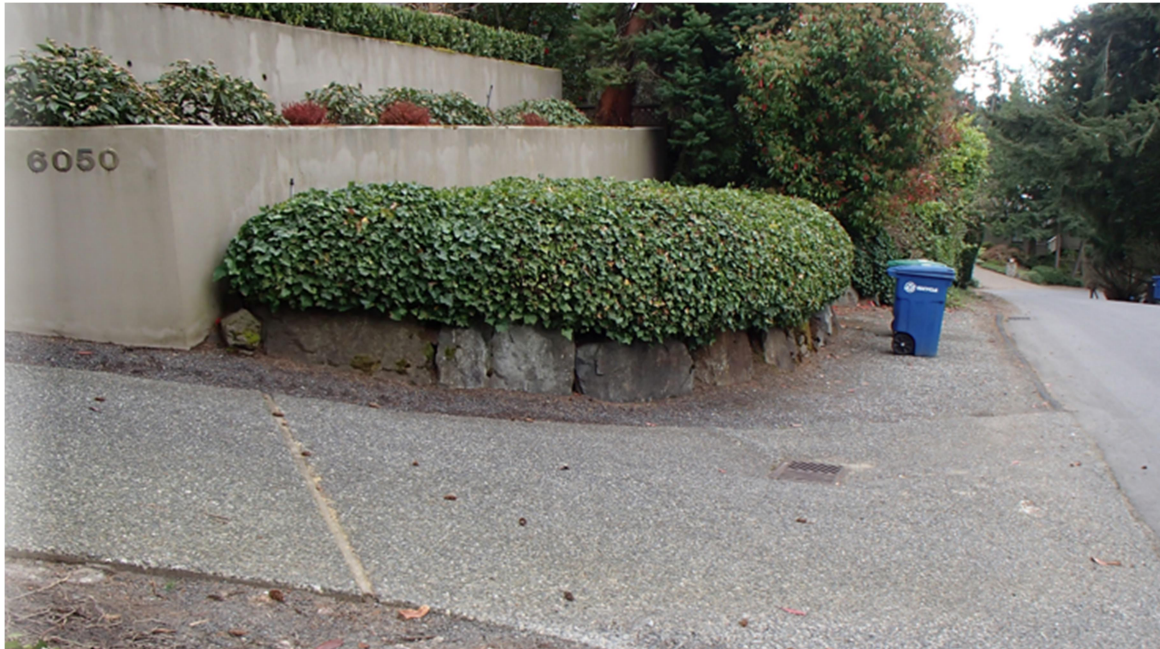
Photo No. 10 Looking southerly at CB #30a-35 adjacent House #6050.

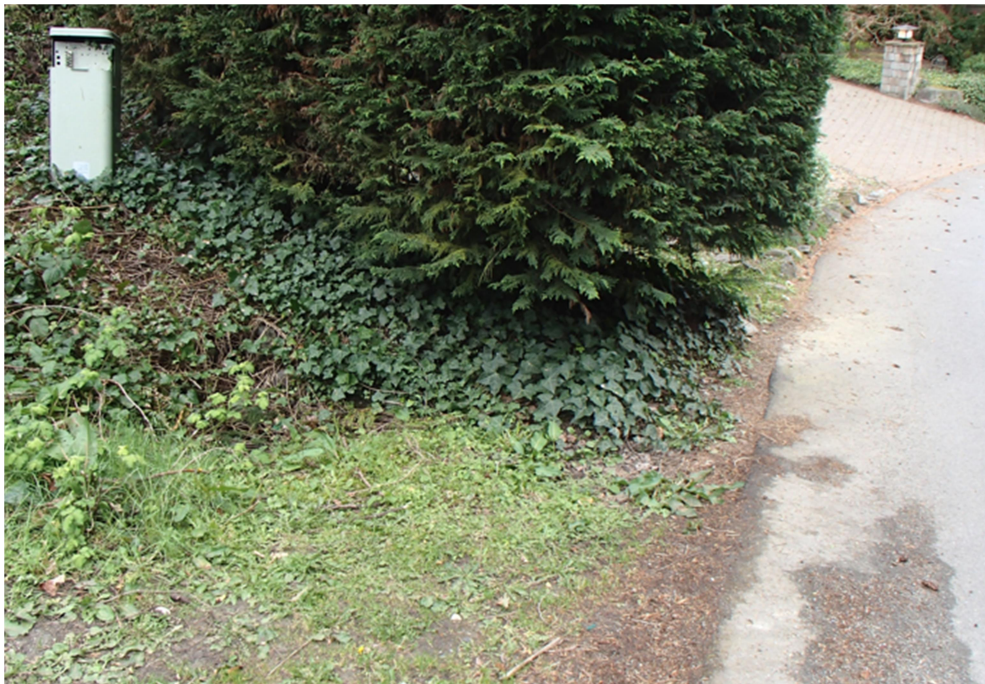
Photo No. 11 Looking southerly at CB #30a-37 just south of House #7820. Note ivy overgrowth but CB appears to be draining. Minor indication of erosion at the pavement edge. Inlet in street appears to be full of sediment (CB#30a-43) not on main line, so no impact to conveyance capacity.

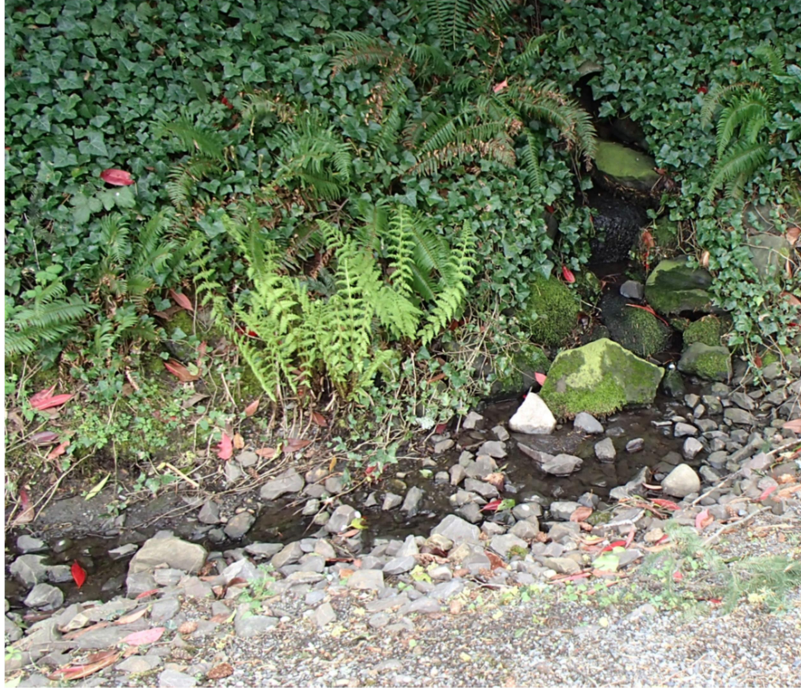
Photo No. 12 Looking east at pipe end discharging to roadside swale just upstream of inlet pipe upstream of CB #30a-38 at House #6065. Swale appears stable with small rock riprap and other cobbles. It appears some of the flow may be diverted south at CBa-37 (see Photo #11) to reduce impacts to this open swale.

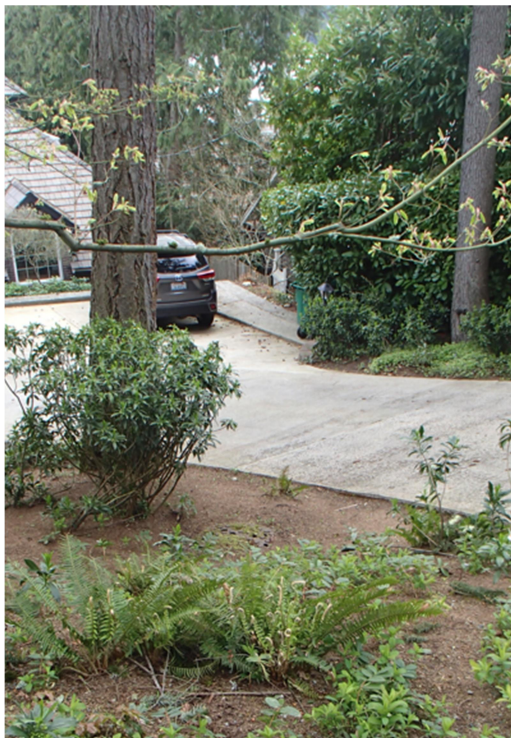
Photo No. 13 Looking west at CB #30a-38 adjacent to House #6215. Solid cover next to driveway and outfall to Lake Washington
