## **Arborist Report-New SFR**

**January 26th, 2023**

**Prepared for:**  
Charles Hatley

**Site Address:**  
4114 83rd Ave.  
Mercer Island, Wa

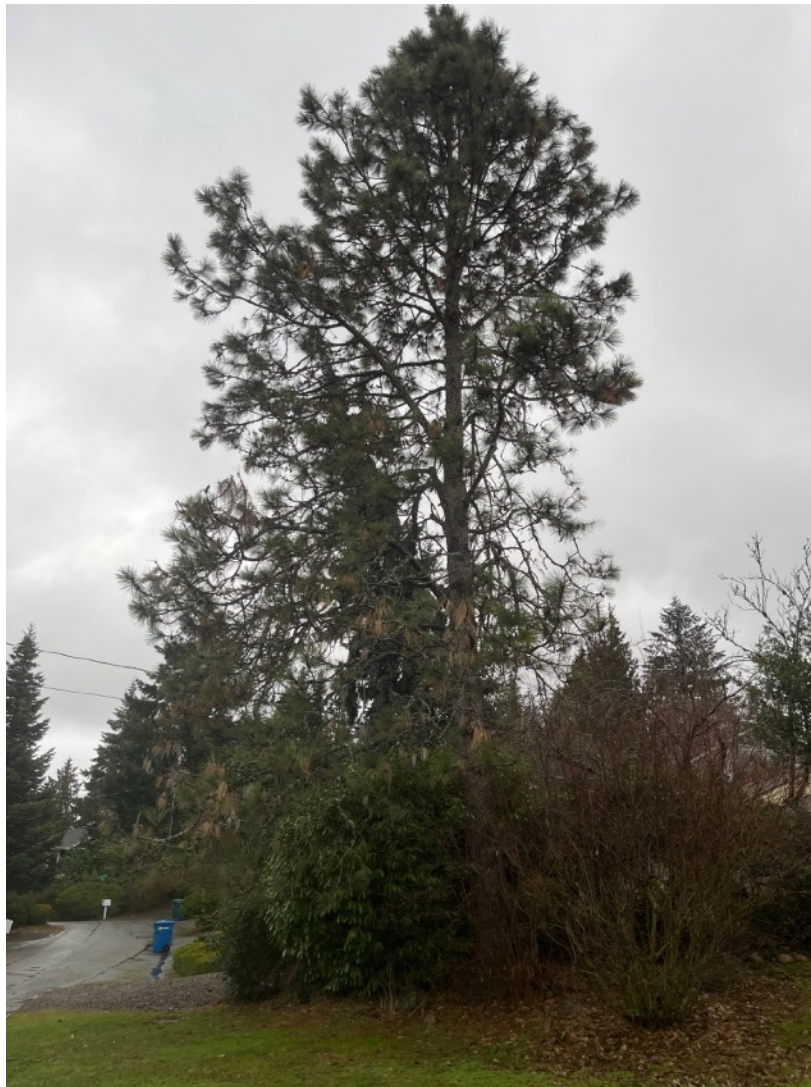
**1371**

**Tree number 1371** is in the northwest corner of the lot. It is a Ponderosa Pine (*Pinus ponderosa*) tree next with a diameter at standard height of 23.5 inches. The tree has a fairly narrow upper canopy and its drip line measures 16 feet. Condition 6.

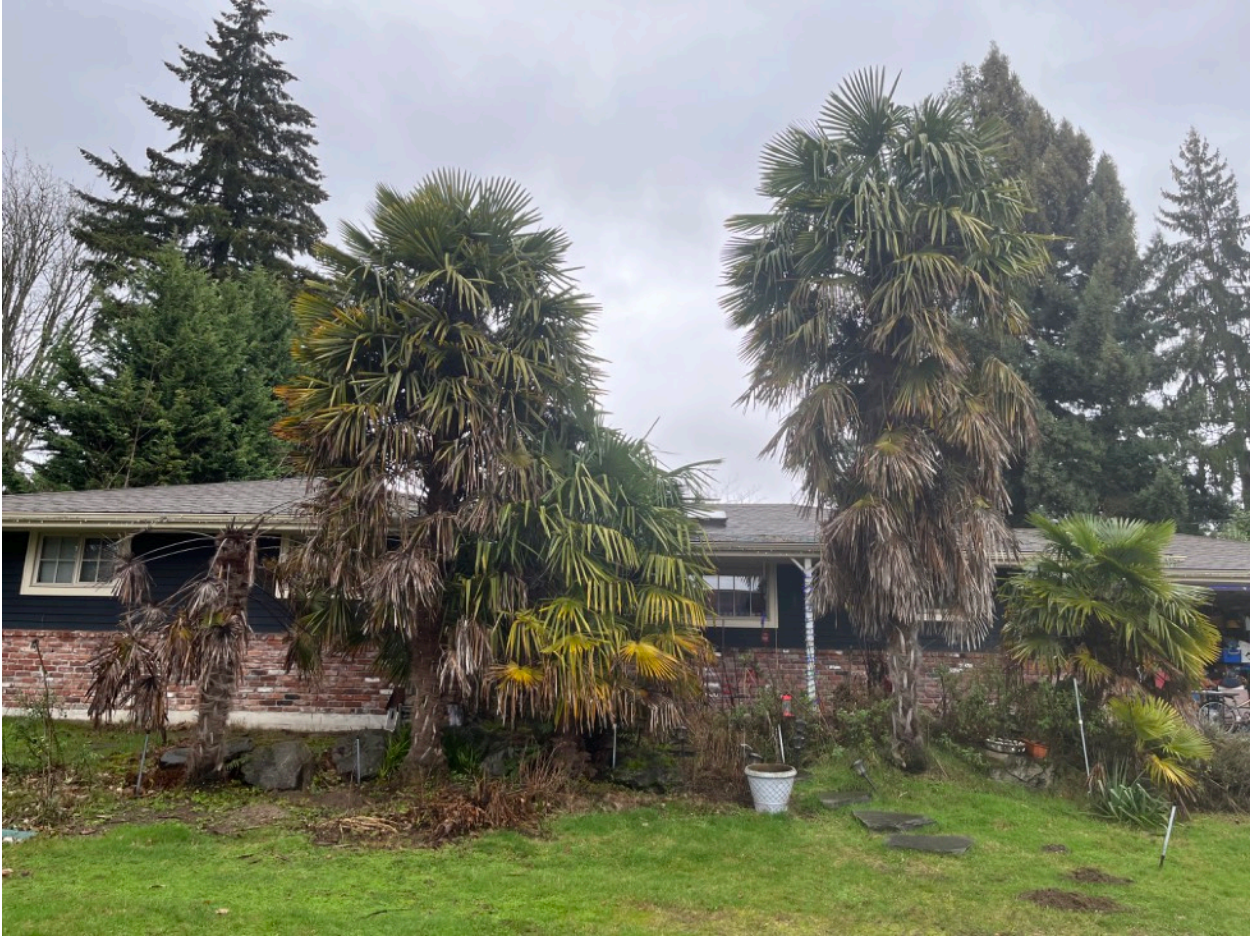
**4 Windmill Palms west of existing SFR. These will need to be removed for the build.**

**The proposed new SFR will require the removal of the Windmill Palms and Crabapples (Tree #'s 1374, 1375, and 1376. All of the other trees can be protected and will not be adversely affected by the proposed developments. Tree Protection Fencing should be placed at the drip line of each retained tree prior to construction activities commencing.**

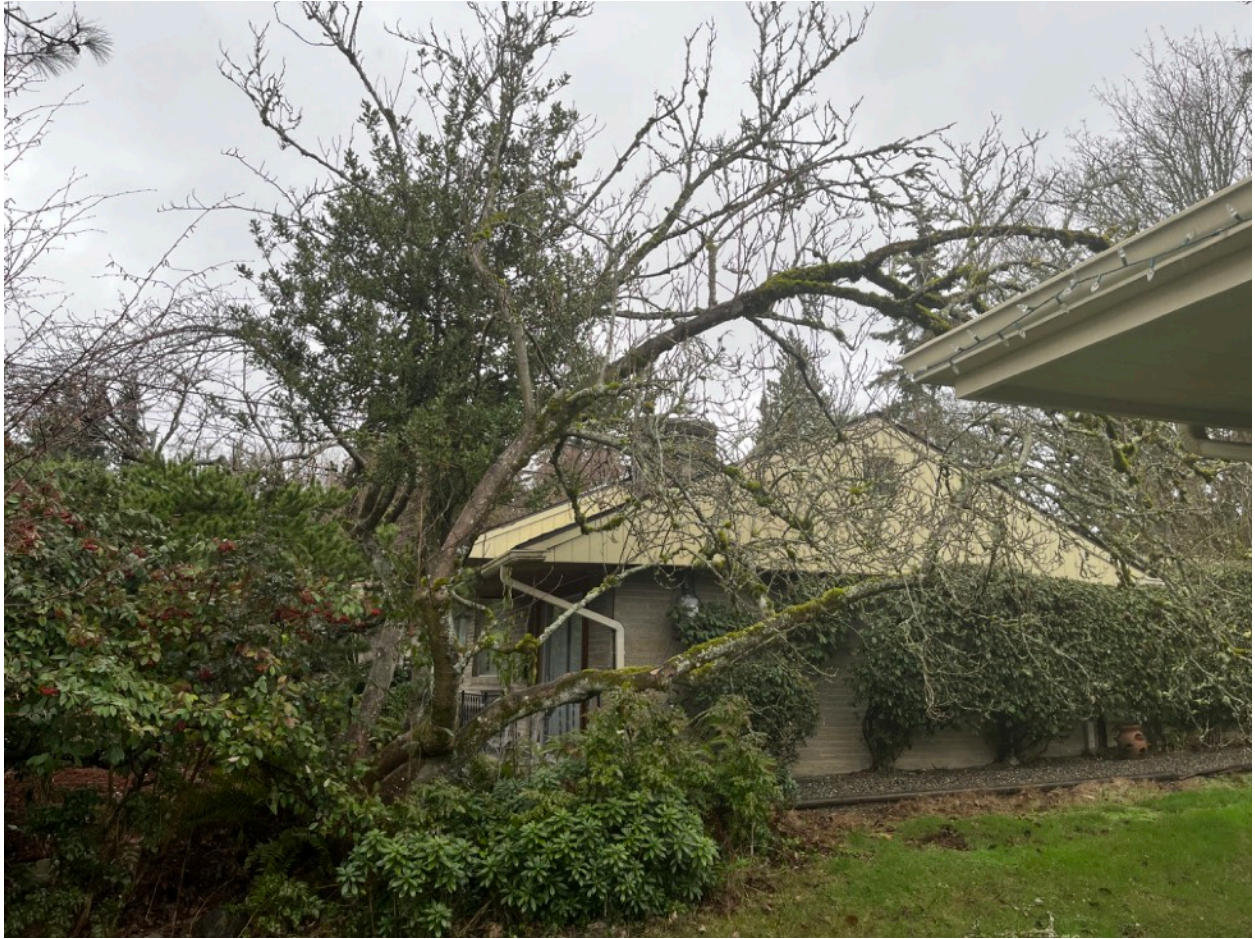
**1372 Neighbor's Magnolia**

Moving directly to the east away from the pine, we come to tree number **1372**, which is a saucer Magnolia that is growing on the north neighbor's property. This tree has three main stems that have diameter at standard height readings of 6 inches, 6 inches, and 5 inches. This is a low, sprawling tree, whose canopy mostly grows to the east to get away from the aforementioned ponderosa pine. The drip line diameter for this tree is 20 feet when measured with the laser rangefinder. Condition 4.

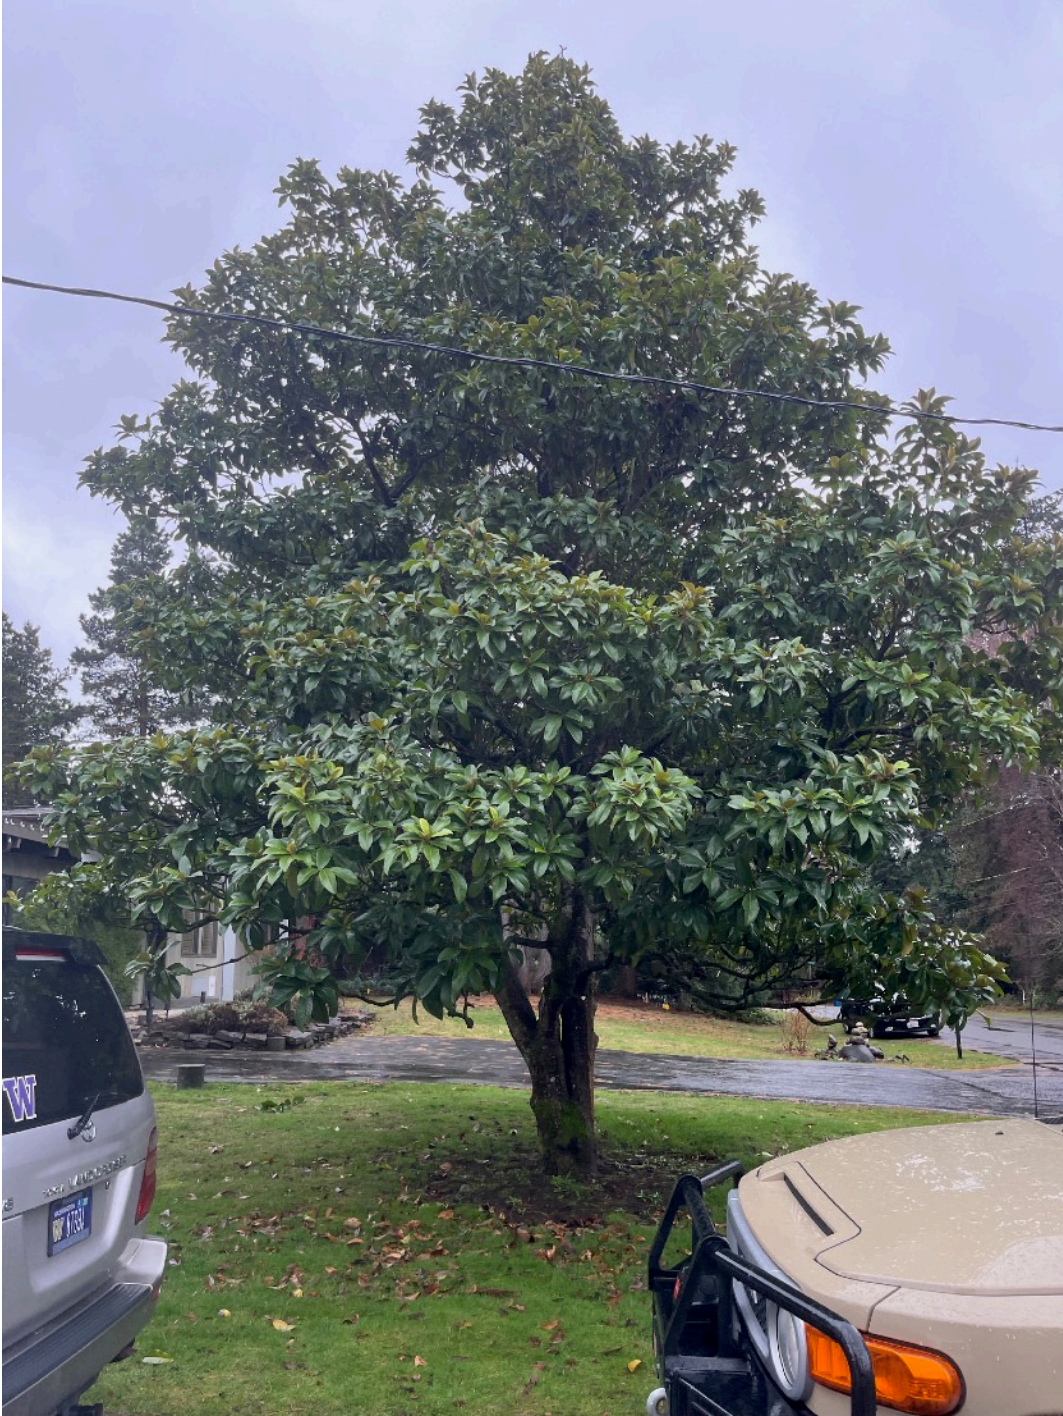
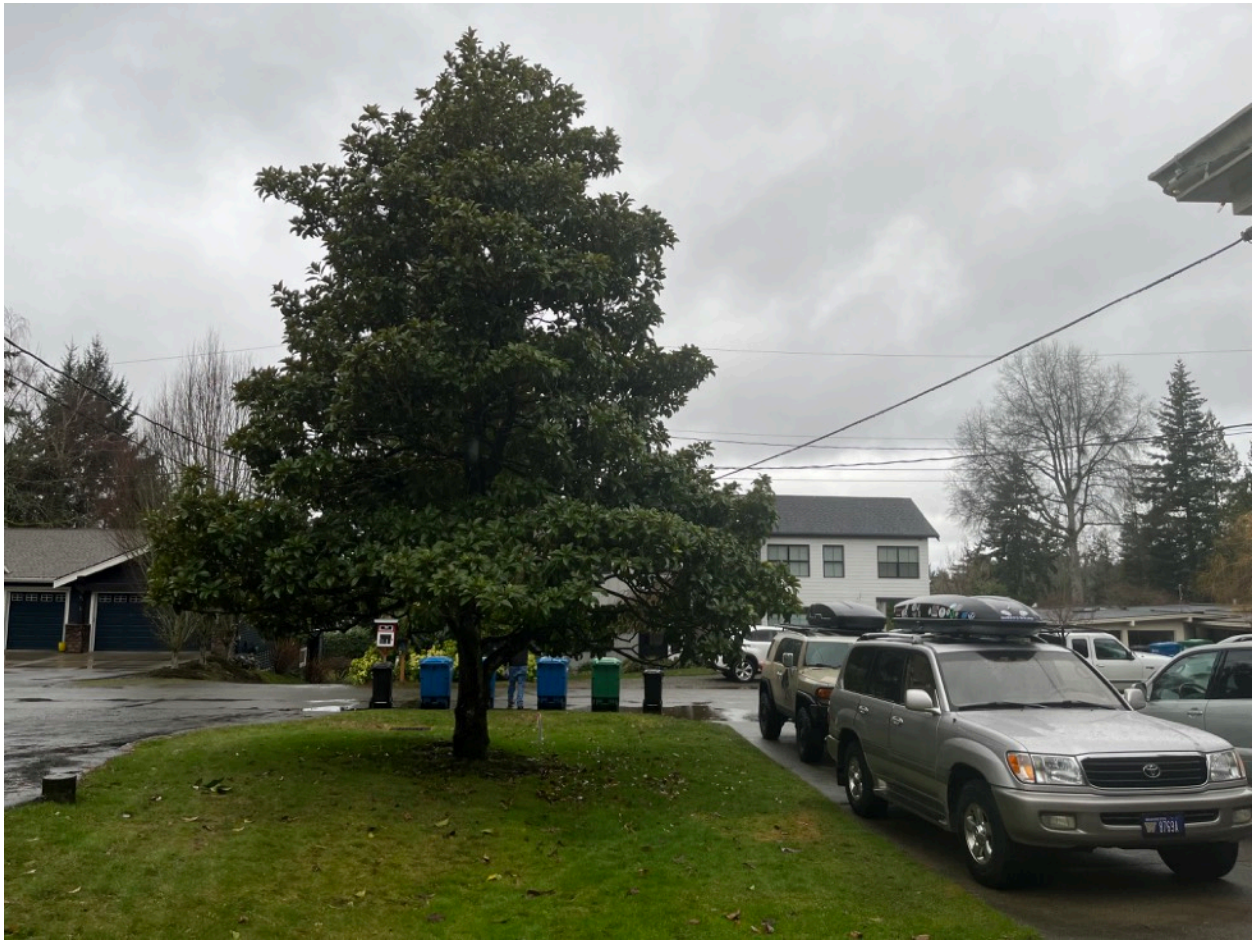
1373

**Tree number 1373** is on the south neighbor's lot. It is an Evergreen Magnolia (*Magnolia grandiflora*) that is condition 6. This tree has three main stems with diameter at standard height readings of 12 inches, 8 inches, and 9 inches. A nice specimen with excellent access to light and a well-proportioned canopy. This tree has a drip line radius of 14 foot. I advise the client to place Tree Protection Fencing around the entire drip line of this tree prior to construction activities commencing. The tree protection fencing should be clearly indicated on the site plan that gets submitted to the city for permitting.

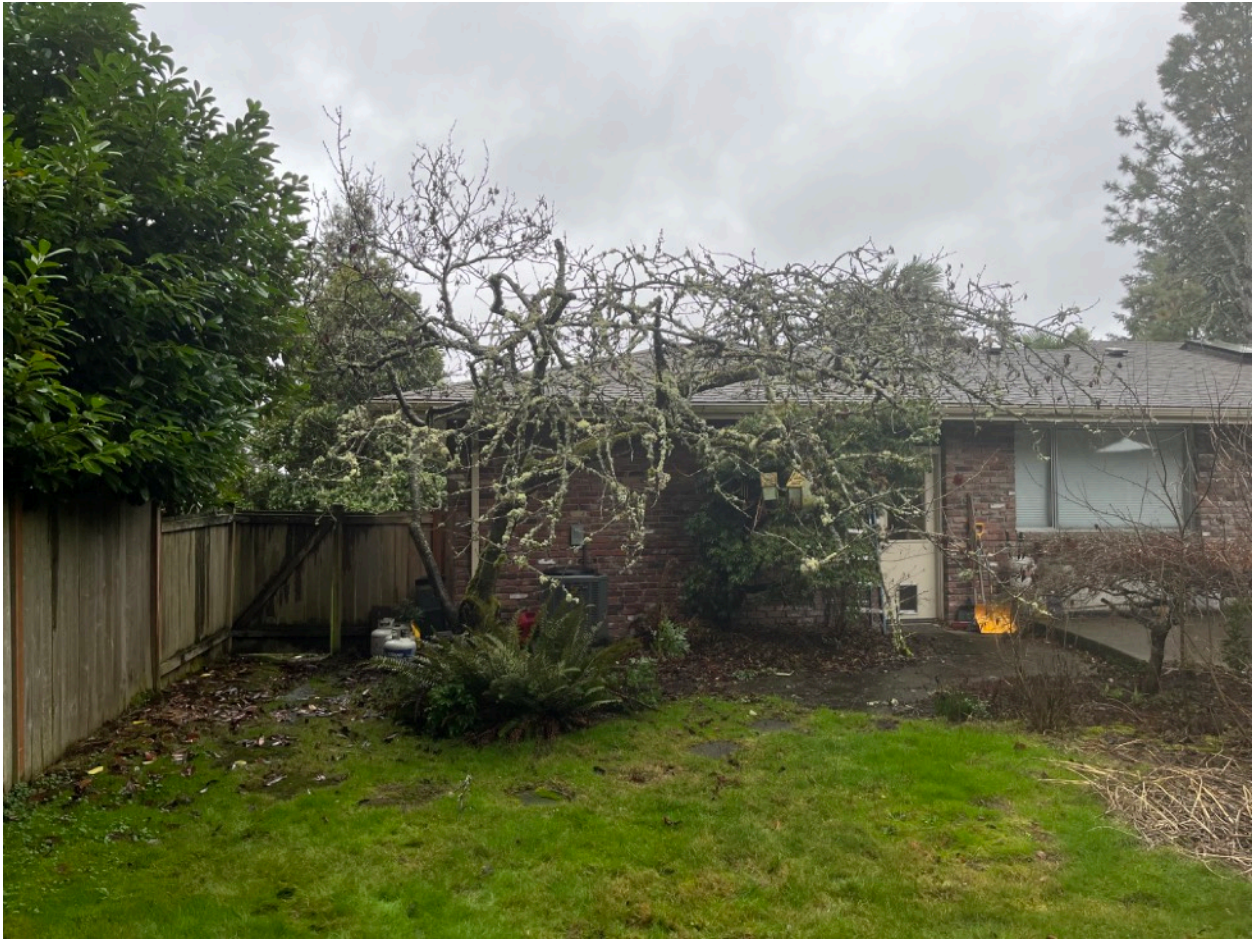
1374

Just inside the entrance to the backyard is a group of Crabapples (*Malus sp.*) that are clustered on the east side of the house. The southernmost tree is **1374** and it is a three stem system with stems measuring 6 inches, 7 inches, and 3 inches. It is apparent that this tree is suffering from some early-season fungal pathogens and it is condition 4. Its drip line radius is 12 feet.

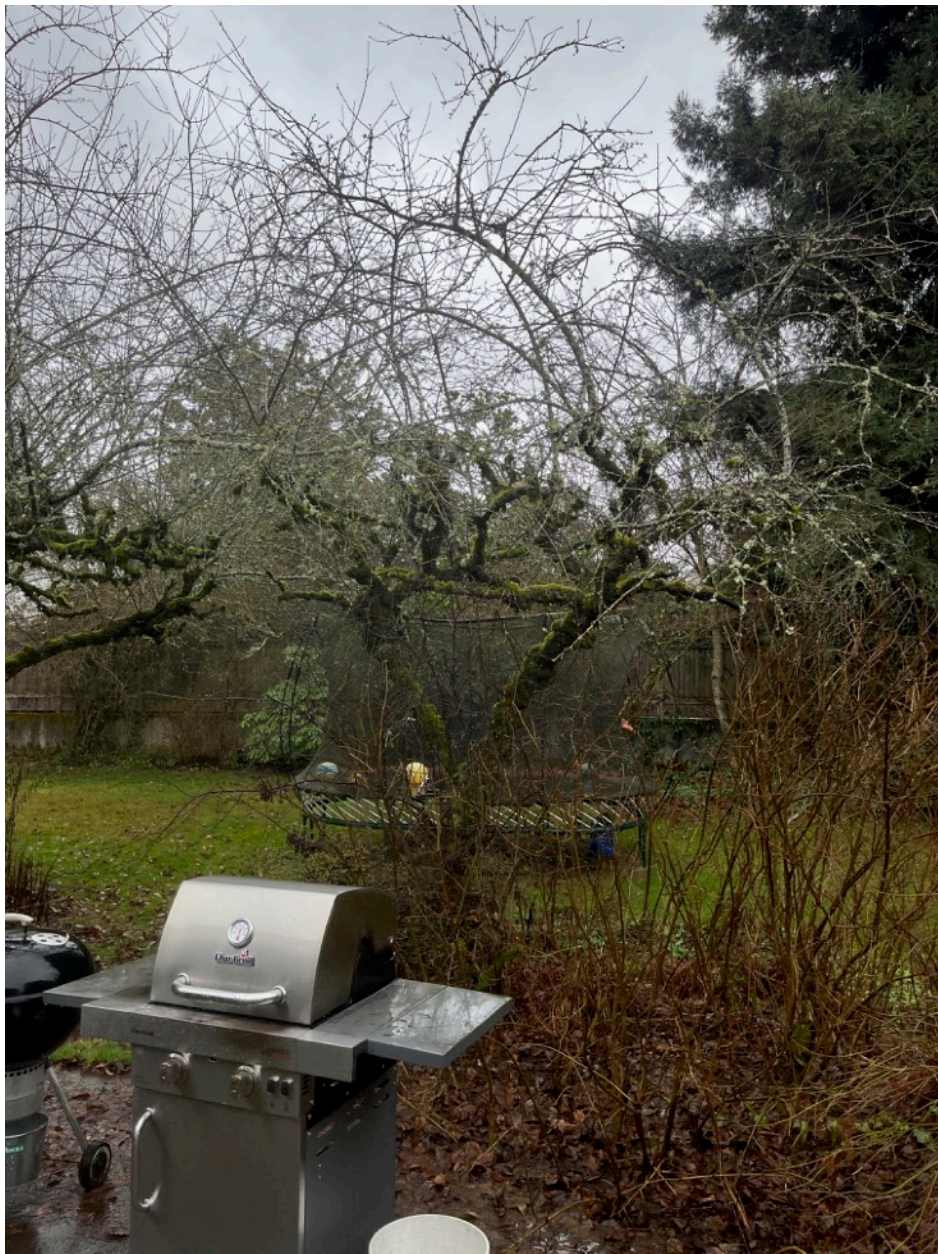
1375

**Tree number 1375** is another Crabapple that is located just to the north of the aforementioned system. This tree's drip line radius is only 8 feet as it is sandwiched between the two other trees and relatively narrow. This tree has two stems with diameter at standard height readings of 6 inches and 4 inches. This tree is condition 2/3.

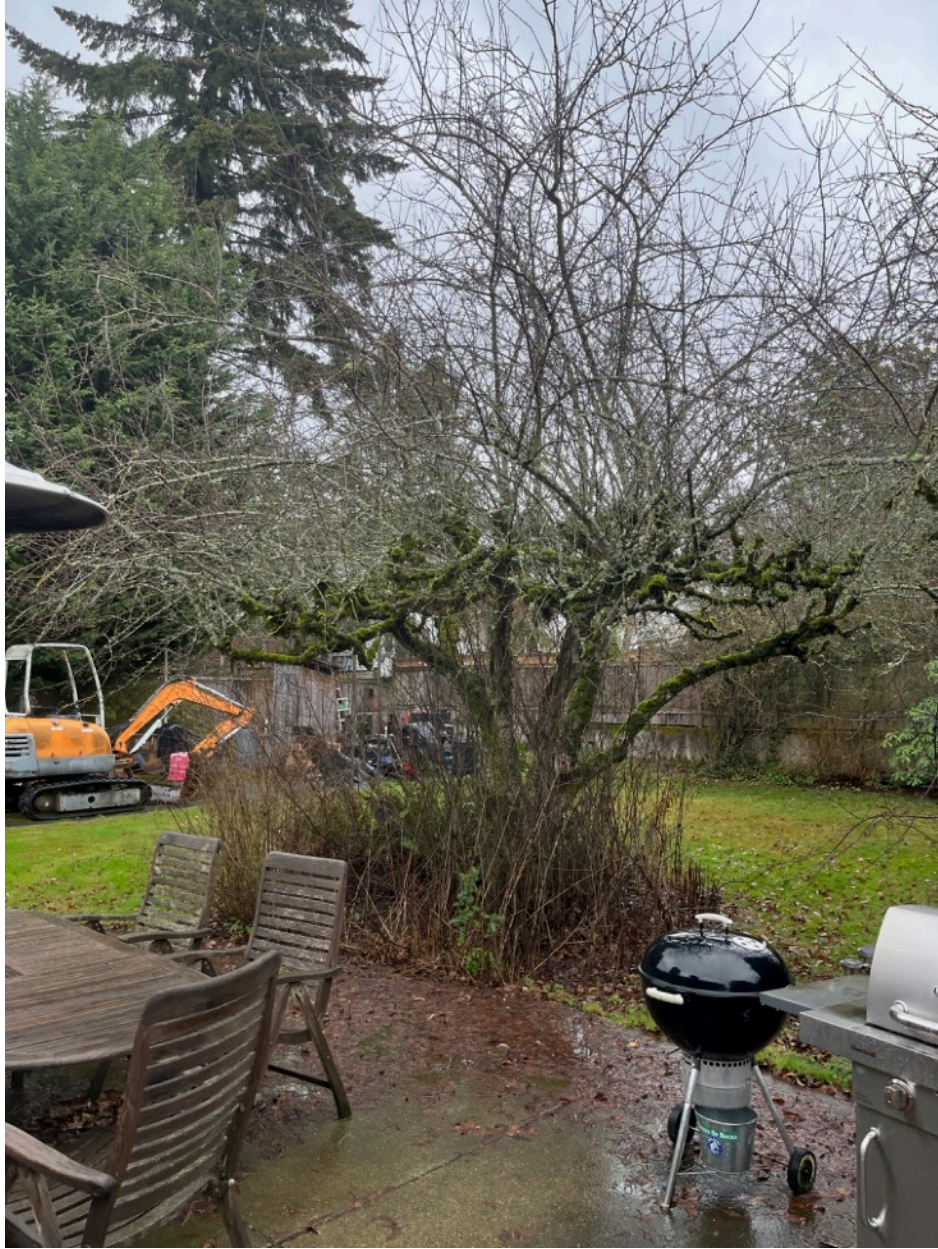
1376

**Tree number 1376** is the broadest of the Crabapple trees and it has four stems. DSH readings are 7 inches, 7 inches, 6 inches, and 4 inches. The drip line radius of this tree is 15 feet. This tree is condition 4/5.

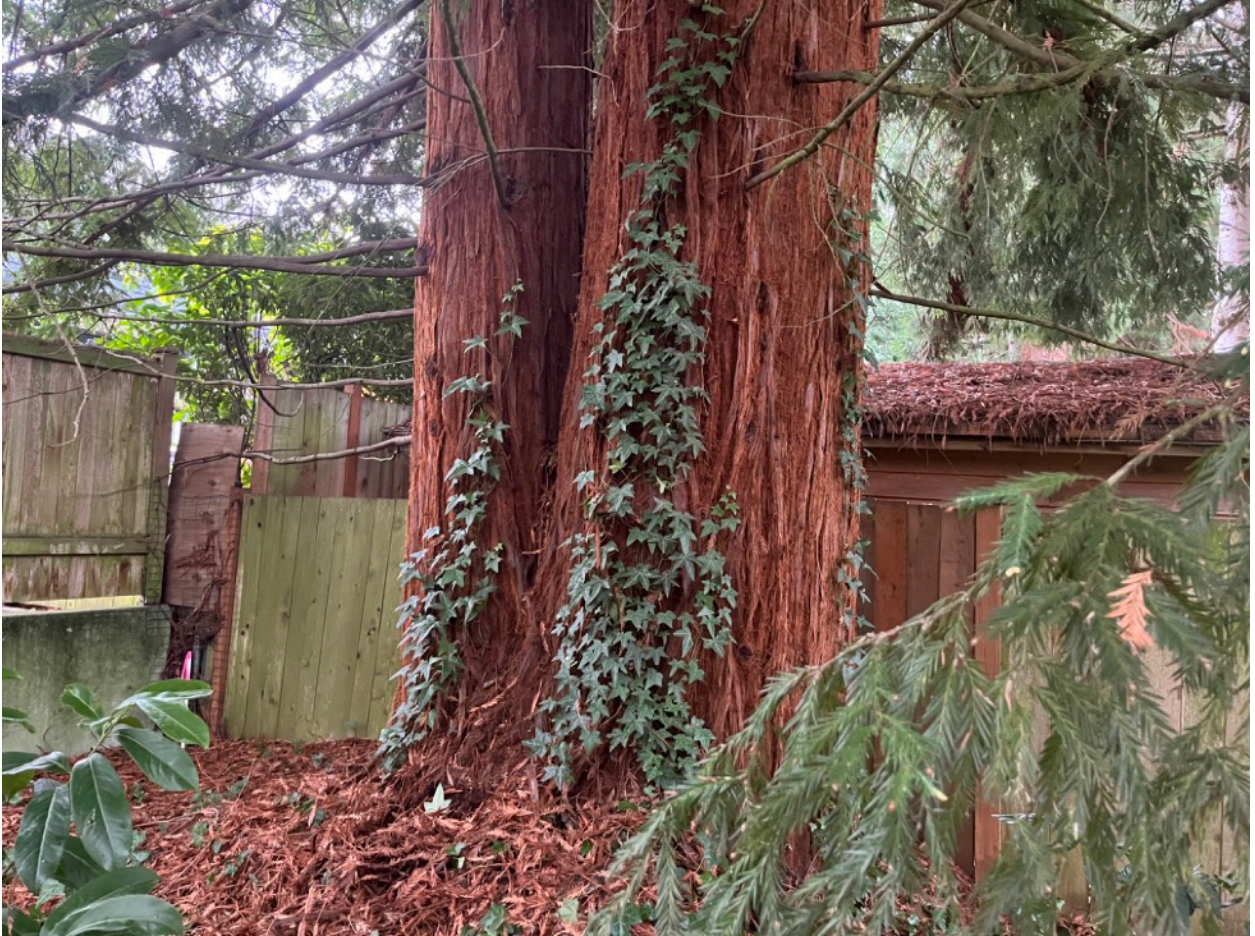
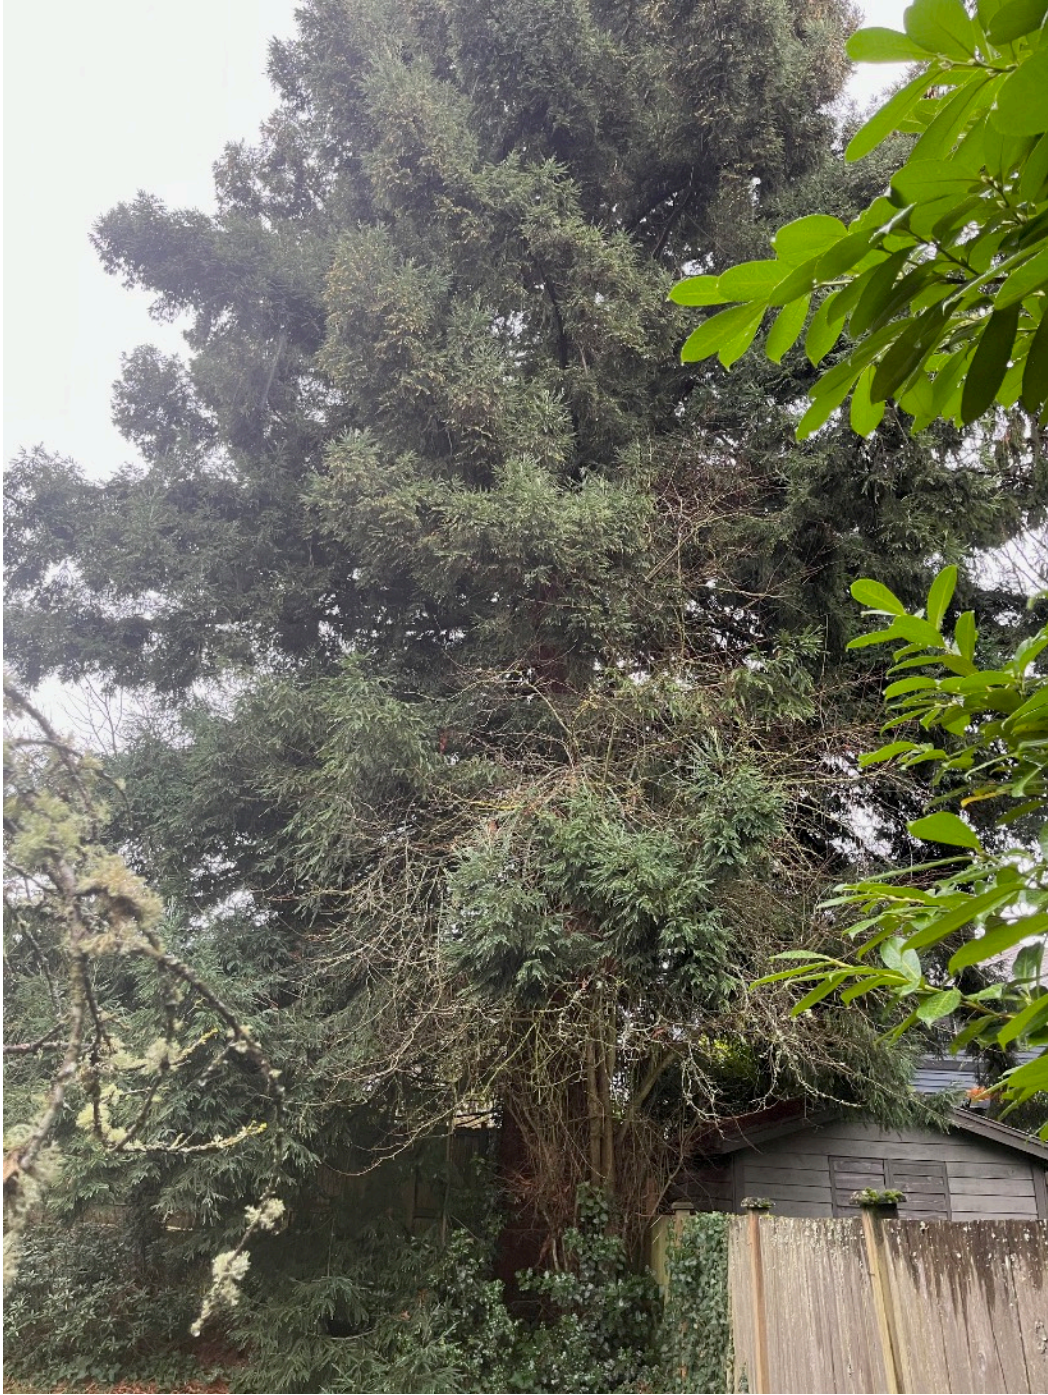
1377

**Tree number 1377** is located in the southeast corner of the lot. This tree is a Coast Redwood (*Sequoia sempervirens*) with two main stems that originate approximately 2 foot above the root flare. The eastern stem has a diameter at standard height reading of 31 inches and the western stem has a diameter at standard height reading of all 42 inches. This is an open grown specimen with excellent access to light and a live crown ratio of nearly 100%. This tree is in excellent condition and pruning on this tree should be limited to clearance for adjacent structures and minor lifting of the low canopy, if at all. For the purposes of establishing a critical root zone radius for this tree, it is more appropriate to use the drip line measurement than the diameter at standard height measurement to extrapolate the geometry. This tree's drip line radius is 23 foot plus the additional distance to the center of the system; totaling 26 feet. It is my suggestion that the client place Tree Protection Fencing around the entirety of the drip line of this tree prior to construction activities commencing and that that fencing be left in place for the duration of the project.

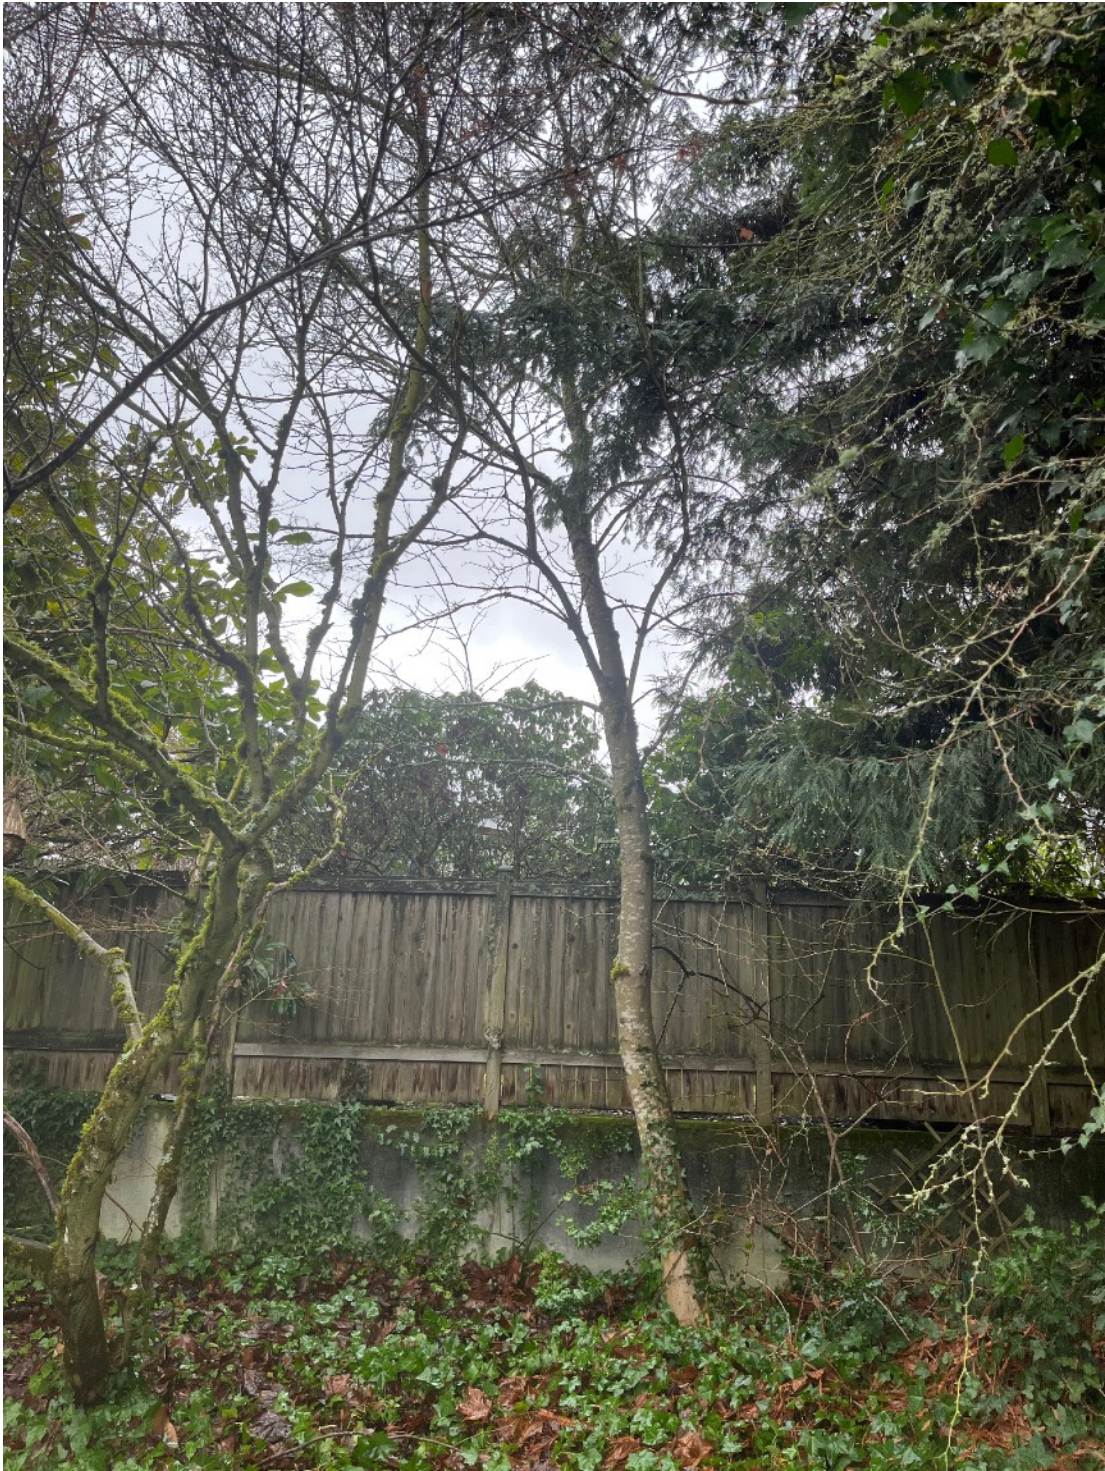
1378

**Tree number 1378** is just to the north of the aforementioned Redwood. It is a young Big Leaf Maple (*Acer macrophyllum*) tree with a diameter at standard height reading of 8 inches and a drip line radius of 6 foot. This tree is condition 6 and has a critical root zone with an 8 foot radius.

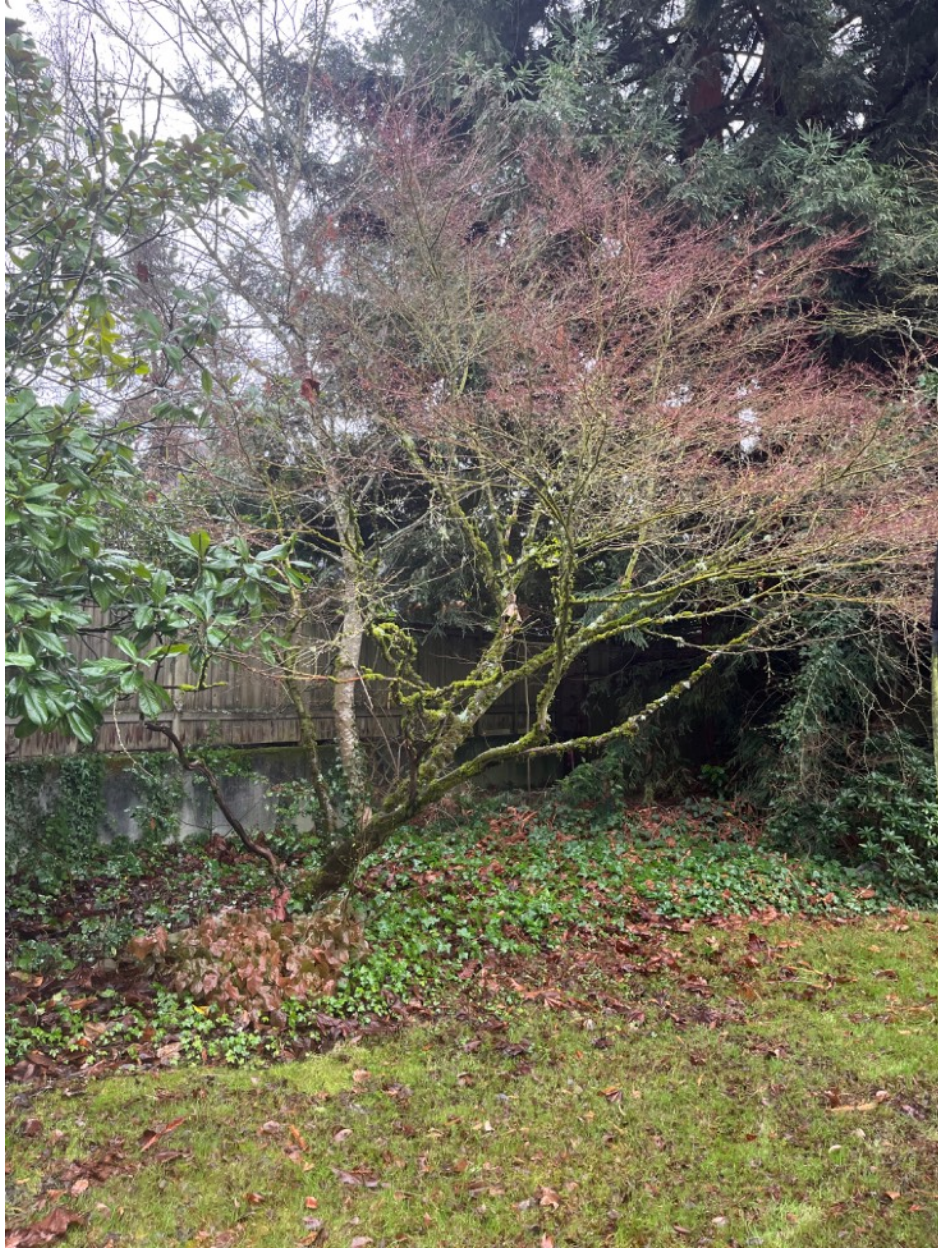
1379

**Tree number 1379** is a Vine Maple (*Acer circinatum*) that is located just to the northwest of the aforementioned maple. This tree has three stems with diameter at standard height readings of 5 inches, 2 inches, and 3 inches. This tree has a drip line at diameter of 22 feet. It is a fairly broad specimen, despite the small DSH measurement.

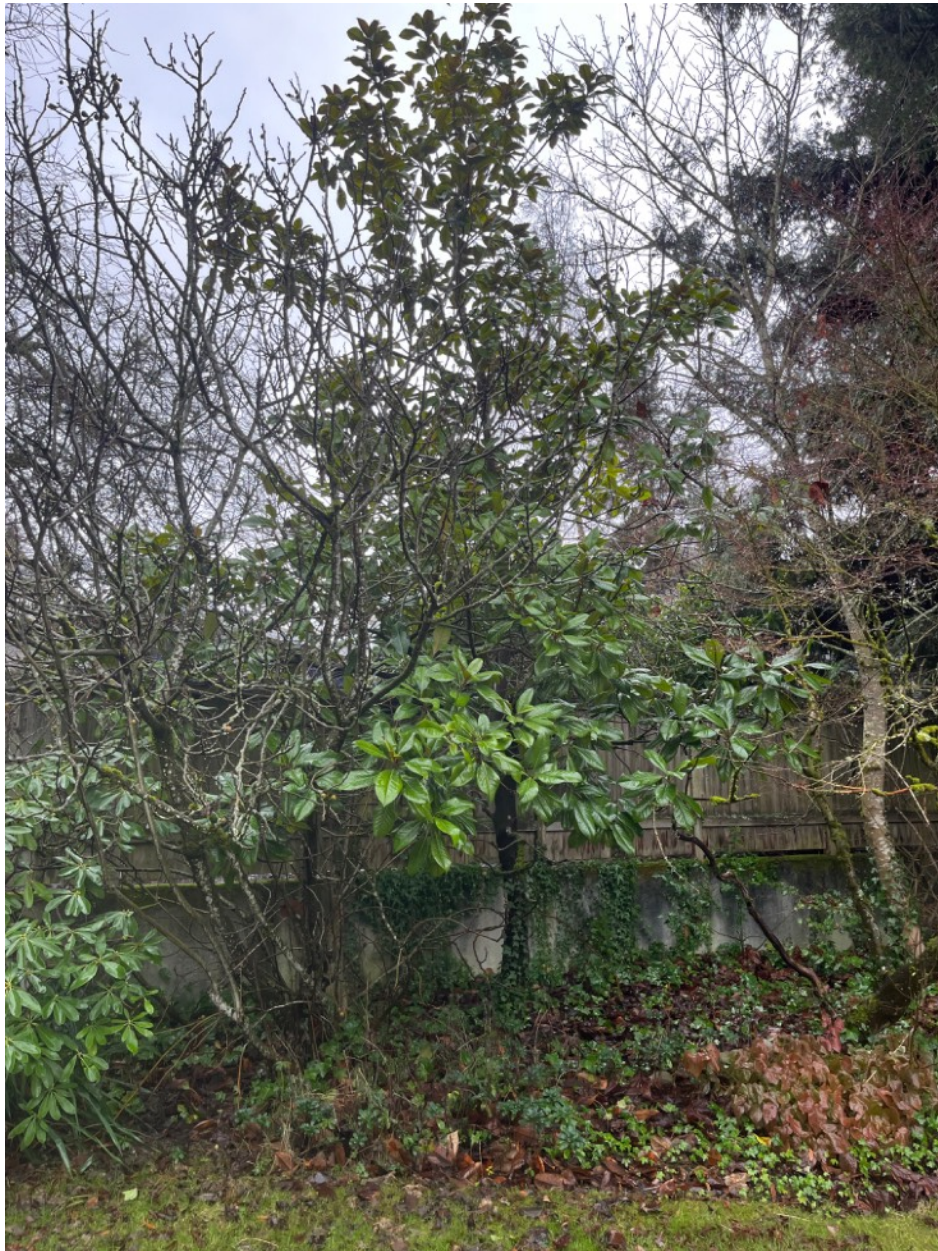
1380

Just to the northeast of the Vine Maple is tree number **1380**. It is an Evergreen Magnolia (*Magnolia grandiflora*) with a diameter at standard height reading of 6 inches and a drip line radius 6 foot. Condition six.

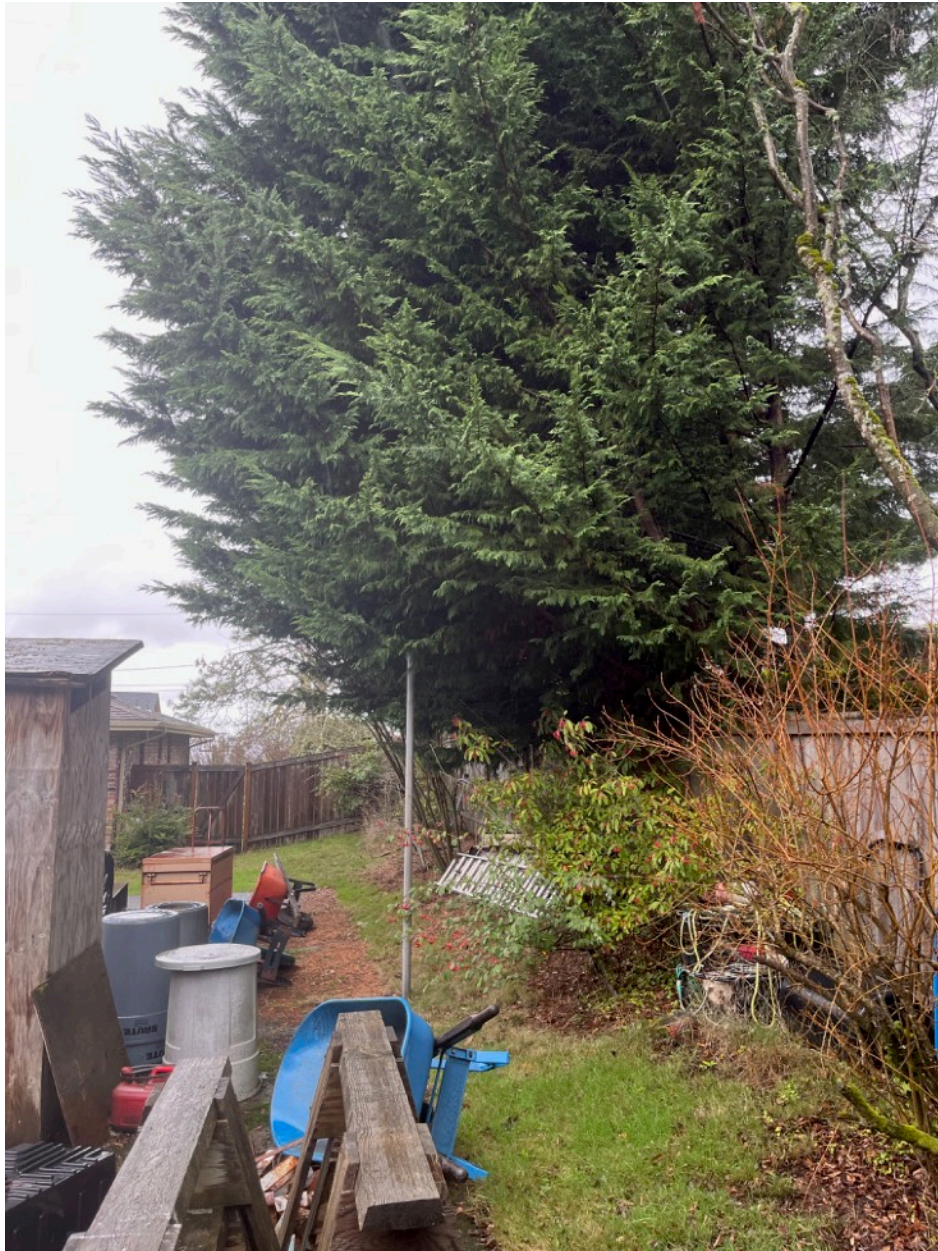
**North neighbor's Leland Hedge**

Over the fence in the backyard, the north neighbor has installed a row of Leyland Cypress (*Cupressus x Lelandii*) within 1 or 2 foot of the wooden fence. During the site visit, I counted approximately 12 trees that have acquired a height of approximately 35 foot. This installation will continue to grow quite a bit and at the time of the site visit, the branches of these trees were extending 16 foot to the south and onto my clients property. Placing tree protection fencing around the drip lines of the Leland Cypress is a good idea prior to construction.
