**To:** Tanya Nachia Somanna, Hoa Hoang  
**Job Site:** 7929 E MERCER WAY 98040  
**Parcel:** 3024059176  
**Subject:** Arborist Report  
**Date:** 6/18/2021, 1/9/2023  
**From:** Andy Crossett, ISA Certified Arborist #PN-7375A, Qualified Tree Risk Assessor, WSNLA  
Certified Professional Horticulturist #2537

### Assignment

Tanya Nachia Somanna of Warmmodern Living contacted me and asked that I prepare an arborist report for the trees located at 7929 E Mercer Way, Mercer Island WA. She was representing her client Hoa Hoang, the owner of the subject property.

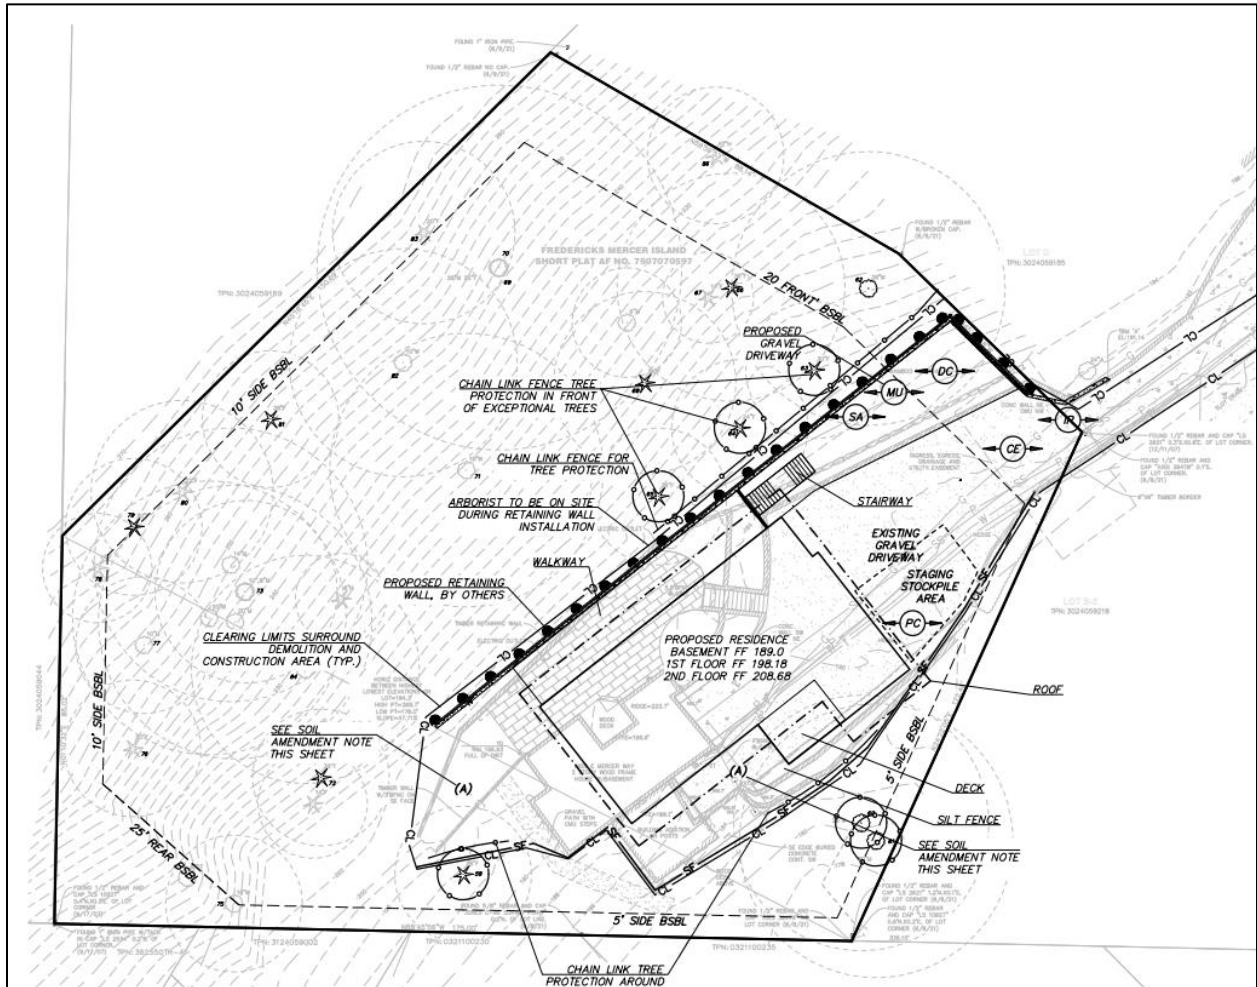
### 6. Proposed Site Plan - Tree Protection

I have identified and measured all on-site trees to define their critical root zones and limits of disturbance. Approximations of the locations of the recommended protection measures have been included on the site map below. The majority of the on-site trees will not be significantly impacted by construction as they are located on the slope north of the home. However, there are a few notable exceptions to this:

**Trees 58, 60, and 61** will be retained but are located within areas that may be impacted by construction activities and will therefore require tree protection fencing to ensure their critical root zones are protected.
