CONSULTING ARBORIST

Job Site: 7929 E MERCER WAY 98040

Subject: Arborist Report

Date: 6/18/2021, 1/9/2023, 12/14/2023 (current)

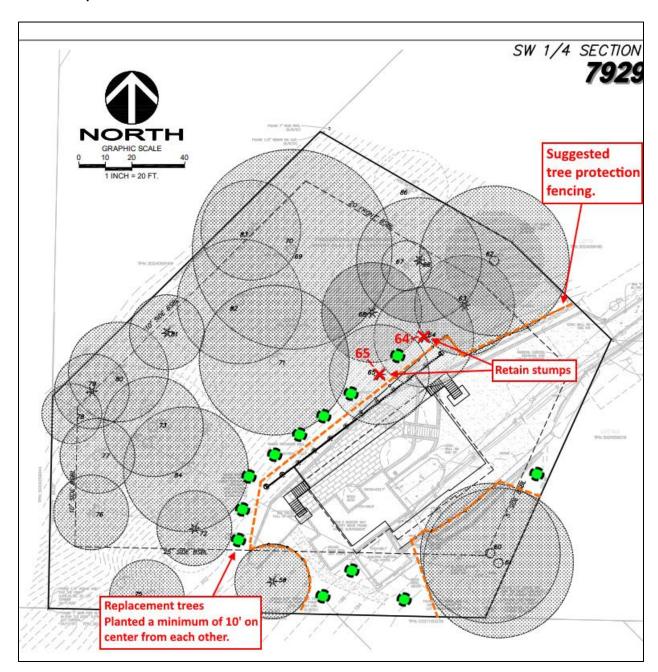
5. Proposed Site Plan - Trees

Tree 62 is a 29" DBH bigleaf maple in good condition. This tree will be impacted by the widening of the driveway and installation of retaining wall. The area of disturbance will occur in the southern portion of the dripline and represents 14.5% of the total dripline area. Per Trees and Development: A Technical Guide to Preservation of Trees During Land Development, bigleaf maple is listed with a "good" relative tolerance to root disturbances. Therefore, is unlikely the health or stability of the tree will be significantly impacted by construction. The proposal to expand the driveway has been withdrawn, and there are no plans for any disturbances within the dripline of this tree.

Trees 63 (31"), 64 (22"), and 65 (31") are all Douglas fir in good condition. These trees will also be impacted by the widening of the driveway and installation of the shoring wall. This disturbance will occur on the south-east portion of each trees critical root zone. The disturbance represents 13.9% of tree 63, 13.3% of tree 64, and 15.6% of their total dripline area. Per Trees and Development: A Technical Guide to Preservation of Trees During Land Development Douglas fir is listed with a good tolerance to root pruning. Therefore, is unlikely that the health of these trees will be significantly impacted by development. However, the trees are fully exposed to southern prevailing winds, and the proposed disturbance may impact their stability. The expected disturbance to tree 63 is limited to the south-west corner of its outer critical root zone area. I do not believe the proposed disturbance will affect its health or stability. However, the disturbance may impact the health and will likely impact the stability of trees 63 and 64 as the disturbance will occur on the south side of their inner critical root zone. They are currently fully exposed to southern prevailing winds. In the event of failure, I believe they would likely fall north into the grove of retained and protected trees on the hillside, and have a low likelihood of falling south towards the Hoang's home and property. In my opinion, it is better to safely remove the trees now so as not to damage retained trees in the event of root failure.

As trees 64 and 65 are part of a protected grove, if they are to be removed, they will require 12 replacement trees. At least half the trees need to be Pacific Northwest natives. Recommended native conifers include Douglas fir, Western redcedar, and Sitka Spruce, or the generally smaller and slow growing shore pine and mountain hemlock. Native small deciduous trees could include Oregon crabapple, Vine Maple, Cascara, pacific dogwood.

Trees 58, 60, and 61 will be retained but are located within areas that may be impacted by construction activities and will therefore require tree protection fencing to ensure their critical root zones are protected.
