## Memorandum

To: Seascape Homes LLC c/o Jon Tellefson  
CC: Sturman Architects c/o Kati Eitzman  
Site: 5214 Forest Ave SE, Mercer Island, WA 98040  
Re: Exploratory Pneumatic Excavation  
Date: August 16, 2023  
Project Arborist: George White,  
ISA Certified Arborist #PN-8908A  
ISA Qualified Tree Risk Assessor  
Reviewed By: Charlie Vogelheim,  
ISA Certified Arborist PN-9375A  
ISA Qualified Tree Risk Assessor  
Referenced Documents: Tree Assessment for Seascape Homes (Tom Hanson, ArborInfo LLC,  
11.21.2022)  
Letter Regarding Tree 1005:2212-079 (Tom Hanson, ArborInfo LLC,  
4.27.2023)  
Site Plan C1.0 (Patrick Harron and Associates LLC, 6.16.2023)

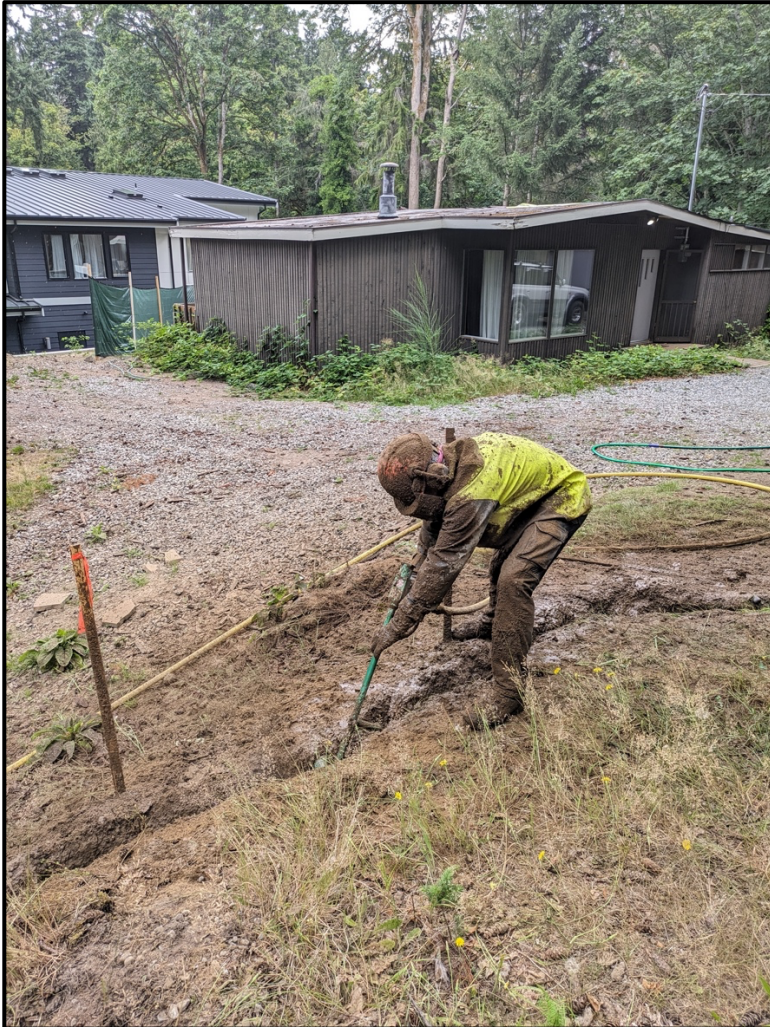
**Photograph 1.** Connor McDermott, of Tree Solutions Inc, Using an AirSpade to open a trench at the proposed limits of excavation.

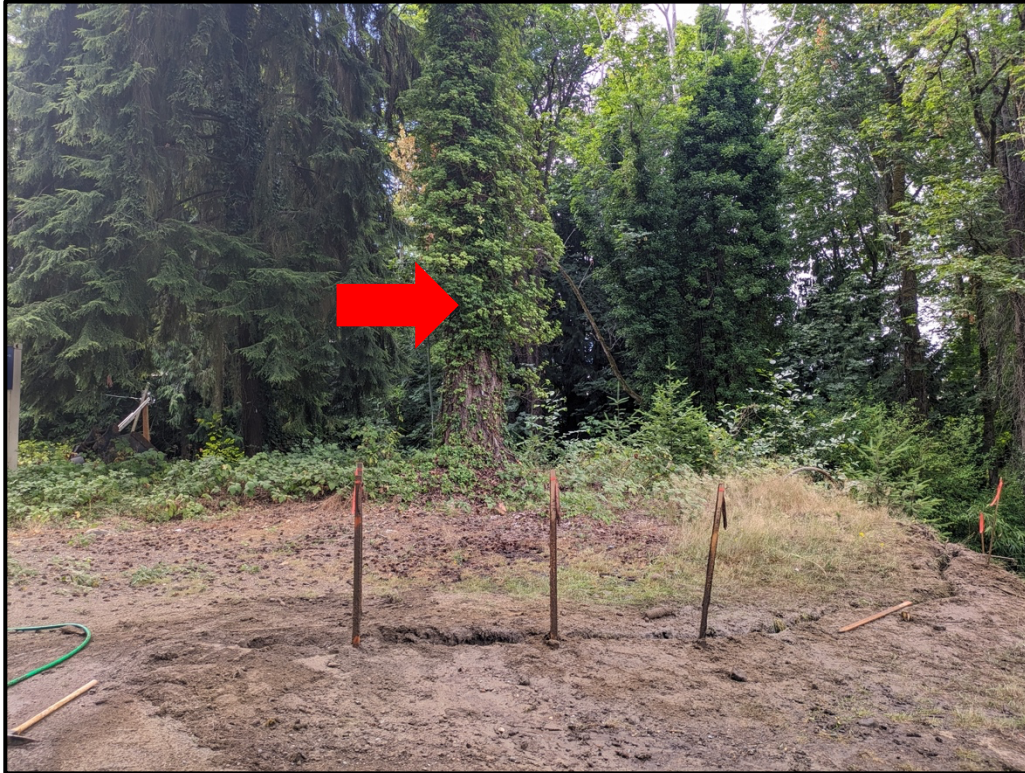
**Photograph 2.** Our completed trench as marked by stakes and flagging. Tree 1005 is indicated with a red arrow.

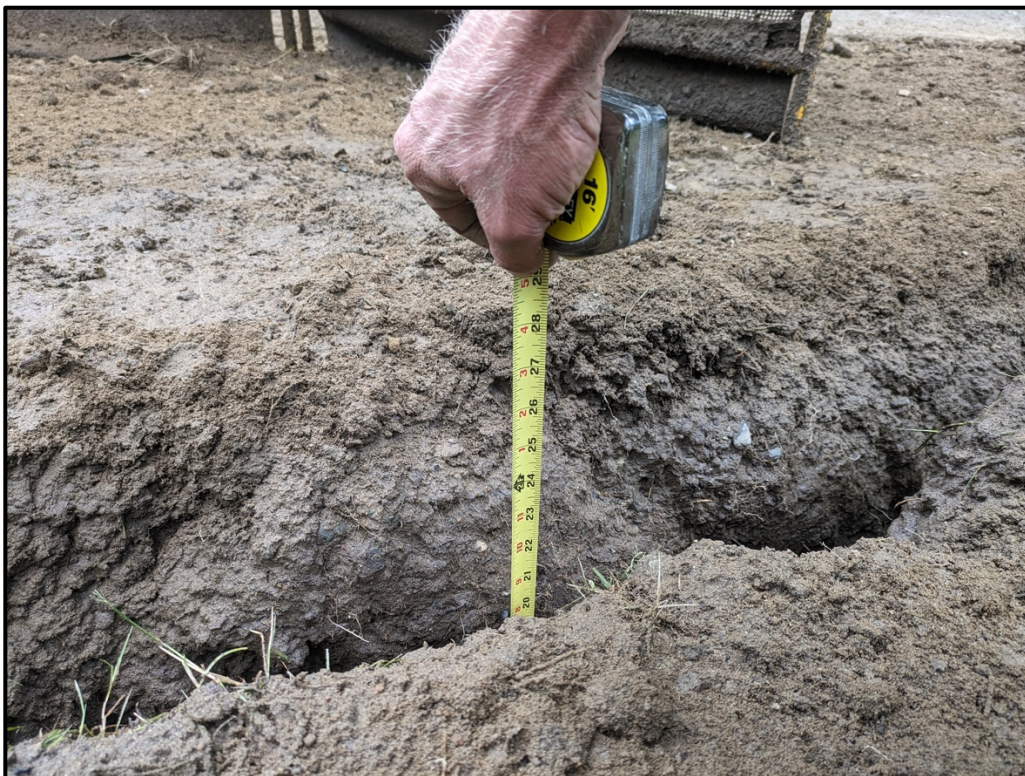
**Photograph 3.** Measuring trench depth.

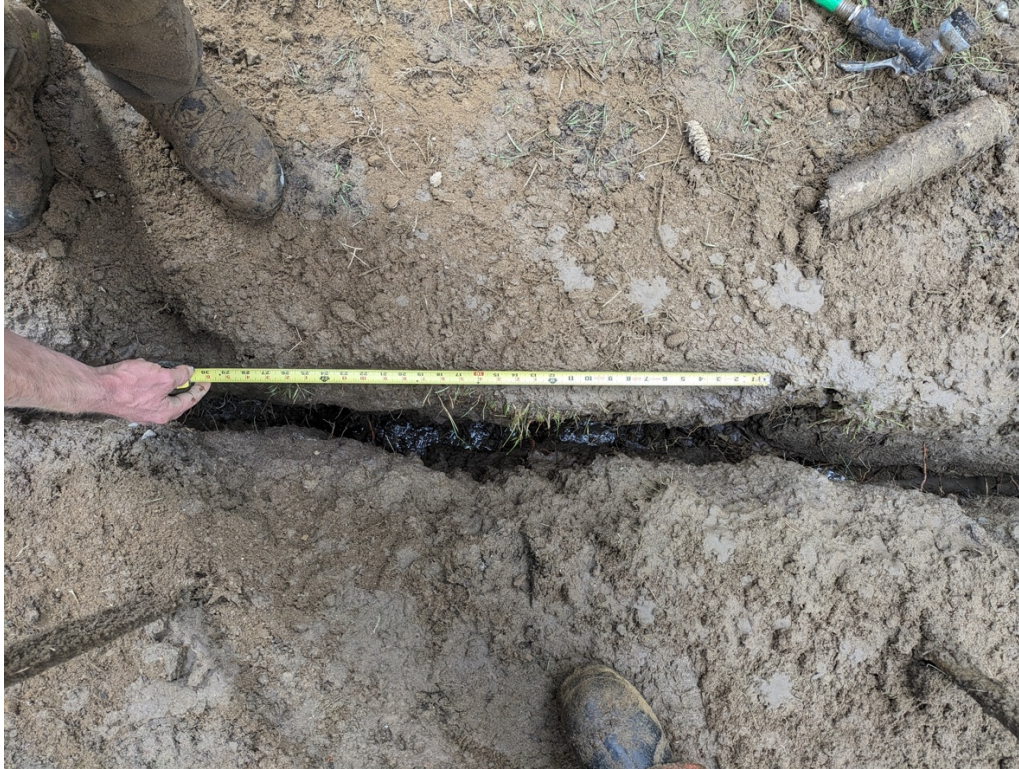
During our exploratory excavation, we did not encounter any roots in excess of .5 inches in diameter. A moderate layer of small feeder roots was observed. In our opinion, excavating at this location will have a minimal effect on the health of the tree and a negligible effect on tree stability. The lack of structural roots in this location can likely be attributed to historic grade cuts and the compact soils present on the east side of the tree.

**Photograph 4.** A typical section of trench. Small feeder roots can be seen at right.

- Do not allow excavation to encroach farther into the critical root zone of tree 1005 as what is currently proposed on the most recent plans (Site Plan C1.0, Patrick Harron and Associates LLC, 6.16.2023)
- Install tree protection fencing consisting of 6-foot-tall chain-link fencing at the proposed limits of excavation.
- Cut any roots exposed by excavation cleanly and immediately backfill to prevent desiccation.
- Notify the project arborist if any roots in excess of 2-inches are exposed by excavation so that impacts may be reassessed.
- Consider installing a 4-inch layer of coarse woody mulch (arborist woodchips) to the critical root zone of tree 1005 to mitigate construction stress and improve soil structure.

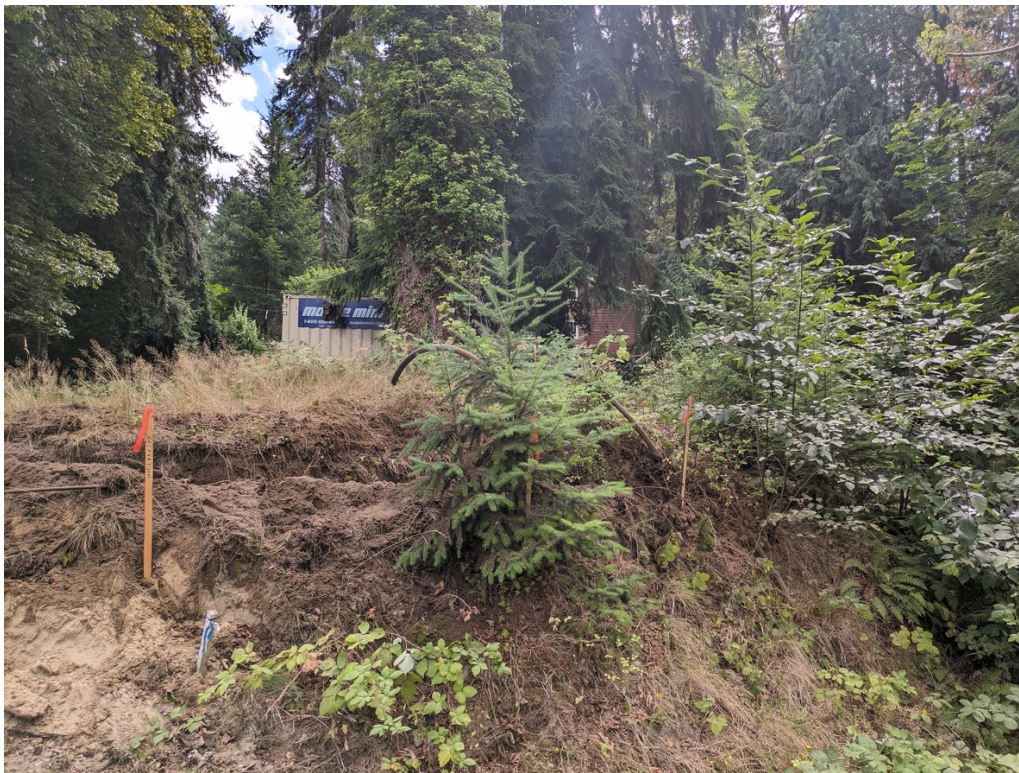
**Photograph 5.** The open trench north of tree 1005 above the existing slope. This slope is likely the result of a historic grade-cut.
