Arborist Report

To: JayMarc Homes c/o Garret Upper
Site: 4740 West Mercer Way, Mercer Island, WA 98040
Re: Tree Inventory
Date: December 1, 2022
Project Arborists: George White
ISA Certified Arborist #PN-8908A
ISA Qualified Tree Risk Assessor
Reviewed By: Joseph Sutton-Holcomb
ISA Boar Certified Master Arborist #PN-8397BM
ISA Qualified Tree Risk Assessor
Referenced Documents: Site Plan A2.1 (Gary Upper, 11.10.2022)
Utility and Tree Plan (Offe Engineers, 11.21.2022)
Attached: Table of Trees
Tree Site Map

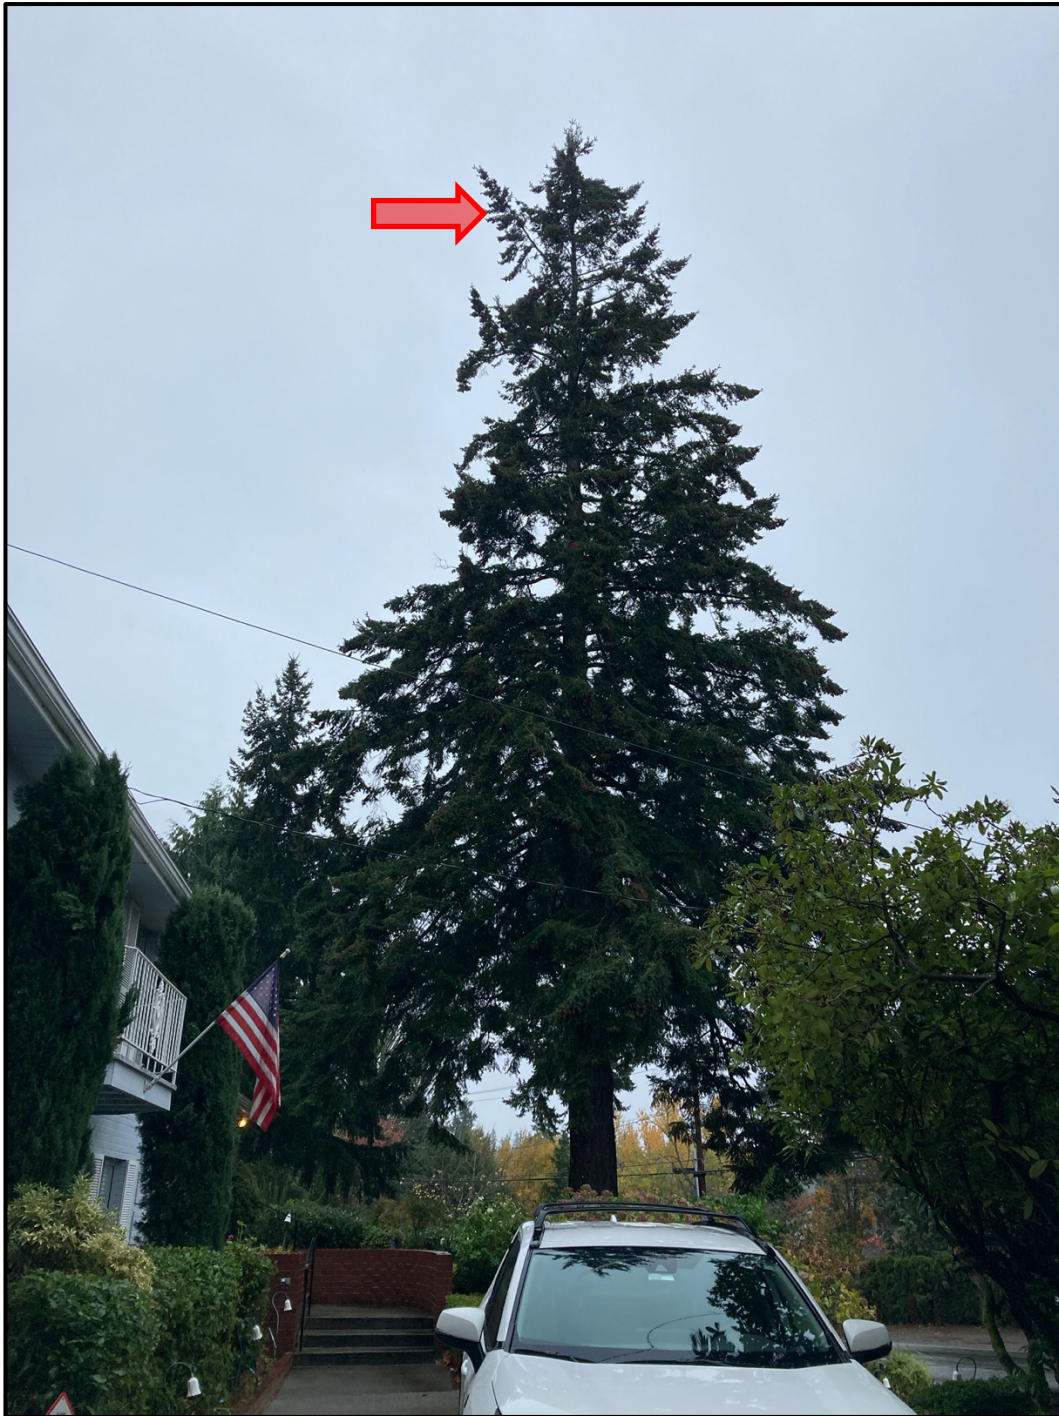
Tree 386 is an exceptional 42-inch Douglas-fir (*Pseudotsuga menziesii*) located west of the existing house. Because of this tree's proximity to the proposed house, specific tree protection measures must be taken to successfully retain this tree.

Photo 1. Tree 386, an exceptional Douglas-fir in excellent condition. We discussed end-weight reduction pruning to lessen the potential for limb break-outs above the house. The red arrow indicates an outlying limb that could be reduced.

If desired, limited end-weight reduction pruning can be performed on tree 386, an exceptional Douglas-fir (*Pseudotsuga menziesii*), by an ISA Certified Arborist. This will reduce the likelihood of limb breakout over the existing house (Photo 1). Outlying limbs and limbs that are particularly heavy can be reduced with cuts under 2 inches in diameter. No more than 10%-15% live crown should be removed in any year.

This tree is to be protected with tree protection fencing. Tree protection fencing must extend to the RLOD listed in the table of trees to the south, to the property edge to the west, to the edge of the existing driveway to the north, and to the proposed limits of excavation to the east. No excavation, grading, materials storage, or machine access is permitted within the limits of the tree protection fencing. Tree protection fencing must be installed prior to any construction or demolition related activities.

The proposed limits of excavation for the house foundation are located 16.5 feet east of tree 386. Because this excavation is located just inside of the Minimum Limits of Disturbance (MLOD), exploratory air excavation must be conducted at the limits of excavation so that the project arborist can identify structural roots at this location. If multiple structural roots in excess of 4 inches in diameter are encountered the MLOD should be expanded to mitigate root impacts. Any exposed roots should be cut cleanly and immediately covered to prevent desiccation.

During the construction phase of the project the tree protection fencing on the east side of tree 386 will have to be reduced to within the MLOD (14 feet from the base of the tree) to allow for worker access. Before the fence is moved soil protection consisting of 6-8 inches of coarse woody mulch covered by half-inch plywood must be installed between the fencing and the proposed house.

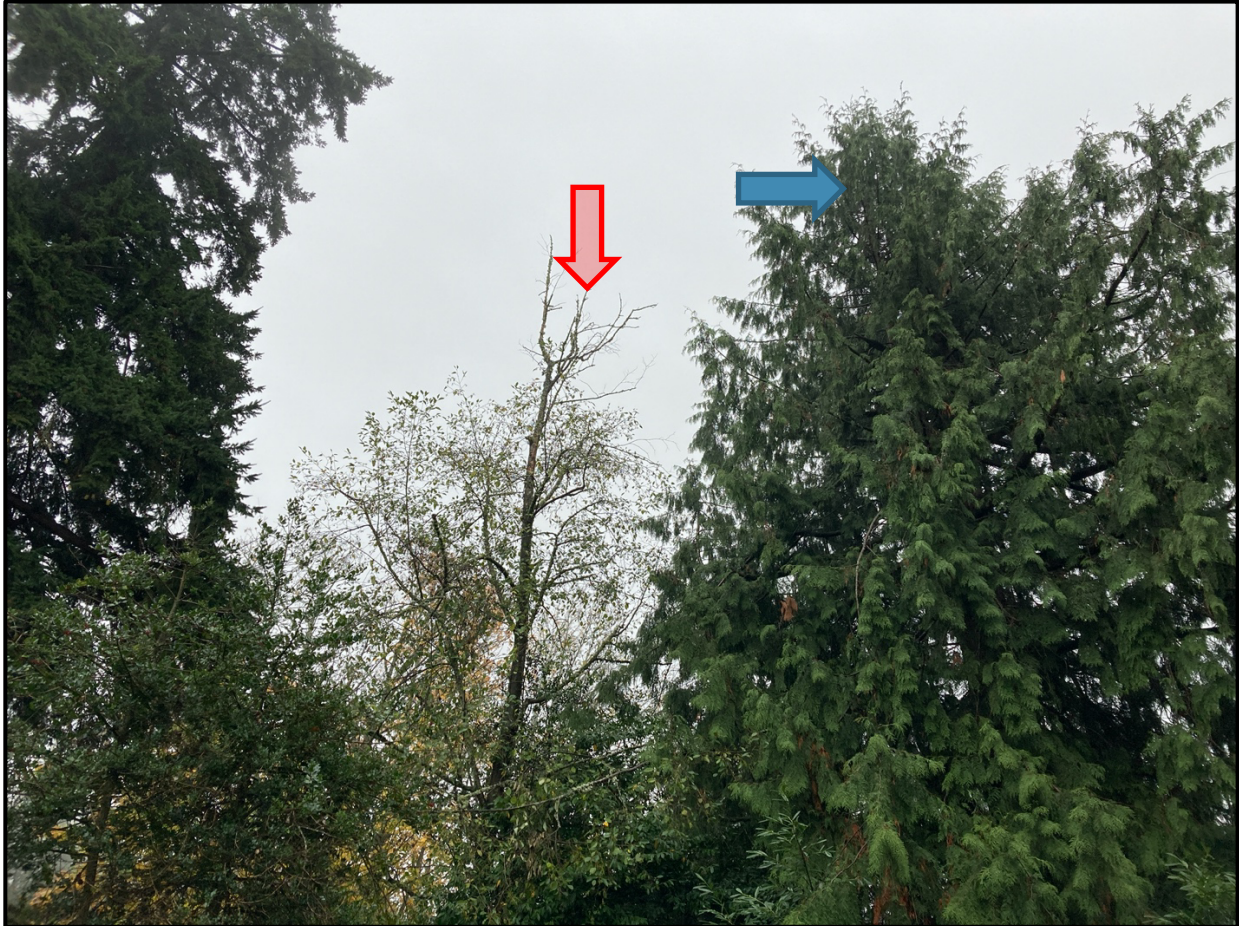
We identified one large, off-site tree that overhung the property line. This tree (Tree A) is a red alder (*Alnus rubra*) in poor health and structural condition.

Photo 2. Tree A and tree 384. Tree A is an off-site alder with a dead top (indicated with red arrow) that is leaning on the fence. Tree 384 (indicated with blue arrow) is an exceptional western redcedar.

Trees 384 and 385 should be protected with tree protection fencing at the Recommended Limits of Disturbance (RLOD) listed in the attached table of trees. No excavation, grading, materials storage, or machine access is permitted within the limits of the tree protection fencing.
