Arborist Report

December 2nd, 2022

Prepared for:
Aspen Homes

Site Address:
9204 SE 60th St.
Mercer Island, Wa.

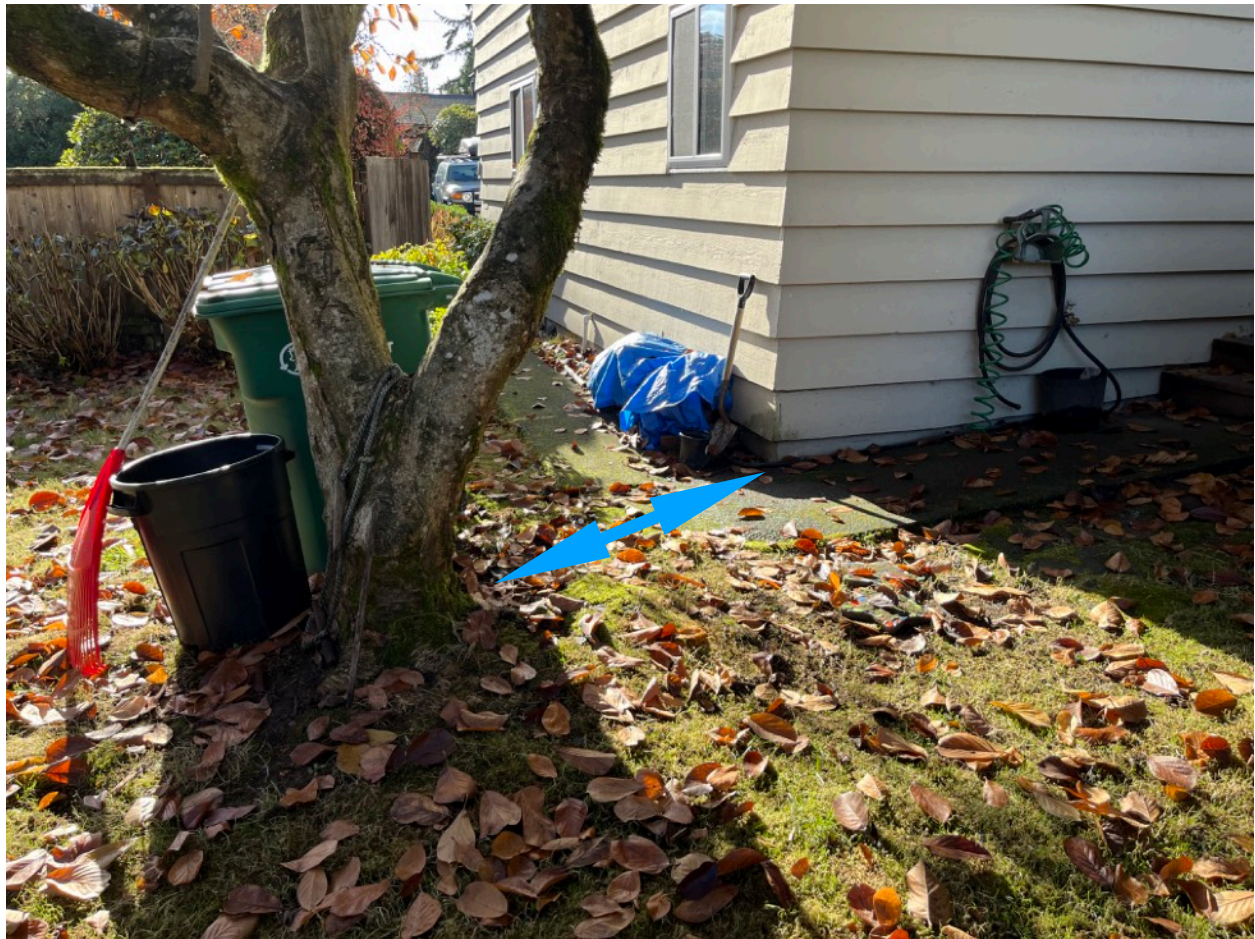
The trunk is only about 6' from the existing corner.

As the project was described to me, the critical root zone disturbances for this particular specimen of Magnolia will be too severe in order for the system to be able to be retained. The amount of pruning and root loss acquired to accommodate the project will almost surely send this tree into steep decline. It is my professional opinion that the best course of action is to remove this specimen of Magnolia prior to construction activities commencing.

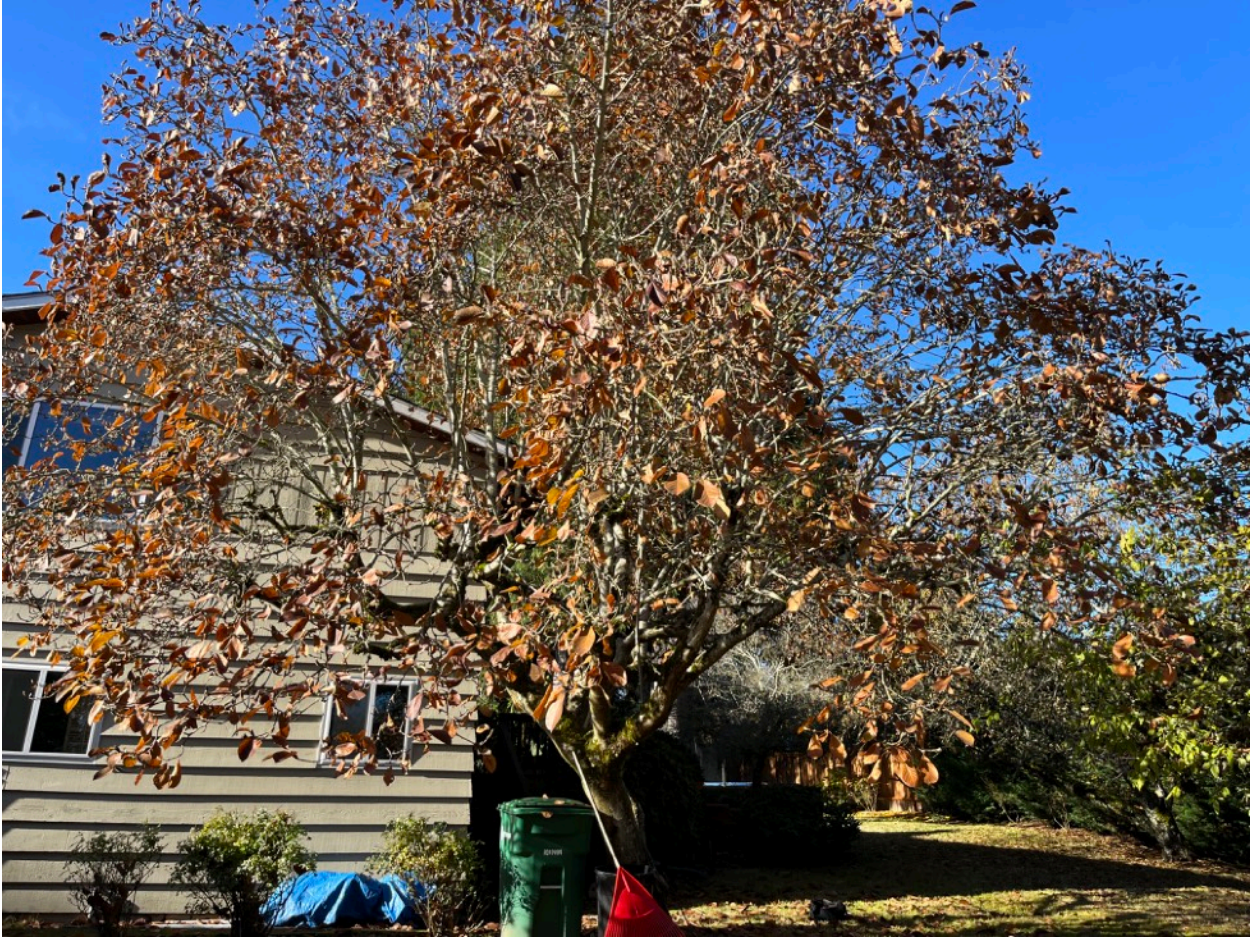
The canopy leans out toward the east and the south.

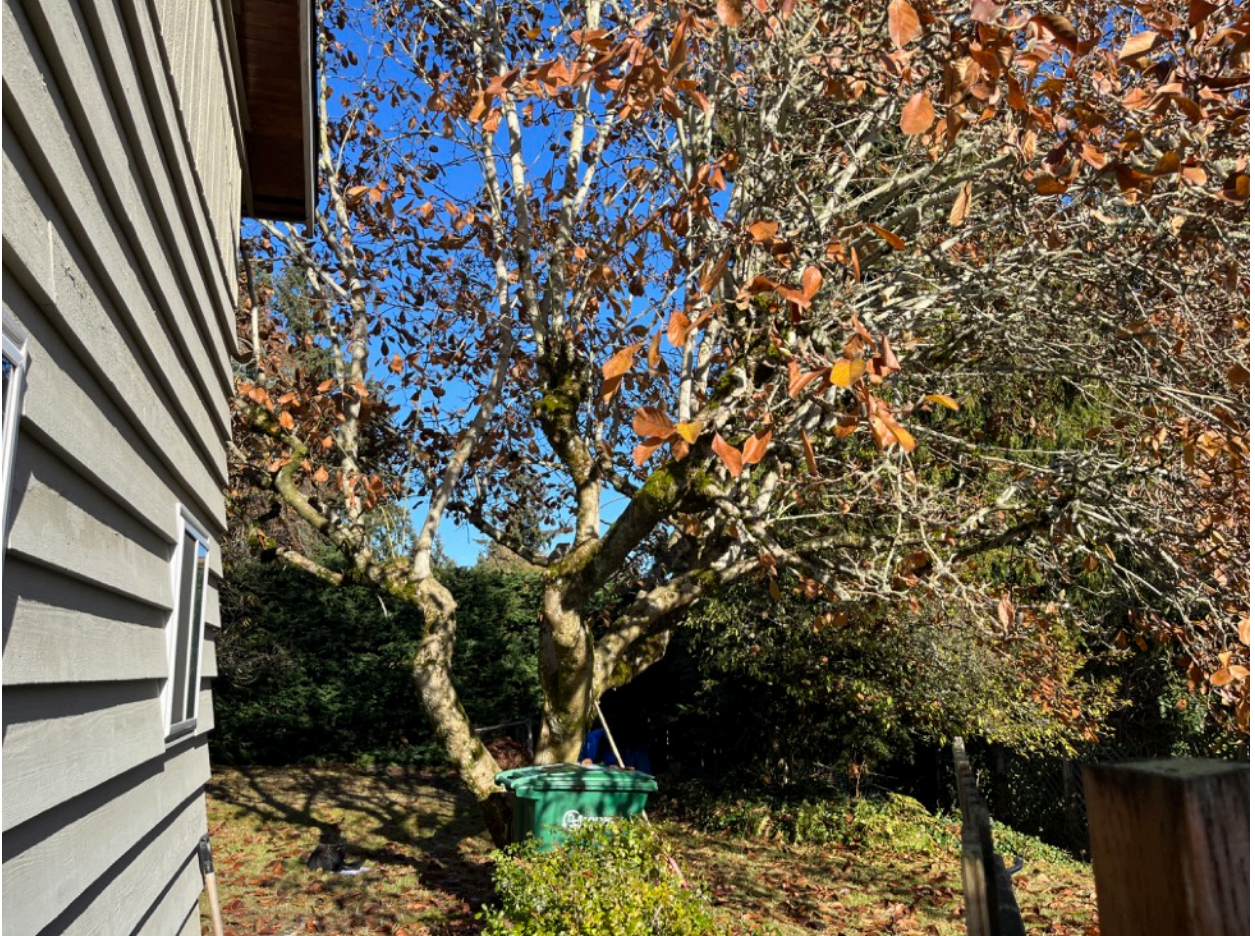
Looking north.

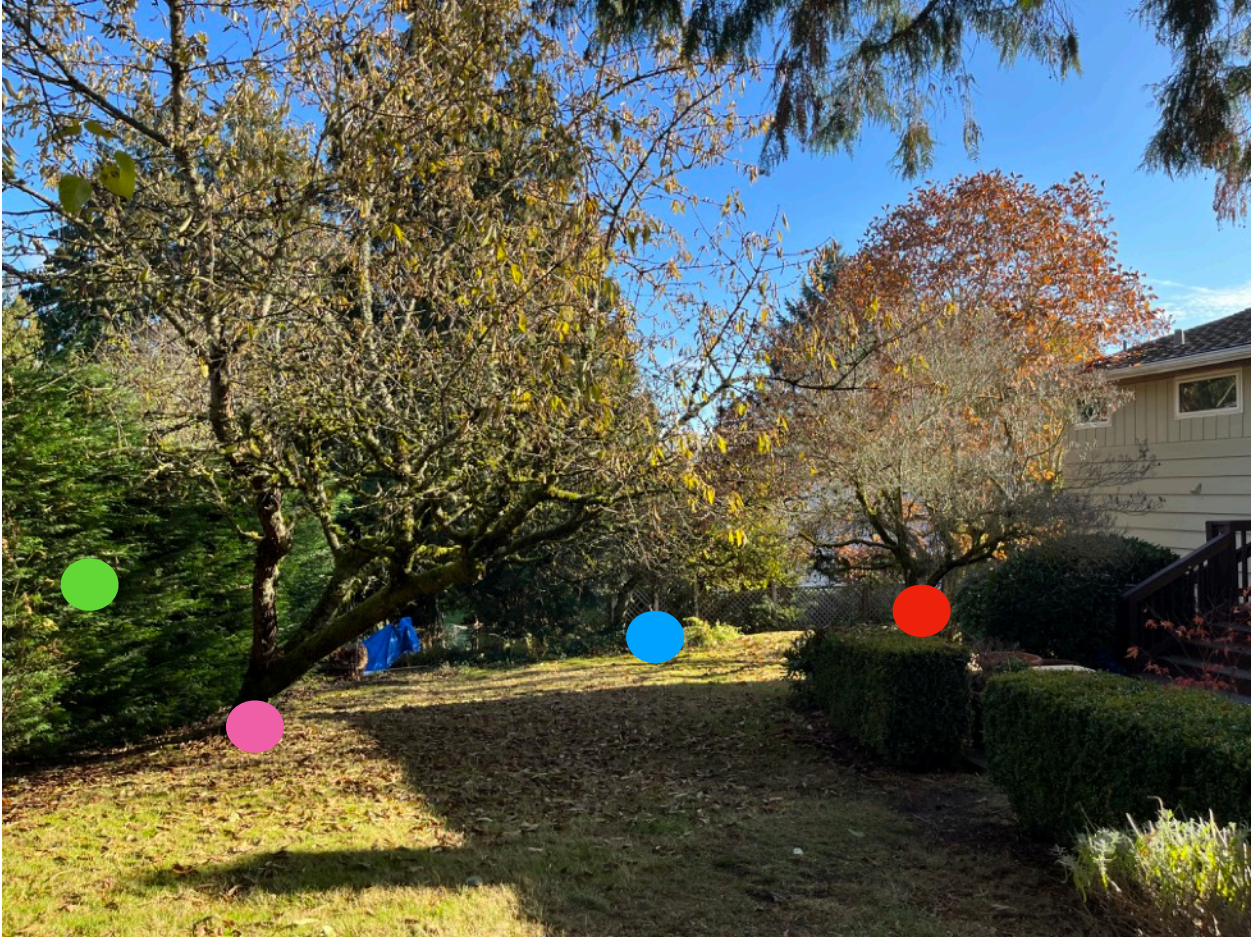
Red-Magnolia
Blue-Fruiting Plum
Pink-Flowering Cherry
Green-Leland Hedge

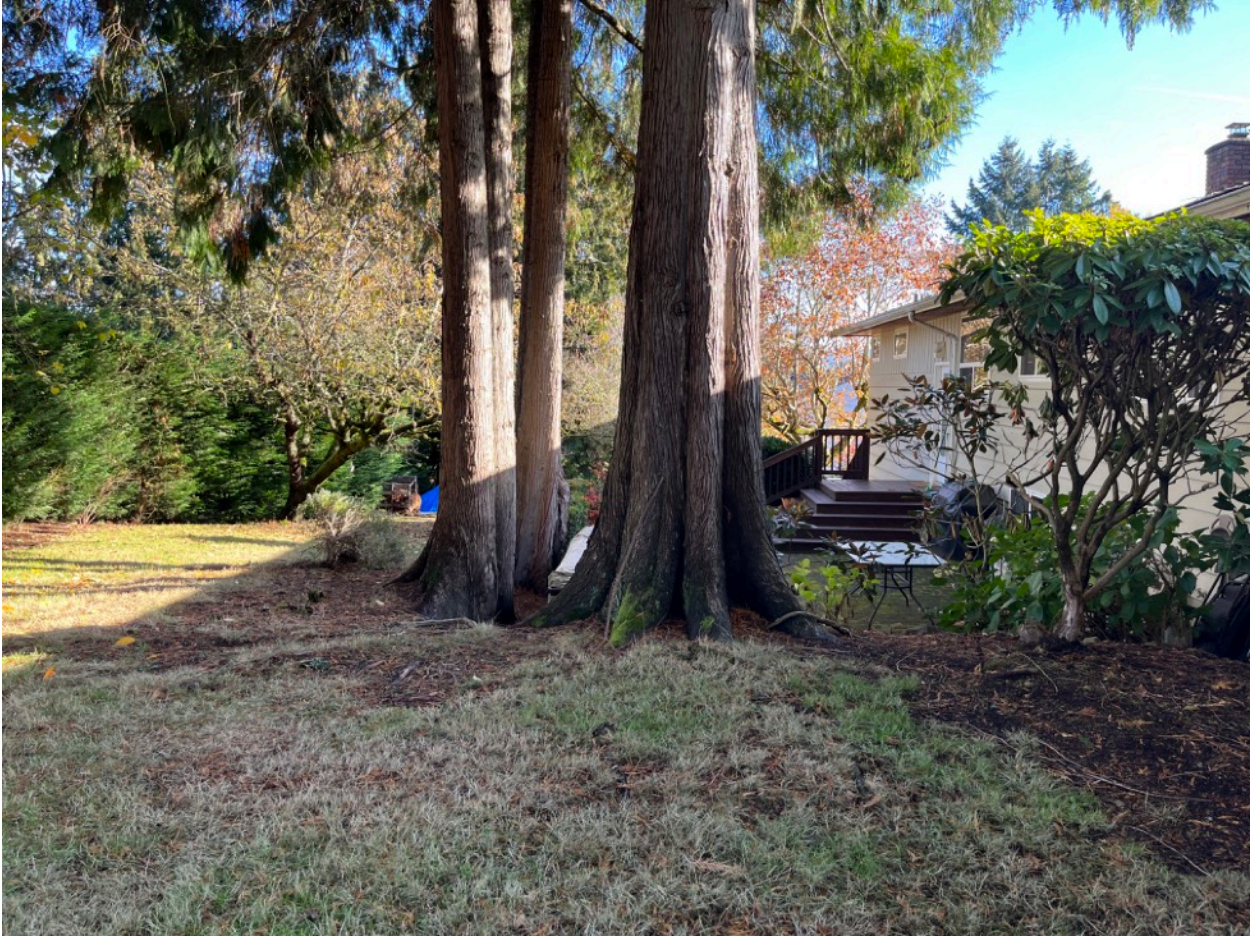
The Wester Red Cedars on the west property line are far from the project and will not be affected.

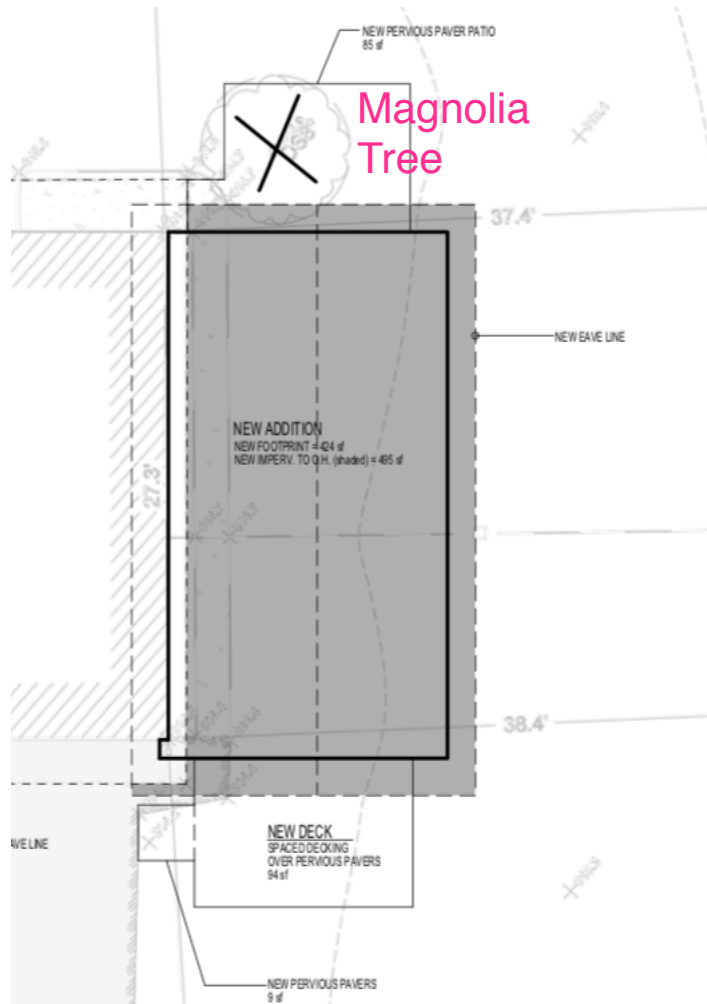
This screen capture shows the proposed new footprint and the proximity to the Magnolia tree.
