Corinne R. Hollister

To: Sam Franklin
Reference: Tree Inventory Report
Date: November 18, 2022
Site Address: 3064 68th Ave SE, Mercer Island, 98040
Parcel: 2175100020

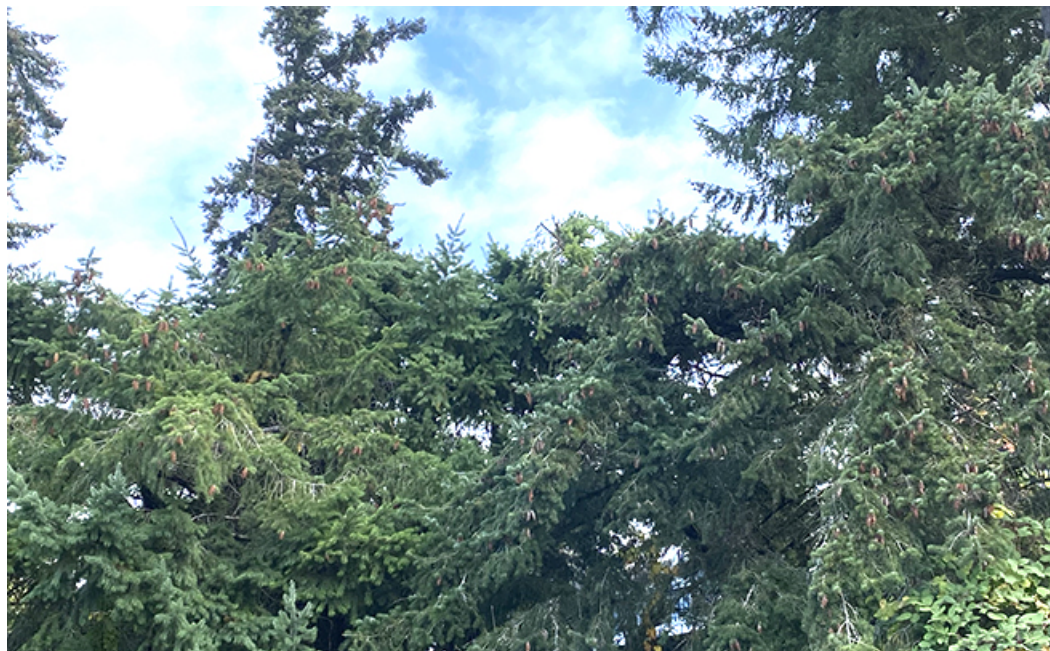
Below: Looking northeast from back of exiting home, below retaining wall. Topped Douglas-fir in foreground. Tree #5 is to the left in photo. Taller trees are offsite.

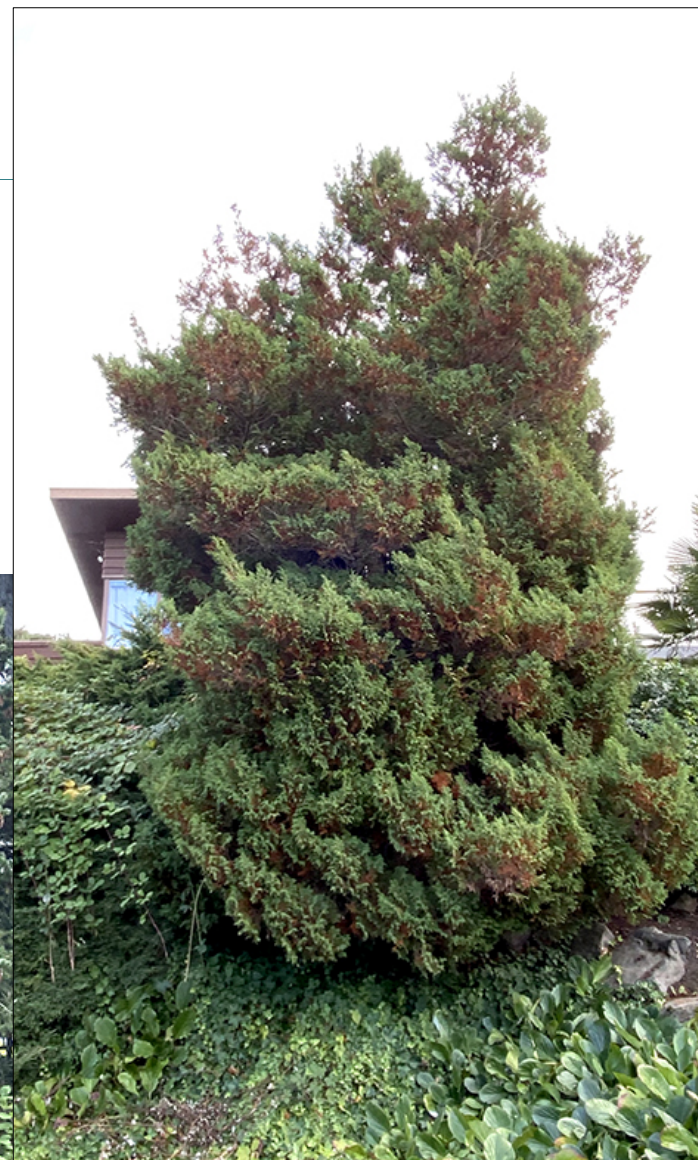
Right: Looking east from 68th Avenue SE, Tree #1 and #2.

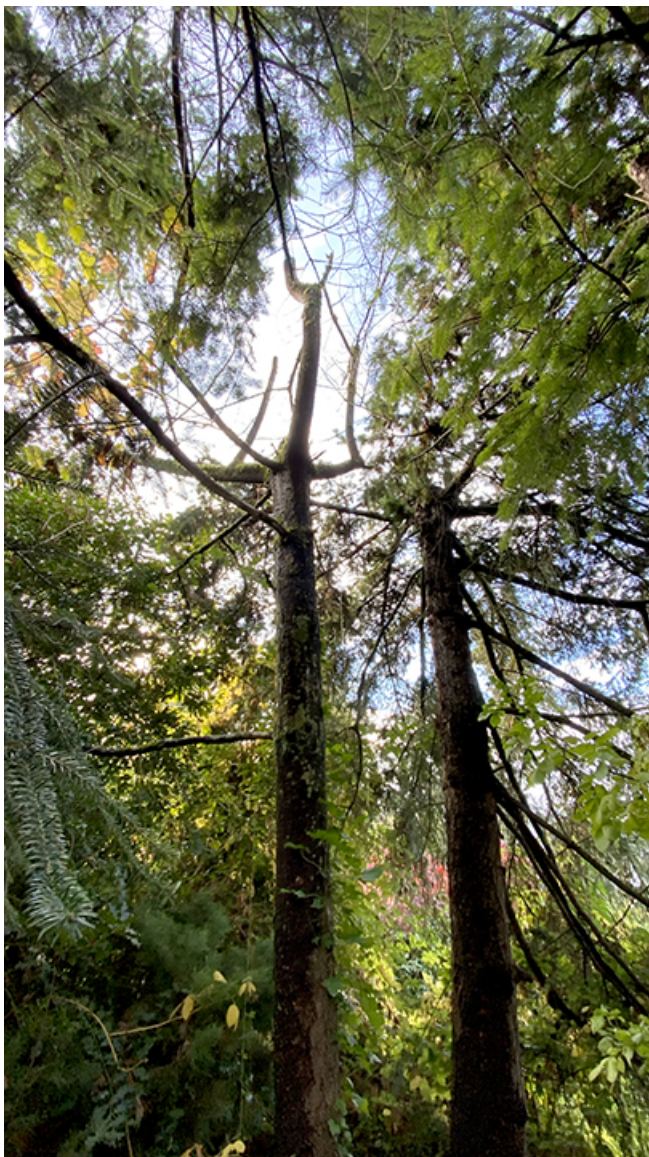
Left: Tree #3 and #4, typical of all trees located on upper east section of parcel.

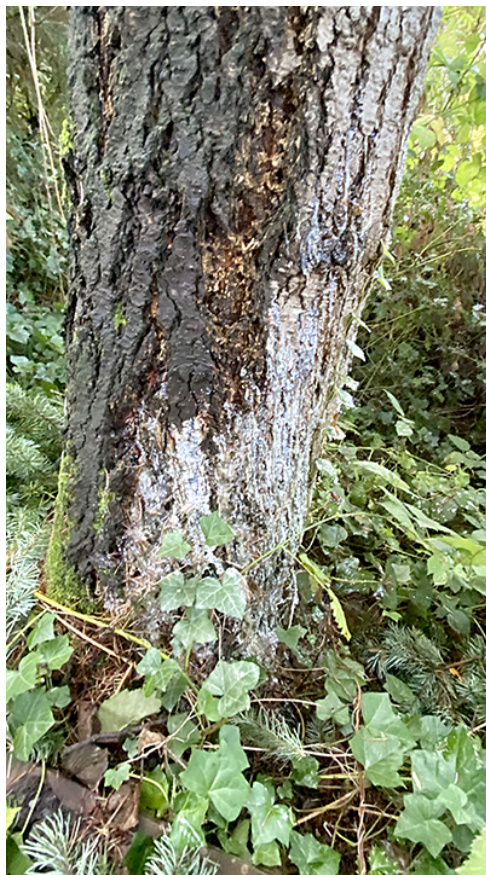
Below: Resin and abnormal bark on Tree #3.
