# CITY OF MERCER ISLAND

### SIDE SEWER VIDEO INSPECTION REPORT

PROPERTY OWNER INFORMATION			
Applicant/Contact:	Kali Rushing		Phone: 509-954-8623
Site Address:	3030 69th Ave SE		
Mailing Address:			
Building Type:	<input checked="" type="checkbox"/> Single Family	<input type="checkbox"/> Multi Family	<input type="checkbox"/> Commercial
CONTRACTOR INFORMATION			
Contractor/Contact:	Jeremy Gookstetter		Phone: 206-402-9739
Address:	P.O. Box 68133 Seattle, WA 98168		
Email Address:	customerservice@PinkySplumbing.biz		
Name of Technician:	Jeremy Gookstetter		
Date of Inspection:	06/15/23	Weather Condition:	Sunny
INFLOW INSPECTION			
Are there any sources of inflow entering the sanitary sewer system:	Yes	<input checked="" type="radio"/> No	
If yes, check all that apply:	<input type="checkbox"/> Sump Pump	<input type="checkbox"/> Basement Area Drain	<input type="checkbox"/> Downspouts
	<input type="checkbox"/> Footing/Foundation Drain	<input type="checkbox"/> Driveway Drain	<input type="checkbox"/> Other:

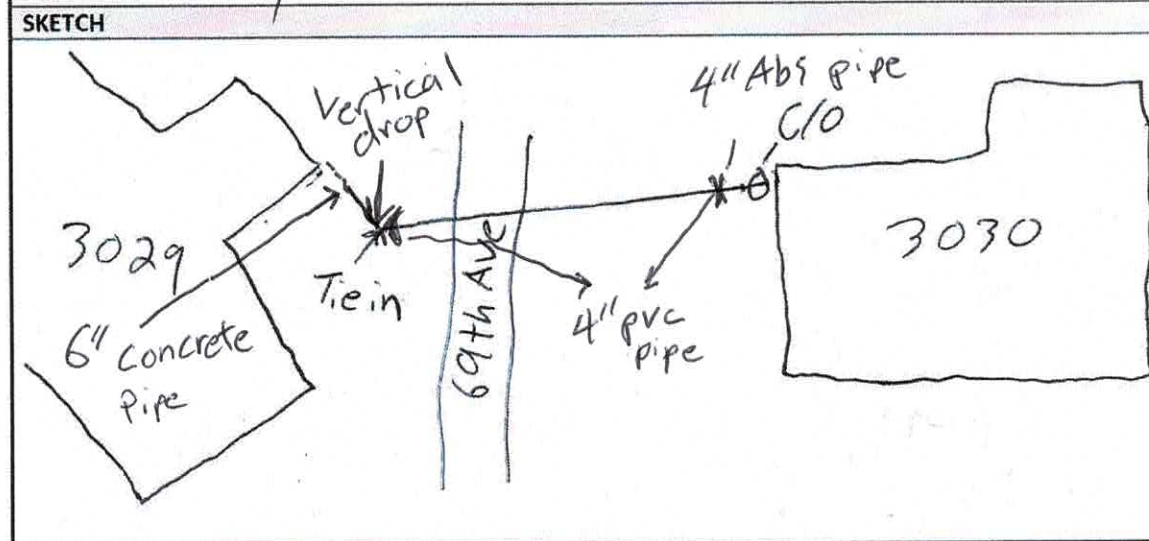
**REFER TO ATTACHED DIAGRAM**

CONDITION OF LATERAL - OBSERVATIONS		
Observation Key: (H-Hole, SV-Soil Visible, EA-Exposed Aggregate, R-Roots, OJ-Offset Joint, C-Cracks, G-Grease/Blockage, S-Sag)		
Footage	Observation	Comments
16 feet		4" PVC to the 4x6 transition into PVC
10 feet		6" PVC connected to 6" concrete
10 feet		6" concrete pipe with a pvc elbow into a vertical drop

I scoped a total of 117~~0~~ feet, 47 feet before it hit a vertical drop and tied in with the main sewer generally appears to be in good condition

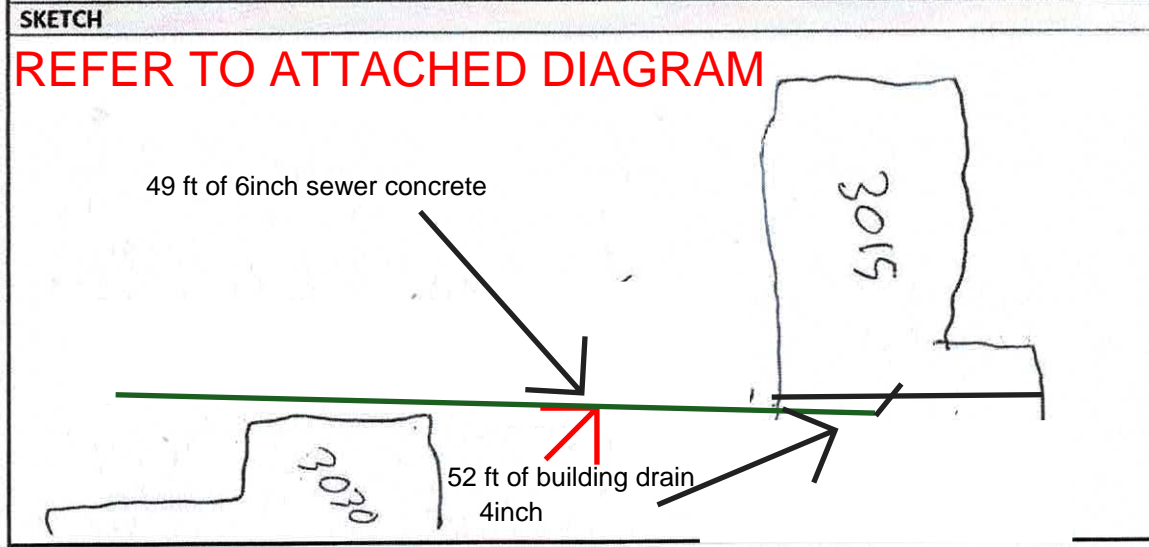
CONDITION OF LATERAL - OBSERVATIONS		
Observation Key: (H-Hole, SV-Soil Visible, EA-Exposed Aggregate, R-Roots, OJ-Offset Joint, C-Cracks, G-Grease/Blockage, S-Sag)		
Footage	Observation	Comments
49 feet	EA	small amount of exposed aggregate
52 feet		This was the length of the building drain before it transitioned to sewer

I scoped a total of 101 feet, 52 feet of which was building drain, 49 feet of sewer line main sewer line was 6in concrete, building drain was a 4inch line, sewer generally appears to be in good condition
