DOWNSTREAM ANALYSIS REPORT

Mastan Residence
2251 71st Avenue SE
Mercer Island, WA 98040

Tax Map #330770-0270
February 12, 2023

CES #2064

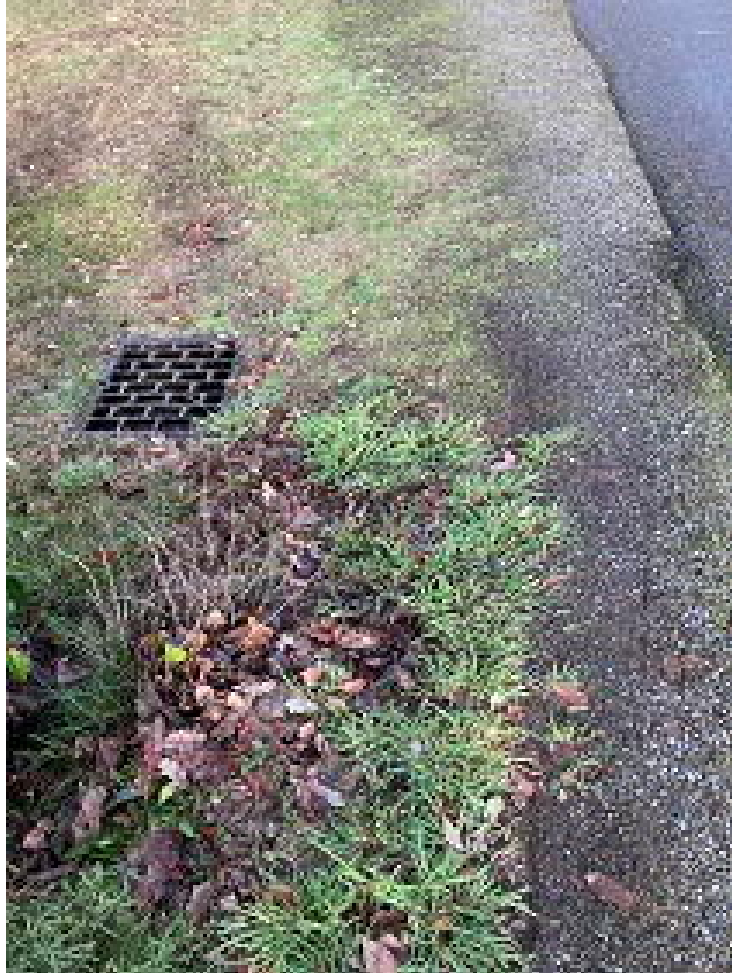
Picture 1:
ROW in front of 2251/ 2243 71st Avenue SE
Water flows north (toward the top of the page)

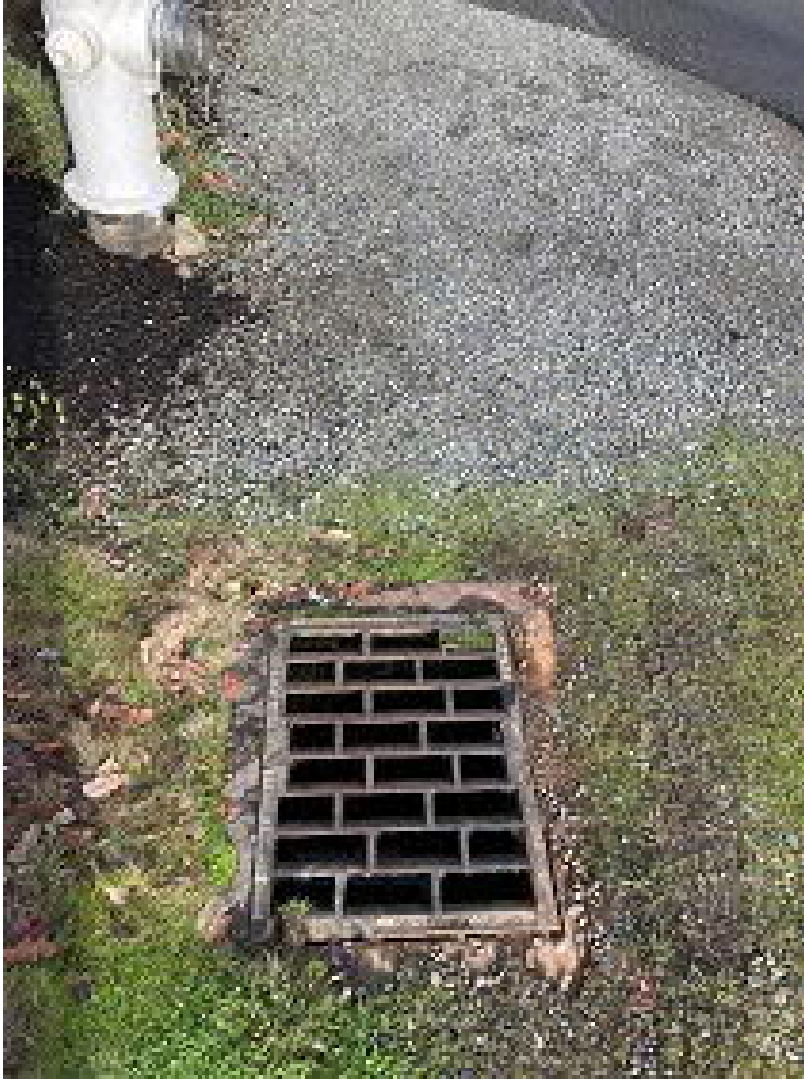
Picture 2:
ROW in front of 2243/2237 71st Avenue SE
12" pipe along 71st

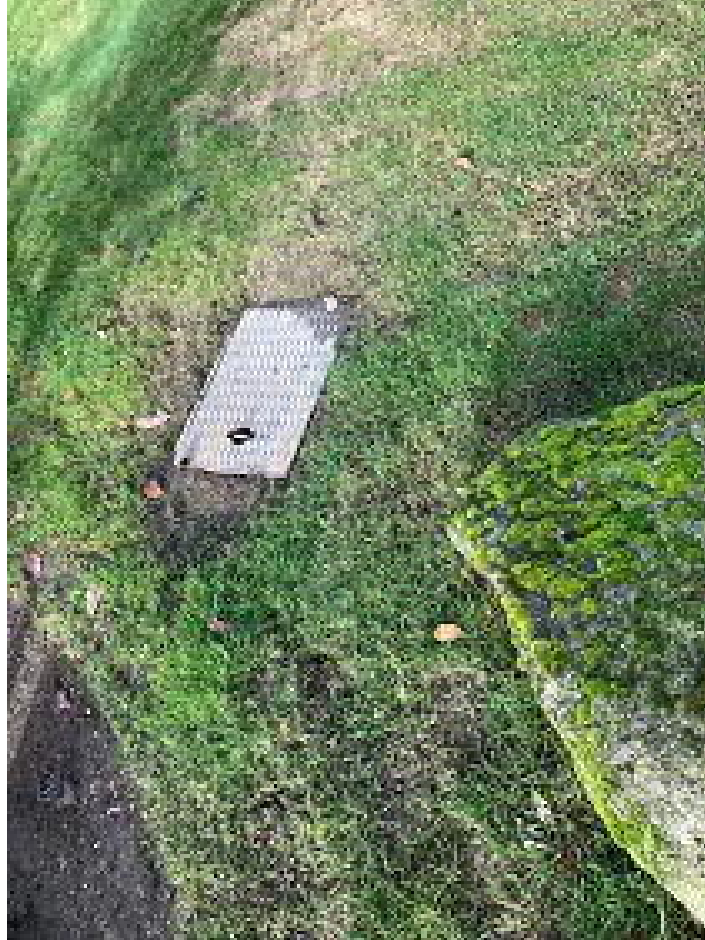
Picture 3:
ROW in front of 2237/2227 71st Avenue SE
12" SD

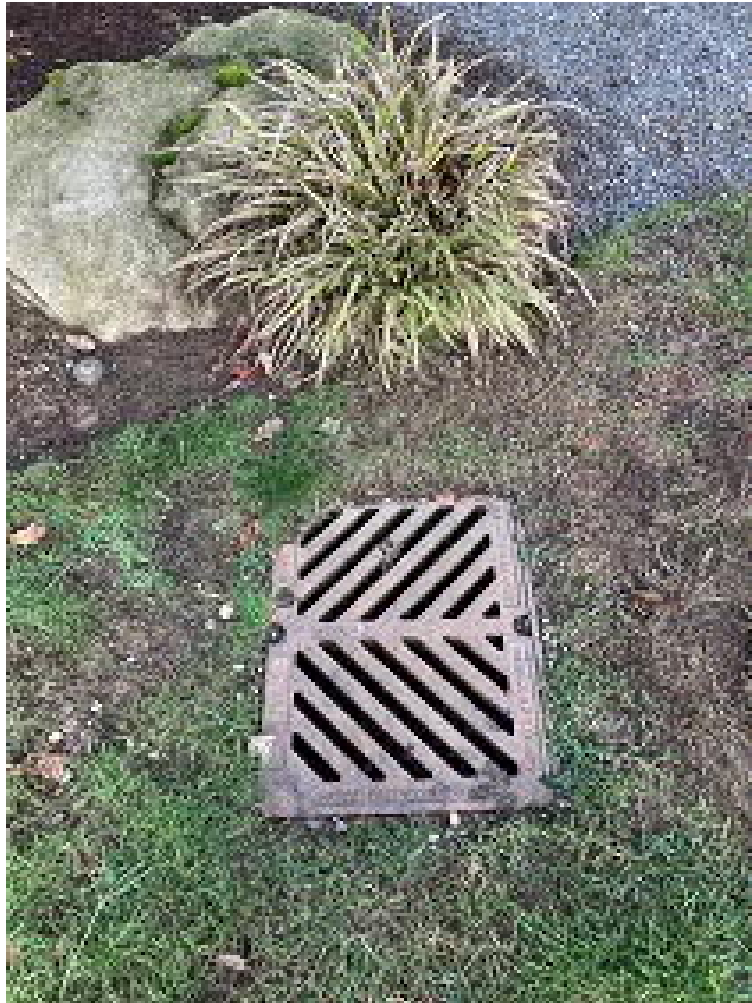
Picture 4:
ROW in front of 2227/2223 71st Avenue SE
flowing north
12" SD

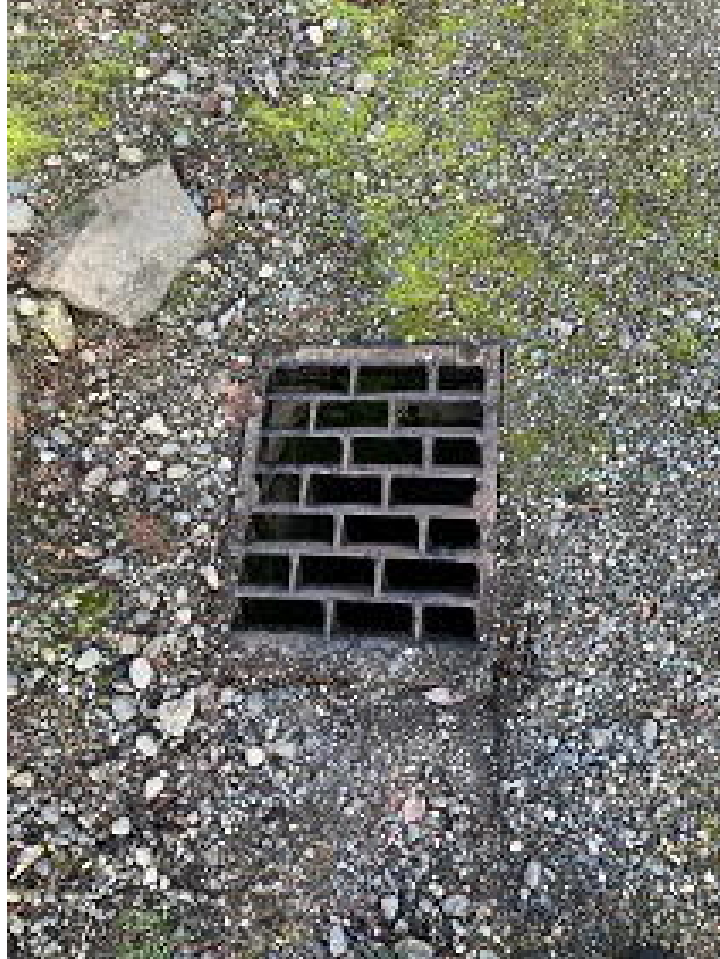
Picture 5:
ROW in front of 2215 71st Avenue SE
12" SD

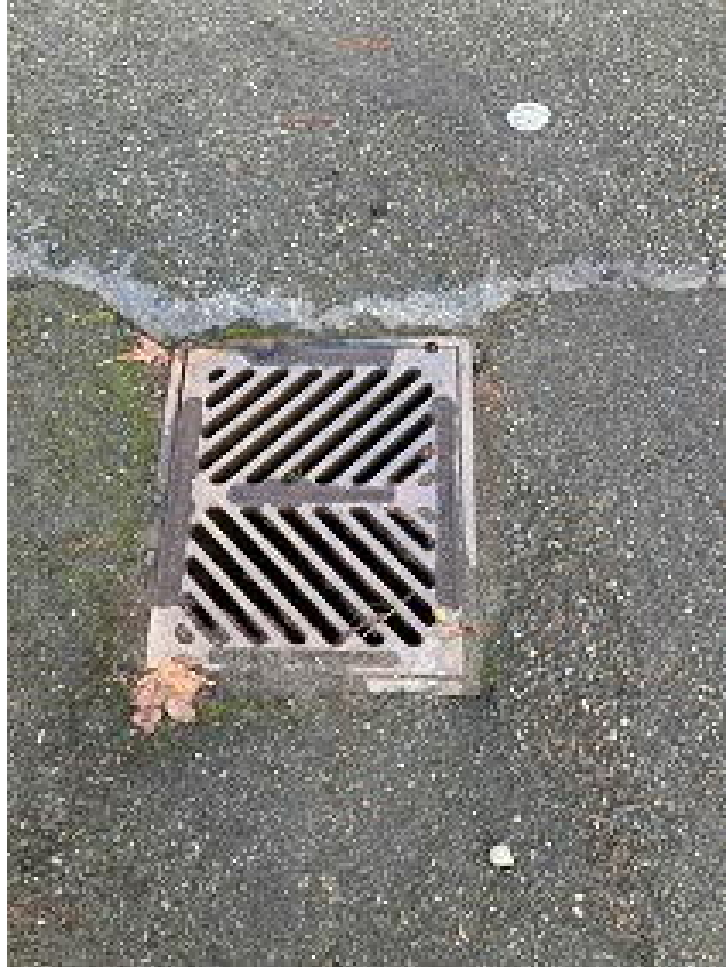
Picture 6:
Corner of 71st Avenue SE and SE 22nd Street
Storm crosses SE 22nd Street toward the north
12" SD

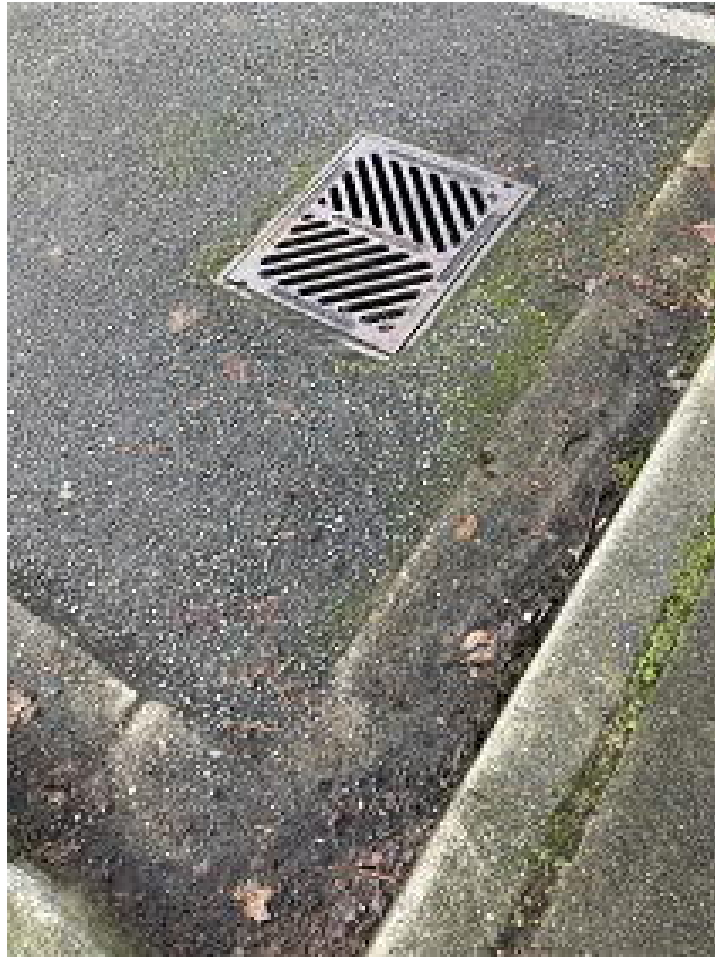
Picture 7:

Parking area at Aubrey Davis Park at intersection with 71st Avenue SE
From here storm pipe crossed under SE 22nd Street (again)
12" SD

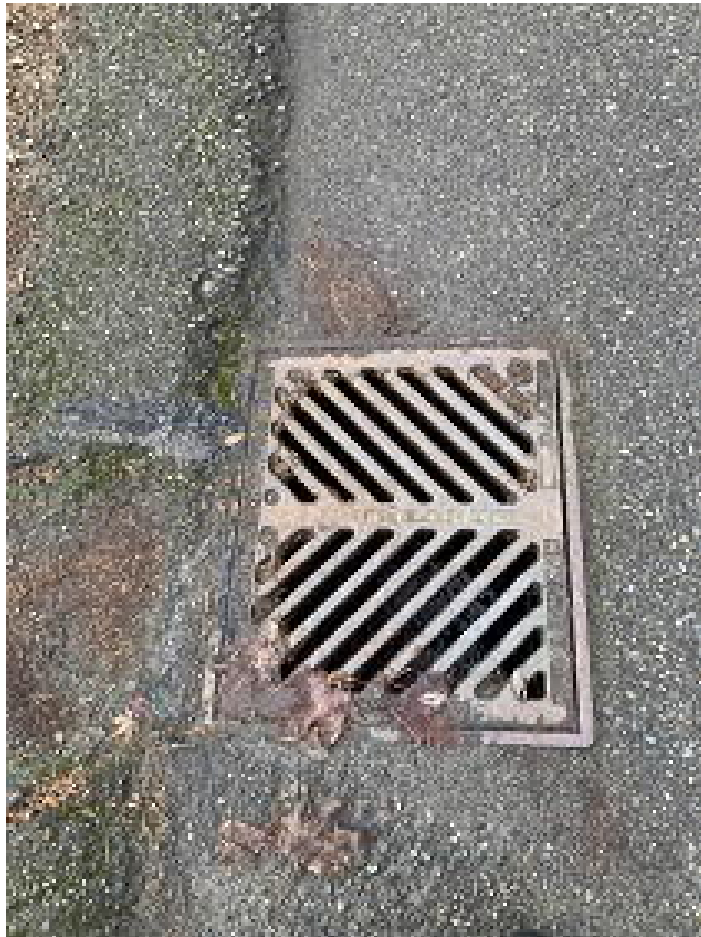
Picture 8:
Southeast corner of SE 22nd Street and 70th Avenue SE
From here, storm pipe crossed west under 70th Avenue SE
12" SD

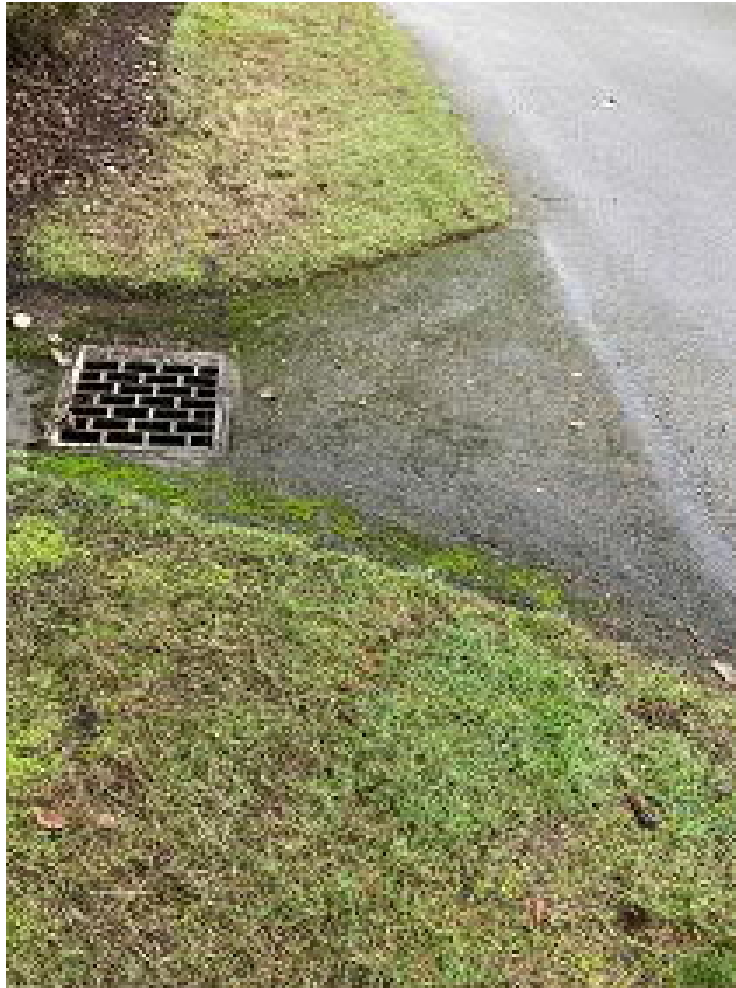
Picture 9:
ROW in front of 2203 70th Avenue SE
CHANGE TO 18" AT THIS CB

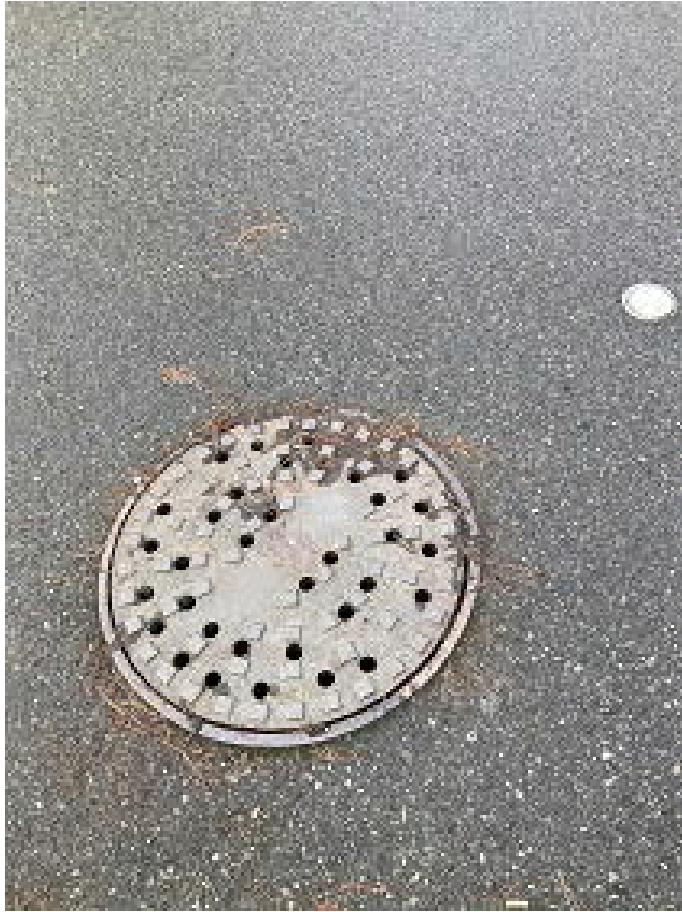
Picture 10:
In the street in front of 2212 66th Avenue SE
From here, the storm pipes go northwest into Aubrey Davis Park
18" SD WSDOT OWNED PIPE

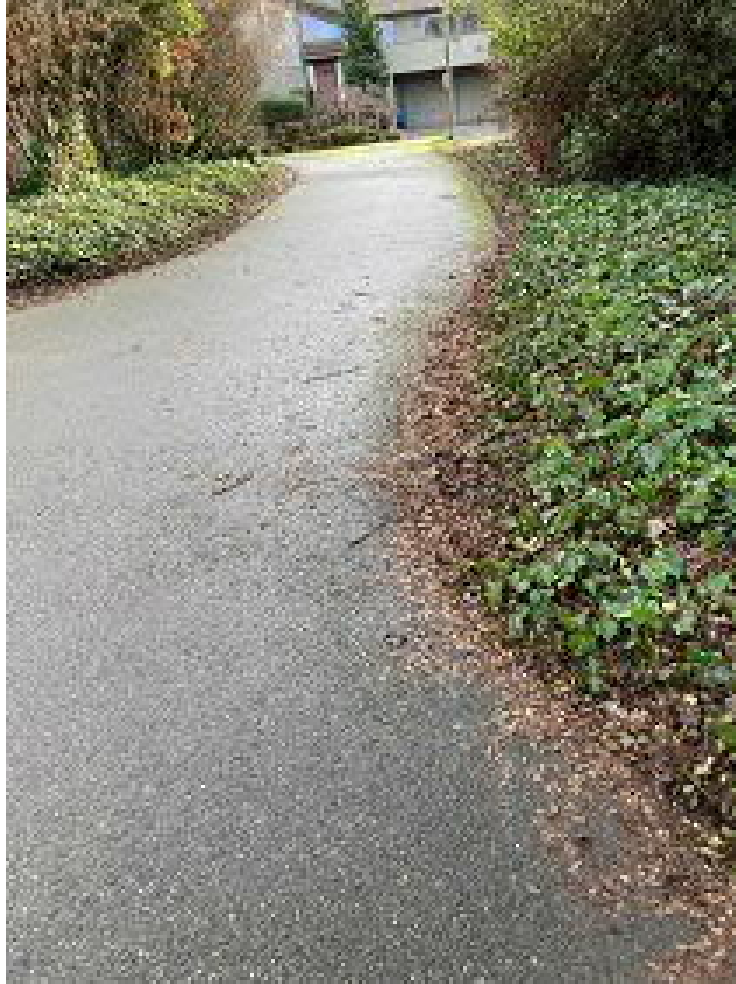
Picture 11:
Aubrey Davis Park looking SE toward 2212 66th Avenue SE
The catch basin is under the ivy somewhere near here
18" SD WSDOT OWNED PIPE

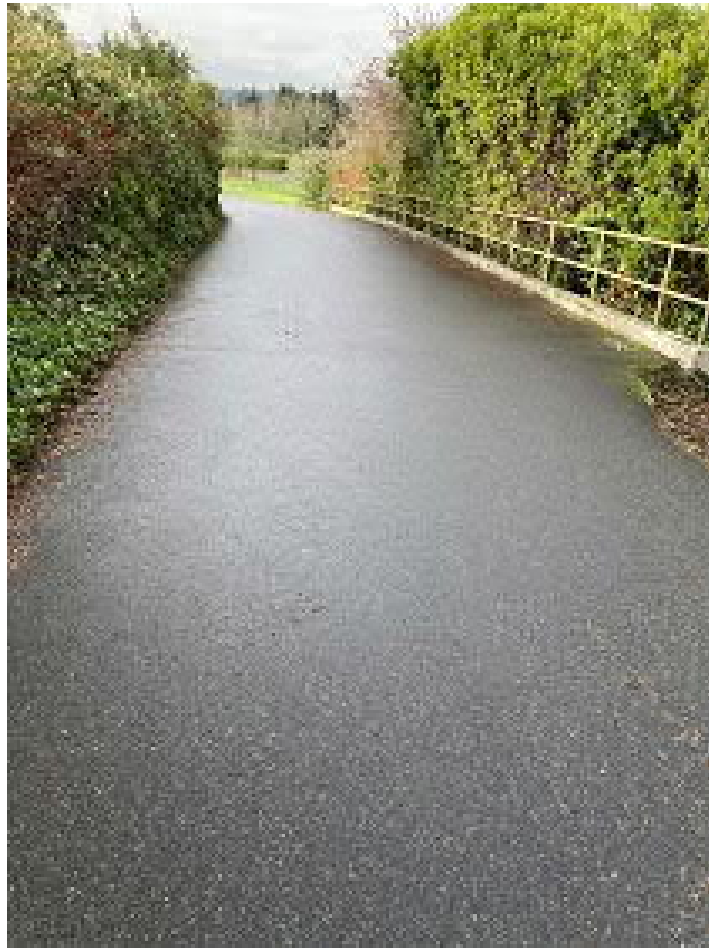
Picture 12:
Aubrey Davis Park looking west toward West Mercer Way
The catch basins are under the ivy/woods in vicinity near here
18" SD WSDOT OWNED PIPE

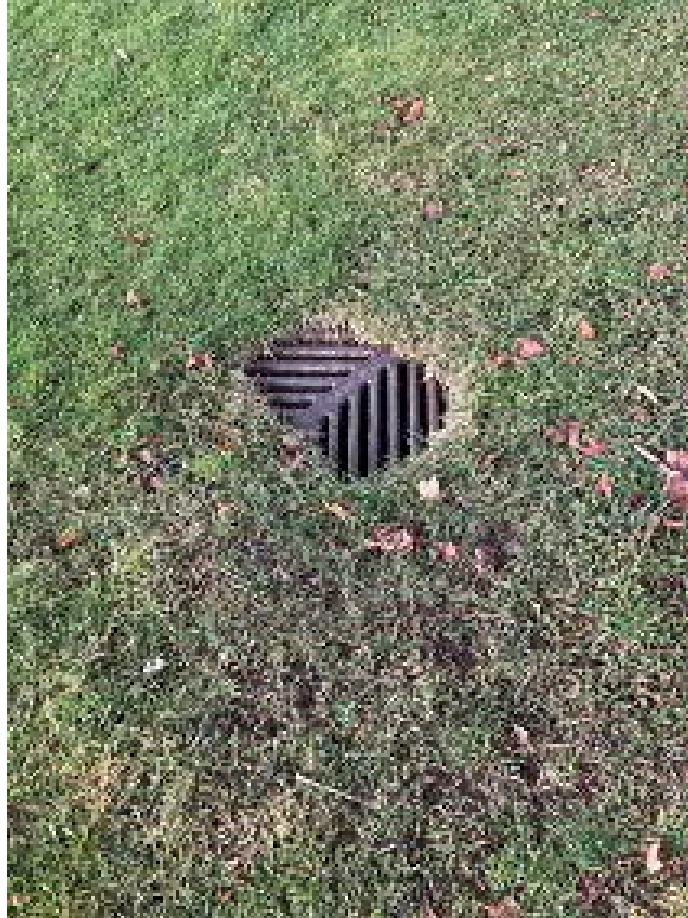
Picture 13:
Aubrey Davis Park at a low point near the playground
From here the storm pipe goes west toward W. Mercer Way
18" SD WSDOT OWNED PIPE

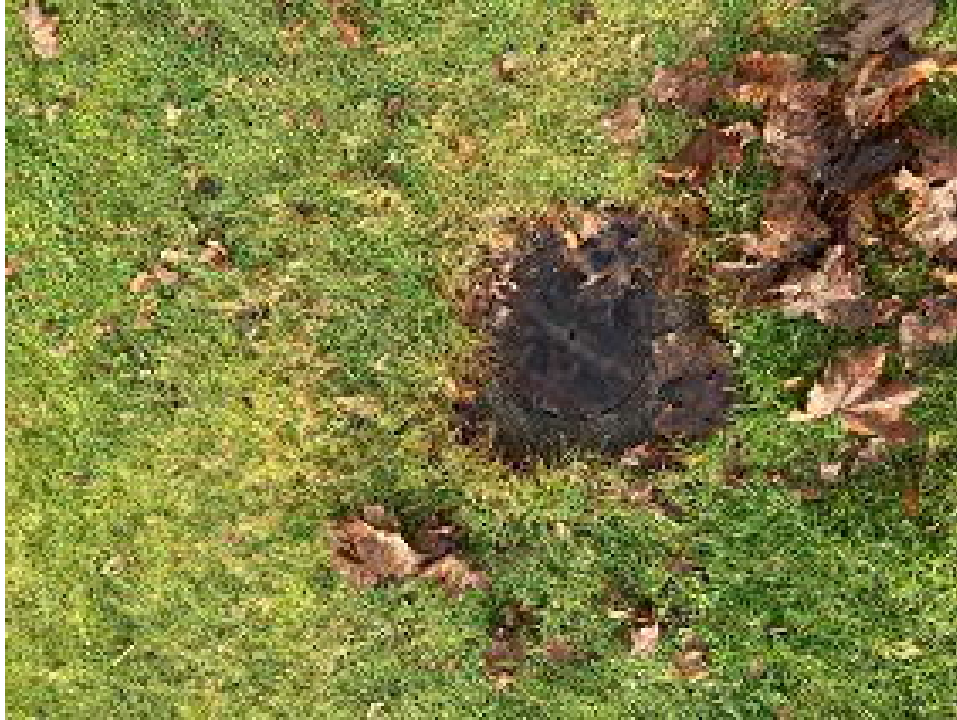
Picture 14:

Aubrey Davis Park very close to W. Mercer Way
This is closest structure that may be storm drain.
18" SD WSDOT OWNED PIPE

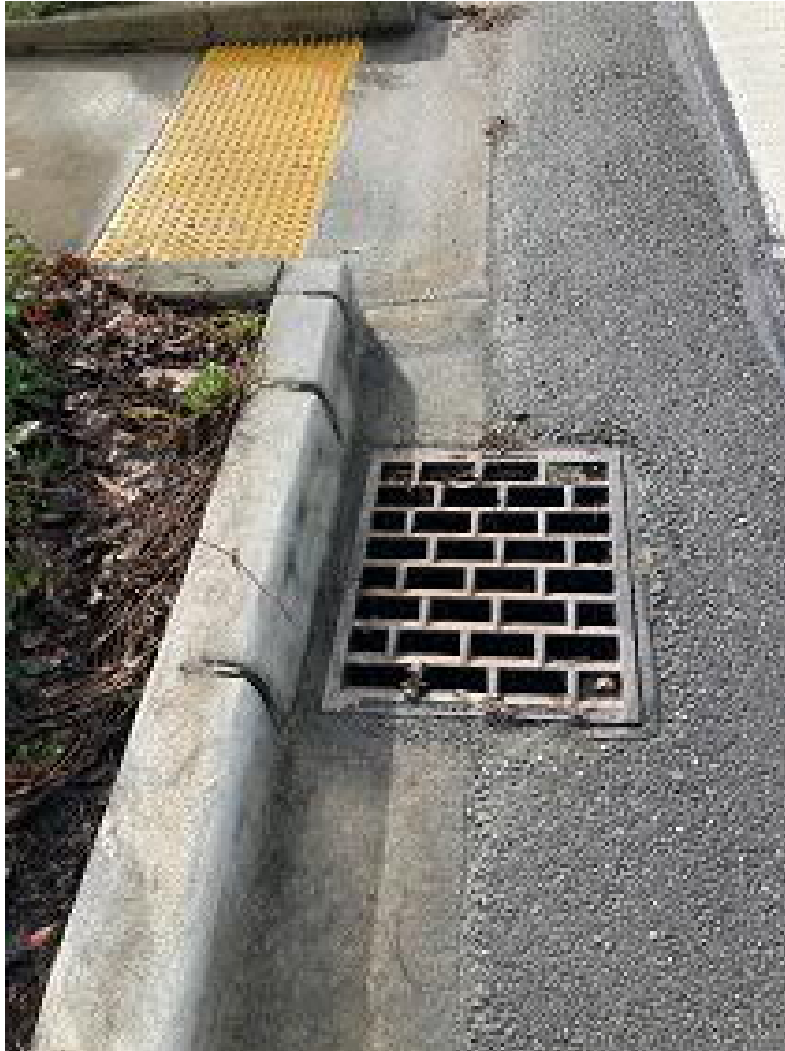
Picture 15:
West Mercer Way
18" pipes head south under W. Mercer Way
18" SD WSDOT OWNED PIPE

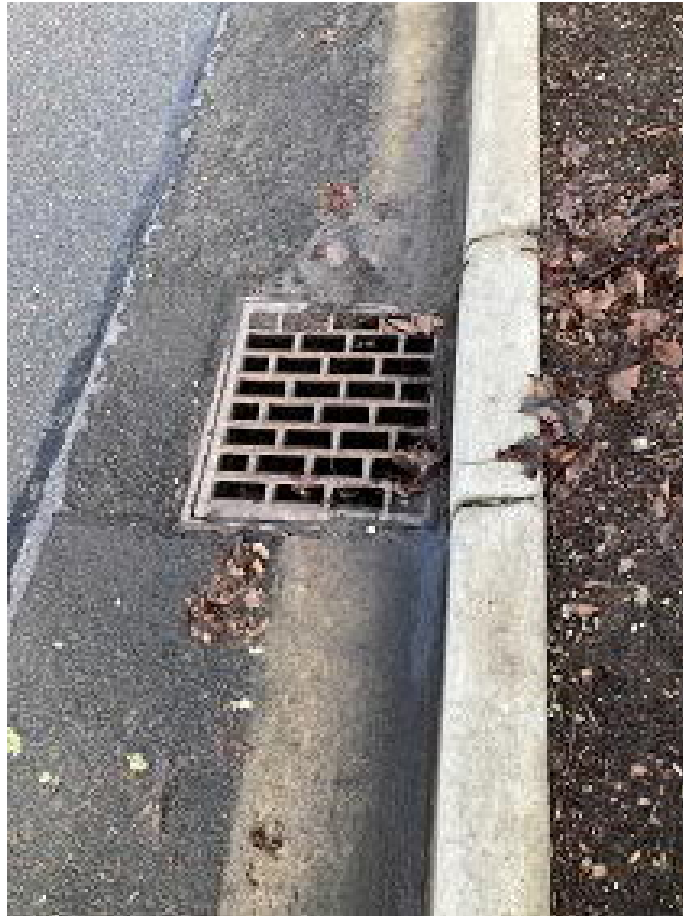
Picture 16:
West Mercer Way just northeast of the I-90 on-ramp
End of ¼-mile analysis; from here pipes cross west (left of page) under W. Mercer Way
18" SD WSDOT OWNED PIPE
