Arborist Report

To: Mina Laban
Site: 10 Brook Bay Rd, Mercer Island, WA 98040
Re: Preliminary - Tree Inventory for Development
Date: October 9, 2023
Project Arborist: Charlie Vogelheim
ISA Certified Arborist #PN-9375A
Qualified Tree Risk Assessor
Referenced Documents: Critical Area Study and Conceptual Mitigation Plan for Laban Remodel 10 Brook Bay Road. Wetland Resources Inc. 4.25.23.
Laban Remodel Corrections 1. Floisand Studio. 10.10.23.
Laban Residence Siteplan. Pacific Stormwater.
Attached: Table of Trees
Tree Site Map
Tree Retention Worksheet

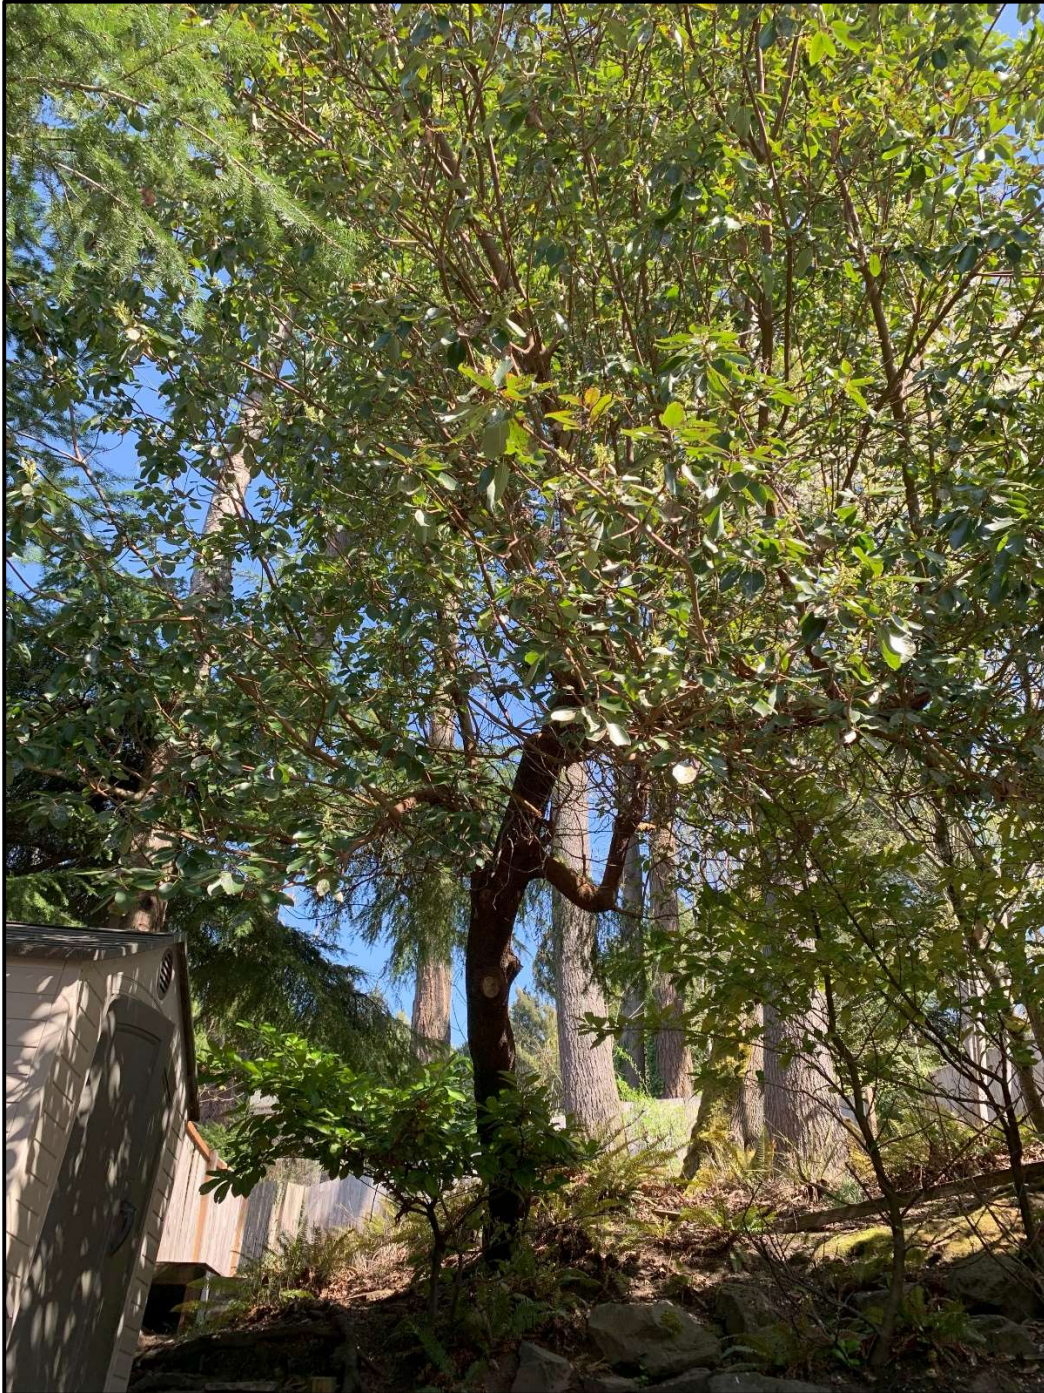
The Demo Site Plan for this project indicates that sheds, the wall, and concrete supports on the east side of the property will be removed. This work will happen within the RLOD of regulated tree 234 and exceptional trees 235, 236, 238, 239, 240, A, and B. Removal of the concrete supports will likely impact roots and we recommend they be abandoned on-site. Methods that may disturb or impact the soil, such as the use of heavy machines, shall be avoided when removing these structures. Bare soil shall be covered with four inches of arborist woodchip mulch and irrigated during the dry summer season. The project arborist shall review the demolition methods and an arborist should be present during the removal of these structures to monitor, document, and direct tree protection measures. Appendix F includes further general tree protection measures. Tree protection fencing shall be replaced at the edge of the RLODs of these trees as soon as the work is completed.

Photo 1. This photo is looking east at the grove of exceptional trees. Plans call for the removal of the shed and the wall which should be done carefully as to not disturb the roots of the trees.

- Review special tree protection measures with Tree Solutions Inc., for trees that may be impacted by the shed and wall removal on the east side of the property.

- Have an arborist present to monitor, document, and direct tree protection measures during the removal of the shed and the wall.
- All off-site trees must be protected during construction. See specifications in Appendix F.
