ARBORIST Memo

4803 Forest Ave SE
Mercer Island, WA

This memo is intended to address a SUB3 Review Comment from John Kenney dealing with Tree #746 and #751.

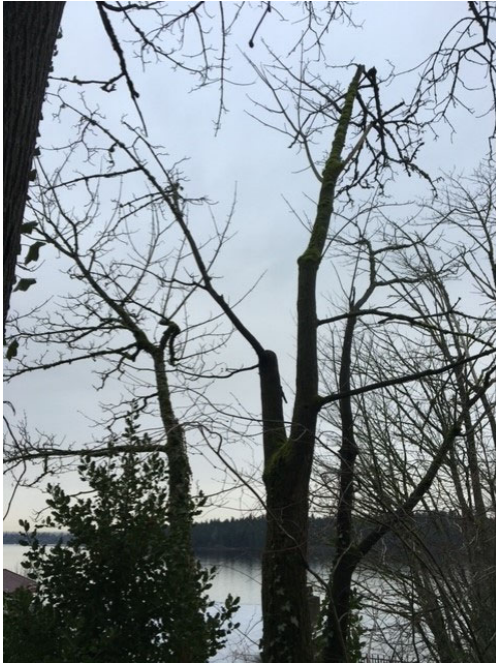
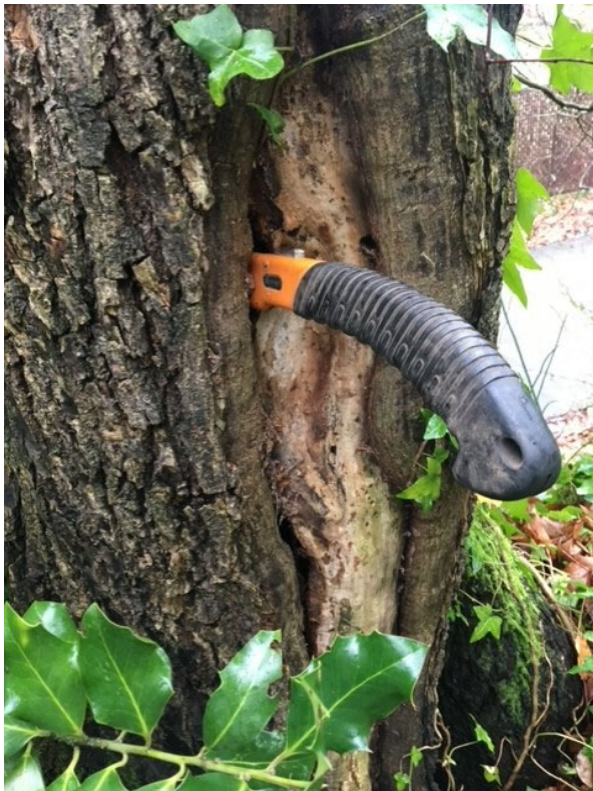
It is my understanding that at some time in the recent past the proposed garage structure and retaining walls were within the dripline of Tree #746. Those plans have been altered to provide dripline protection for Tree #746. The above referenced Review Comment also asks for detail on tree #751. This tree is located on the crest of a steep slope and was surrounded by thick bramble the first time I assessed the trees on that site. Subsequent to that initial assessment, and due to changes in the siting of the proposed garage structure, there was a need to further assess Tree #746. During that site visit we took the time to clear the bramble from around the base of Tree #751, which revealed advanced decay in the buttress and root collar. The attached photos show a 18" pruning saw easily inserted into the decay column. While there is response wood, it is not vigorous and the decay is so advanced as to allow light to be seen from one side of the root collar, through and under the tree. We also measured the two stems and then calculated the DBH to be 25.3". I've included a photo detailing the dieback and loss of limbs in the canopy. As you know, *Kretzchmaria deusta* is prevalent in our Big Leaf Maples. This subject property is vacant currently, so the risk of failure is slightly mitigated by that fact. Once construction begins, the risk of unfavorable consequences from a partial or complete failure will be considered High.

The two photos below show the significant structural defects and limb dieback. The buttress wood and root collar decay is advanced.
