Re: Arborist Report – Hong/Kao Residence

DCG/Watershed Reference Number: 230306

We are pleased to present you with the findings of our tree inventory and assessment for the proposed project at 5425 W. Mercer Way (parcel #2948900015) in Mercer Island, WA. Lars Freeman-Wood, an ISA Certified Arborist® and Qualified Tree Risk Assessor with DCG/Watershed, visited the subject property on May 9, 2023, to inventory and assess trees within the project area.

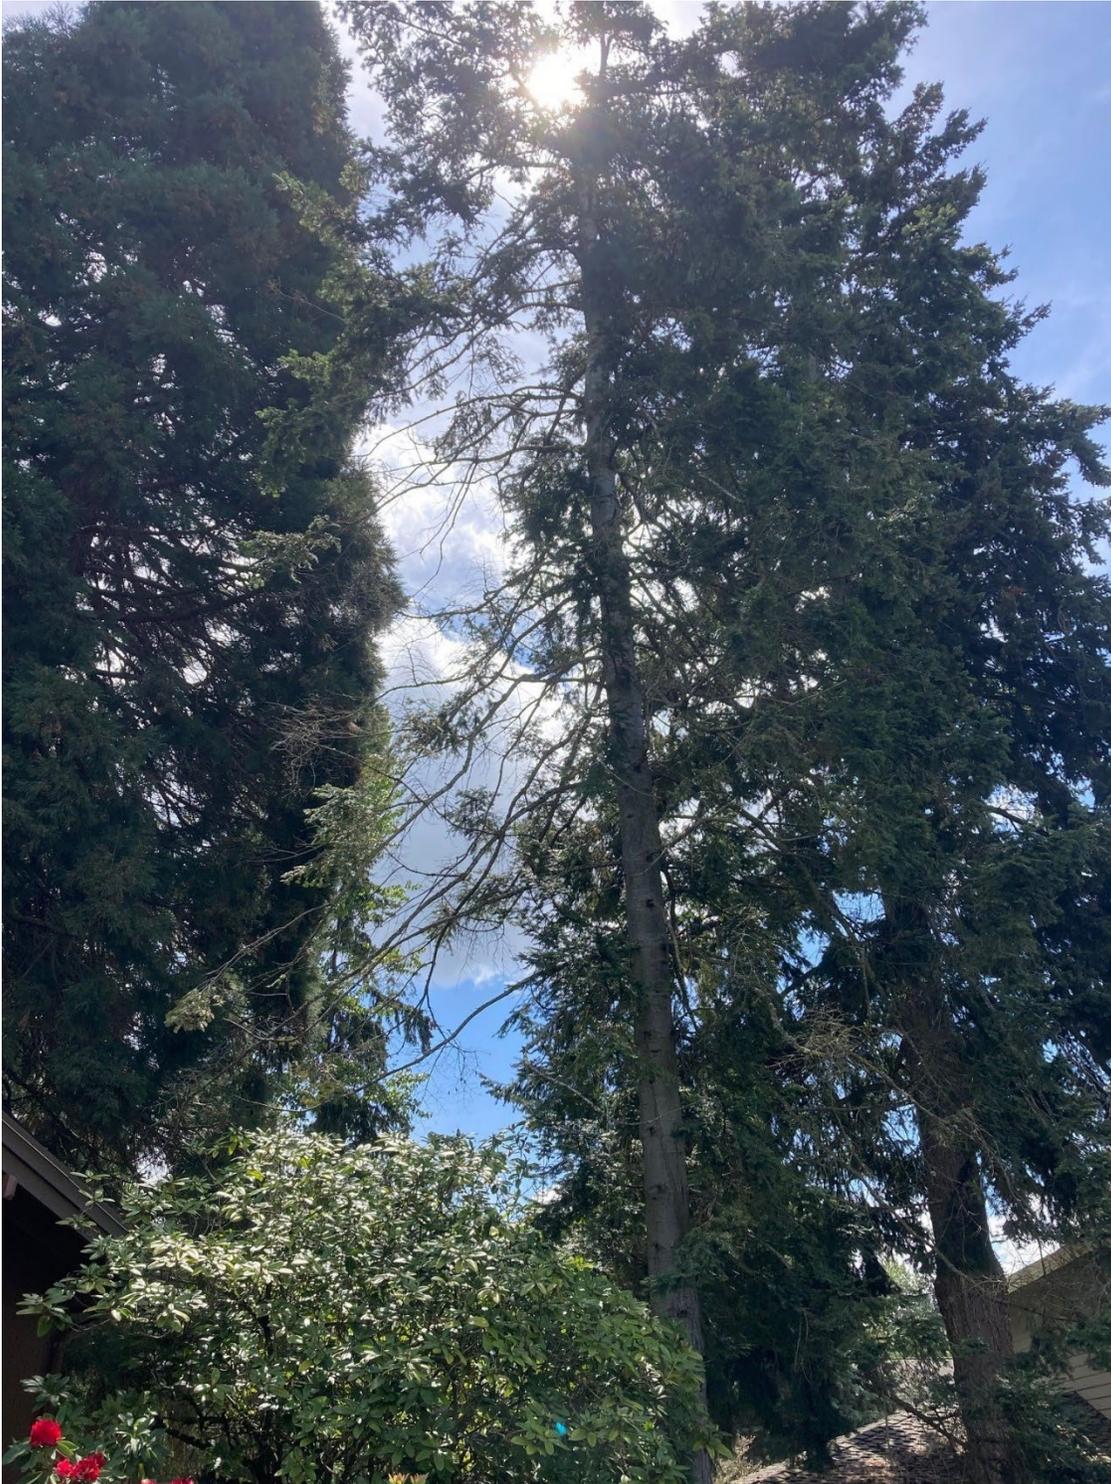
Tree #9 and Tree #11 should be removed due to their being in *Poor* condition with significant canopy dieback. See Figures 2 and 3 for photos of the trees.

Figure 2. Tree #9, silver fir in *Poor* condition with significant canopy dieback.

If Tree #9 and Tree #11 are removed, they will need to be replaced with four new trees, according to MICC 19.10.070.A. Replacement trees shall be primarily those species native to the Pacific Northwest, according to MICC 19.10.070.B.2. Replacement coniferous trees shall be at least 6 feet tall, and replacement deciduous tree shall be at least one and one-half inches in caliper, according to MICC 19.10.070.B.3.

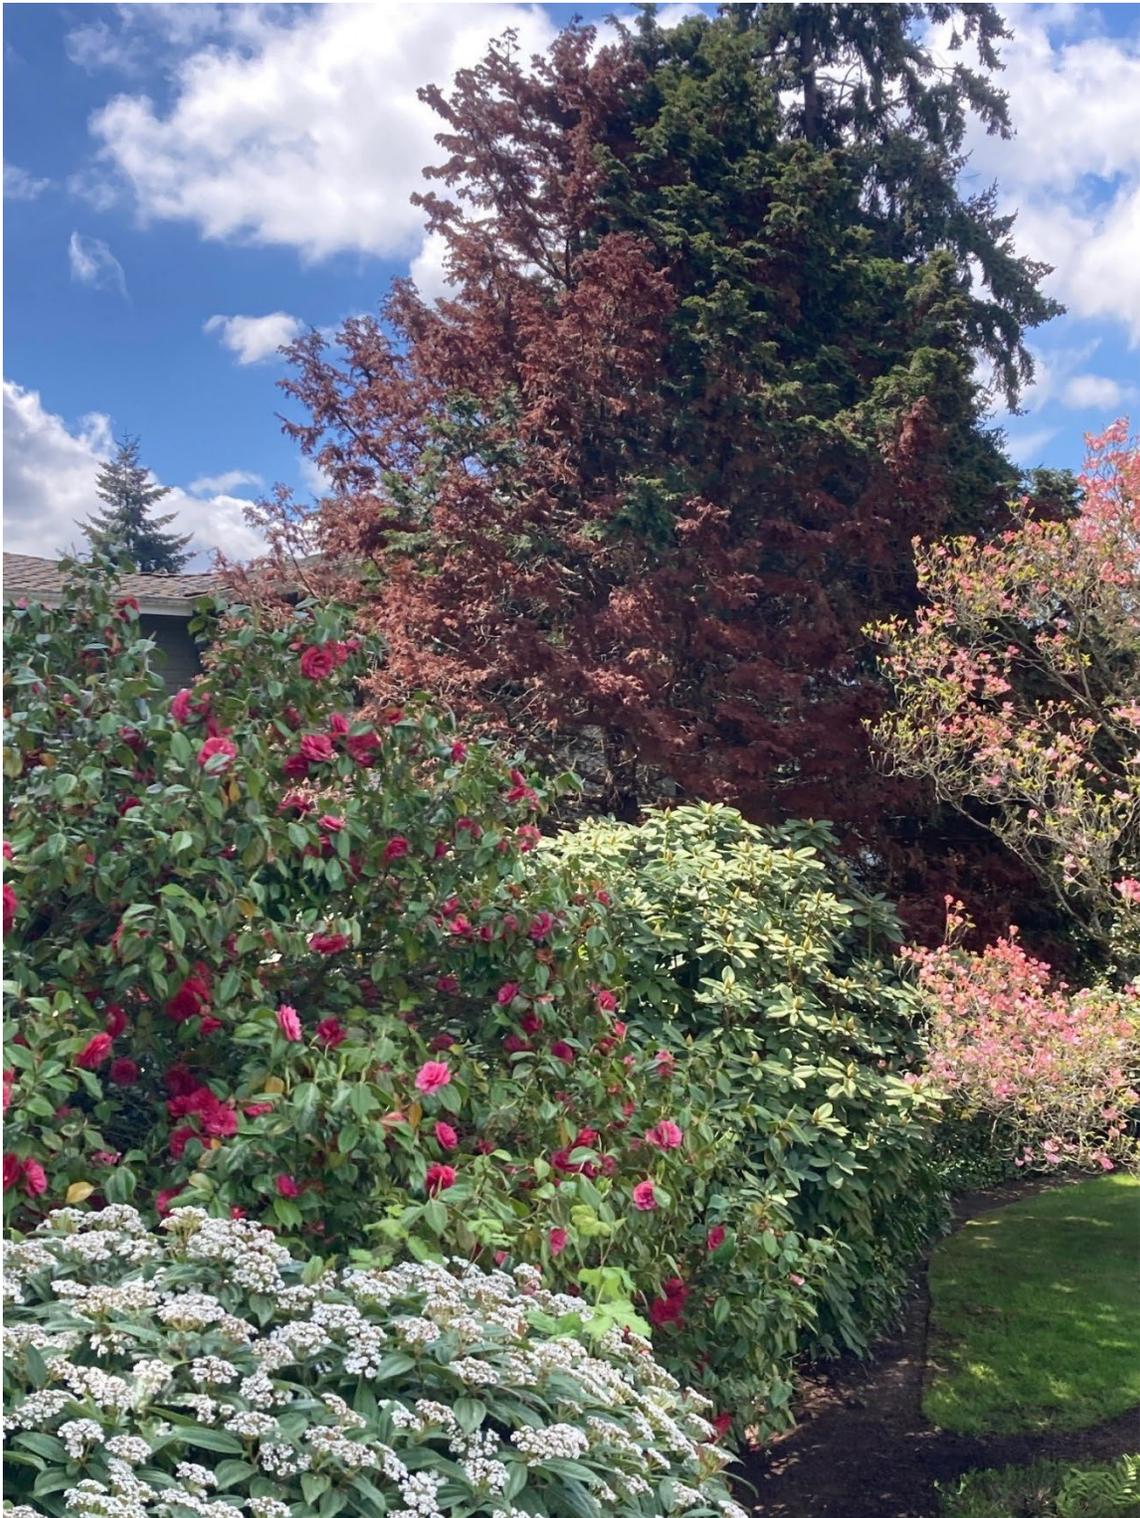
Figure 3. Tree #11, Hinoki cypress in *Poor* condition with significant canopy dieback.

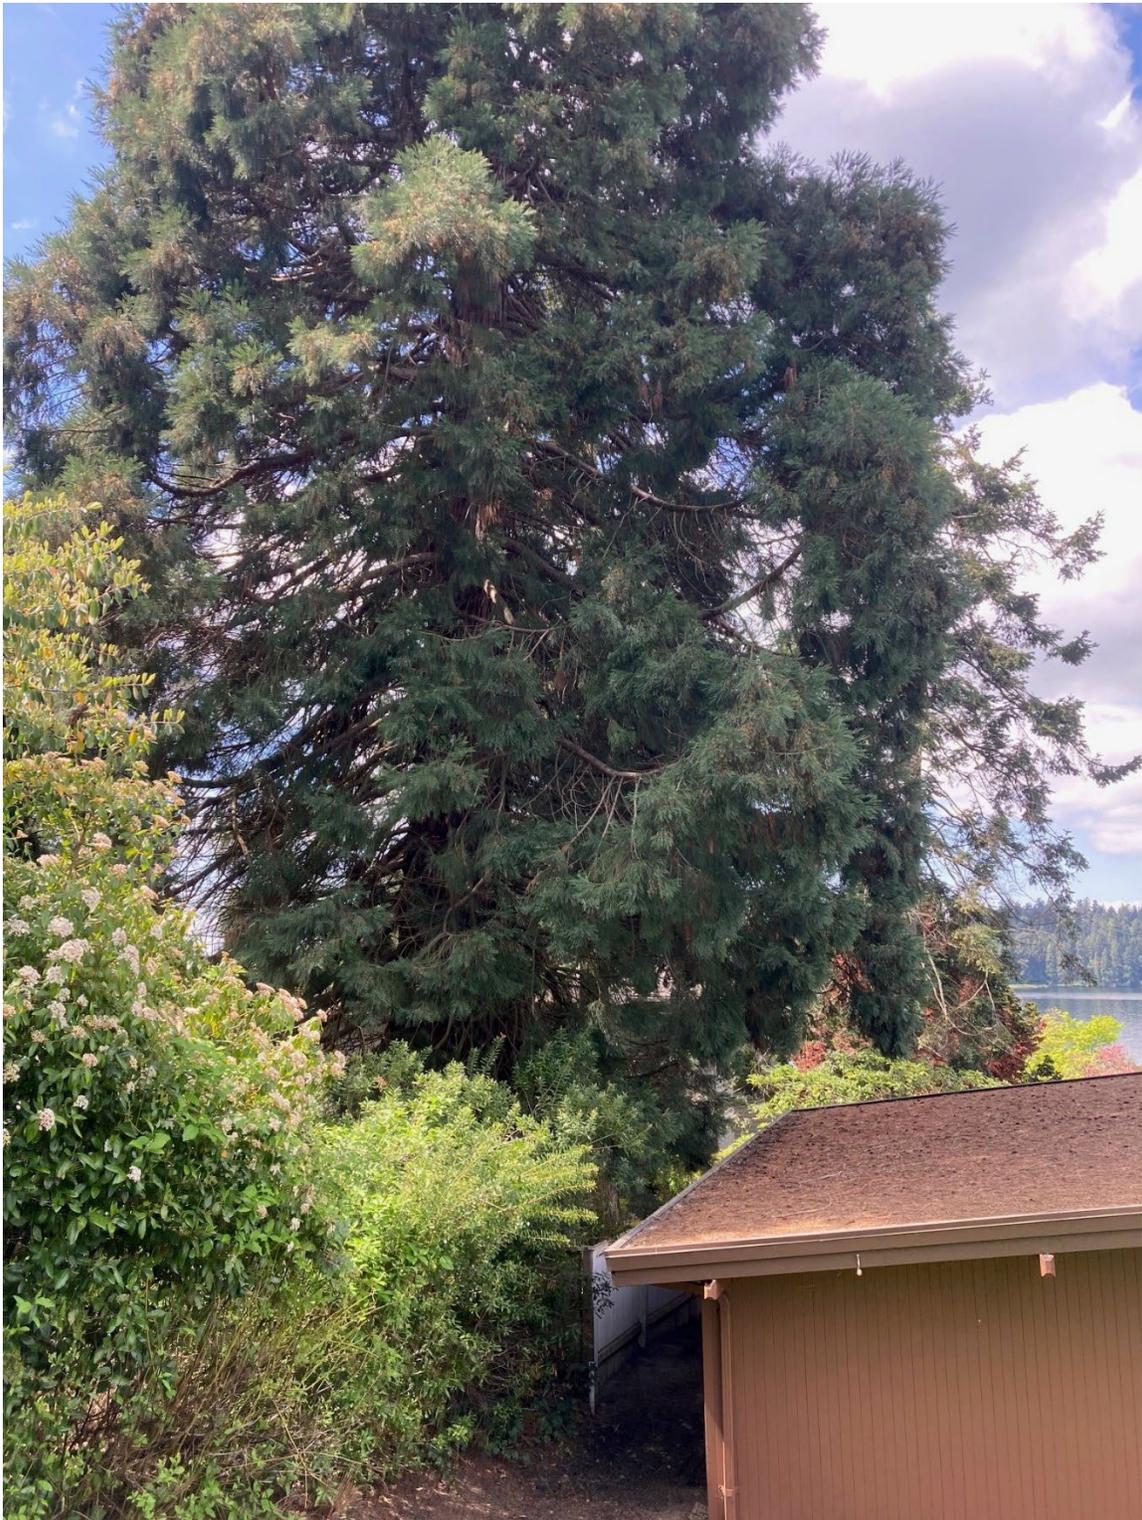
The proposed demolition of the garage and addition of the DADU on site will be within the Critical Root Zone (CRZ) of off-site Tree #8 and therefore the tree protection zone for off-site Tree #8 will need to be modified from the typical dripline recommendation. Tree protection fencing should be set at the edge of the adjacent garage proposed for demolition. Due to the location of the existing garage's foundation currently within the CRZ of off-site Tree #8, along with the orientation of the proposed DADU having less of a footprint within the CRZ of off-site Tree #8, it is unlikely that the addition of the DADU will encounter significant roots within the new building footprint. The proposed DADU having less of a footprint within the CRZ of off-site Tree #8 will mean more permeable surface for roots to have access to oxygen and soil space within the CRZ of the tree. Since off-site Tree #8 was found to be in *Good* condition with normal vigor and health, along with the tree protection recommendations listed below, the tree should remain healthy and viable.

Figure 4. Tree #8, off-site giant sequoia near current garage.
