Consulting Arborist Services

Reference: Tree Inventory Report

Date: May 31, 2023

Site Address: 8434 SE 38th, Mercer Island 98040

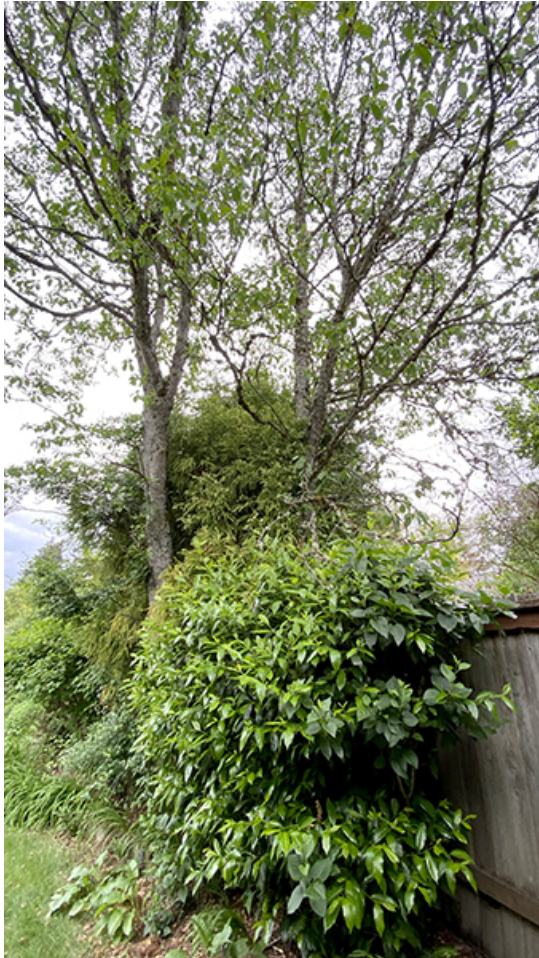
Two (2) Exceptional Pacific dogwoods are located at the NE corner of the existing home.

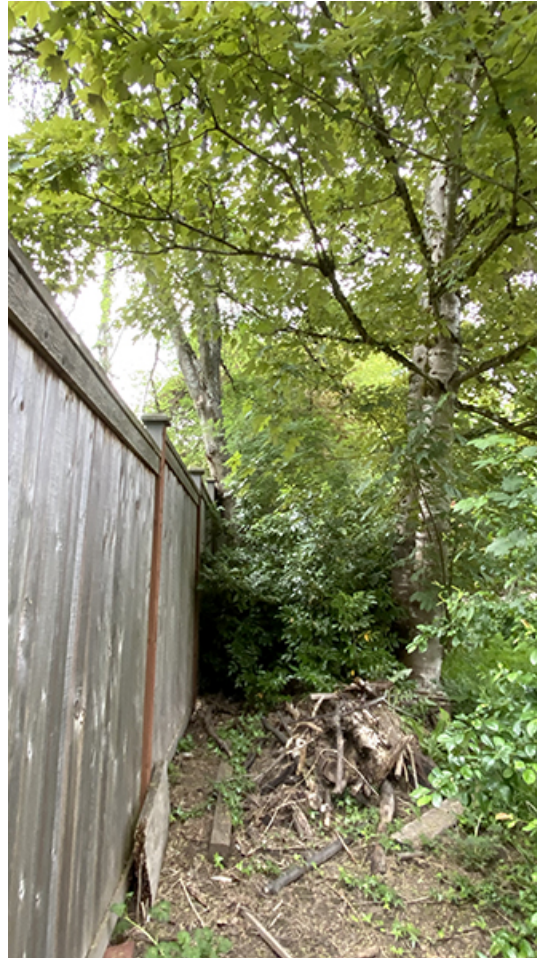
I recommend an advanced tree risk assessment be performed on Tree #18 if Tree #19 is removed. Tree #18, a 14-inch Mountain ash, exhibits trunk decay and leans to the north. Removing Tree #19 would likely increase likelihood of tree failure as it provides protection from prevailing southwest winds.

Tree #19 (right) and Tree #18 (left) located at the back of the existing home, along the north property line.

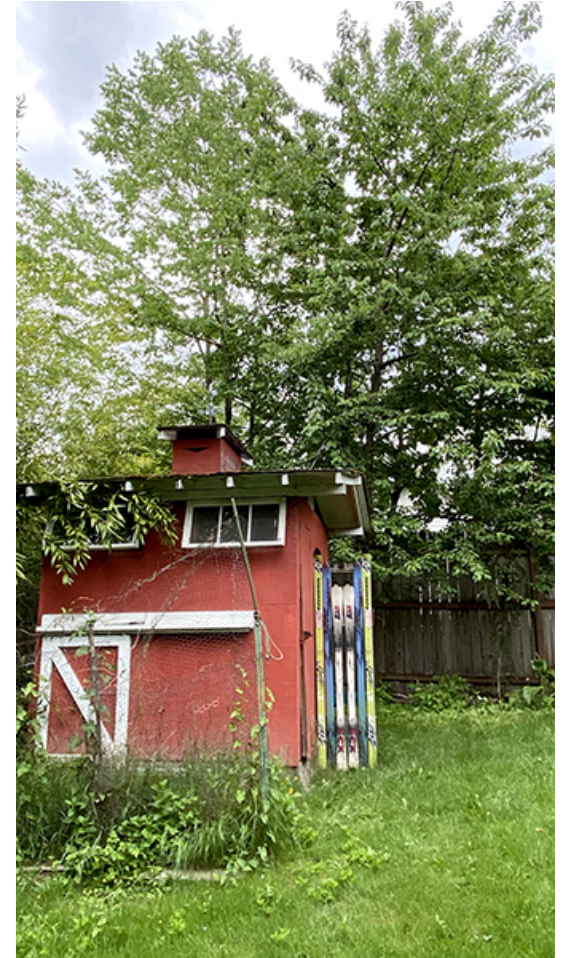
There are three (3) offsite trees with overhanging branches at the northeast corner of the lot.
