May 5, 2023

Island Crest Builders
c/o Justin Davis
3605 86th Ave. SE
Mercer Island, WA 98040

Re: **Tree Survey Report** for the address above (Parcel #5021900045).

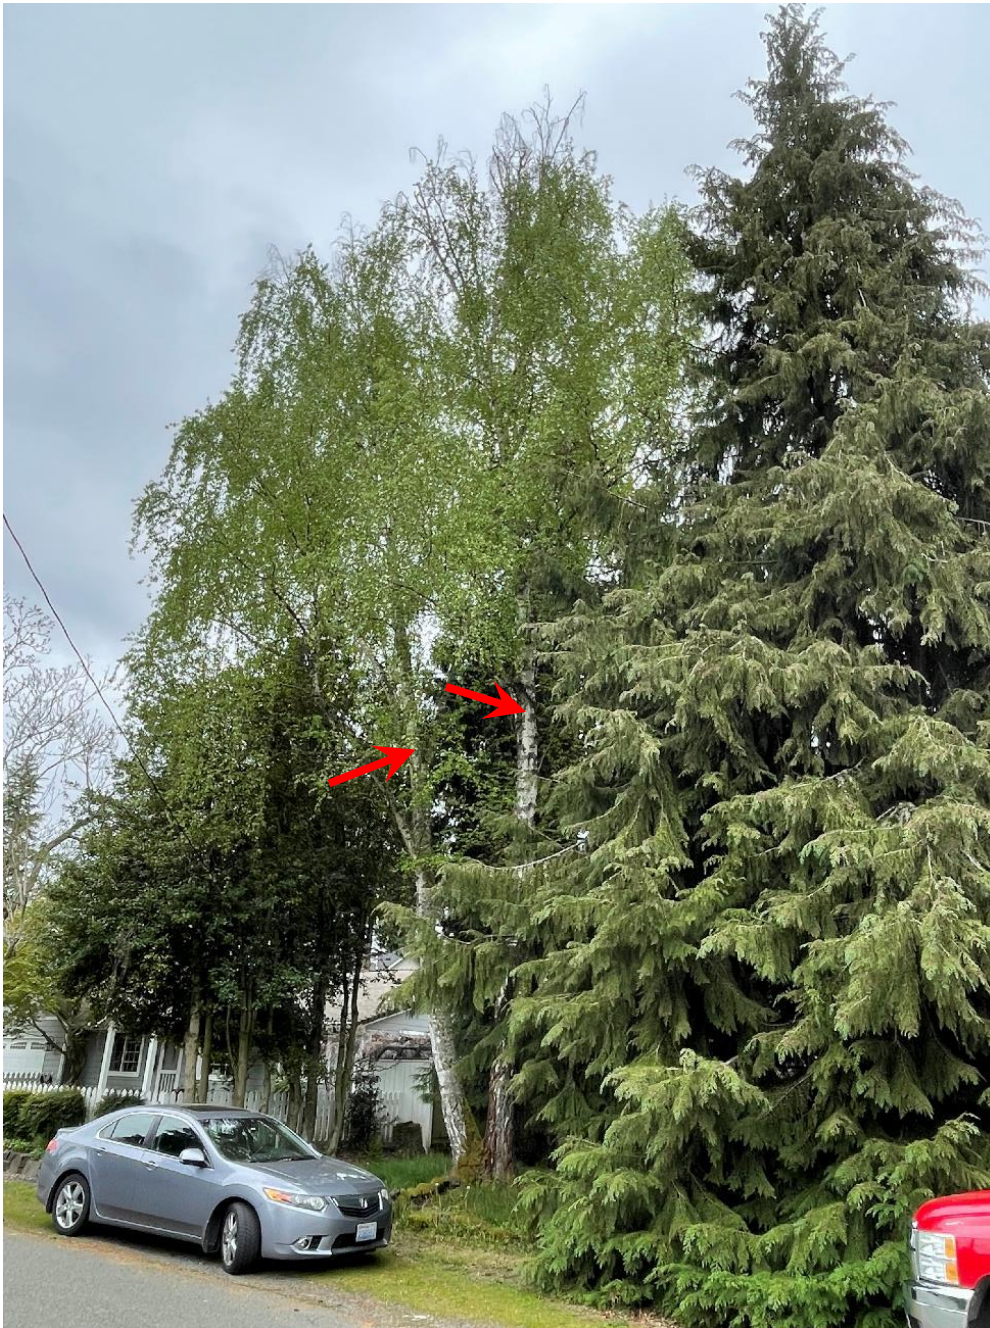
Birch Tree #109:

The picture above taken at the time of the inspection shows Birch tree #109. The red arrows indicate the two trunks of the tree. The top canopy exhibits dieback from Birch Bronze Borer (insect) activity which there is no control. This tree is not feasible for preservation and will not be able to recover from insect activity.

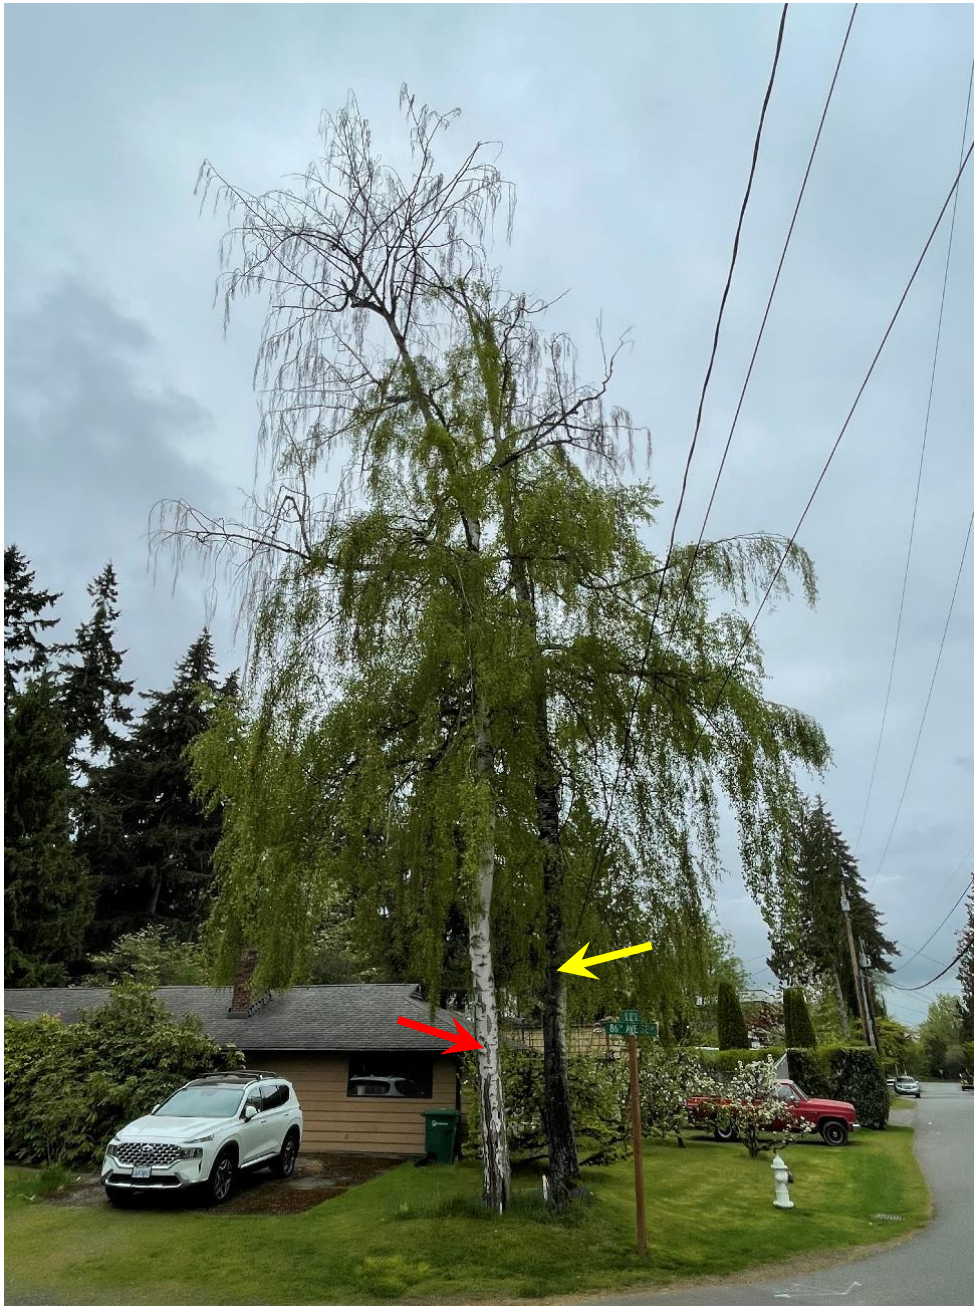
Birch Trees #111 and #112:

The picture above shows Birch trees #111 and #112 at the time of the inspection. The yellow arrow indicates tree #111 and the red arrow indicates tree #112. Both trees exhibit partial dead canopies from Bronze Birch Borer (insect) activity with tree #112 having the most dieback. These two trees are not feasible for preservation and cannot recover from insect activity.

Canopy exhibits dieback from Bronze Birch Borer activity. No control available for such insect activity. Expect continued dieback and eventual death. Tree is not viable for retention.

Remove
