October 3, 2023

Island Crest Builders
c/o Justin Davis
3605 86th Ave. SE
Mercer Island, WA 98040

Re: **Tree Survey Report** for the address above (Parcel #5021900045).

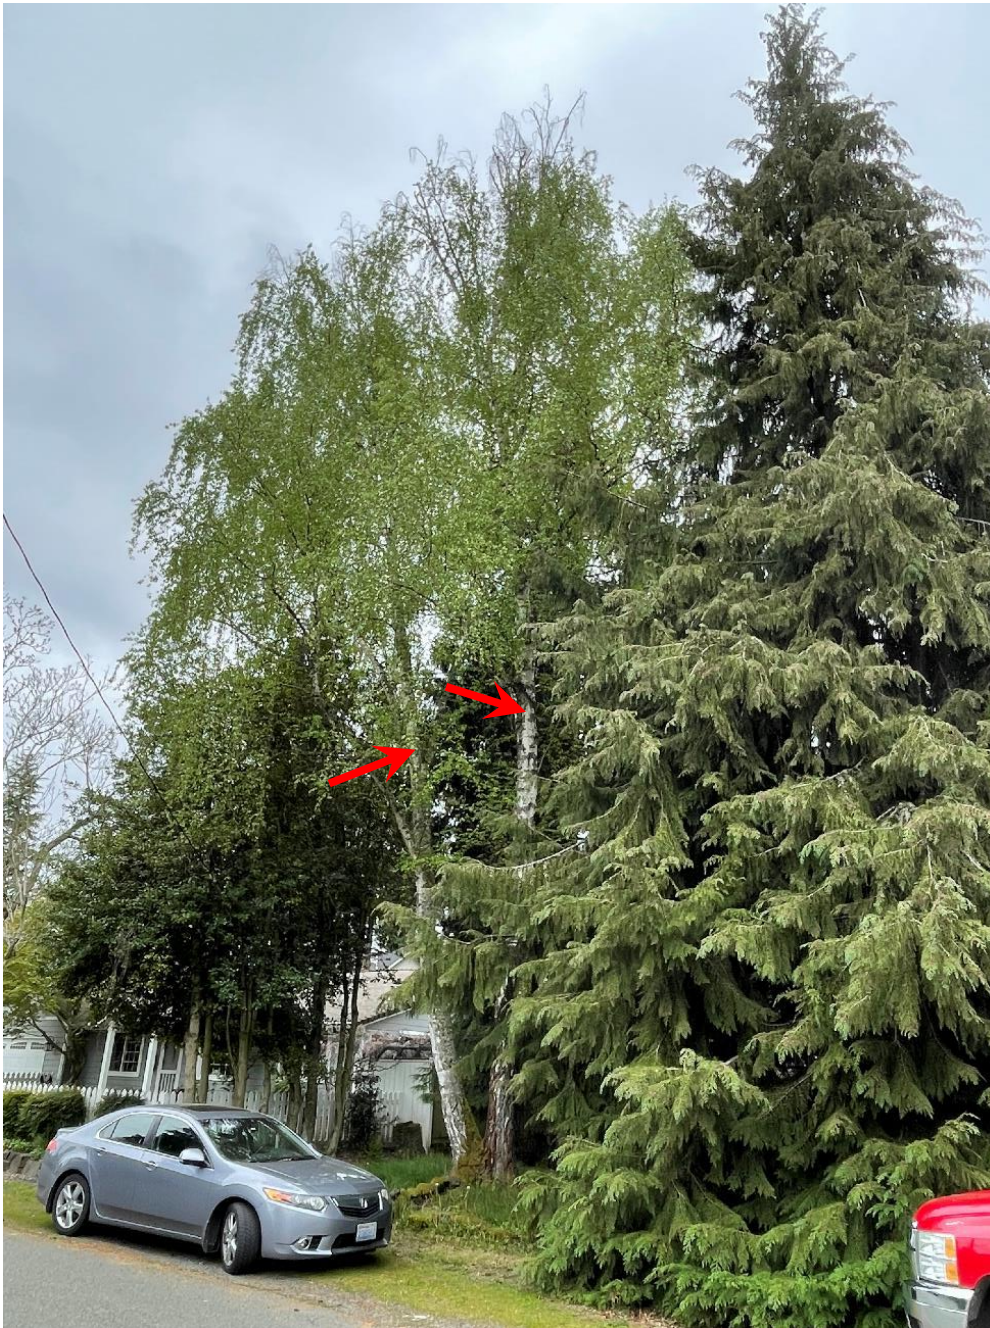
Birch Tree #109:

107	Holly	6.5"	6.0'	6.0'	Good	Asymmetric canopy to the south. No signs of decay or disease. <i>Improbable</i> risk of tree failure.
108	Holly	7.0"	8.0'	6.0'	Good	Sturdy tree with no signs of decay, disease, or structural defects. <i>Improbable</i> risk of tree failure.
109	White Birch <i>Betula pendula</i>	16.9" 19.8" [26.0"]	18.0'	20.0'	Fair	Dead top stem growth from Borer (insect) activity. No signs of decay or disease. <i>Possible</i> large part failure. <i>Improbable</i> whole tree failure.
110	Red Cedar	30.5"	18.0'	22.0'	Good	Sturdy tree with no signs of decay, disease, or structural defects. <i>Improbable</i> risk of tree failure.
111	White Birch	15.2"	14.0'	12.0'	Fair	Dead top stem growth from Borer (insect) activity. No signs of decay or disease. <i>Possible</i> large part failure. <i>Improbable</i> whole tree failure.
112	White Birch	13.6"	14.0'	12.0'	Poor	Dead top canopy from Borer (insect) activity. 50% live crown ratio. No signs of trunk decay. Probable large part tree failure.

The picture above taken at the time of the inspection shows Birch tree #109. The red arrows indicate the two trunks of the tree. The top canopy exhibits dieback from Birch Bronze Borer (insect) activity which there is no control. This tree is not feasible for preservation and will not be able to recover from insect activity.
