Chen Harvey

Response to Mercer Island comments letter

CHEN RESIDENCE

ARBORIST TREE PLAN

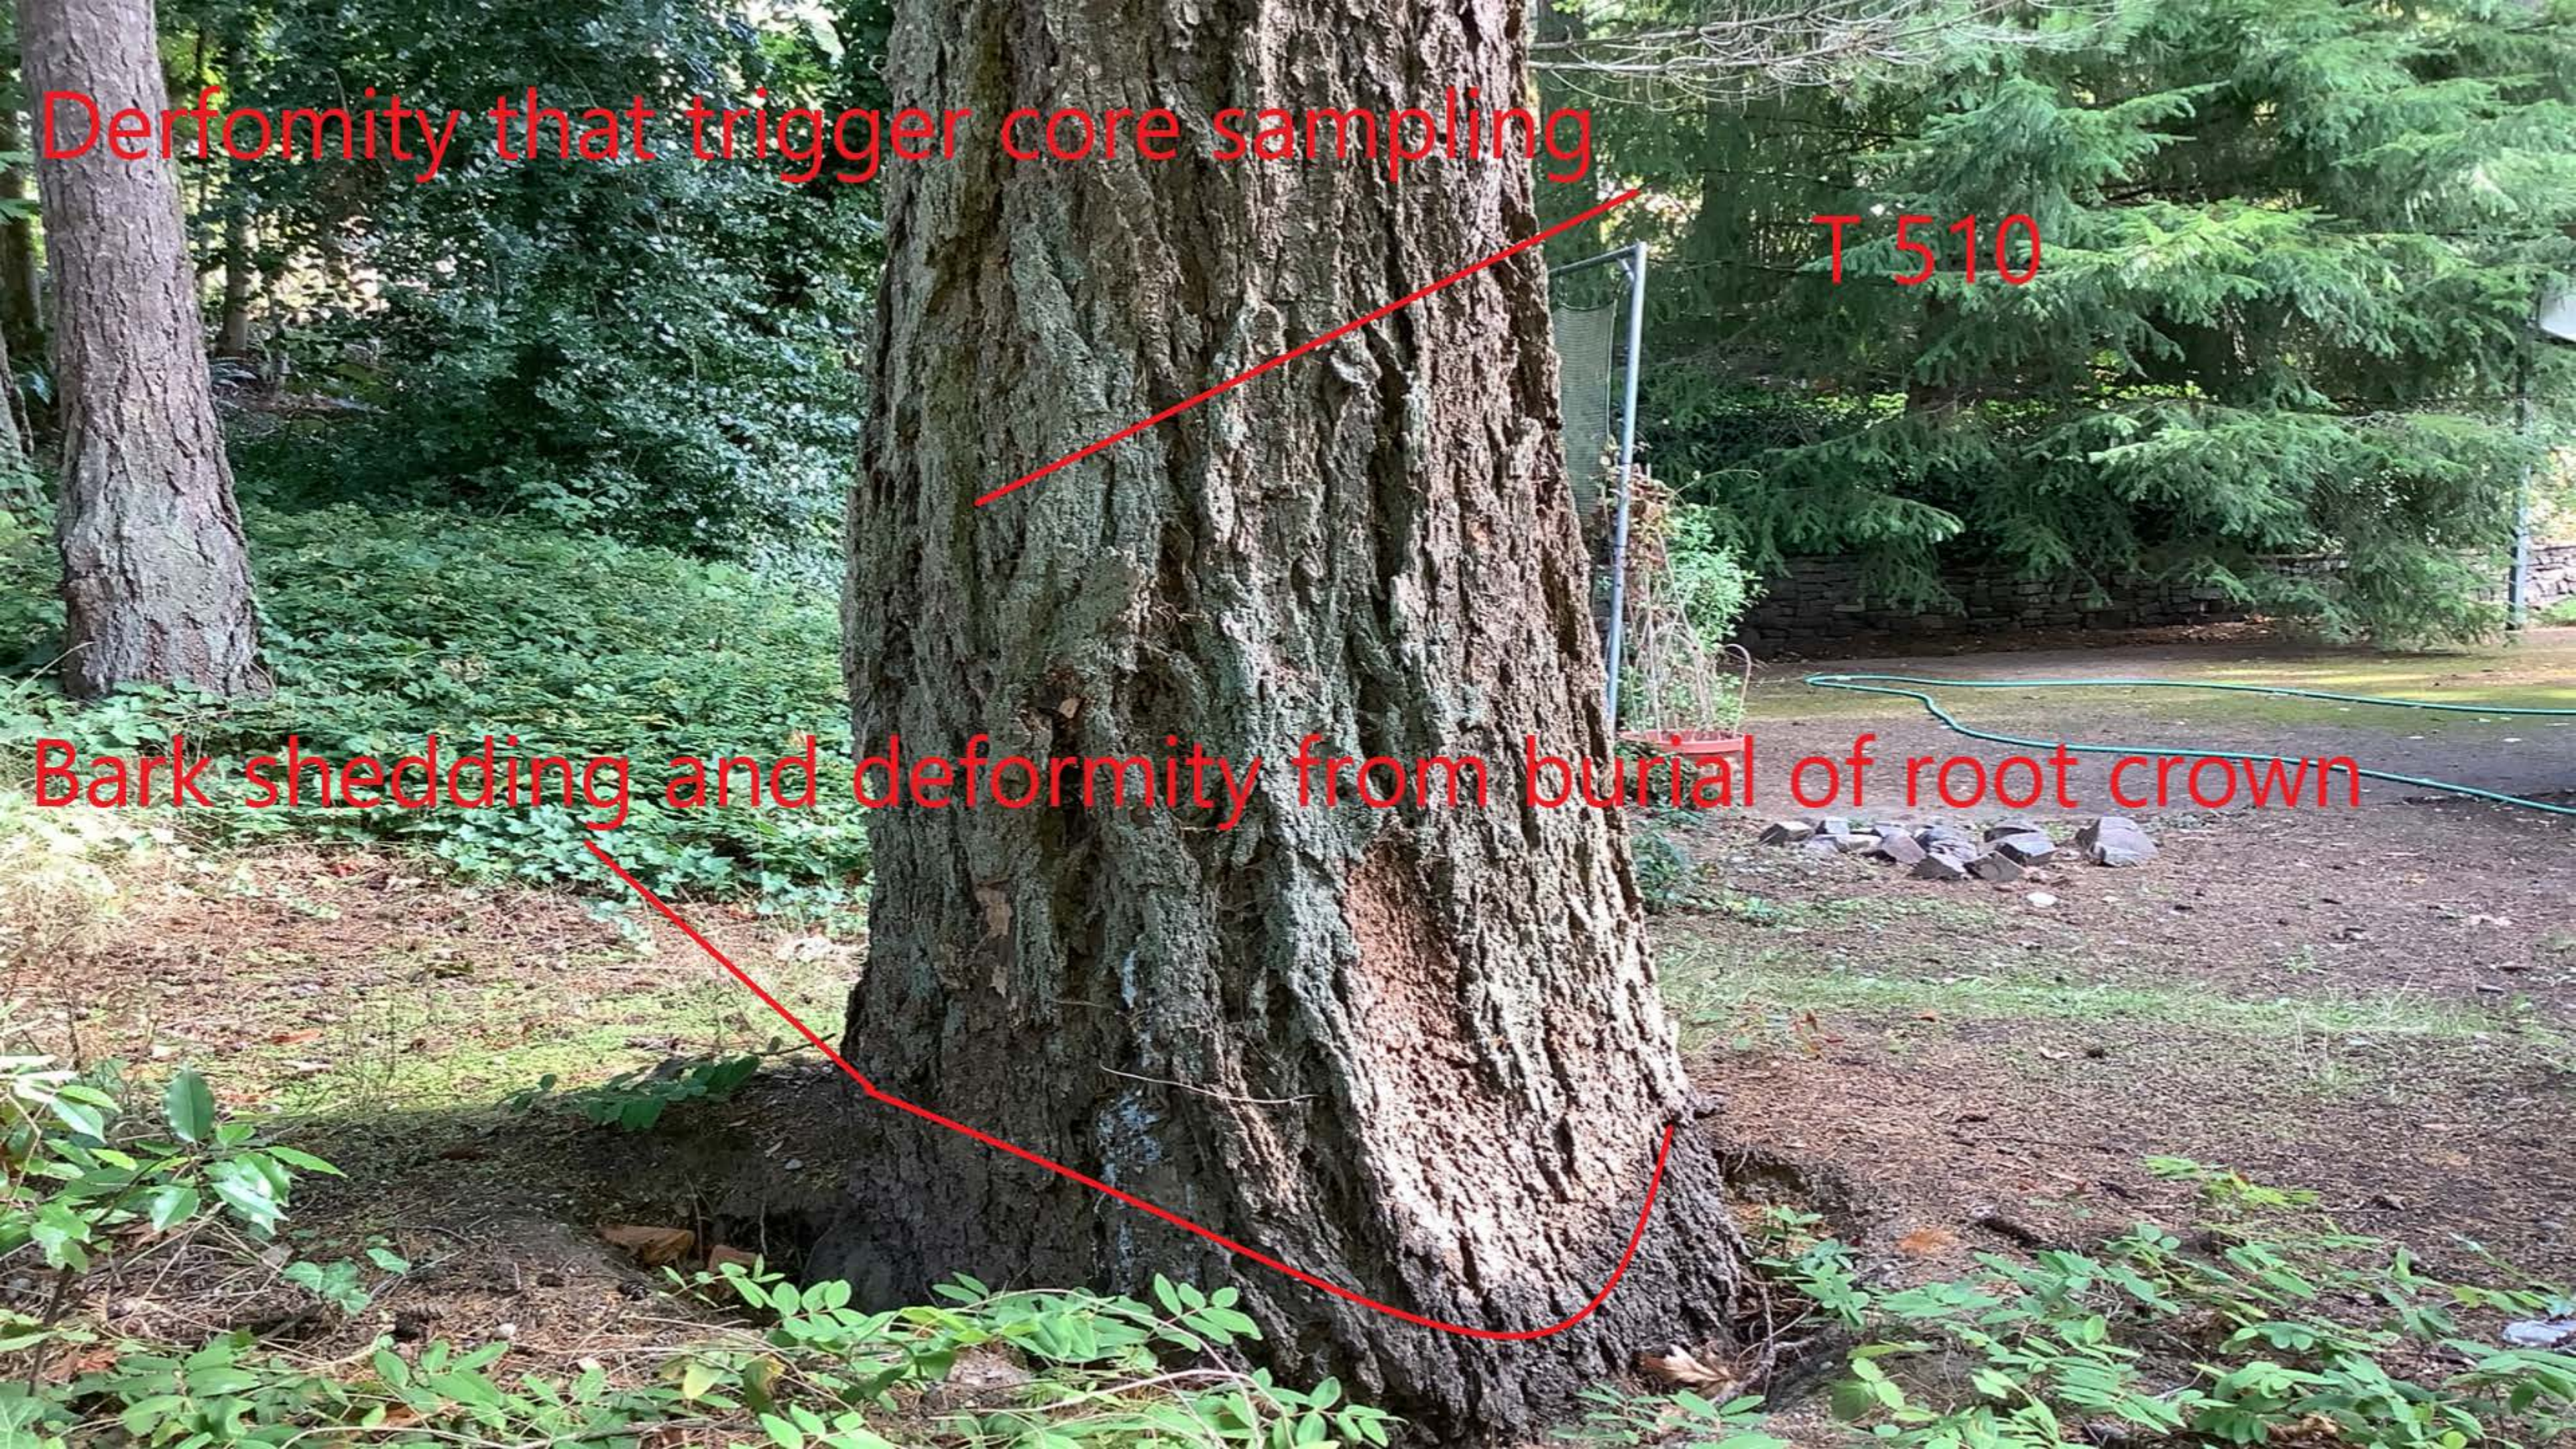
T 510

While we were inspecting 510, we noticed butt swell. As butt swell can be indicative of a tree's response to an internal weakness a decision was for further evaluation. We used a core bore and found decay as outlined in our original report. Air-Spading was done on the root crown of tree 510 to a depth of 18" see the photo. It is our opinion that the tree's root crown was buried in the past and this has resulted in the trees inner defect. Note the bark deterioration just below the red line in the picture of the root crown.

Deformity that trigger core sampling

Bark shedding and deformity from burial of root crown

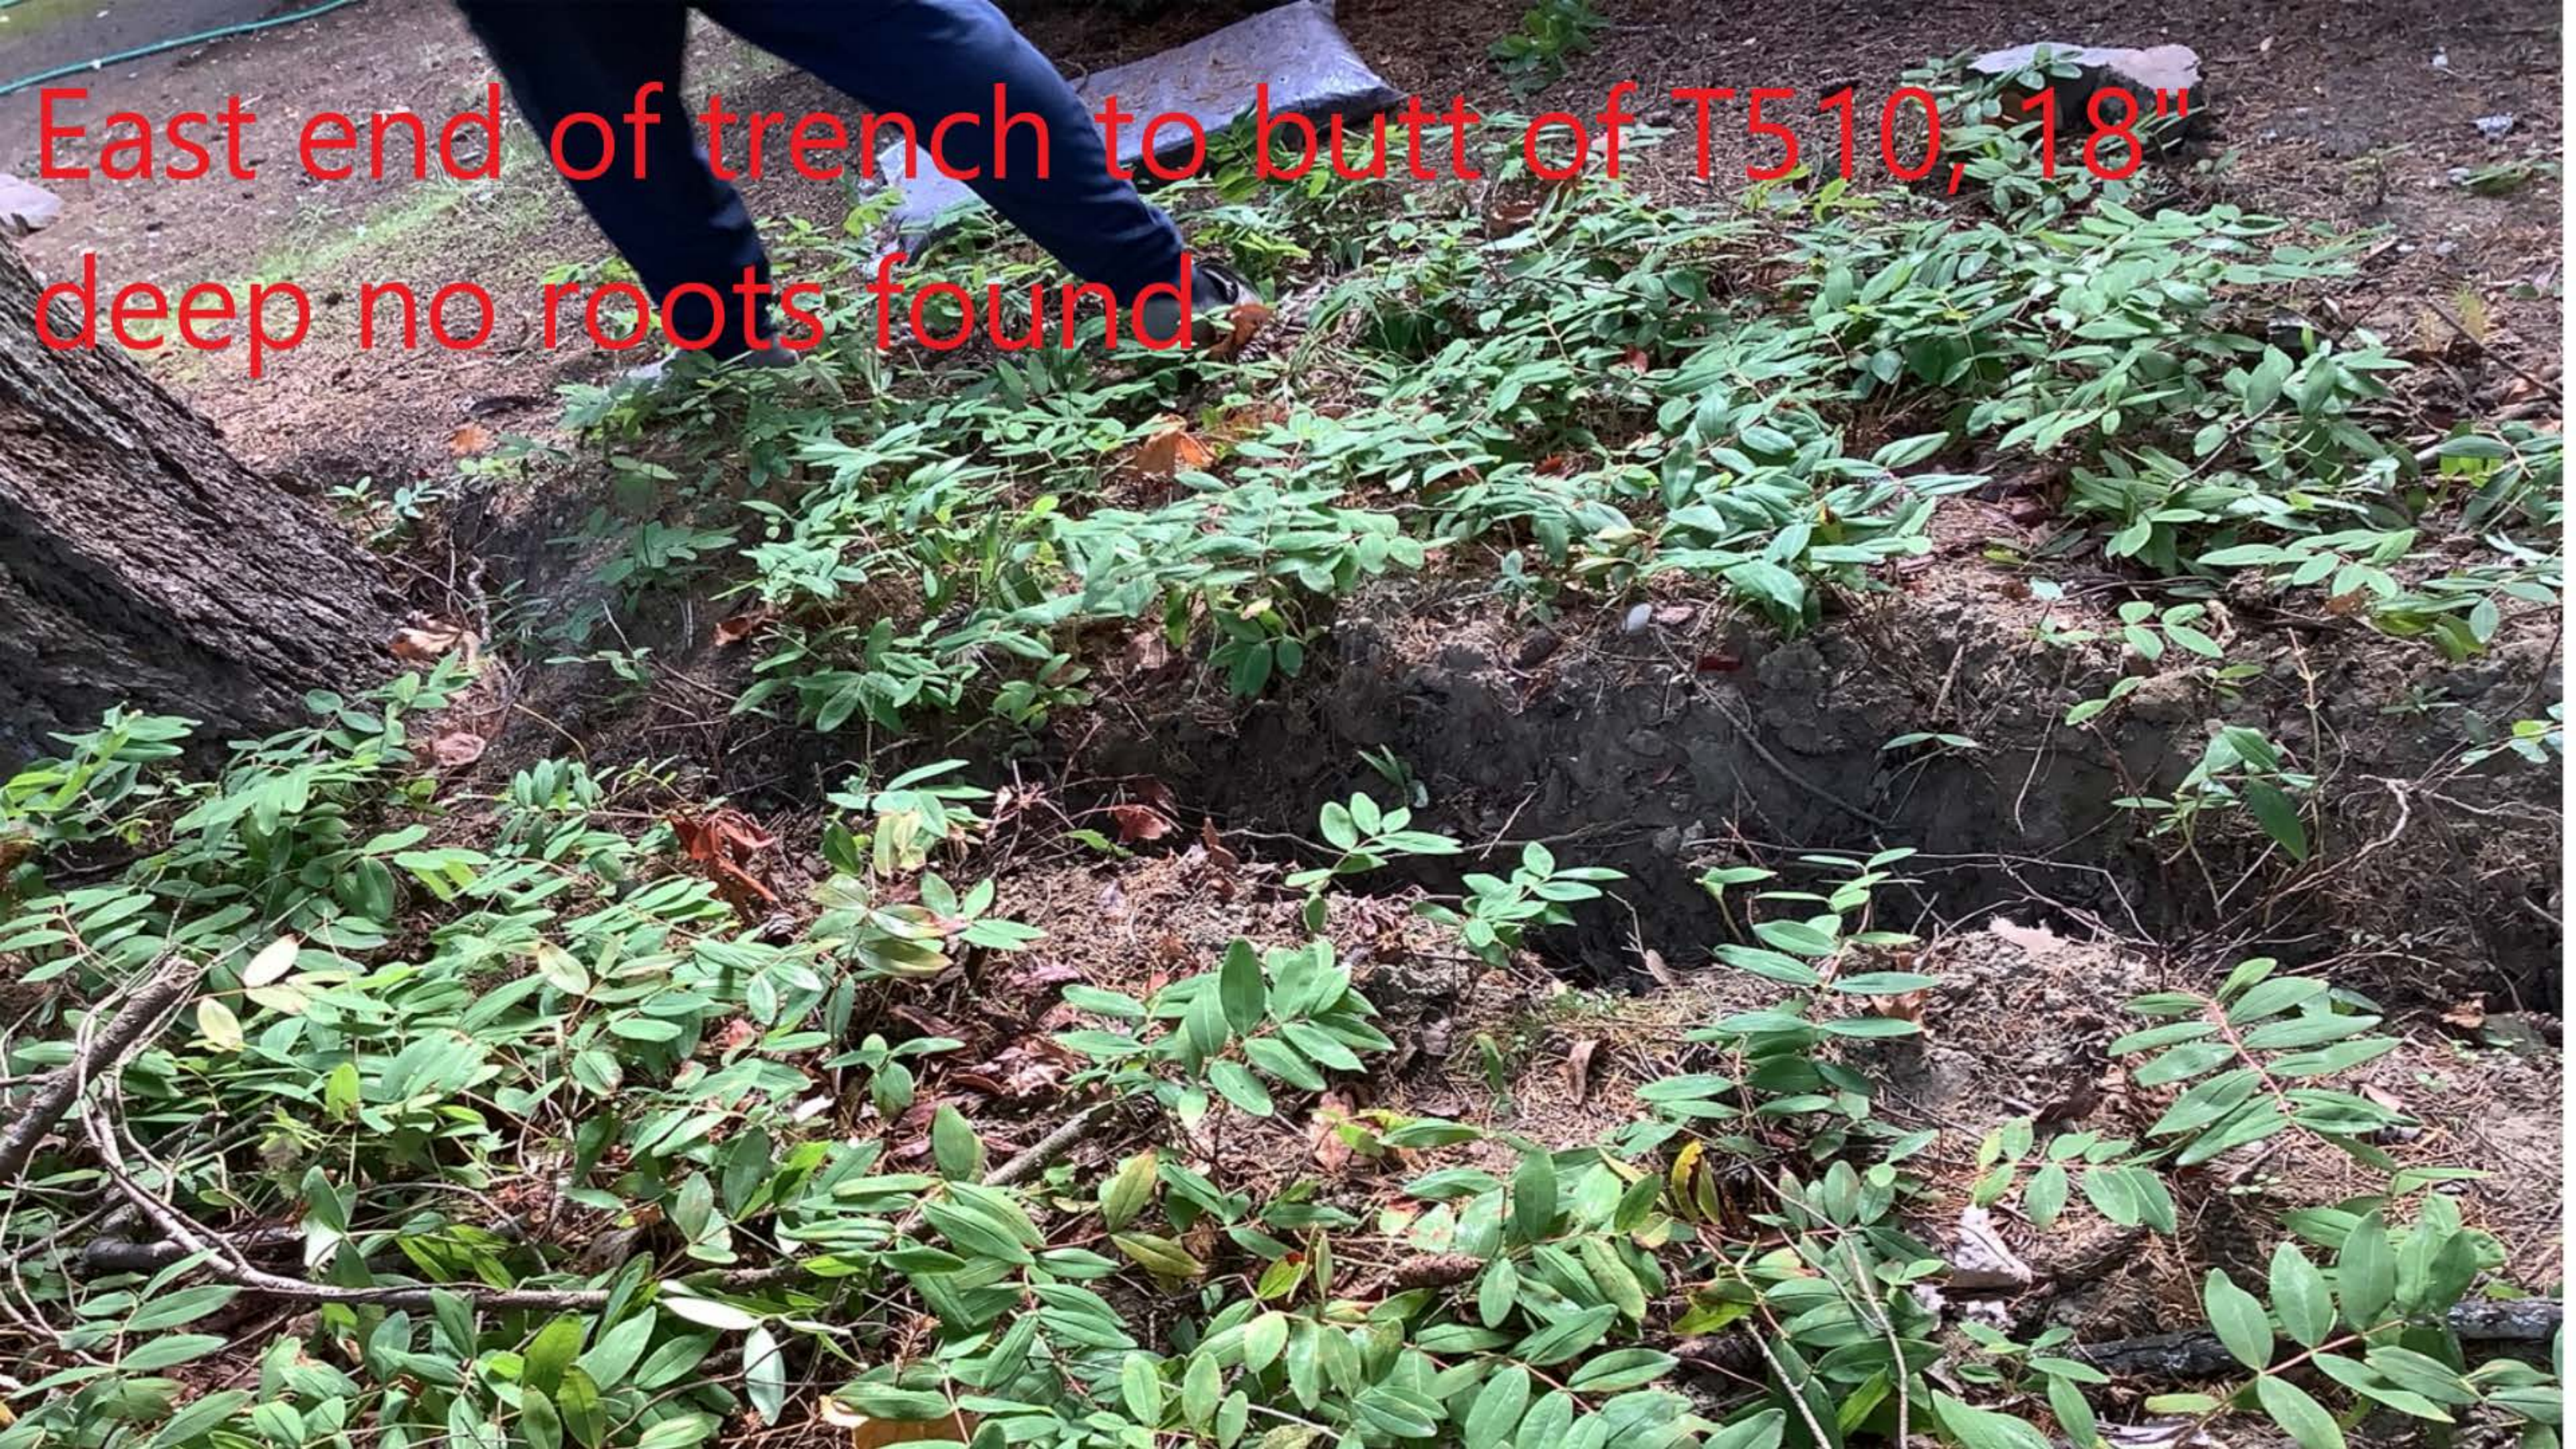
East end of trench to butt of T510, 18"  
deep no roots found

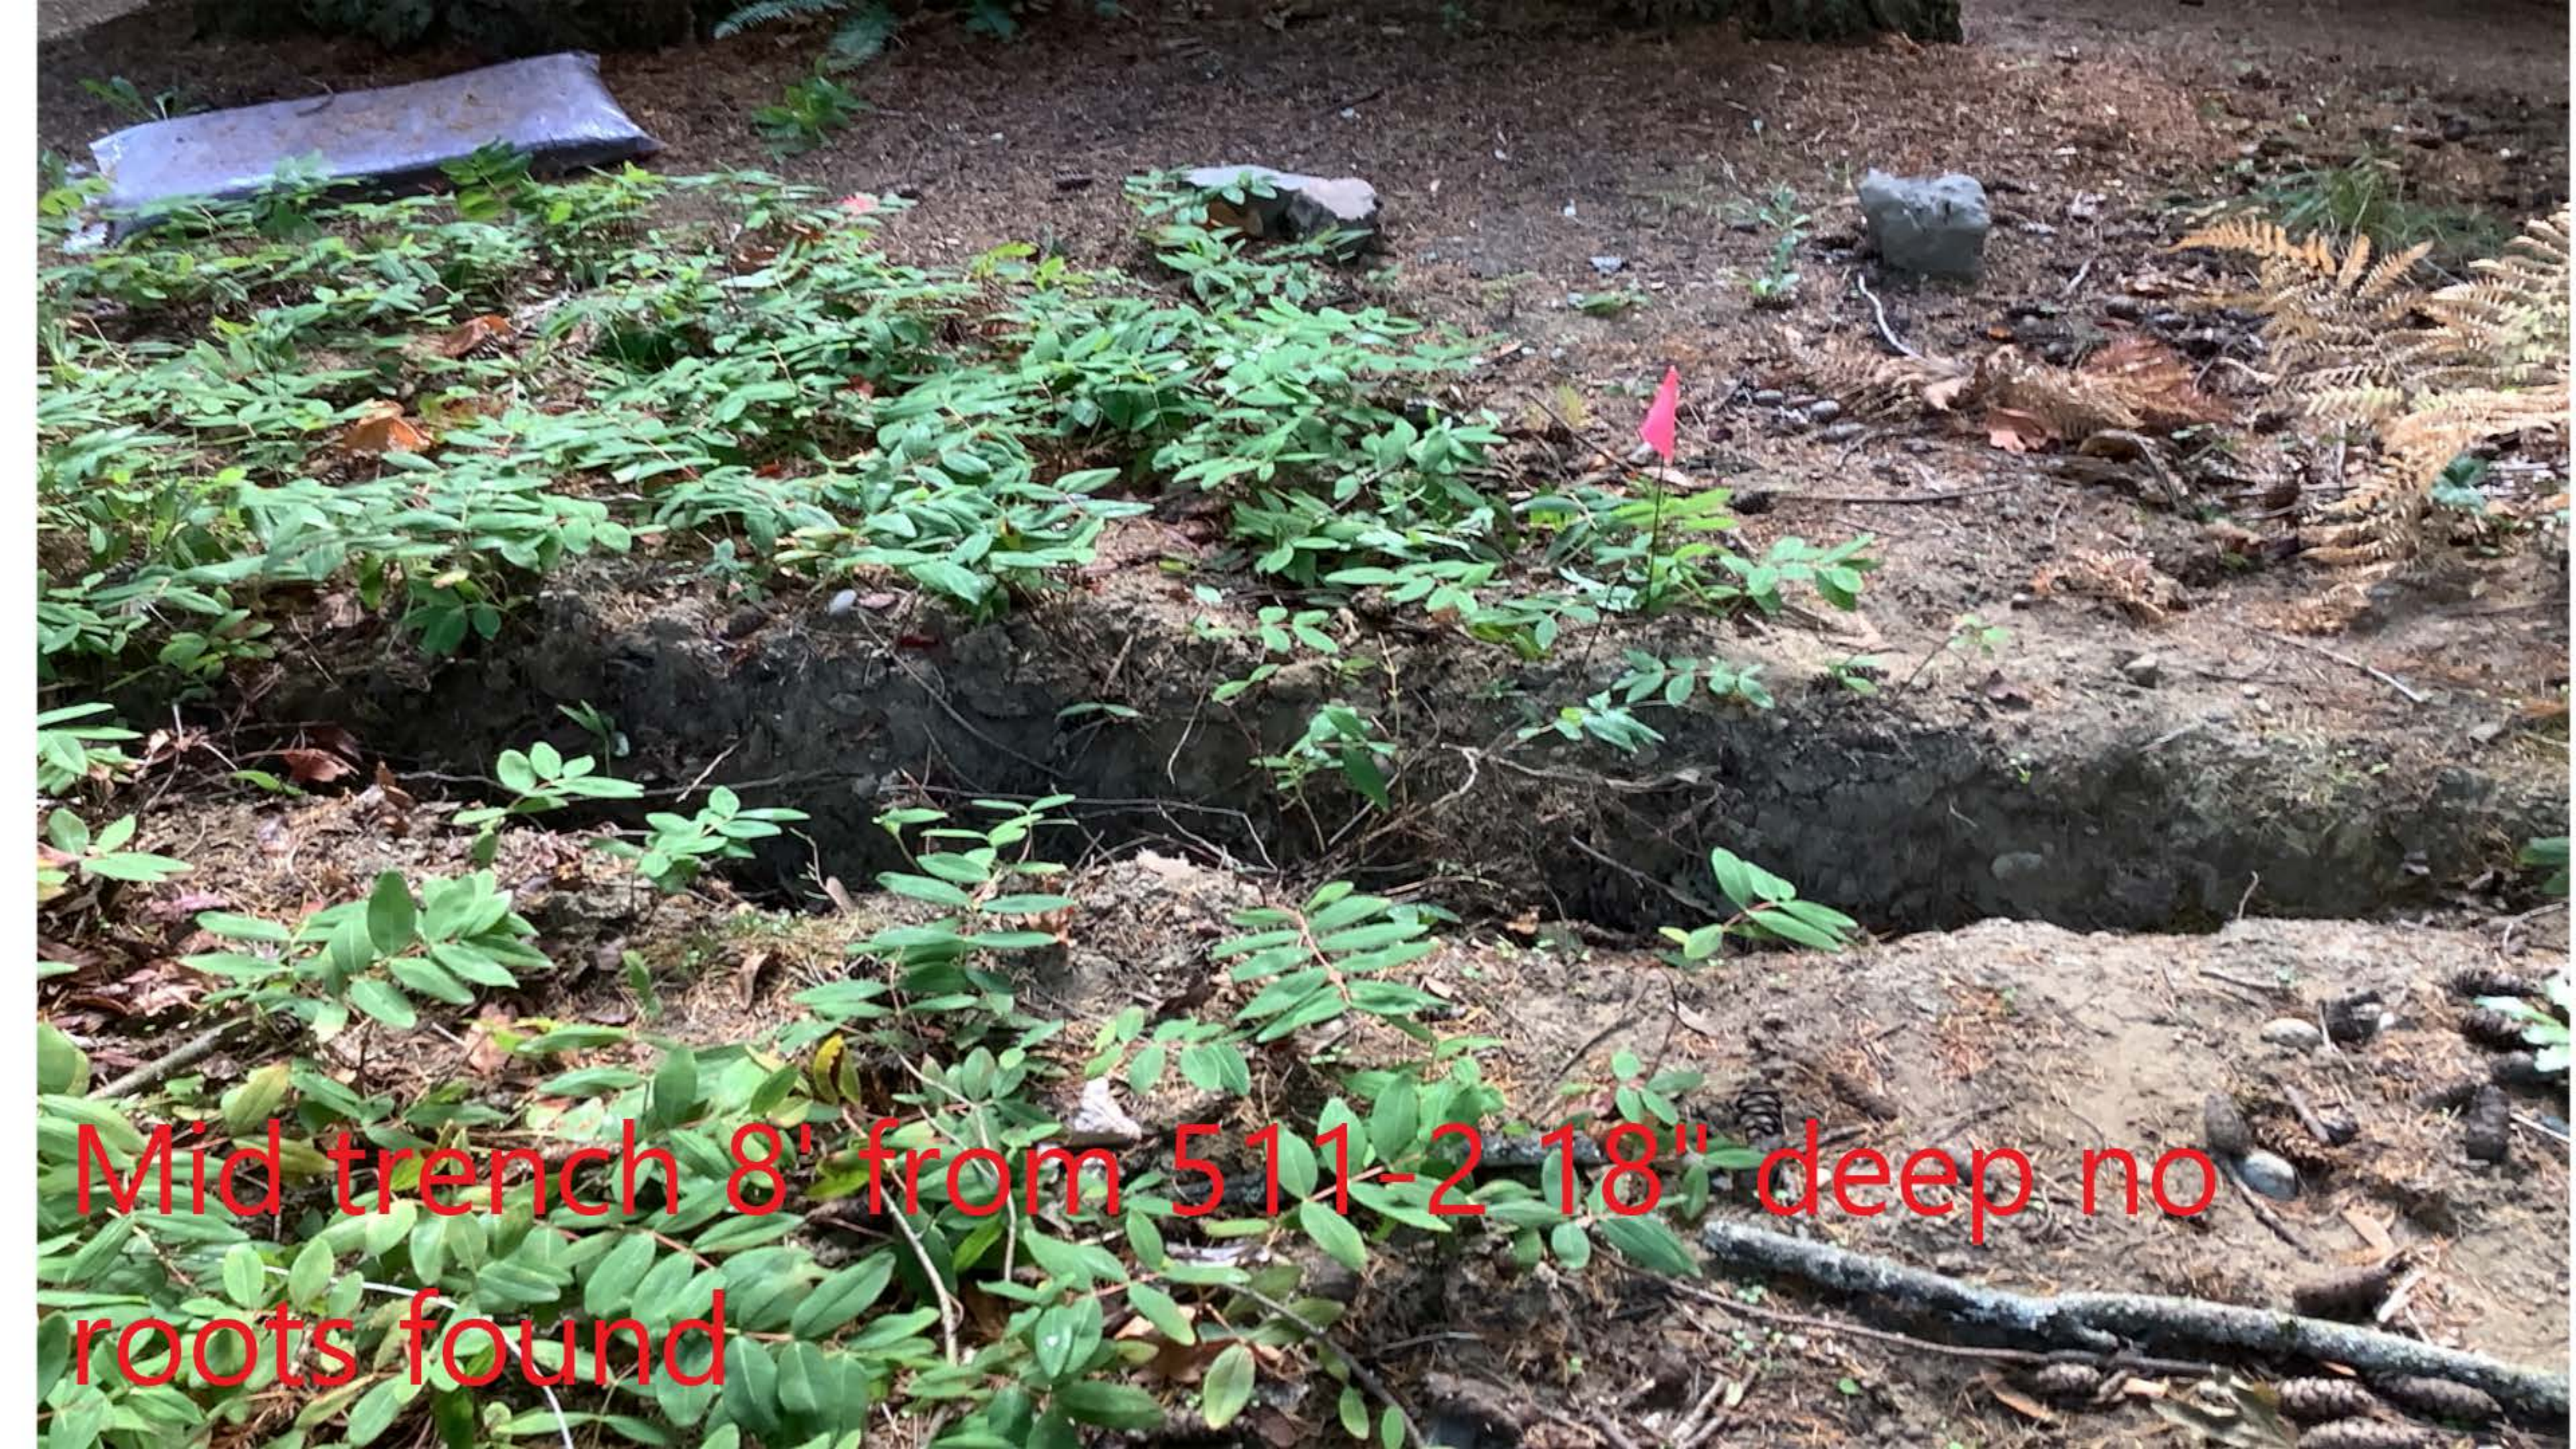
Spading was done to a depth of 18" and no roots were found 8' north of the trunks of 511 & 512 again see the photos. See the photos that show the trench which runs from the base of tree 510 to 20' west of tree 512.

Mid trench 8' from 511-2 18" deep no roots found

Trees 511 & 512 Exceptional Douglas Firs on neighboring property. The proposed building foundation is with the dripline of the trees. Air Spade work was done 8' from the trees to a depth of 18' from tree 510 to a point outside of the dripline to the west. No roots were found connected to these trees. It is my opinion that tree protection fencing be positioned at the trench formed and the tree will flourish after construction.

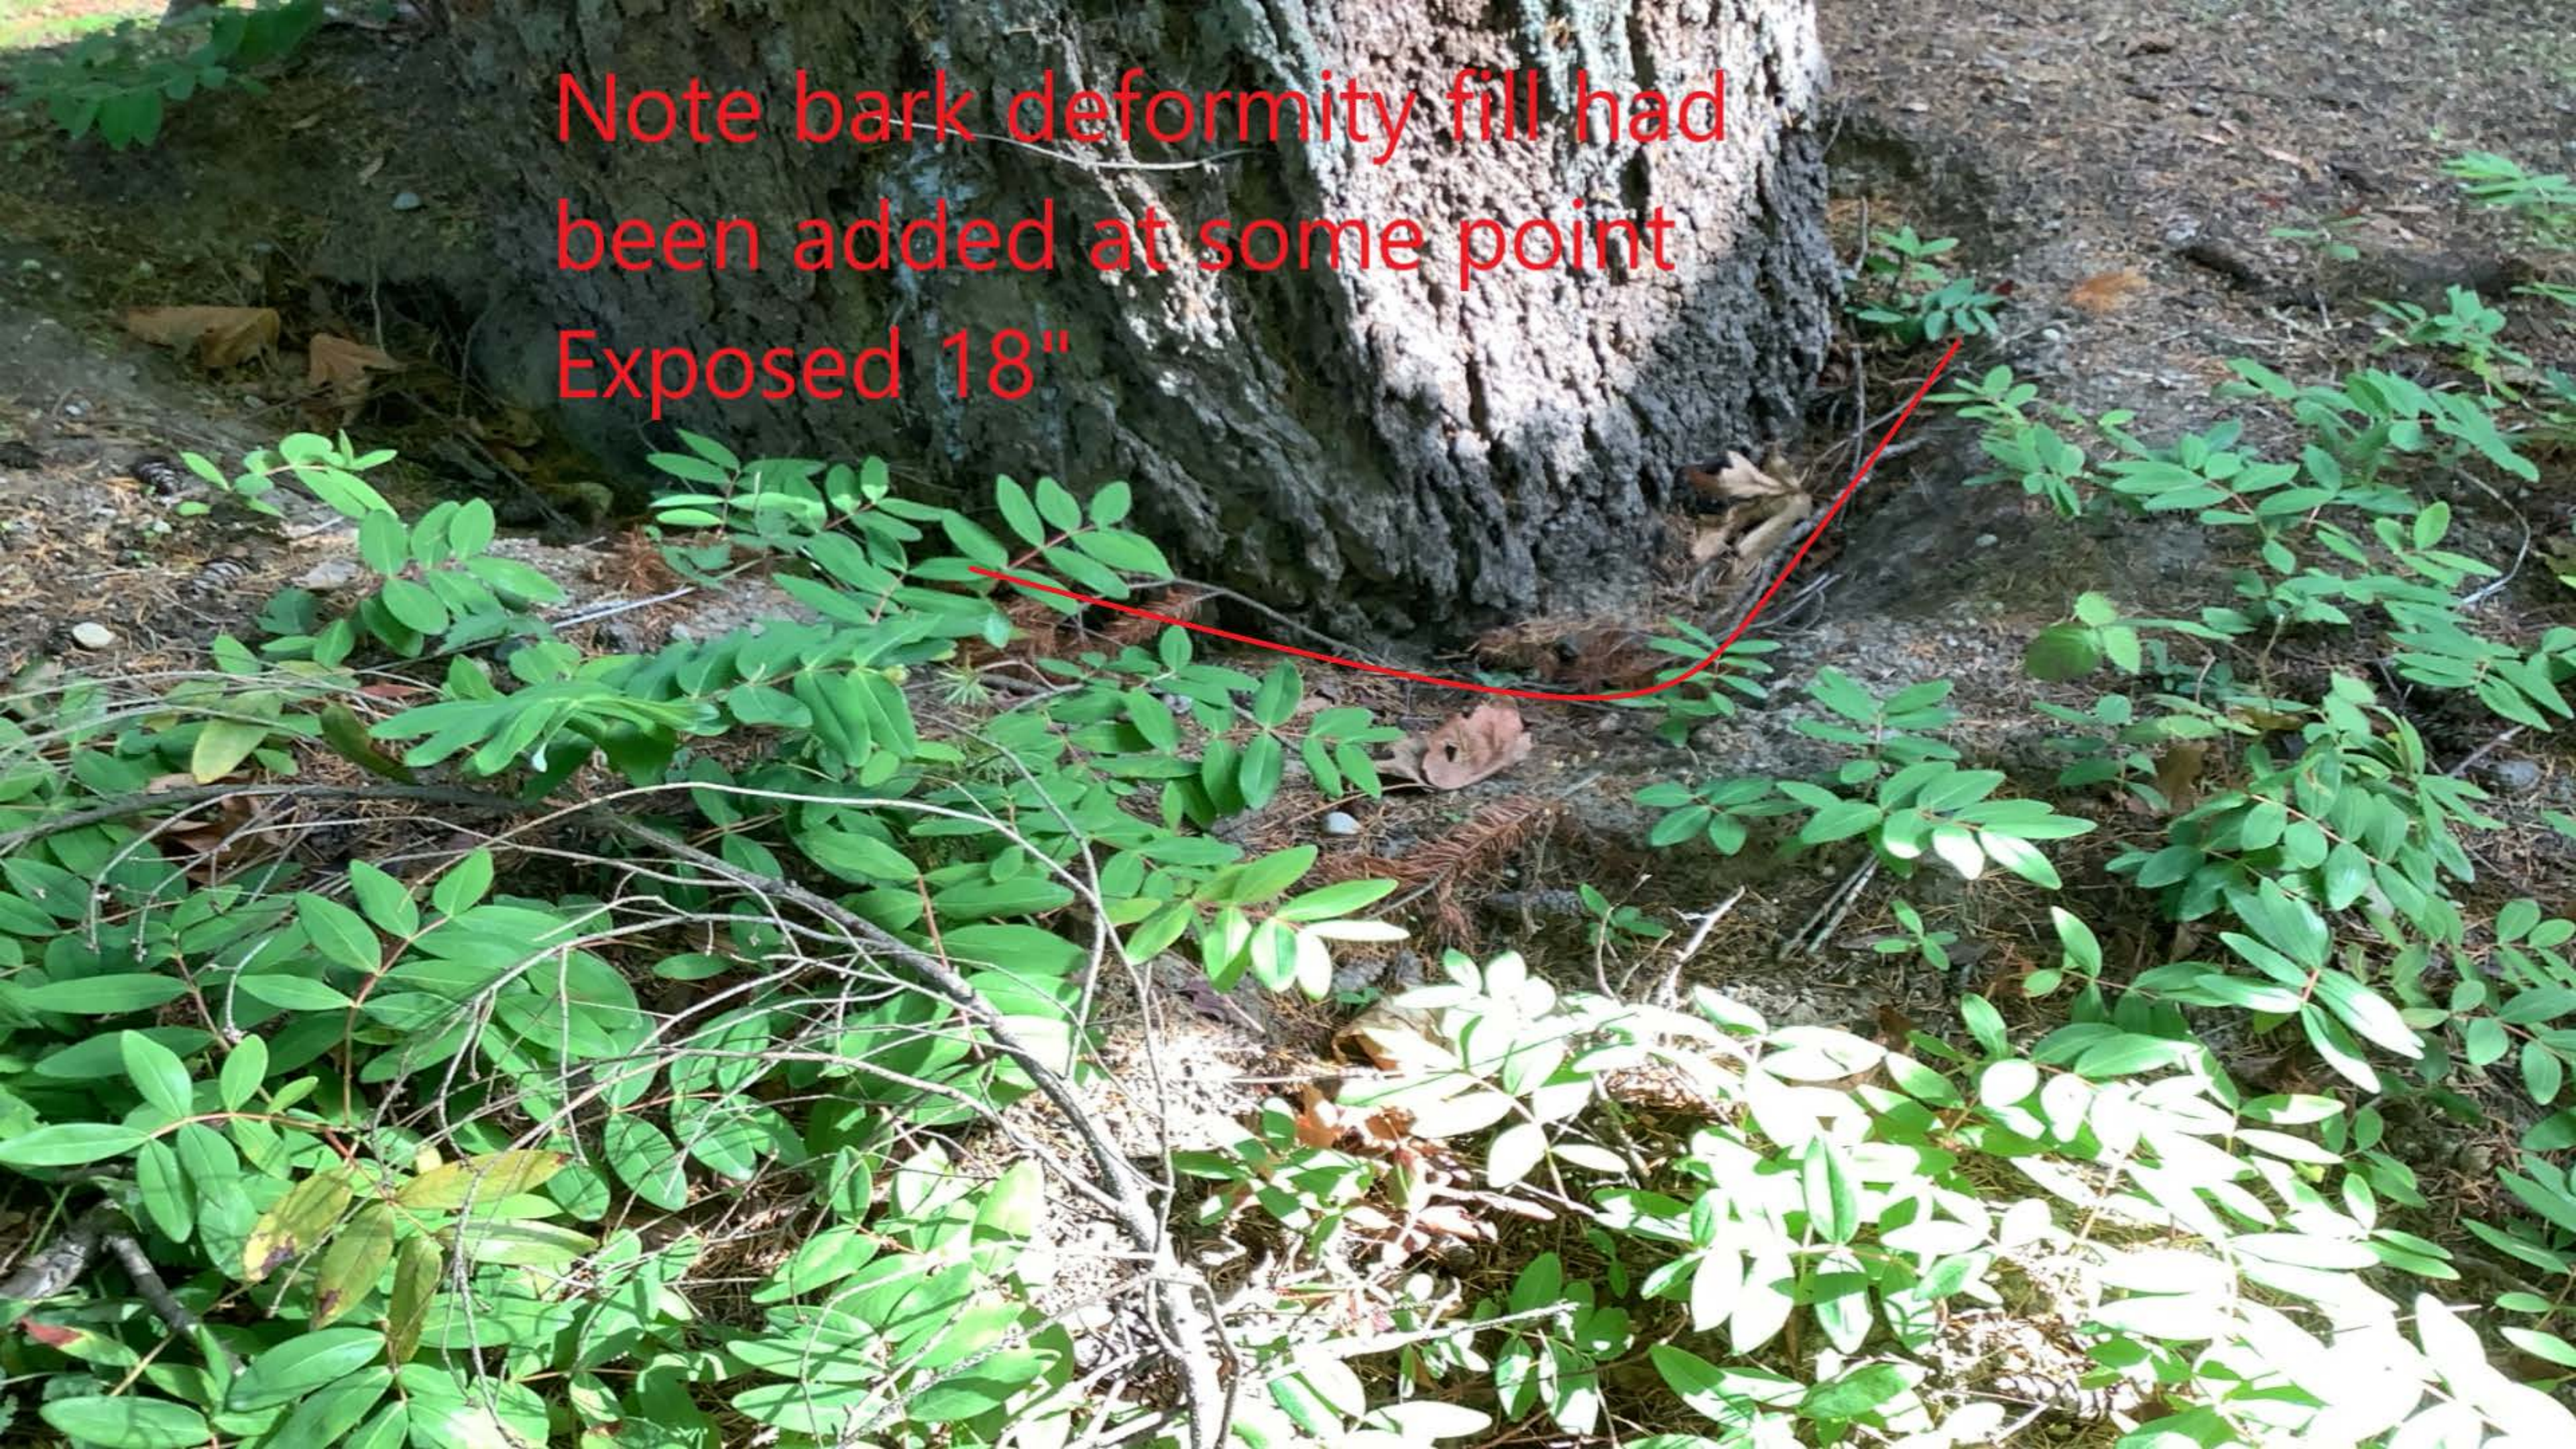
Note bark deformity fill had  
been added at some point  
Exposed 18"

**Terminal end of 18" deep trench 8' from T511-2  
extends to base of T510 no roots found**

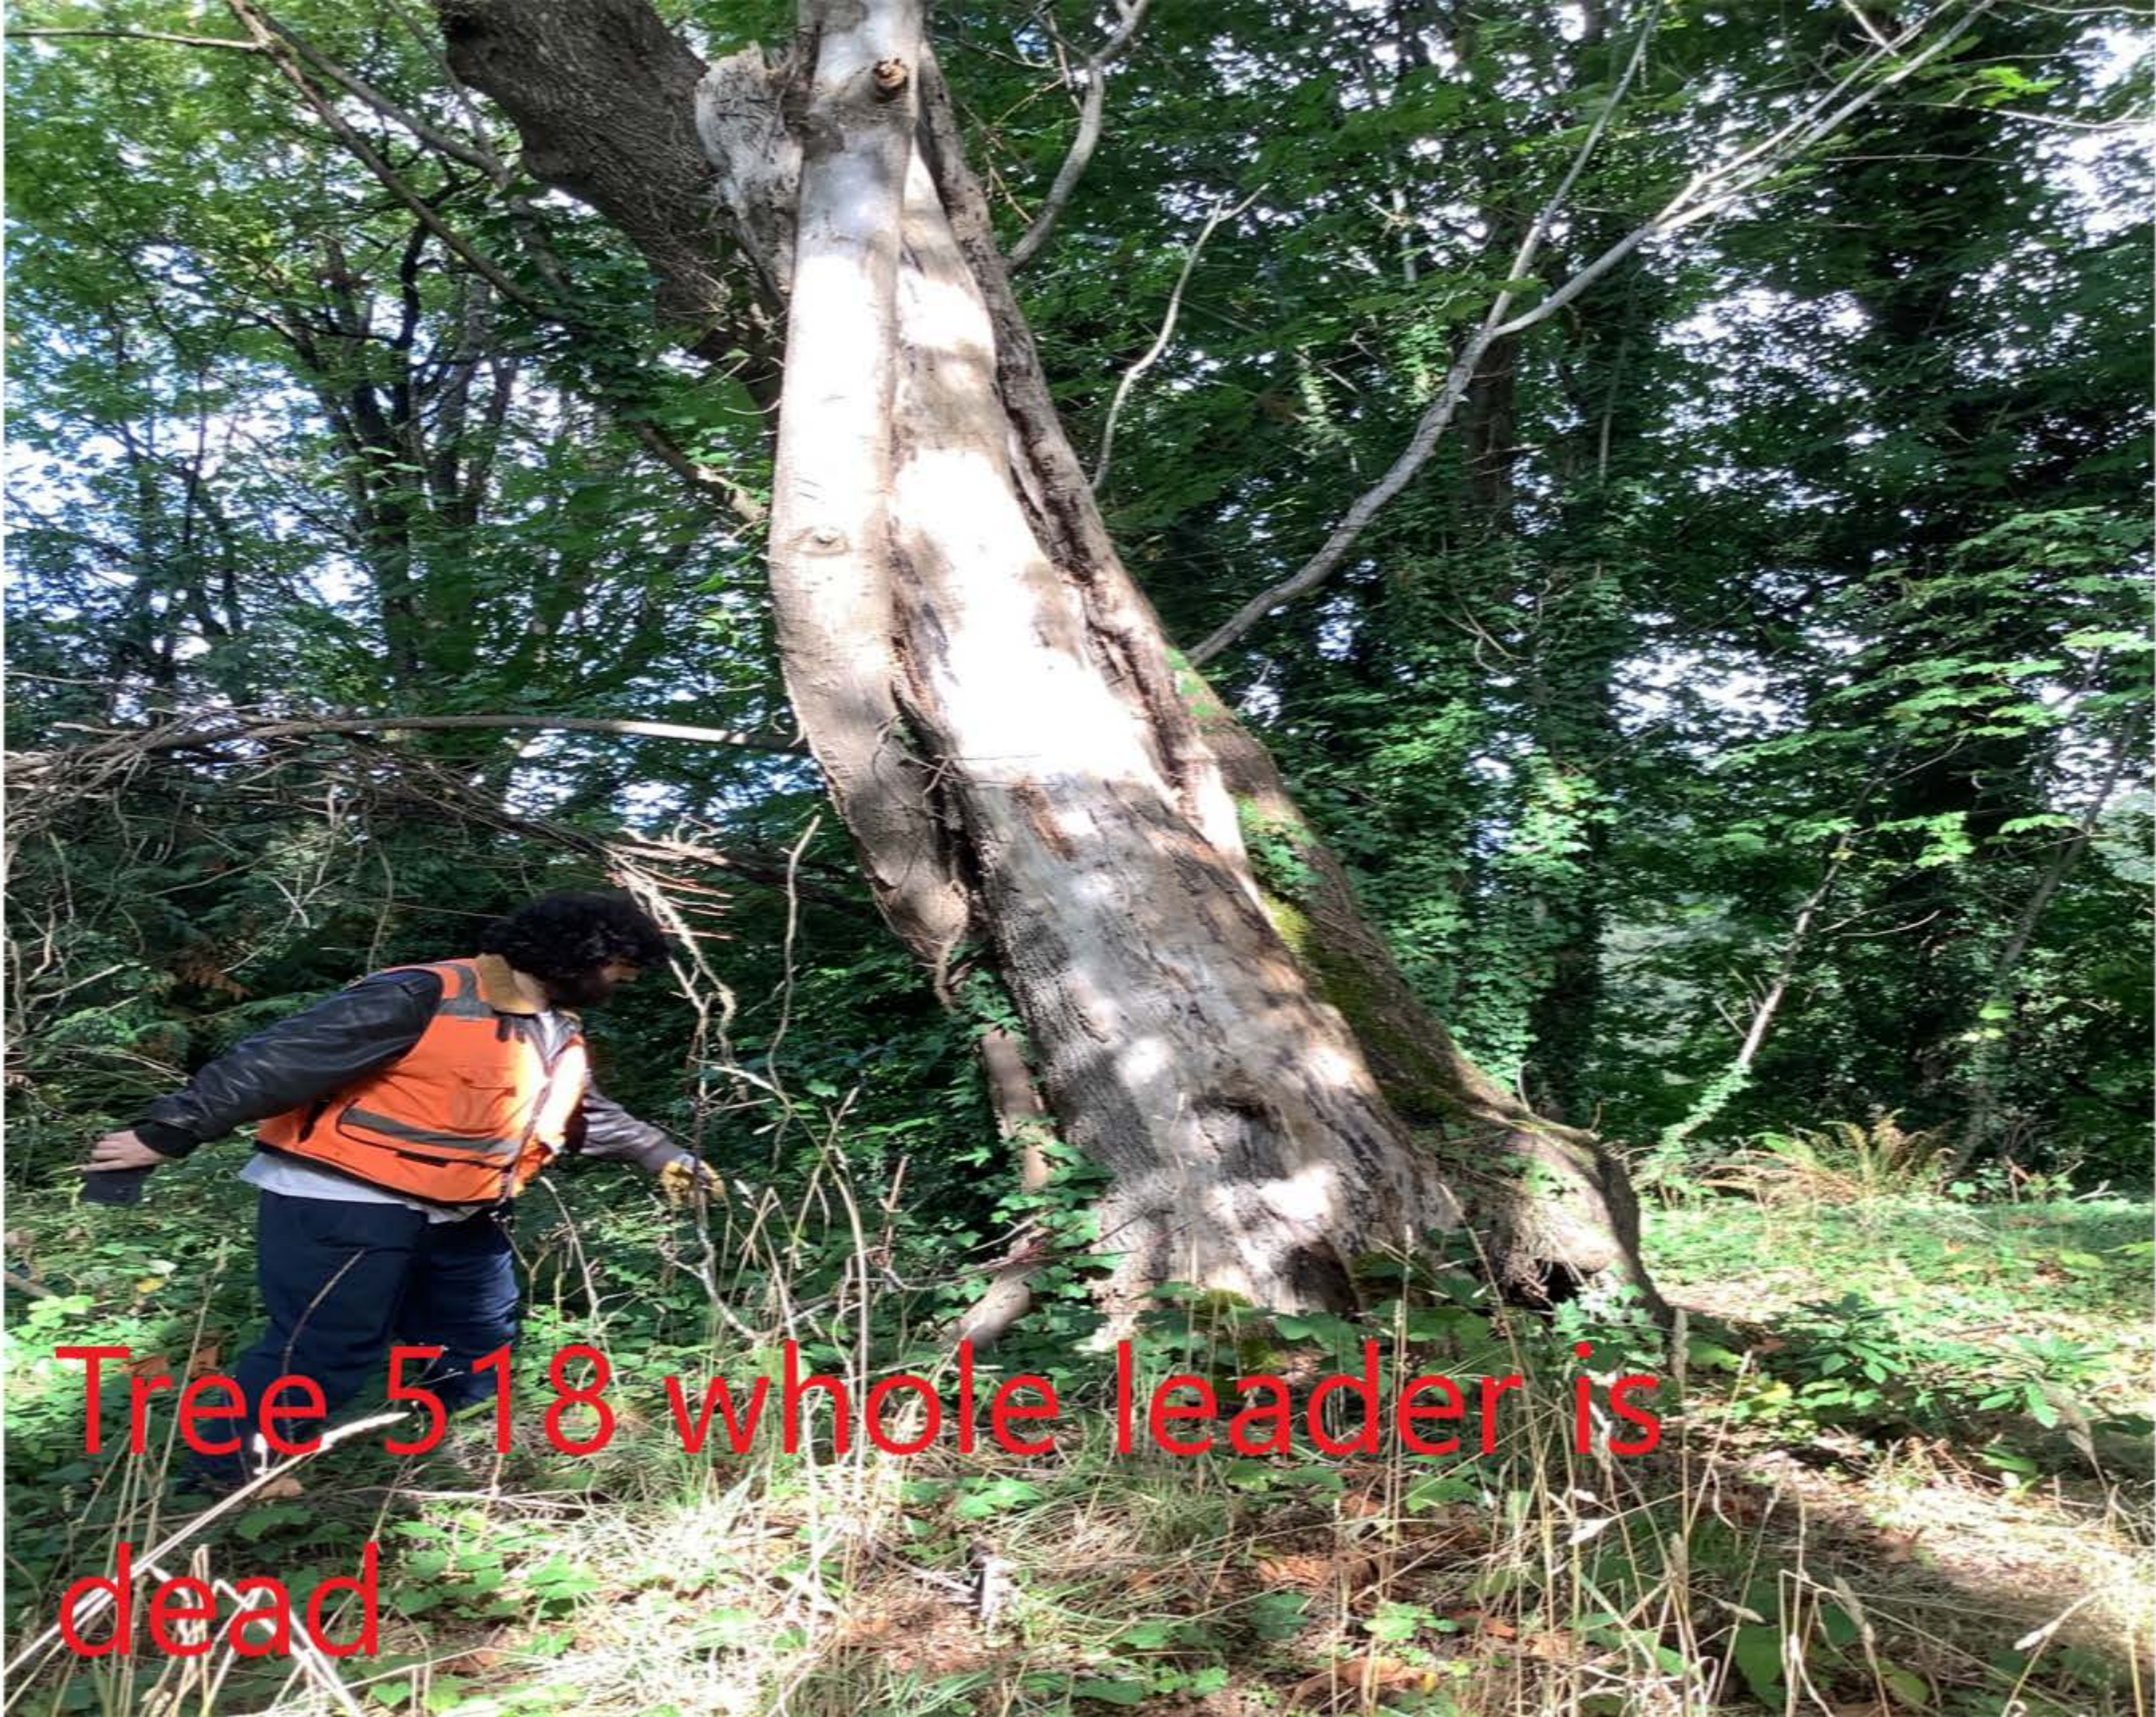
Tree 518 whole leader is  
dead
