Arborist Report

To: Shane Katsoolis
Site: 6202 SE 22nd St, Mercer Island, WA 98040
Re: Retroactive Tree Assessment
Date: March 25, 2024
Project Arborist: George White,
ISA Certified Arborist #PN-8908A
ISA Qualified Tree Risk Assessor
Reviewed By: Katherine Taylor
ISA Certified Arborist #PN-8022A
ISA Qualified Tree Risk Assessor
Referenced Documents: Proposed Drainage Plan (EightBlox Studios, 2.23.2024)
Site Levels Plan (EightBlox Studios, 2.23.2024)
Landscape Plan (EightBlox Studios, 2.23.2024)
Attached: Watering Guidelines (Tree Solutions Inc., 2021)

This arborist report is a retroactive tree assessment requested by the city after two trees were removed or impacted by the property owner as a result of adjacent earthwork.

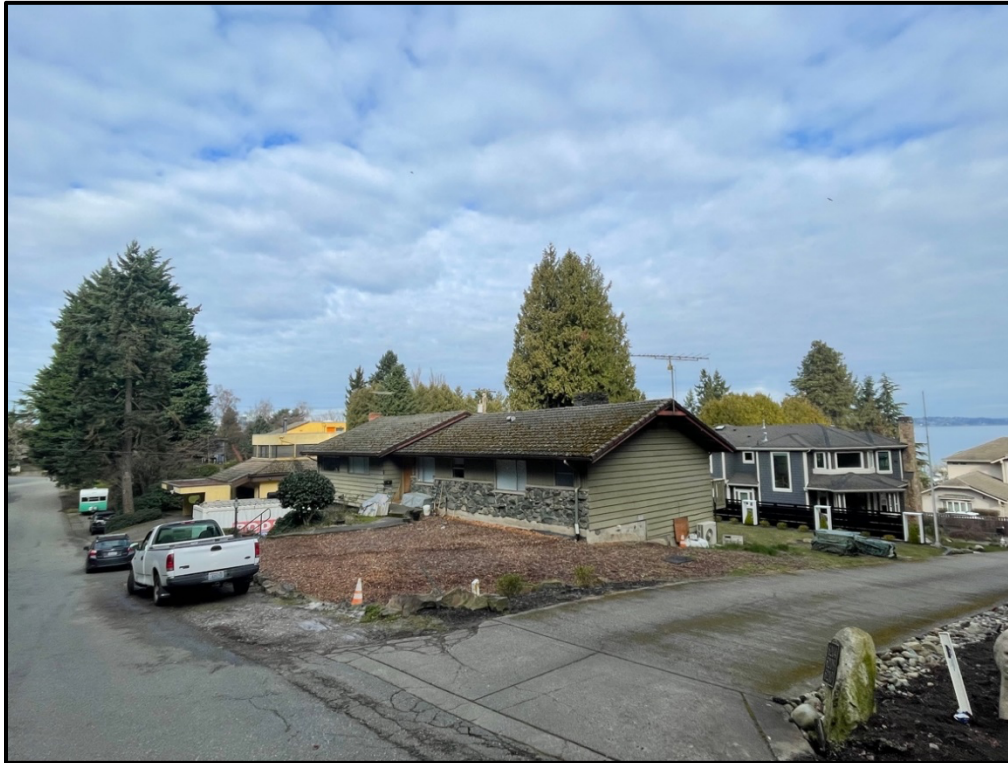
At the time of my site-visit, the site had been almost entirely cleared of vegetation (Photo 1) in preparation for proposed improvements. I was unable to observe the stumps of removed trees.

Photograph 1. Existing site conditions.

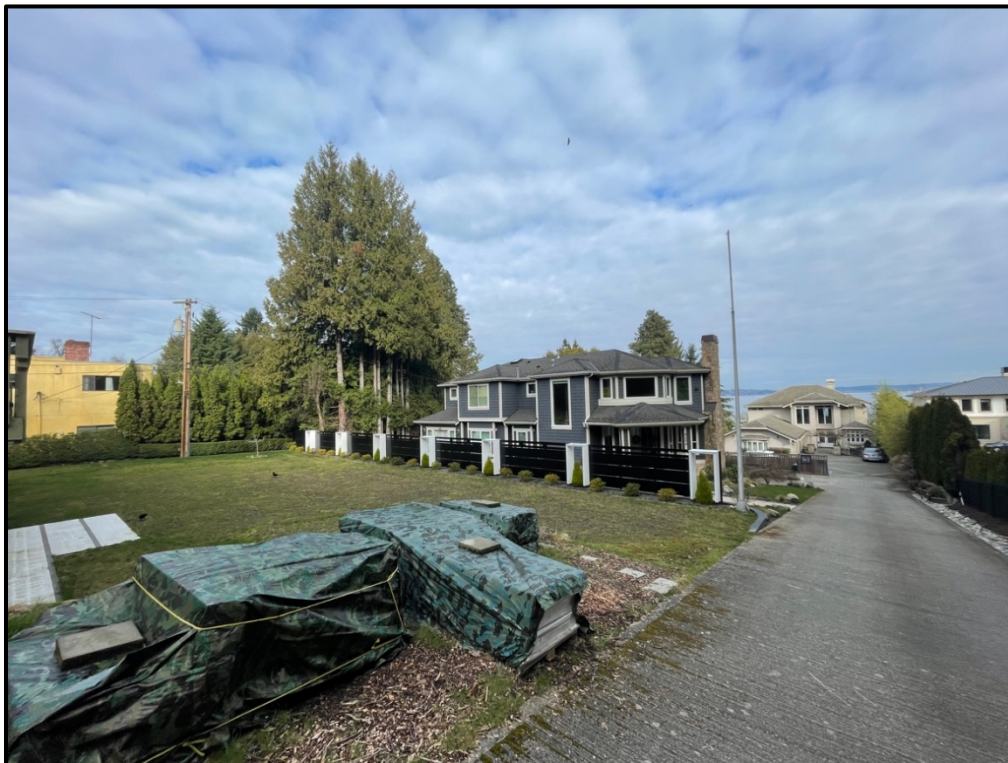
Photograph 2. Existing conditions in rear yard of the subject property looking toward the neighboring home.

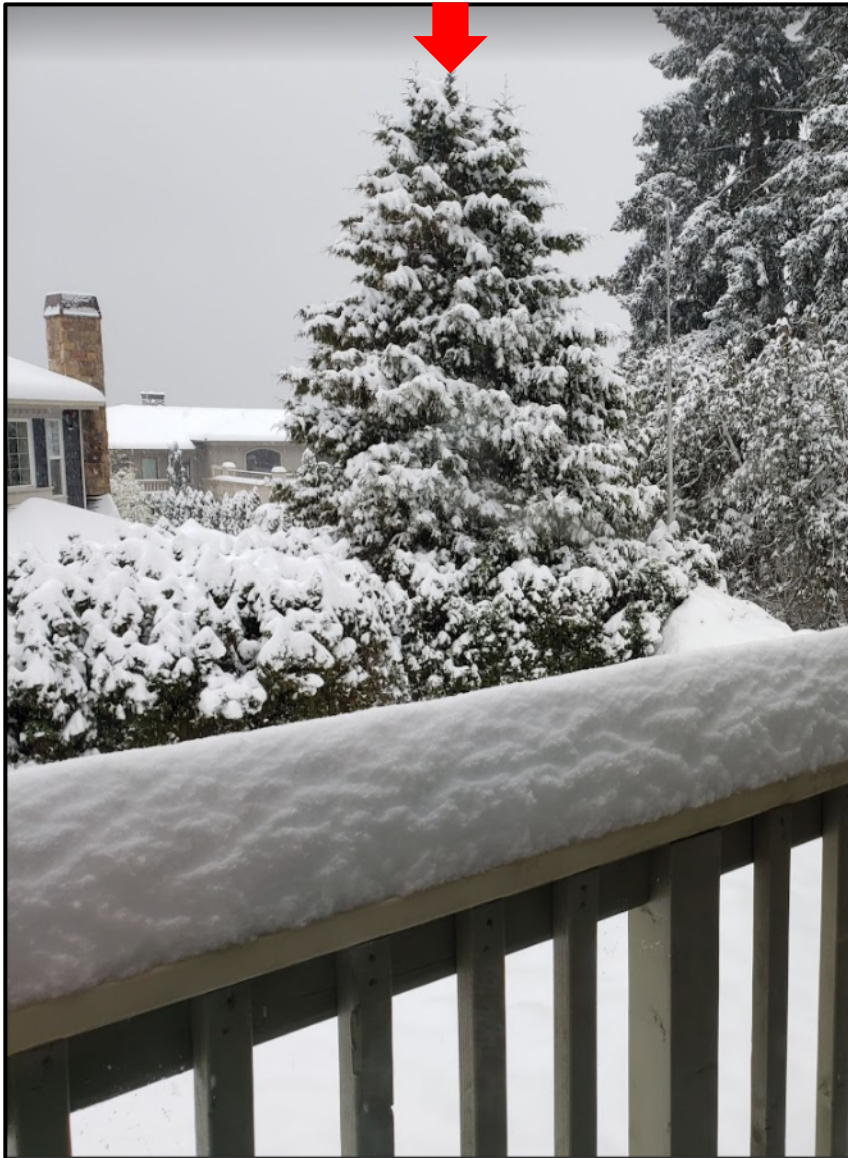
Tree 1 was a small evergreen tree that was planted in the northeastern corner of the site. Based on review of provided photographs and publicly available images, I estimate that tree 1 was approximately 20-25 feet in height prior to removal (Photo 2). I determined this by comparing the height of tree 1 to referenced objects of known height such as the adjacent hedge, and neighboring house.

While the trunk of tree 1 is not visible in any of the provided or publicly available photographs, I am confident that tree 1 was below 10 inches in DSH and is therefore unregulated under MICC. In my professional experience, the trunks of Excelsa western redcedar tend to be quite slender compared to their height and crown spread diameters. It is rare to encounter a specimen of this cultivar in excess of 10 inches in diameter.

Photograph 3. A photograph of Tree 1 provided by the client taken in 2021. The hedge to the left is approximately 7 feet tall. Extrapolating from the hedge height, I estimate that this tree was 20-25 feet tall. It should be noted that the house immediately behind tree 1 is two stories tall but is at a significantly lower grade.

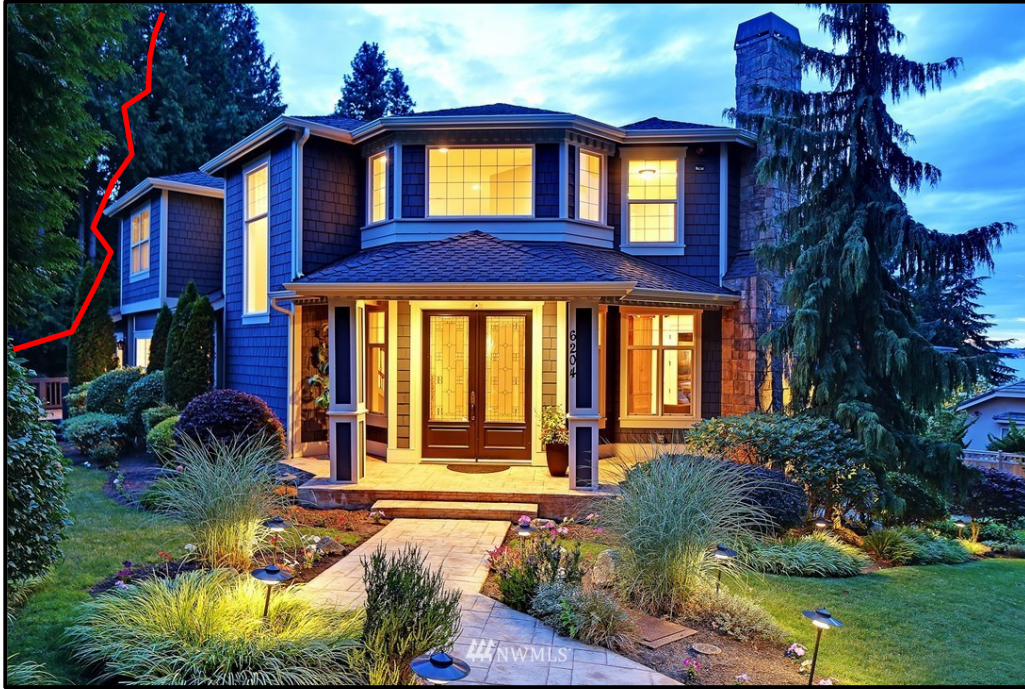
Based on review of provided photos, aerial imagery, and photos taken from a 2020 real estate listing, I was able to determine that Tree 1 was an ornamental cypress (*Cupressaceae*) variety. The very dense, scaled foliage and wide crown profile relative to height (Photos 2 and 3) led me to believe that tree 1 was most likely an Excelsa western redcedar (*Thuja plicata* 'Excelsa'). Excelsa western redcedars are a

Photograph 4. A photograph of the north neighbor's house taken from a real-estate listing when the house was last sold in 2020. The scaled foliage of tree 1 can be seen in the upper right-hand corner of this photo (outlined in red).

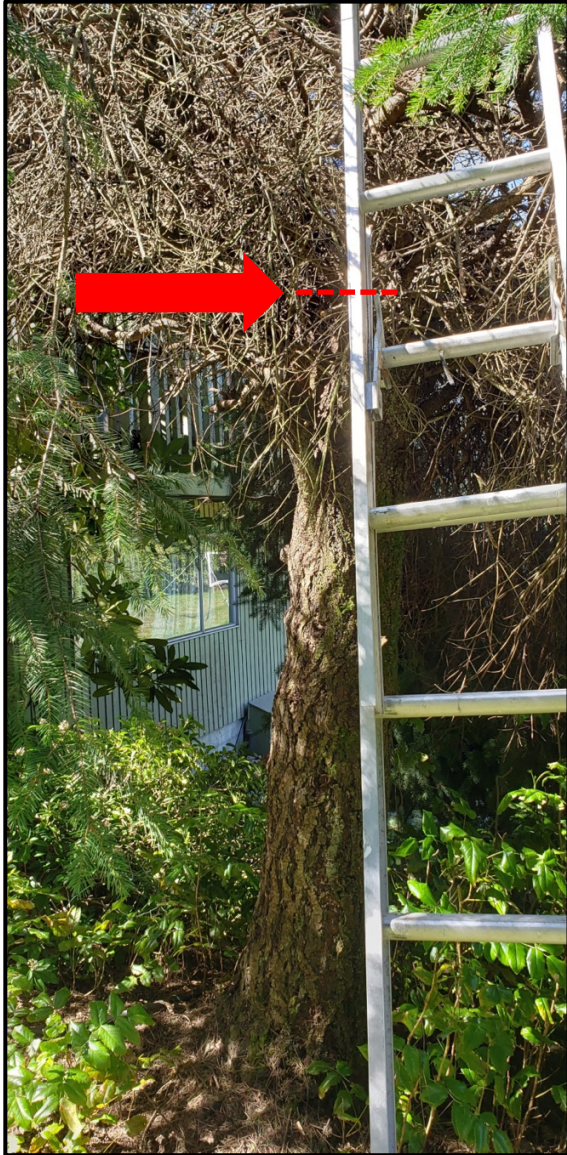
After reviewing provided photos of tree 2, I was able to determine that this tree was a small Douglas-fir (*Pseudotsuga menziesii*) in poor structural condition. I identified the species based on the flat linear needles and furrowed bark visible in the provided photographs (Photo 4). The number of dead branches present in the provided photographs (Photo 4), and the shortened height of the tree lead me to believe that this tree was topped repeatedly and may have been hedged in the past. A Douglas-fir of this size would have been tall enough to see from the street if allowed to grow naturally, however this tree cannot be seen in Google Street View images from 2018 (Photo 5).

By extrapolating from the known dimensions of the ladder present in a provided photograph (Photo 4), I estimate that this tree was 7 inches in DSH prior to removal and was therefore not regulated as a large tree under MICC.

Photograph 5. A photograph of tree 2 provided by the client showing the furrowed bark and needles typical of Douglas-fir. Using the pictured ladder as a reference (rungs are typically 12-14 inches apart and 12-14 inches wide) I estimate that the diameter at standard height (indicated with red arrow) is approximately 7 inches.

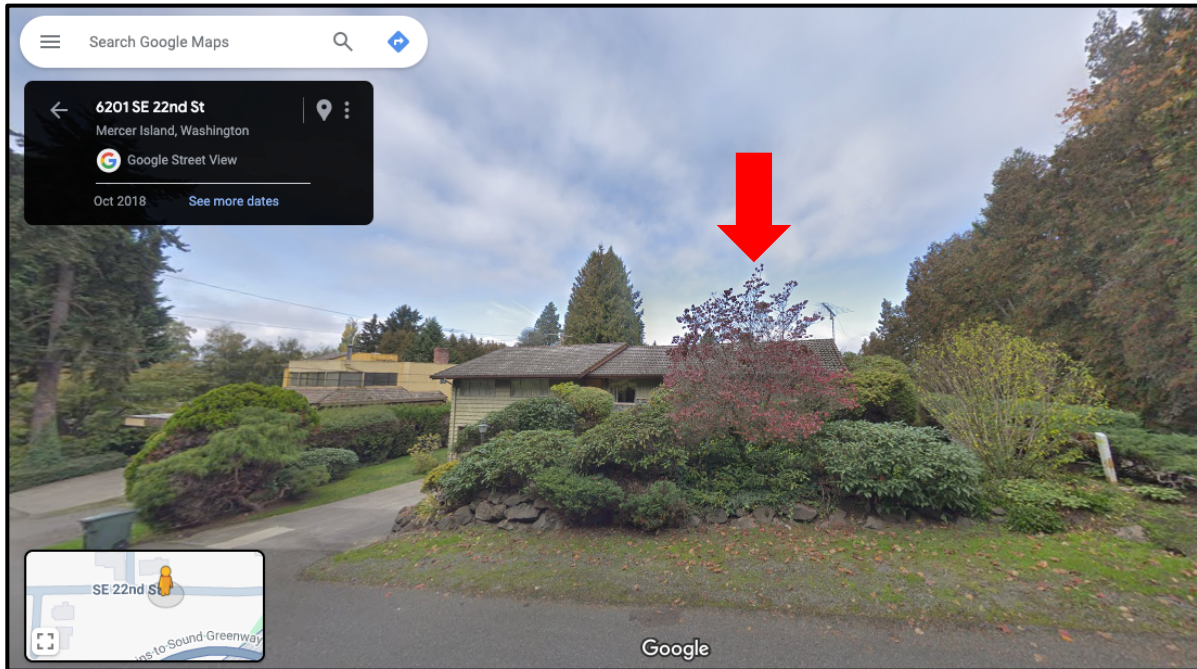
One Florida dogwood (*Cornus florida*) tree is visible in the front yard of the site in Google Street View but appears well below 10 inches in diameter in the image from 2018.

Photograph 6. Google Street View imagery dated Oct 2018 showing the vegetation that existed on-site prior to site clearing. Only one of these species, the florida dogwood (red arrow) is capable of reaching regulated size. However, based on the height and maturity of this tree as seen in this image, I believe it is well below 10 inches in diameter.

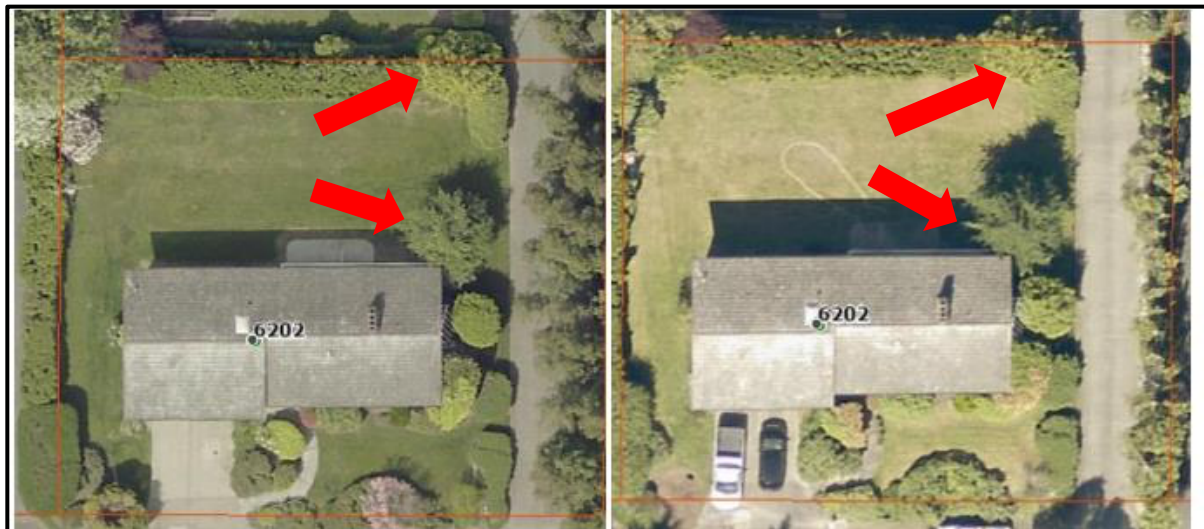
Based on publicly available aerial imagery sourced from King County iMap (Photo 7), no additional trees approaching regulated size (aside from trees 1 and 2) can be seen in 2021 or in 2019. This leads me to conclude that no large trees have existed on the site in the previous 5 years.

Photograph 7. Aerial imagery sourced from King County iMap of the subject property. No tree removals can be seen in between 2019 (left) and 2021 (right). No trees of significant size other than trees 1 and 2 (red arrows) can be seen in either image.
