ARBOR INFO LLC

Tree Assessment

Sherry Tseng
2720 71st Ave. SE
Mercer Island, WA

Date
August 14, 2017

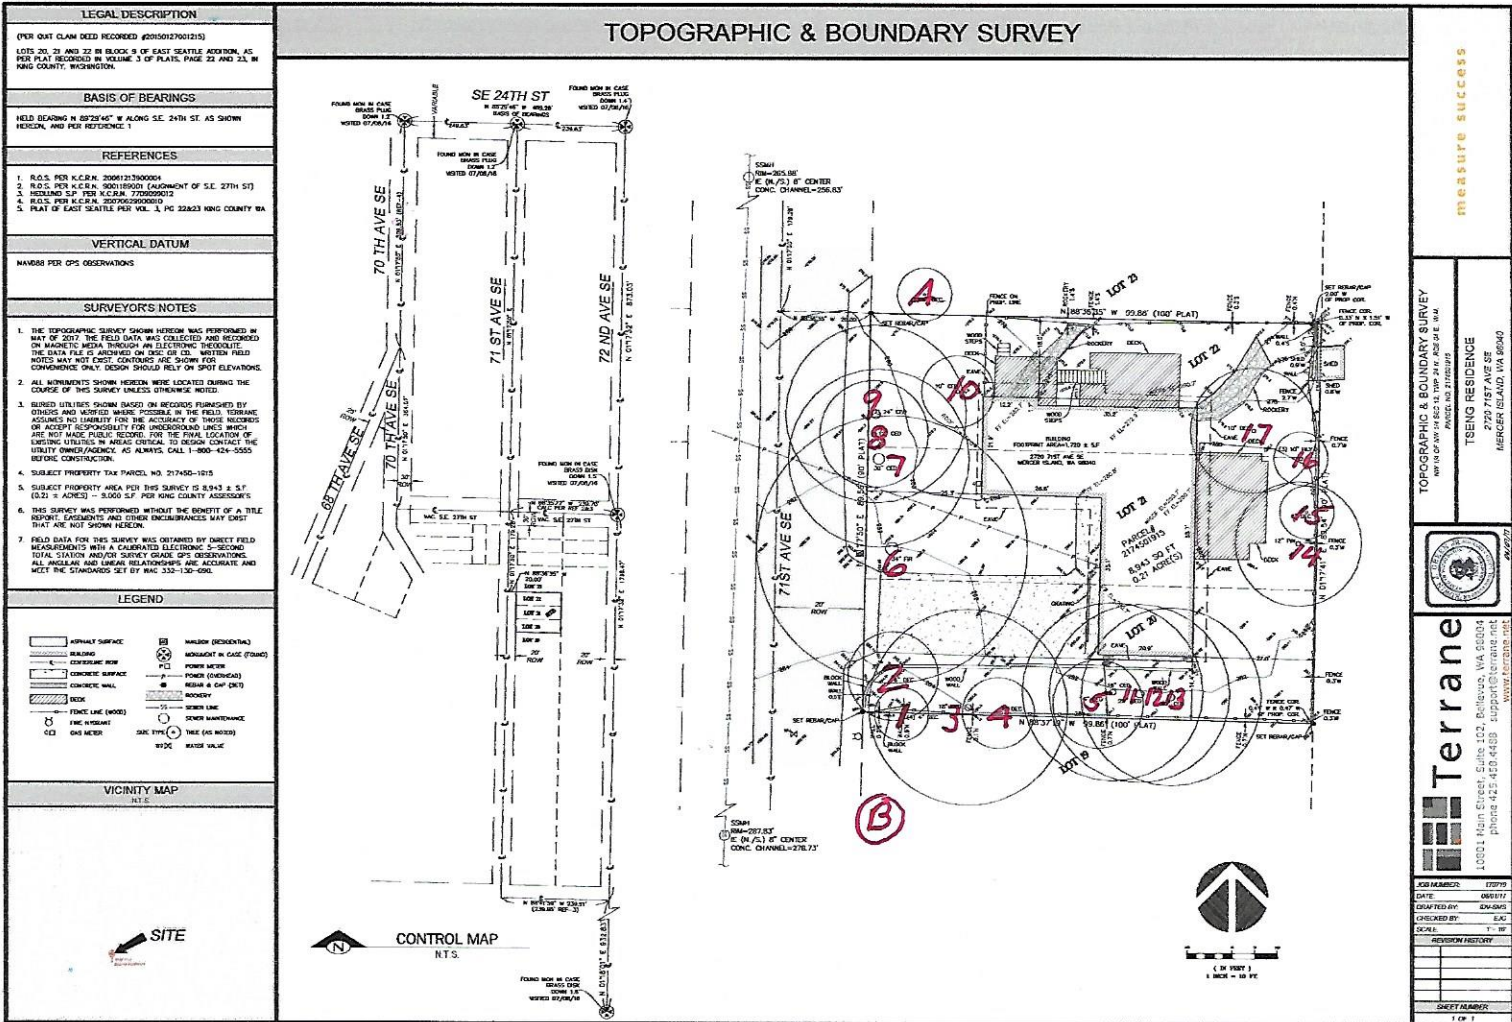
TSENG TREE LOCATIONS

I tagged the trees with a numbered aluminum strip: Onsite trees are numbered 1-17. Off-site trees A and B as shown on the attachments are not labeled. Attached is a plat of the property as it now exists with the trees hand labeled.
