February 21, 2024

### LNL Builds

Davey Resource Group, Inc. (DRG) was contracted to respond to the adjusted tree protection fencing for TREE ID#s 647 & 649 near development activities on the site at 74th Avenue SE (PIN: 5315100-458 in Mercer Island, WA). Excavation is expected to encroach into the required tree protection zone (TPZ) which is defined as the average dripline radius. Reduction of the TPZ may be permitted by the city arborist to allow construction related activity if:

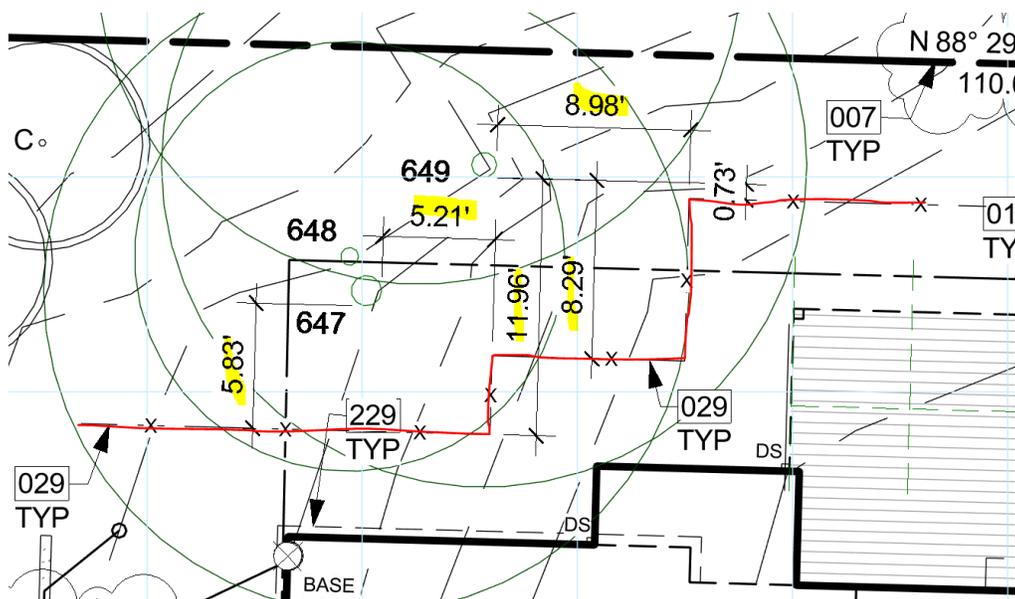
The TPZ of these two (2) trees will be reduced to facilitate excavation for the new structure. Excavation is proposed at 5.83 feet south to 5.21 ft. east of **TREE ID# 647** and 11.96' south to 8.98' east of **TREE ID# 649**. The average dripline radius for these trees is 15'. The structural root zone radius of these trees is 8' and 6' respectively.

Both of the impacted trees are young and healthy. Furthermore, bigleaf maple trees are able to tolerate heavy pruning and soil limitations. It is expected that these trees will not be significantly impacted by the reduced TPZ and excavation within the TPZ if the following actions are followed:

- Prior to any soil disturbance at the site the LOD for excavation are marked in the field.
- The soil can then be removed with a pneumatic air-tool ~6 inches outside the LOD for the new building. The trench will be ~6" wide and 12" deep or greater.
- Once exposed, the roots of the trees will be pruned by a certified arborist. The pruning cuts will be made as close to the LOD as feasible.
- The trench will then be filled with native soil or amended soil, as needed.
- A 4" layer of mulch or wood chips will be applied just outside the filled trench and throughout the entire remaining TPZ's.
- Tree protection fencing will then be installed just outside the backfilled trench.

Root pruning, instead of tearing and ripping roots with large excavation equipment, reduces the potential future vectors of decay. Clean cuts made using sharp tools allow the tree to undergo its natural process of compartmentalizing wounds, preventing the spread of decay. It is recommended that the arborist performing the work make note of the size and quantity of pruned roots. If many large anchoring roots require removal the tree may become structurally unstable. In this instance, the whole tree may need to be removed to reduce tree risk at the site.
