DOWNSTREAM ANALYSIS REPORT

Day Residence
9843 Mercerwood Drive
Mercer Island, WA 98040

Tax Map #545600-0490
September 29, 2021

CES #2002

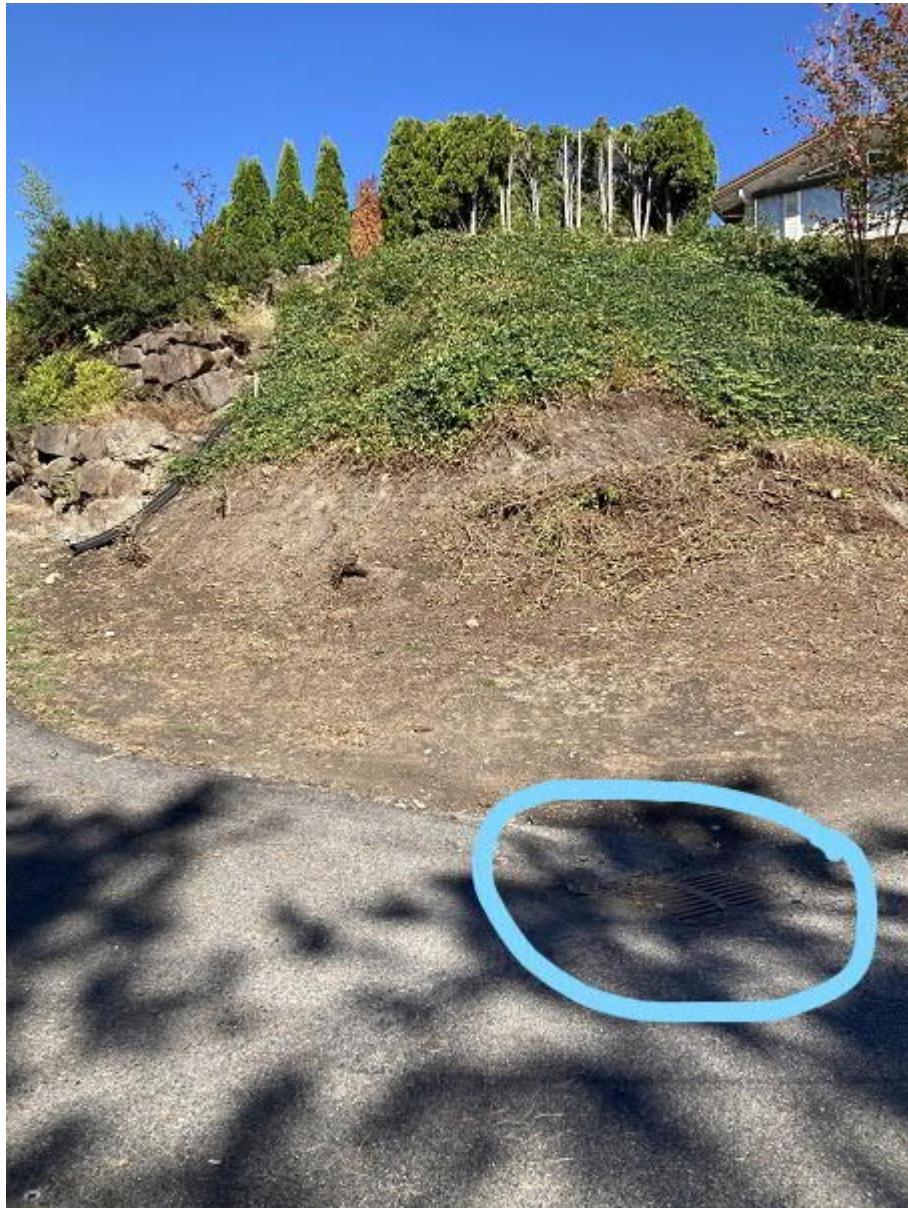
Picture 1: northernmost corner of Mercerwood Drive and SE 43rd Place
Existing house is up the hill on the right side of the picture. The catch basin we propose to connect to is circled; it's hard to see because of the shadows.

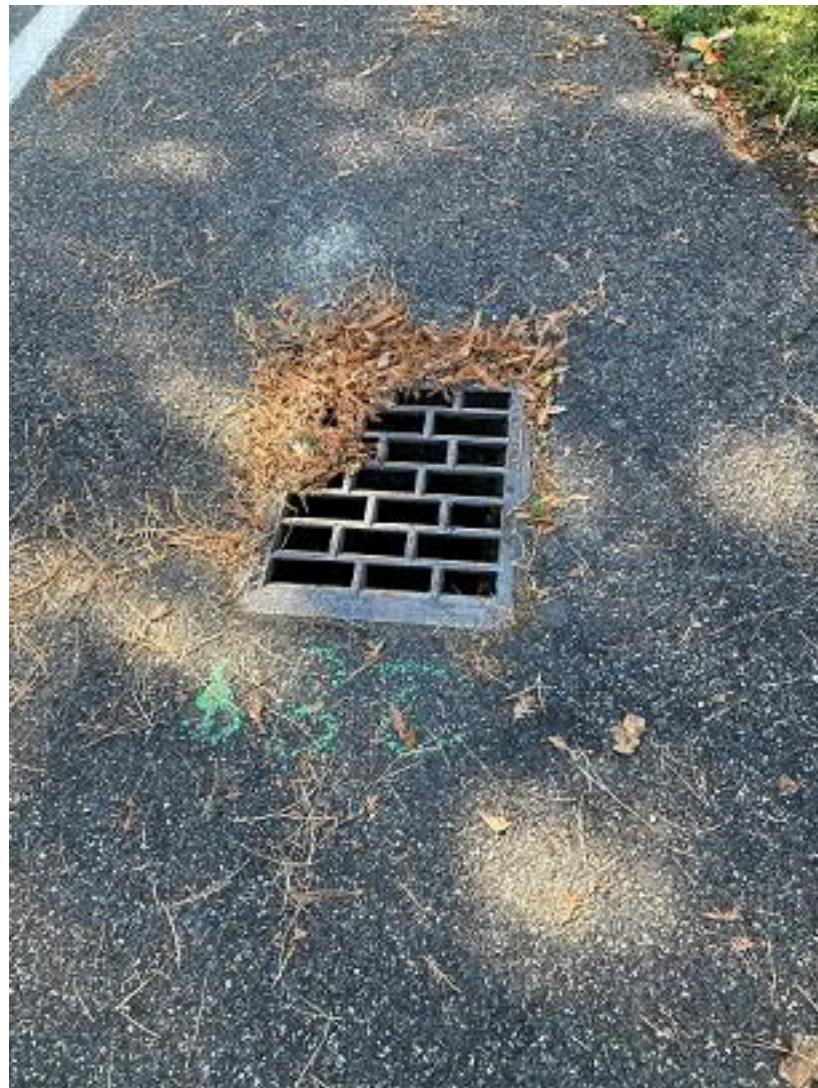
Picture 2: westernmost corner of Mercerwood Drive and SE 43rd Place
Catch basin across 43rd Place SE from the first one.

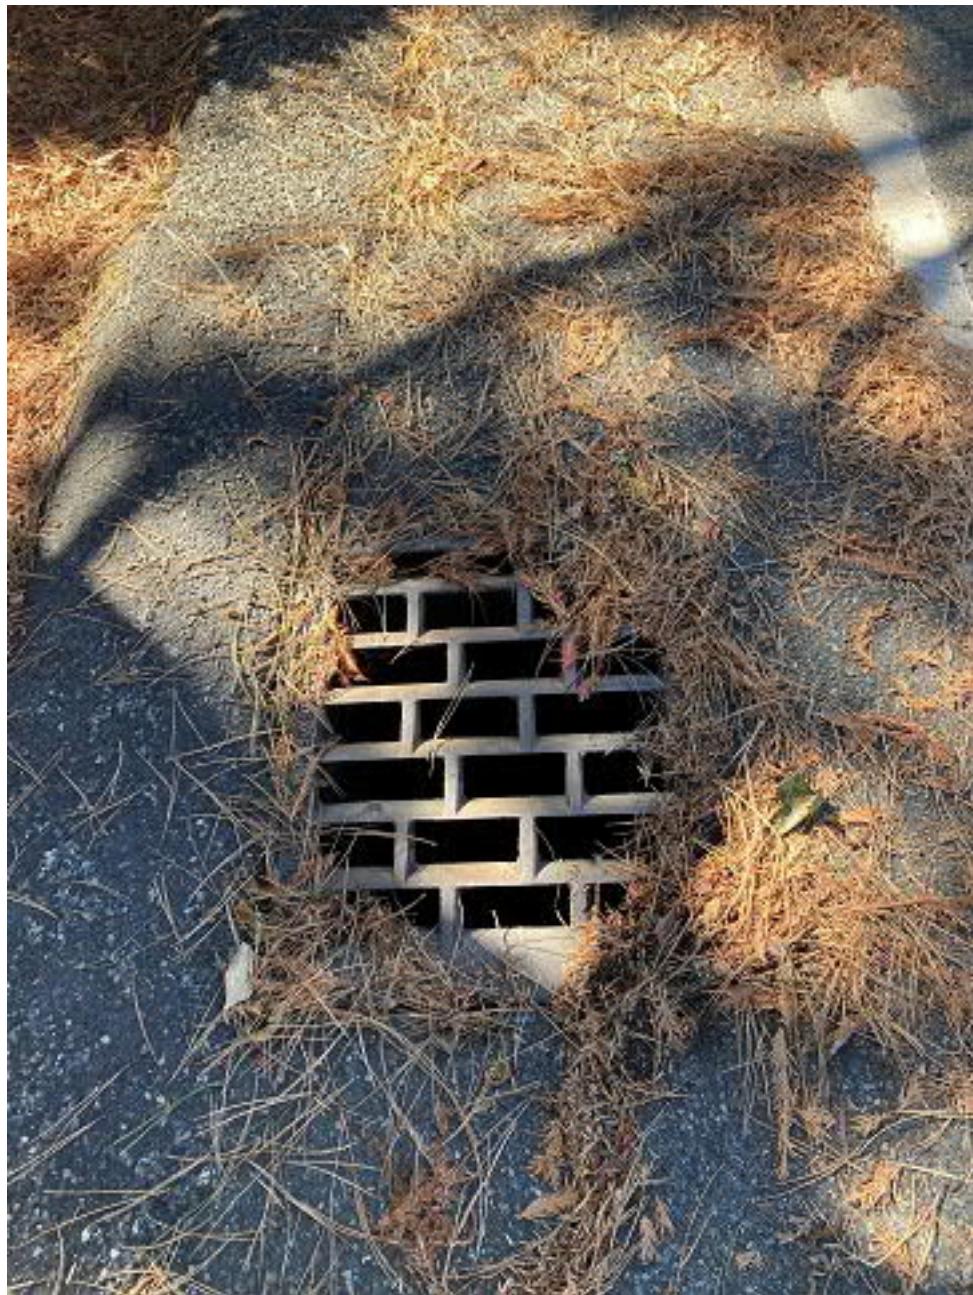
Picture 3: southernmost corner of Mercerwood Drive and SE 43rd Place
Following the mapped flowpath, this catch basin is across Mercerwood Drive.

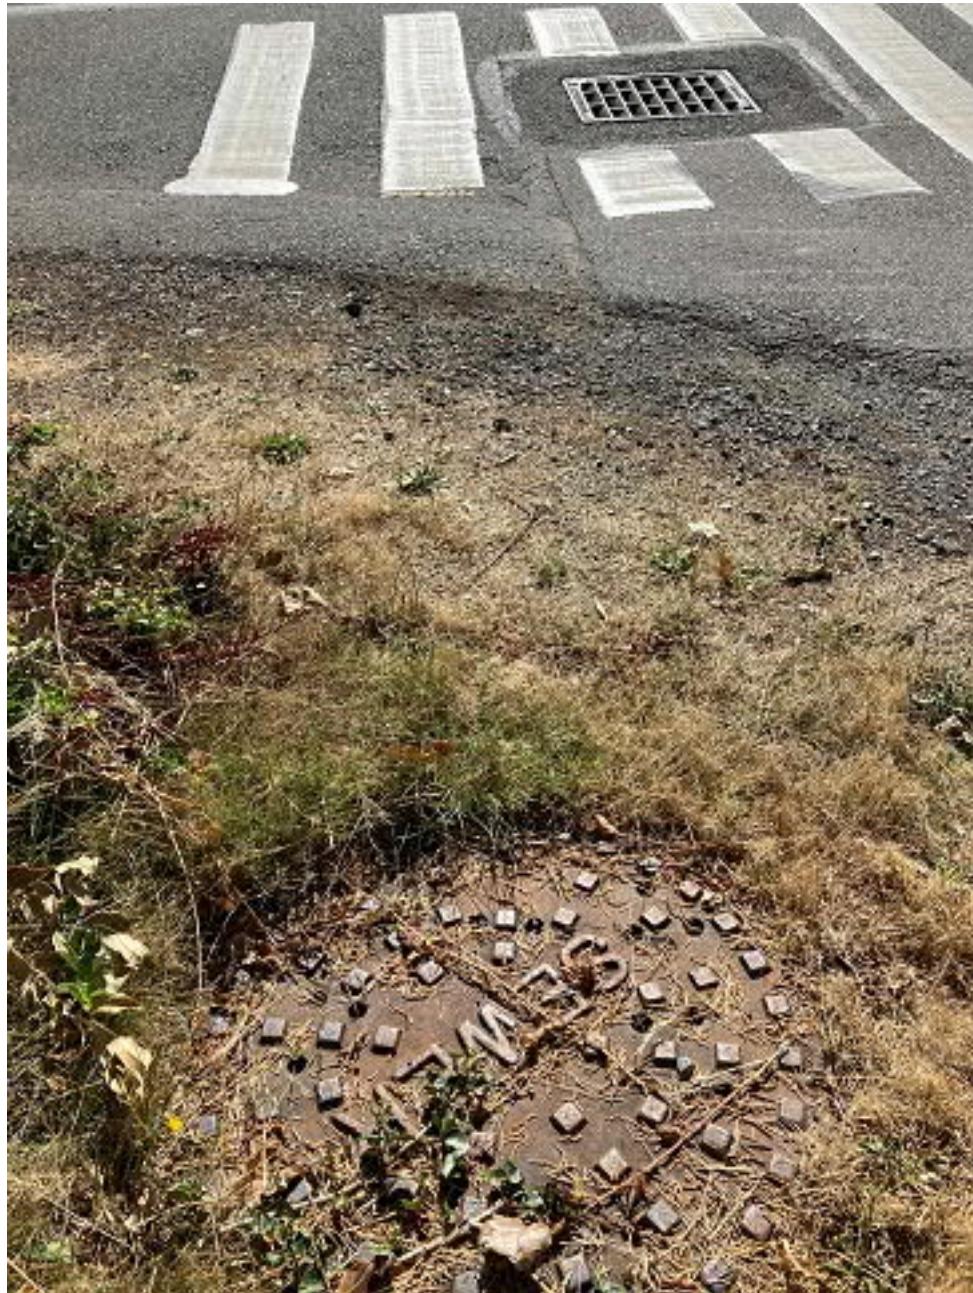
Picture 4: northernmost corner of Mercerwood Drive and East Mercer Way

The catch basin in question is the one that is labeled “sewer”. The other is an offshoot that leads back to it. From here the water heads across East Mercer Way and under the tennis courts to 100th Avenue SE (access road).

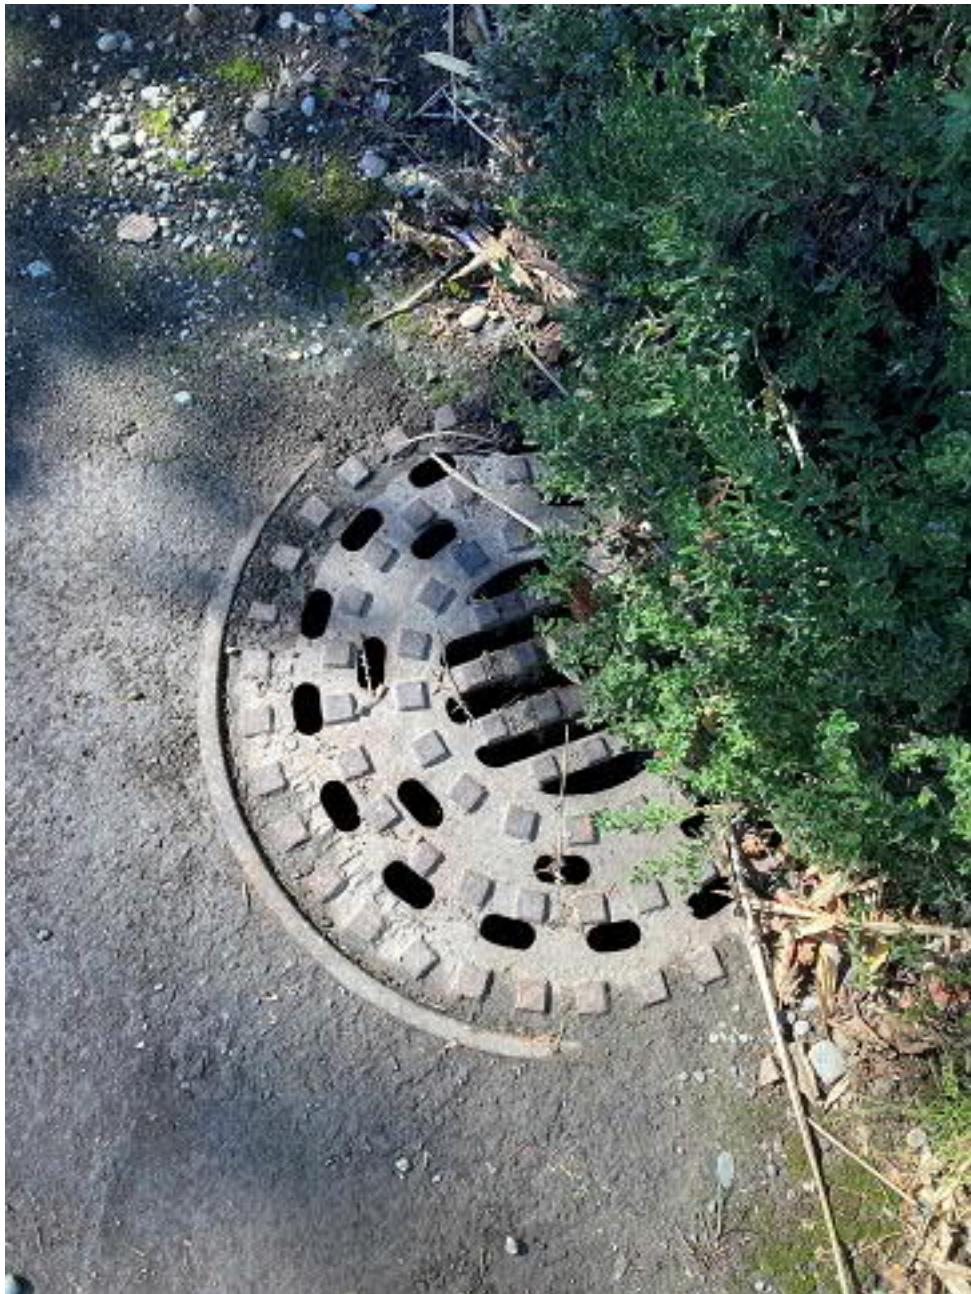
Picture 5: on the access road at 4242 East Mercer Way (residence)

Flowing water was heard down in this catch basin, an indication that it is working properly. From here water crosses southeast under the access road and enters a steep, wooded area which is inaccessible. This engineer could not personally verify the downstream path from here but it is likely all underground anyway.
