Project: Pre-construction assessment for lot re-development at 4731 90th Avenue SE, Mercer Island, WA. Parcel number 0191101145.

Objectives: Addendum to Laughing Trees Landscapes report dated 4/17/2022 exploring the limits of impact on the site trees.

RE: Latest plan set review for remodel at 4731 90th Avenue SE. PN-0191101145.

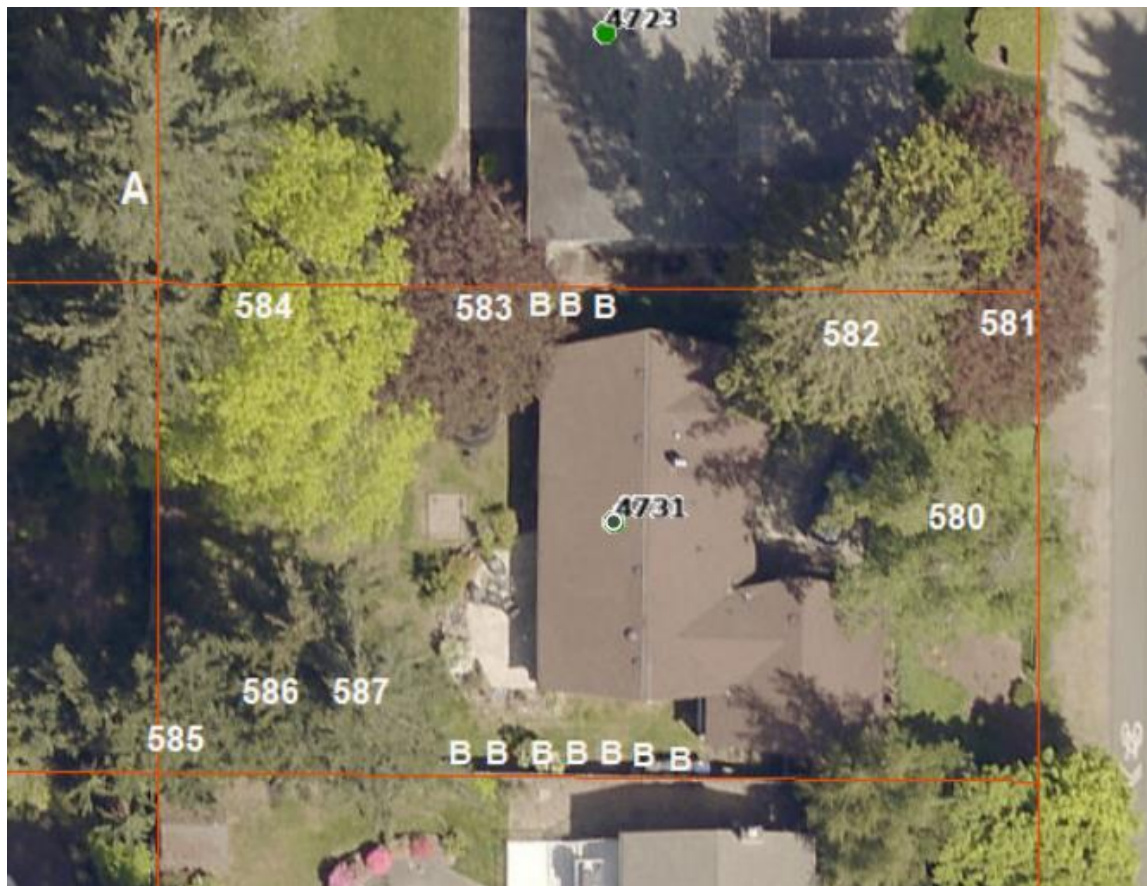
Figure 2. Aerial image circa 2019 with the rough placement of the subject trees denoted.

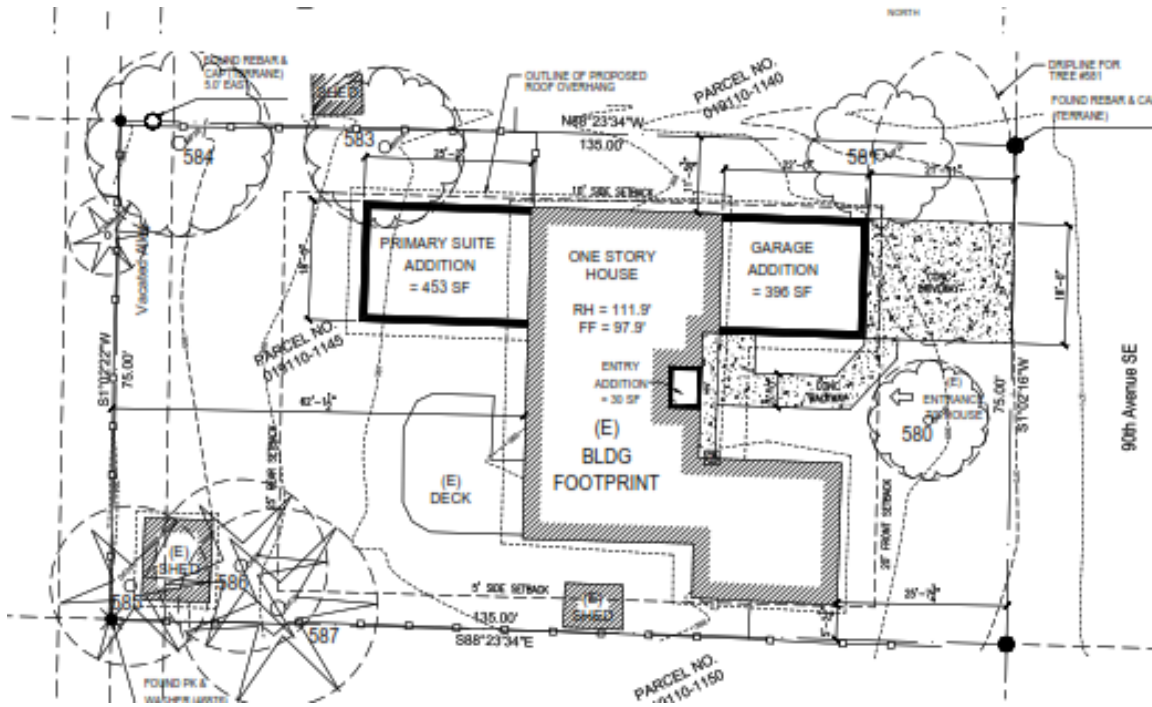
The proposed layout of the remodel is shown in Figure 4. Only the trees along the north side of the lot and the one in front (east) are in the construction impact zone. They will be discussed below.

Figure 4. Excerpt from the proposed site plan showing the new layout.

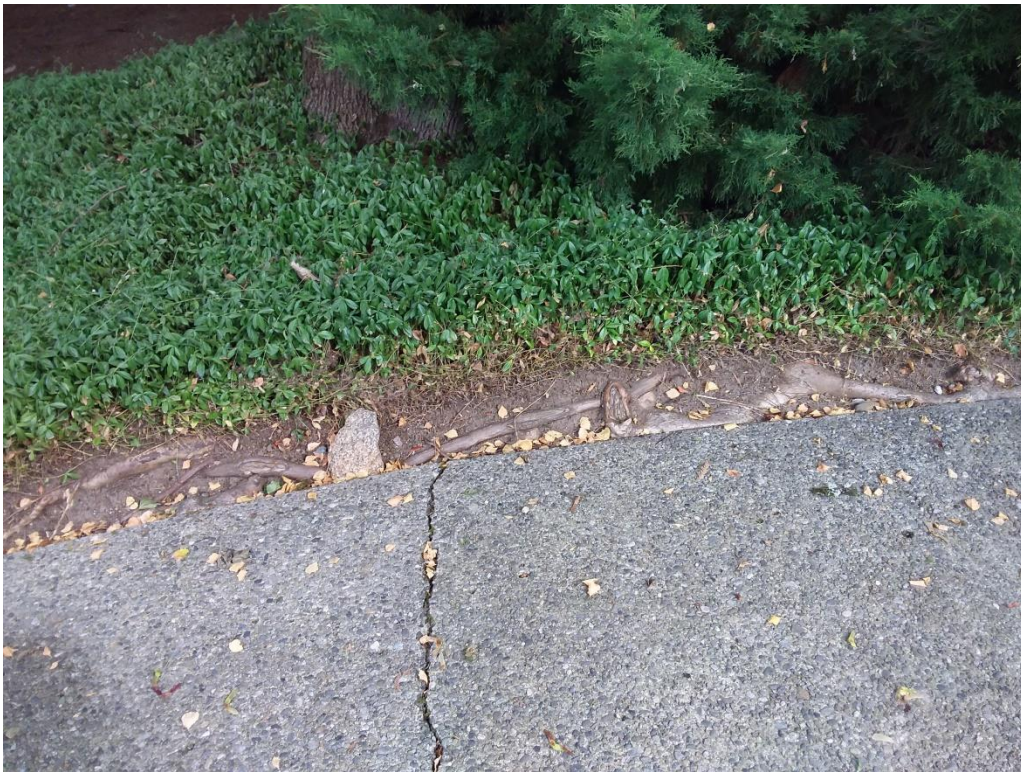
The #581 Norway maple is only 58" N of the closest point of the existing driveway which curves into its SE quadrant as shown in Figures 3 and 5. Its roots protrude along the north edge of the driveway in a multiple spots. Extreme care will have to be taken when removing the existing concrete to ensure the maple's roots are not damaged. Once the driveway is lifted the area will have to be immediately covered with 6-8" of arbormulch to protect the exposed roots. This tree will gain close to 70 square feet of rooting space when the project is completed.

Figure 5. Looking down and north at the roots from the #581 maple growing along the north edge of the existing driveway.

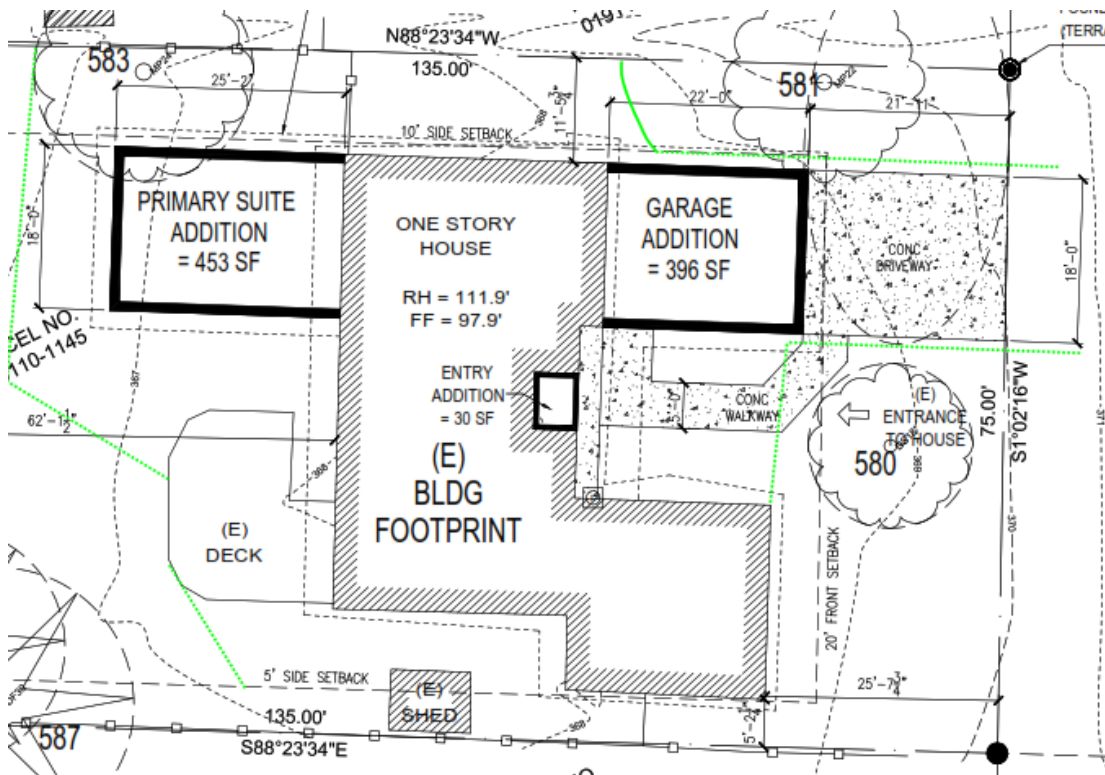
Figure 6. The faint green lines indicate the rough placement of the tree protection fencing.

Once the existing driveway is removed the fence should be set at the north edge of the new driveway, brought out east to near the street, and stretched west just outside the border of the new garage foundation (Figure 6). It will have to curve north just far enough from the existing NE house corner to allow access to the rear.

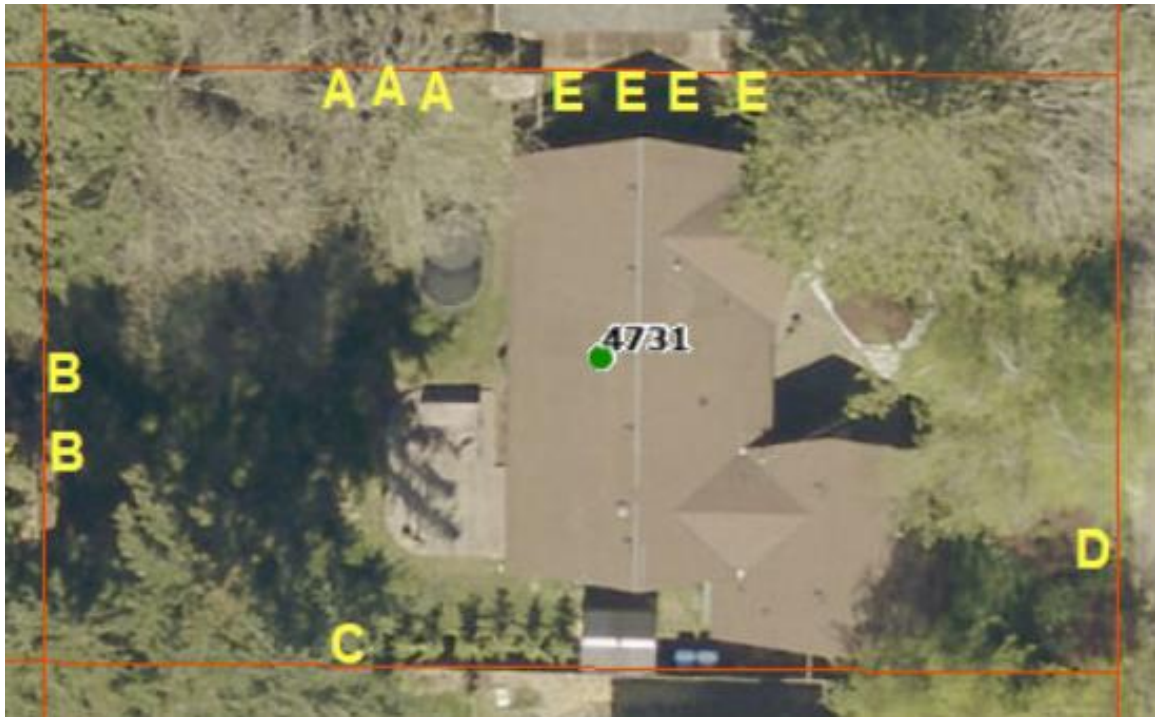
Figure 7. Rough planting schematic showing the locations alluded to in the 'Discussion' section of the report. The annotations do not dictate a specific species of plant rather the area where one of a number of different trees could be installed.

To add depth, additional screening, and color interest three or four Autumn Brilliance Serviceberries (*Amelanchier x grandiflora* 'Autumn Brilliance') could be planted along the west fence line. This varietal of the native serviceberry provides year round color and great habitat for birds and small mammals. Three redbuds (*Cercis canadensis*) could be used instead for the color aspect but they are not as multifunctional habitat wise as the serviceberries. Crepe myrtle (*Lagerstroemia indica*) comes in many different colors and is another decent choice for the space. Placement for this set of plants will be indicated with a 'B' in the schematic.

On the south side of the yard there is space to plant a 'tree of interest'. A maidenhair tree (*Ginkgo biloba*), columnar Copper beech (*Fagus sylvatica* 'Dawyck Purple'), a pair of Japanese Stewartia (*Stewartia pseudocamellia*), or even a Weeping Sequoia (*Sequoiadendron giganteum* 'Pendulum') would fit nicely in the space between the #587 fir and the west end of the row of seven Leyland cypress. The spot will be marked with a 'C' on the planting map.

There is an open area in the SE corner of the yard that would be a good place to install a smaller medium spreading tree with good color. A crepe myrtle or redbud would work as would a Bloodgood Japanese Maple (*Acer palmatum* 'Bloodgood'). A pair, or even a set, of Mountain Hemlock (*Tsuga mertensiana*) could anchor the corner nicely. This spot will be marked as 'D'.

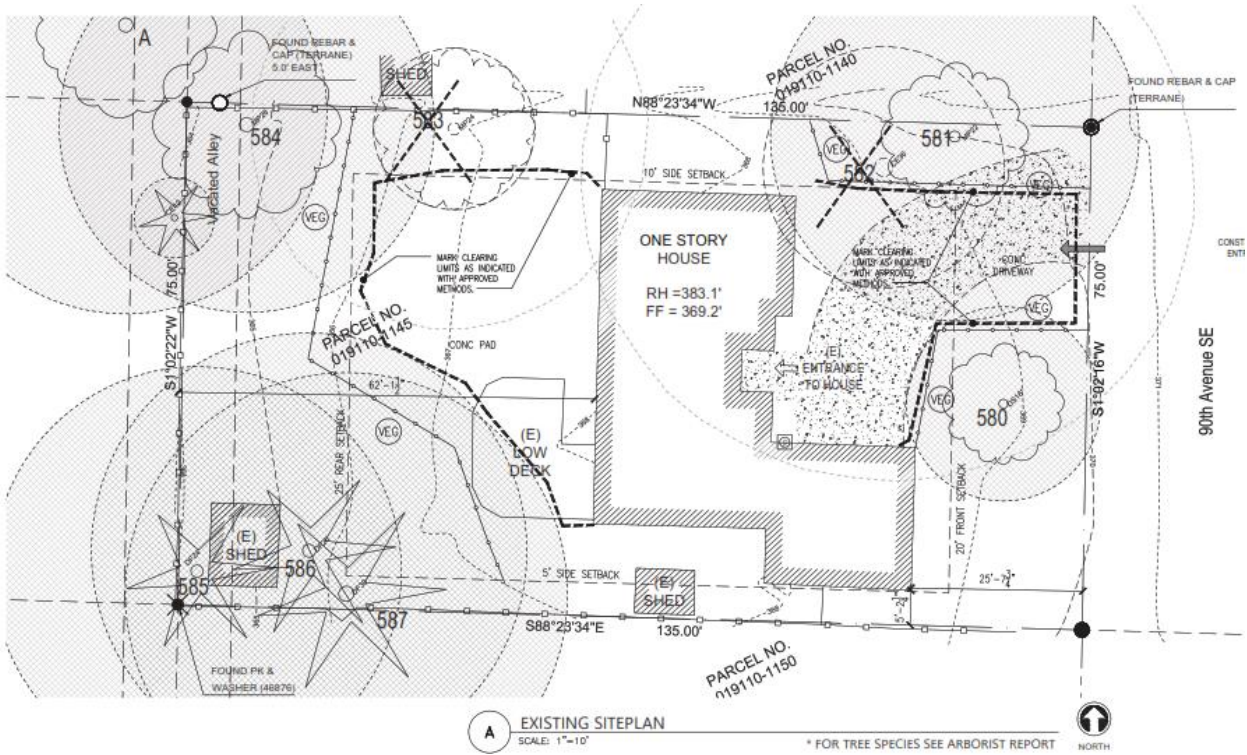
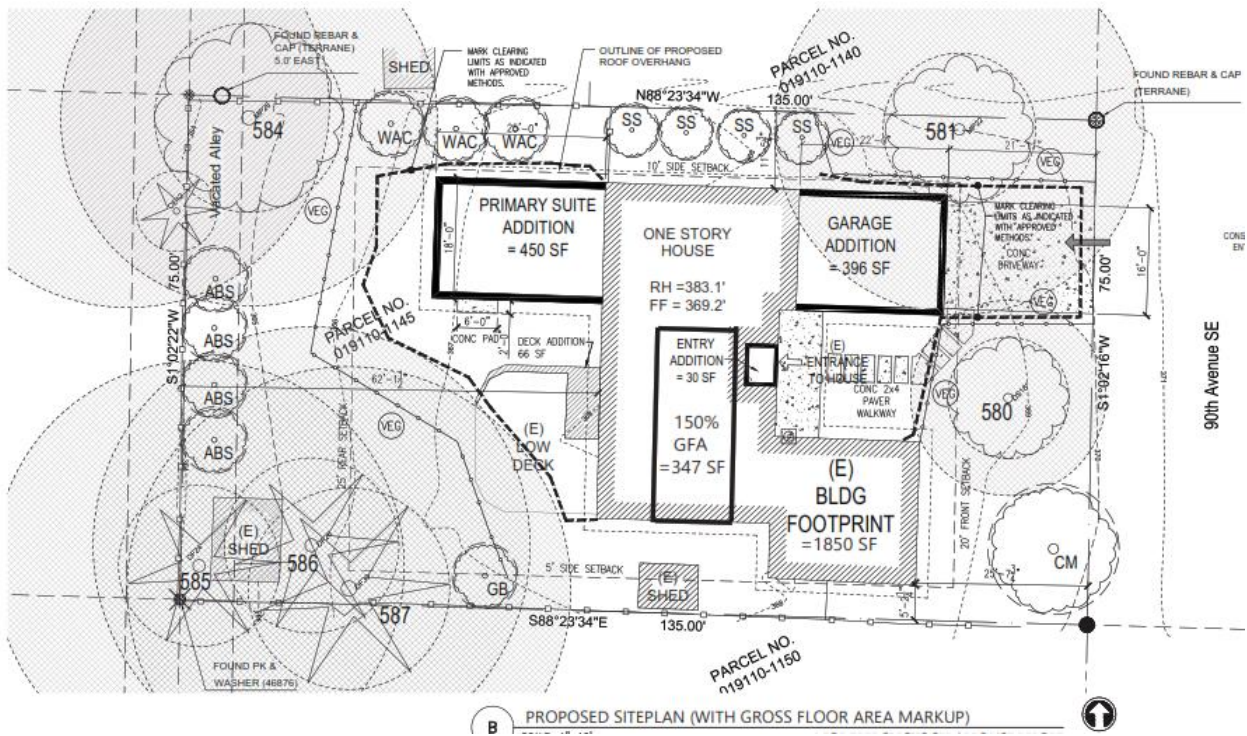
Figure 1. Excerpt from the new version of the 'Existing Site Plan'.

Figure 2. Excerpt from the new version of the 'Proposed Siteplan'.

As requested by the City arborist the new set shows the locations of all the site trees clearly along with their CRZs and protection requirements. Exceptional site trees are noted with an 'EX'. The locations of the proposed replacement trees are also shown (Figures 1 and 2).
