Arborist Report

To: JayMarc Homes c/o Alex Spahman
Site: 9619 SE 34th St, Mercer Island, WA 98040
Re: Tree Inventory and Assessment
Date: June 24, 2022
Project Arborist: Tyler Bunton
ISA Certified Arborist #PN-8715A
ISA Qualified Tree Risk Assessor
Reviewed By: Haley Galbraith
ISA Board Certified Master Arborist #PN-7512BM
Municipal Specialist; ISA Qualified Tree Risk Assessor
Referenced Documents: Site Plan, Sheet A2.1 (JayMarc Homes, 6/10/2022)
Attached: Table of Trees
Site Plan, Sheet A2.1 (JayMarc Homes, 6/10/2022)

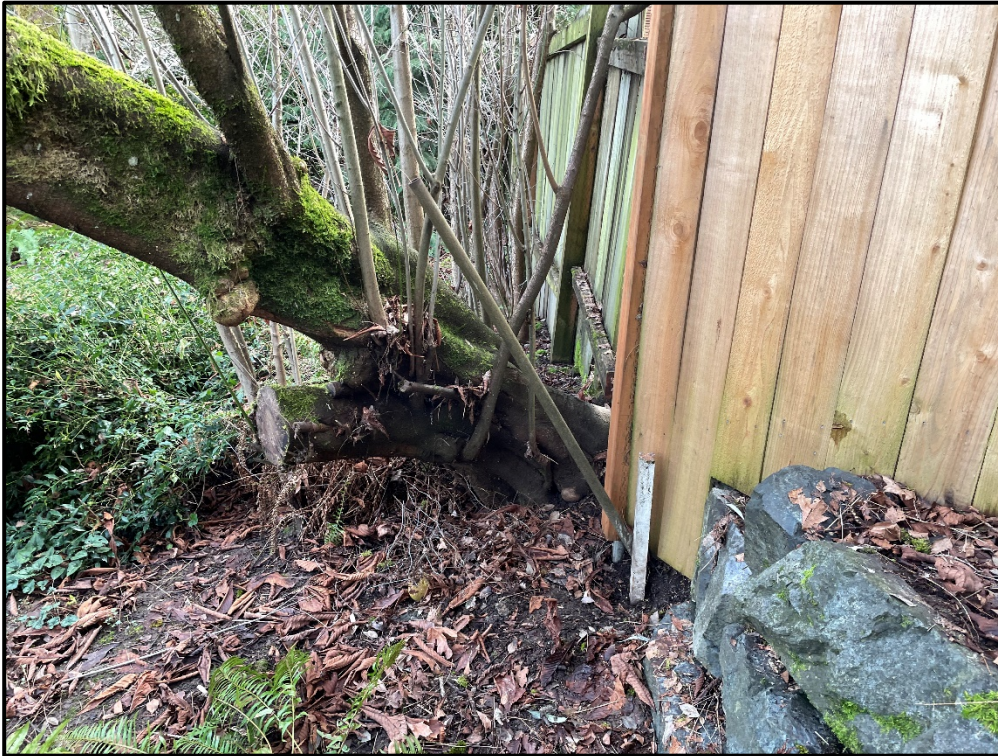
Tree 214 is a flowering plum (*Prunus cerasifera*) in good health and poor structural condition located centrally on the southern property line. This tree has split at the base between two codominant trunks. Currently the base appears stable, however, the failure has resulted in the canopy of the tree nearly touching the ground when in leaf.

Photograph 1. The northern trunk of tree 214 leaning to the south.

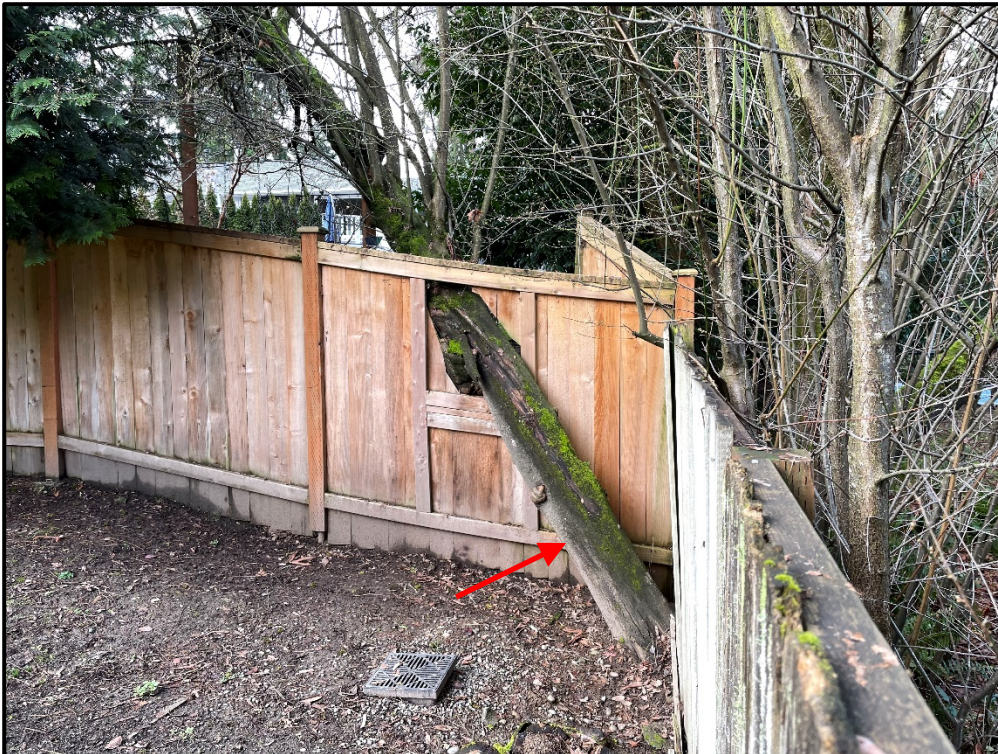
Photograph 2. Photo taken looking over the fence on the southern property line. The south trunk of tree 214 is indicated by the red arrow.

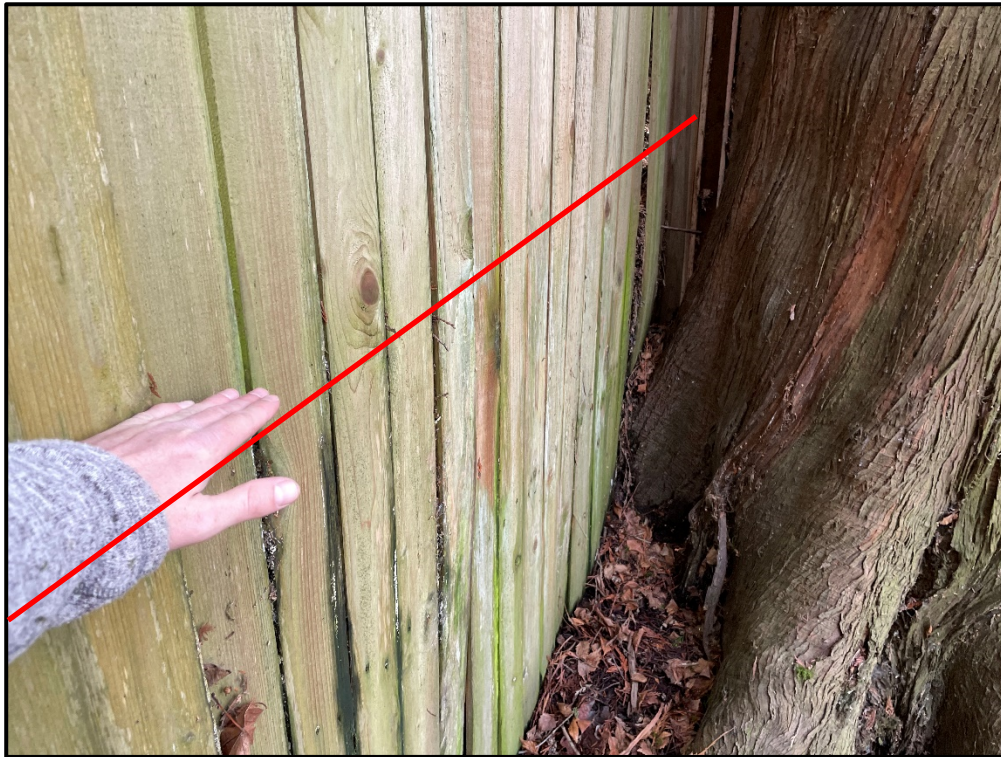
Tree 219 is an exceptional-by-size western redcedar (*Thuja plicata*) tree in fair health and structural condition with a diameter at standard height (DSH) of 40.1 inches. At the time of my assessment this tree sounded hollow from the base to approximately 6 feet with a bulge in the trunk at approximately 5 feet above the base. South of the fence on the southern property line there is approximately 3 feet of fill. This fill was likely pushed against the fence when the adjacent property to the south installed their sport court in 2008.

Photograph 3. The base of tree 219 in relation to the fence on the southern property line. The red line indicates the approximate level of fill against the fence to the south.

- Perform advanced testing on tree 219 to determine the presence of internal decay.
- Obtain all necessary permits and approval from the city prior to commencement of site work.
- Update site plans to include limits of disturbance.
- Demolish existing structures within tree protection areas carefully, replacing tree protection fencing immediately after structures are removed.
- Install tree protection fencing as indicated on Site Plan, Sheet A2.1 (JayMarc Homes, 6/10/2022).
- All pruning should be conducted by an ISA certified arborist following current ANSI A300 standards.
- Ensure tree protection standards comply with MICC 19.10.080 and ISA Best Management Practices (BMP) – Managing Trees During Construction.

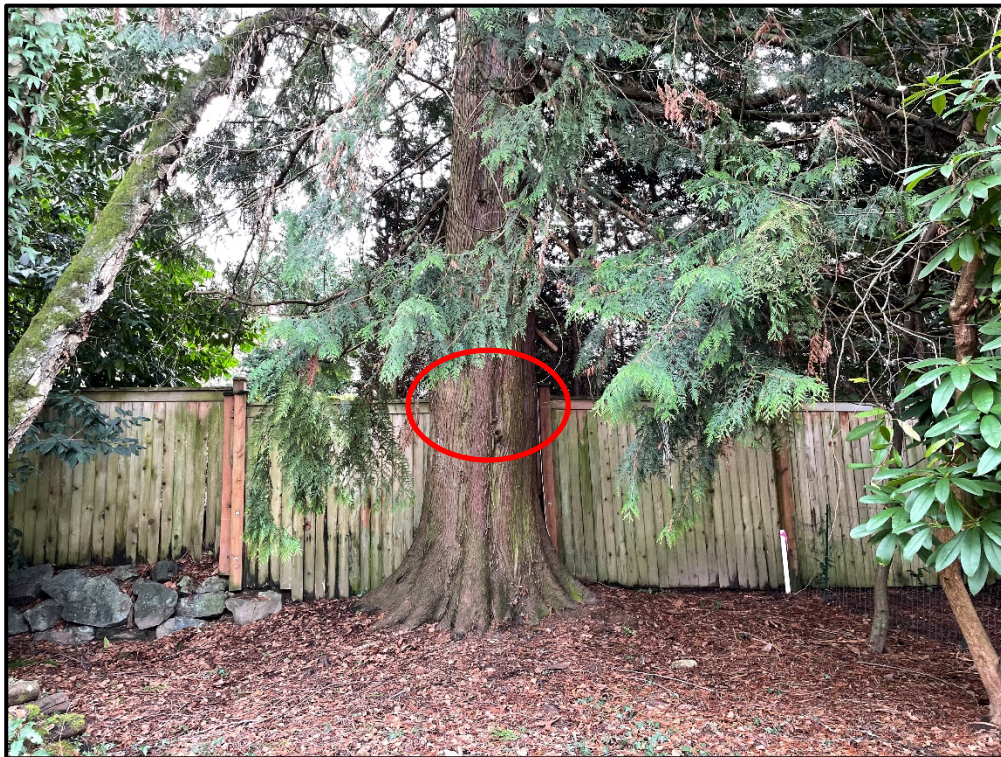
Photograph 4. The base and trunk of tree 219 with the area of trunk bulge circled in red.

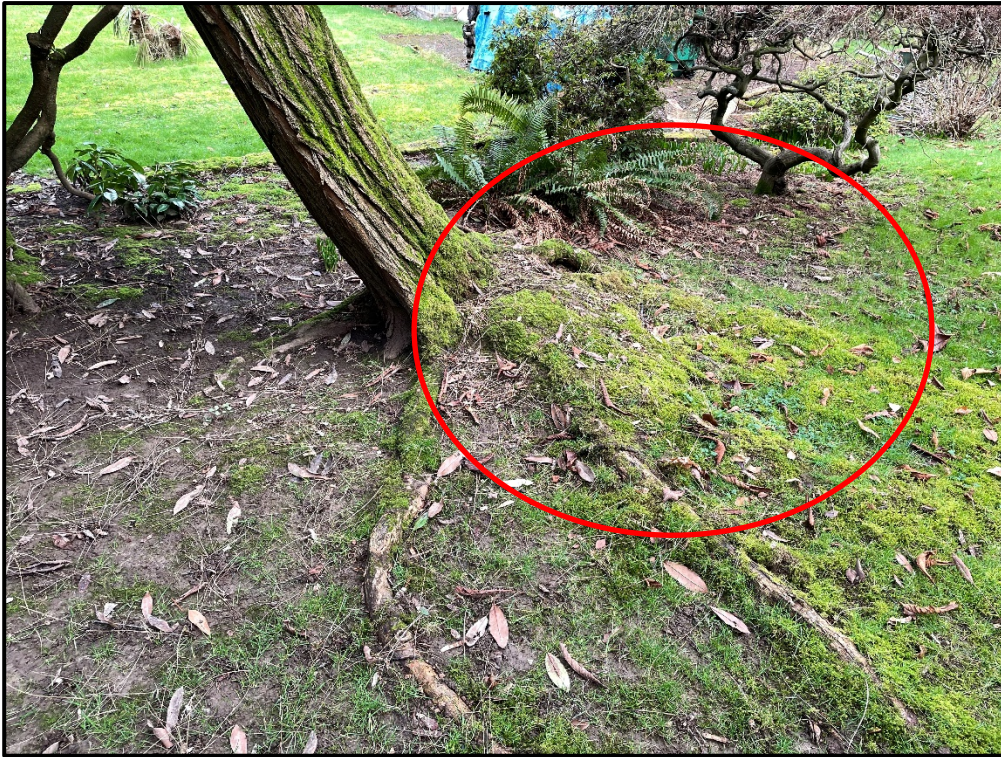
Tree 220 is a black locust (*Robinia pseudoacacia*) tree with a DSH of 15 inches in good health and fair structural condition. This tree appears to have partially failed at the base when it was approximately 25 feet tall; above 25 feet the trunk grows vertically.

Photograph 5. The partially failed base of tree 220 with the uplifted side circled in red.

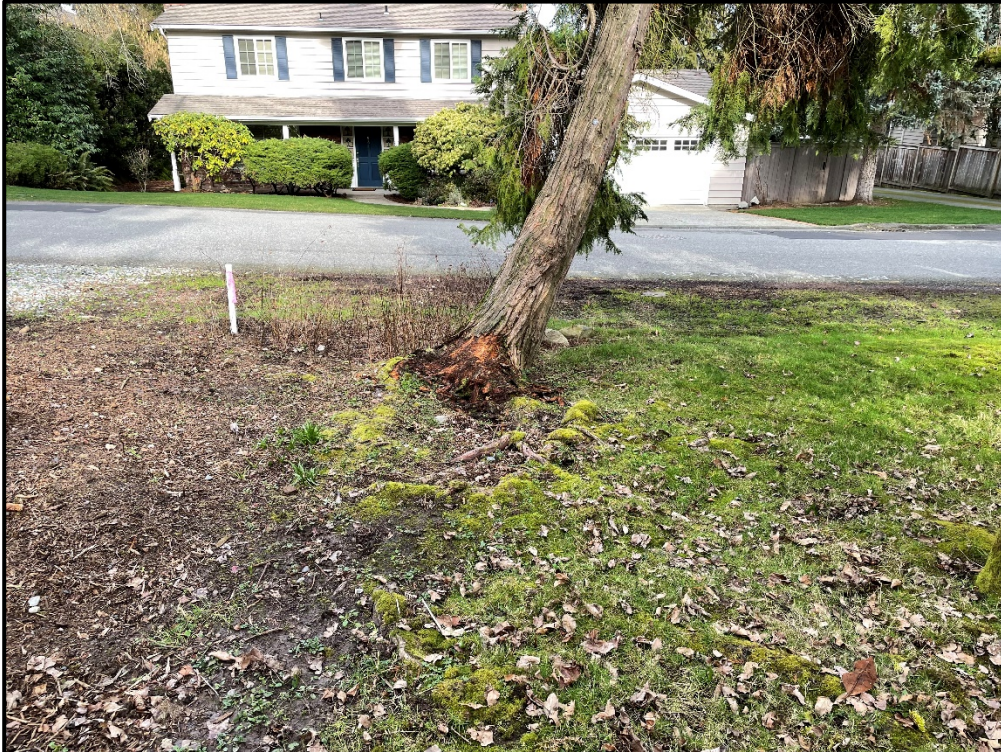
Tree 226 is a Lawson cypress (*Chamaecyparis lawsoniana*) tree with a DSH of 14 inches in good health and fair structural condition. This tree has a swept base and corrected lean to the northeast. There are several large surface roots from this tree extending approximately 35 feet south into the yard. An adjacent tree recently failed to the north impacting the power lines and the neighbors garage across the street.

Photograph 6. The base of tree 226 showing the swept base and lower trunk lean.

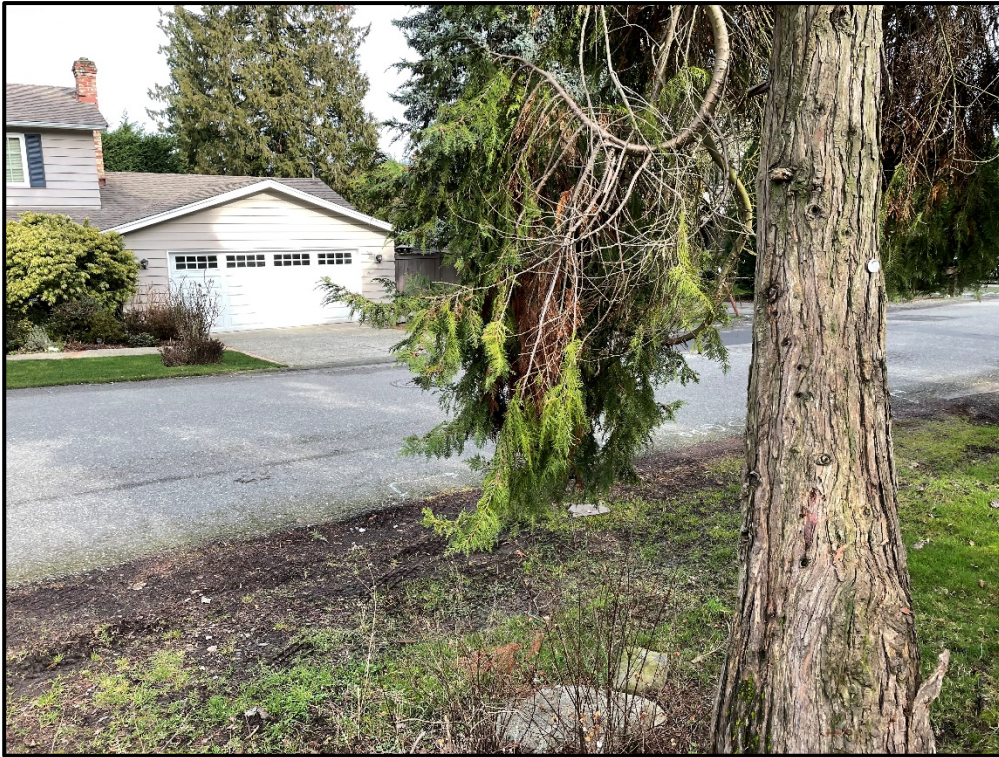
Based on the direction of lean of tree 226, the most likely target of impact in the event of failure at the base would be the power lines. With a possible likelihood of failure, a high likelihood of impacting the power lines, and significant disruption/damage, this tree presents a moderate level of risk to the power lines, and an overall moderate level of risk to surrounding targets.

Photograph 7. Photo of tree 226 taken in the direction of the lower trunk lean. The tree targets immediately to the right of the garage in the photo. Three phase power lines are immediately out of frame above the photo.
