SHOFFNER CONSULTING

RE: Tree Inventory Report - 4104 83rd Ave. SE Mercer Island, WA.

TREE EVALUATION DATA

TREE INVENTORY MAP
PARCEL NO. 3826500040

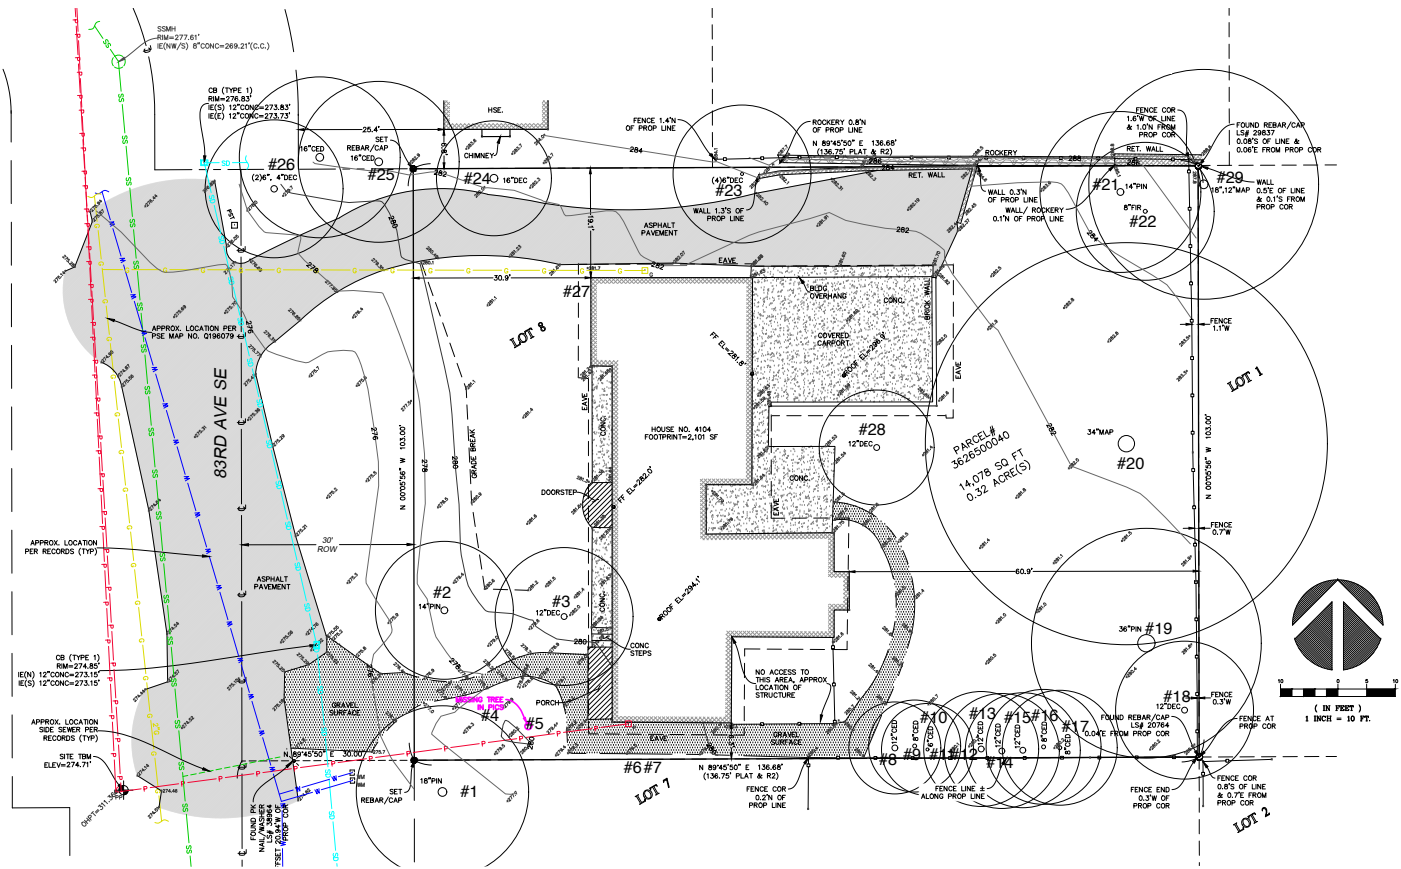
The information gathered on all of the trees is provided in the accompanying Tree Evaluation Data spreadsheet. No trees on or just off-site possessed any conditions, symptoms of conditions or defects worth noting.

Tree protection fencing is to be installed at the specified LODs prior to beginning any work on the site including clearing and grading and is to remain in place throughout development.
