SHOFFNER CONSULTING

November 7, 2023

RE: Tree Inventory Assessment Report - 4216 83rd Ave. NE Mercer Island, WA.

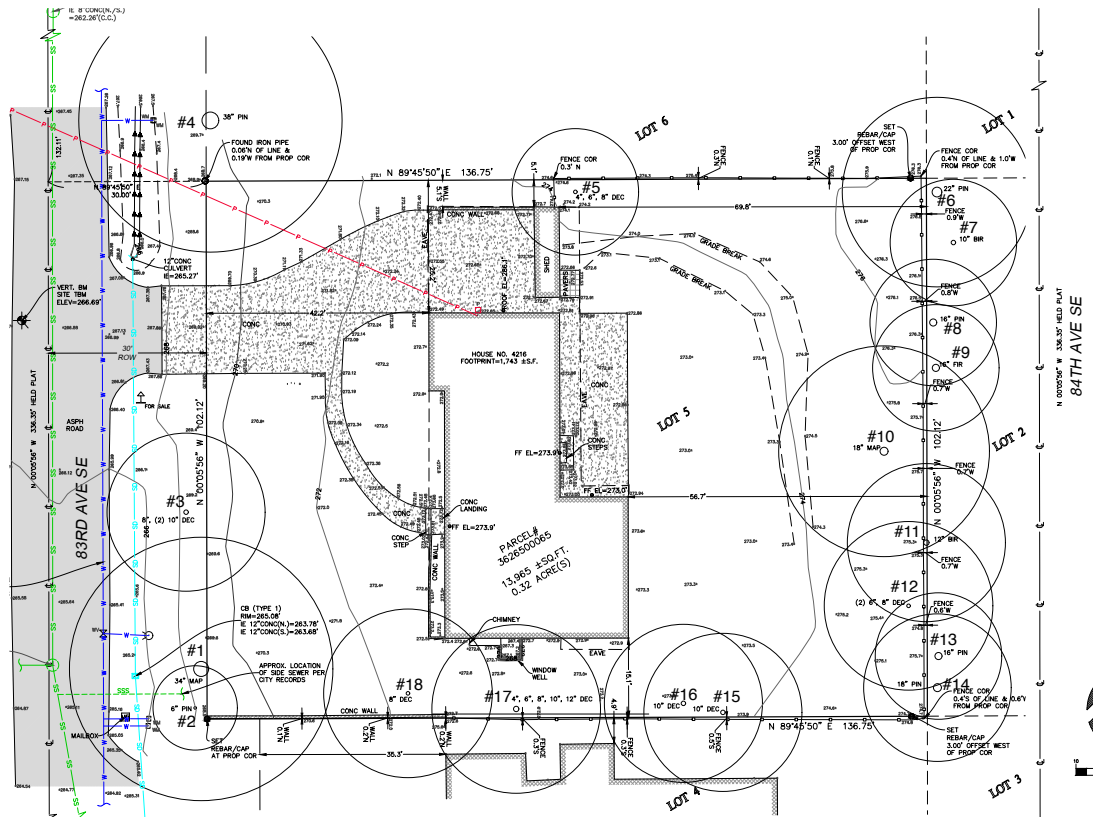
TREE INVENTORY MAP

There are four significant trees on the property, #10, 11, 17 and 18. Three symbols on the survey are rhododendrons that are large shrubs, not trees.

There is a total of four significant trees (10 inches or greater) on the property, none of which are exceptional by size. To meet the required retention, two trees (#10 and #11) along the eastern property line are being retained.

Retained trees are to be protected with protection fencing per City of Mercer Island standards located along the LOD of the trees to delineate the tree protection area (TPA).
