## **GEOTECHNICAL ENGINEERING INVESTIGATION**

Proposed Accessory Dwelling Unit  
6450 E Mercer Way  
Mercer Island, Washington  
Parcel#: 302405-9004

October 5, 2023  
Project No. 2EH03221024

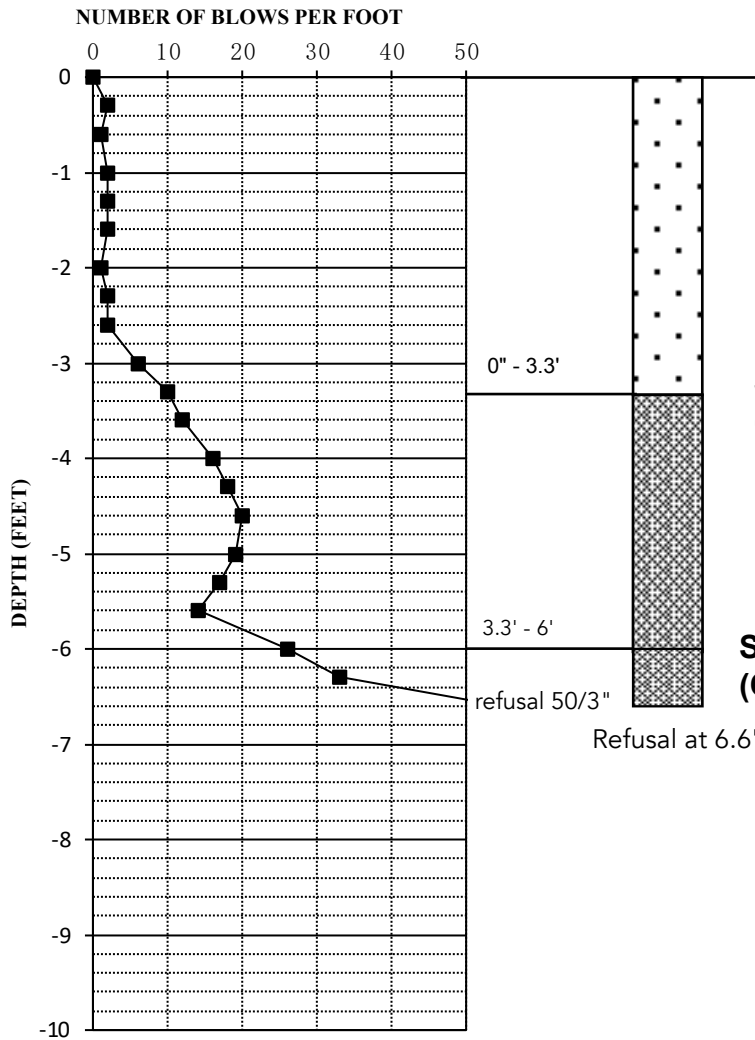
X,Y =  
 Surface Elevation = 48'  
 Surface Conditions = Ground Cover

**LOOSE SILTY SANDS**

**SILTY SANDS WITH GRAVEL /SILT (SM-ML)**

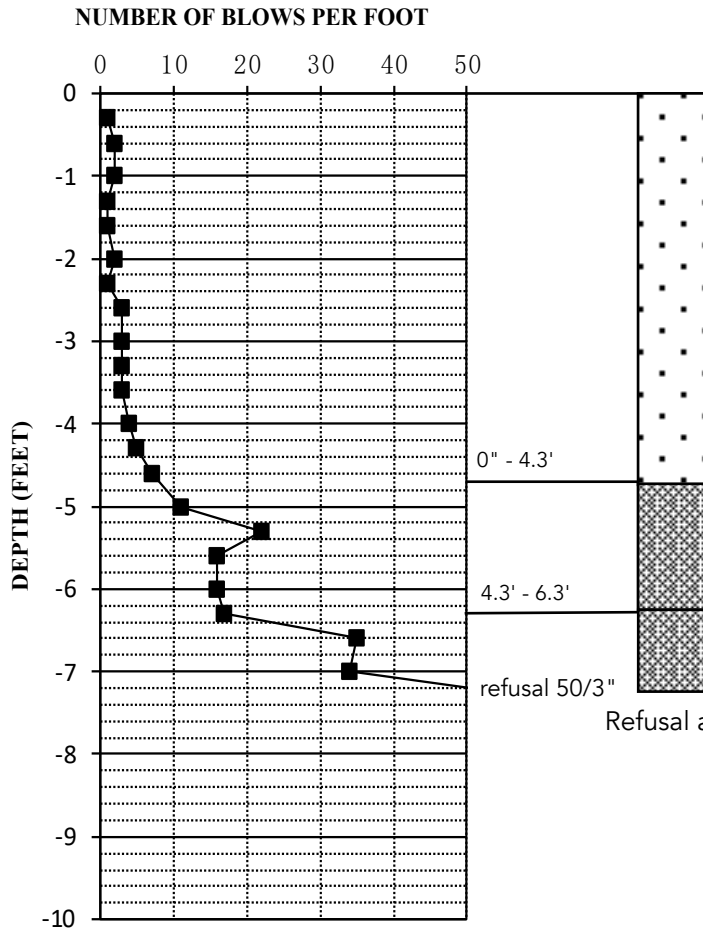
X,Y =  
 Surface Elevation = 56'  
 Surface Conditions = Ground Cover

**LOOSE SILTY SANDS**

**SILTY SANDS WITH GRAVEL/SILT (SM-ML)**

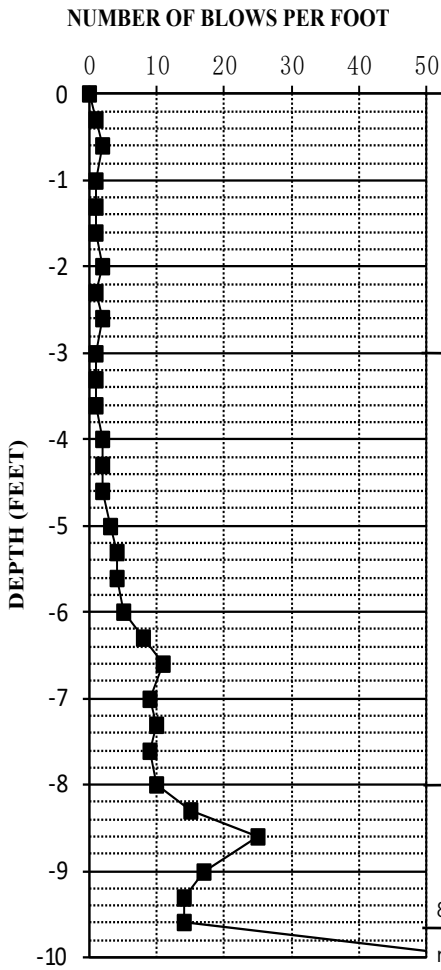
**DCP-3** DYNAMIC CONE PENETRATION TEST

slope. The soil was dry, crumbly when disturbed, and loose in situ. However, the fill soils were encountered in DCP#3 at top of slope that is ~5 feet way from foundation of detached garage to a depth of approximately 5.3 feet below the ground surface. We interpret the existing fill as being placed during the construction of the existing detached garage.

X,Y =  
 Surface Elevation = 62'  
 Surface Conditions = Ground Cover

**FILL**

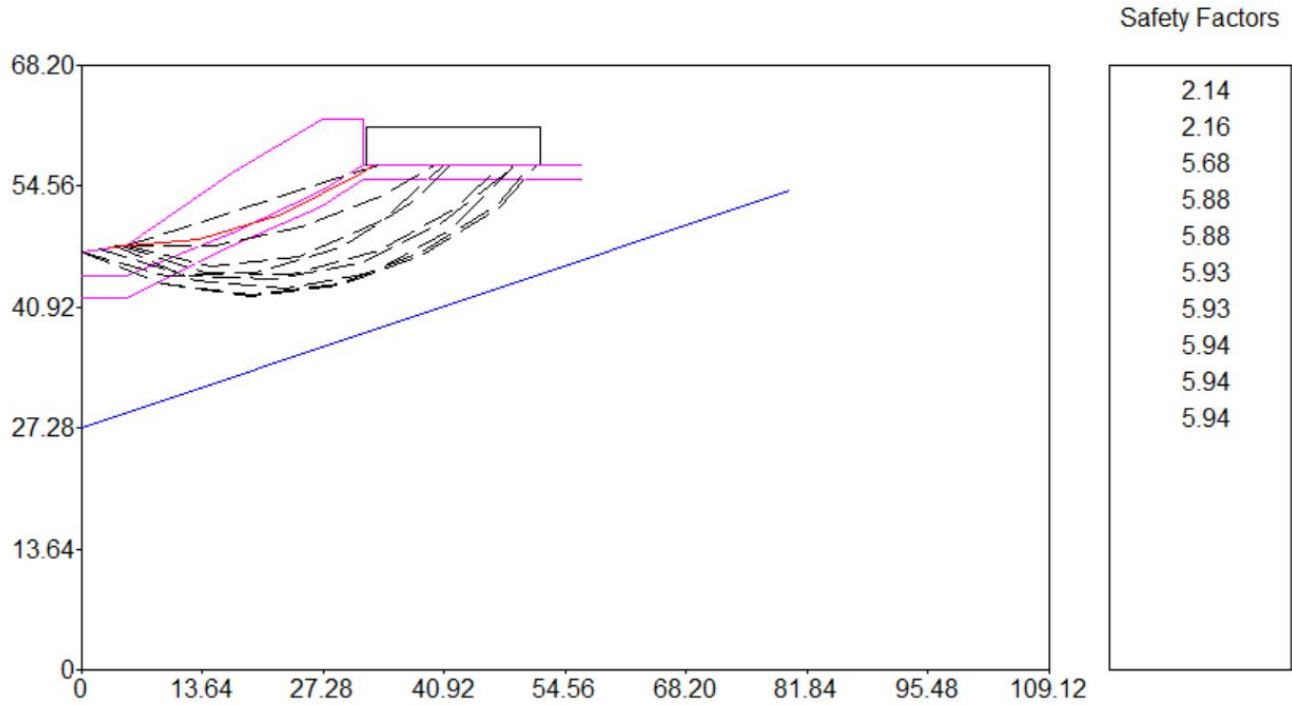
*Figure 7*

**STATIC CONDITION**

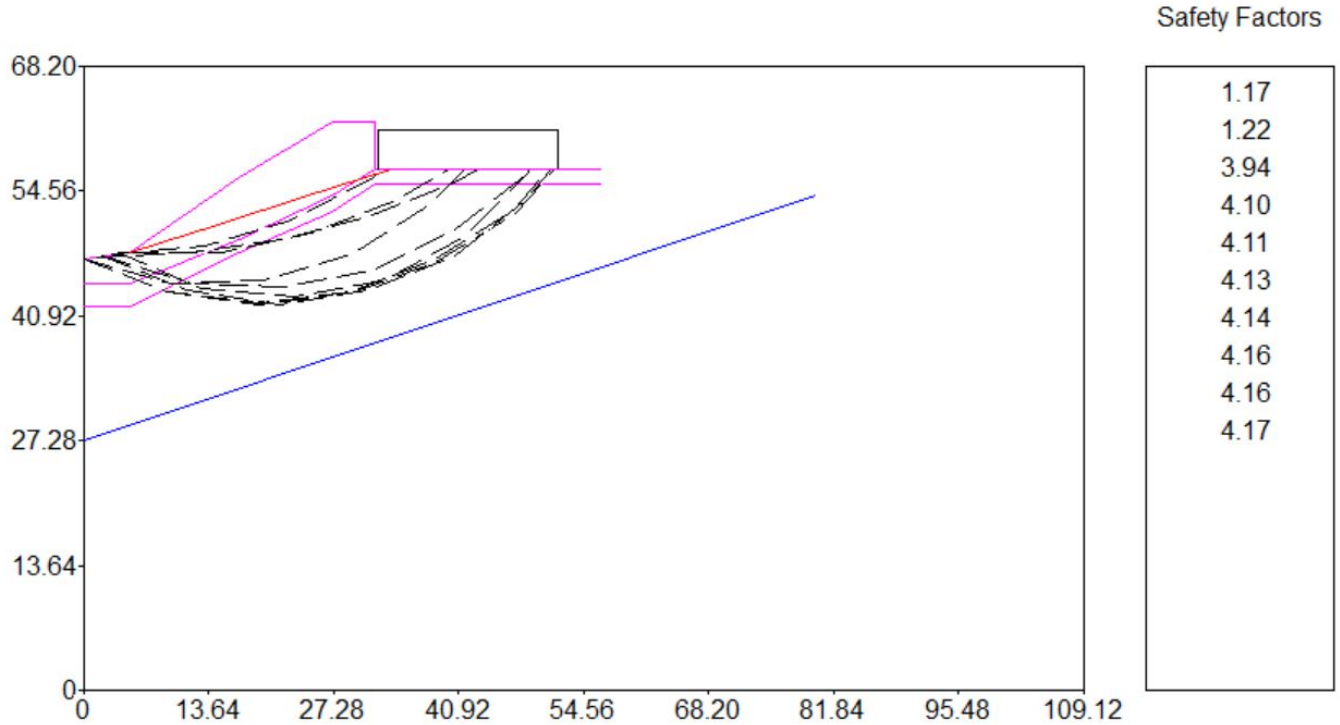
Analysis showed that cross-sections A-A', Figure 8, do meet the minimum FS of 1.125 for seismic conditions for a horizontal earthquake coefficient of 0.31g.
