## **Arborist Report**

**February 27th, 2024**

**Prepared for:**  
Aspen Homes

**Site Address:**  
2956 72nd Ave SE  
Mercer Island, Wa

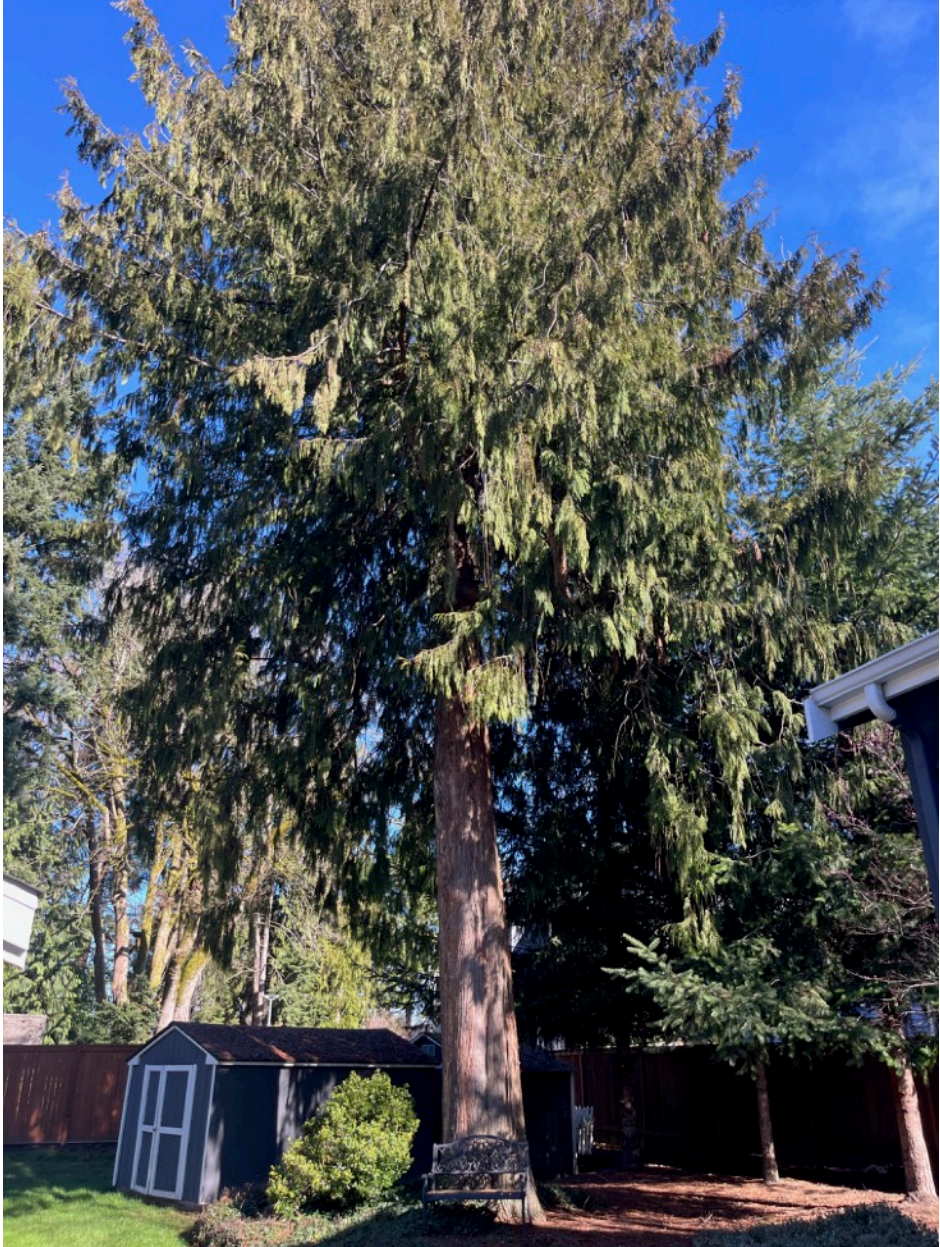
**Looking north at 2430**

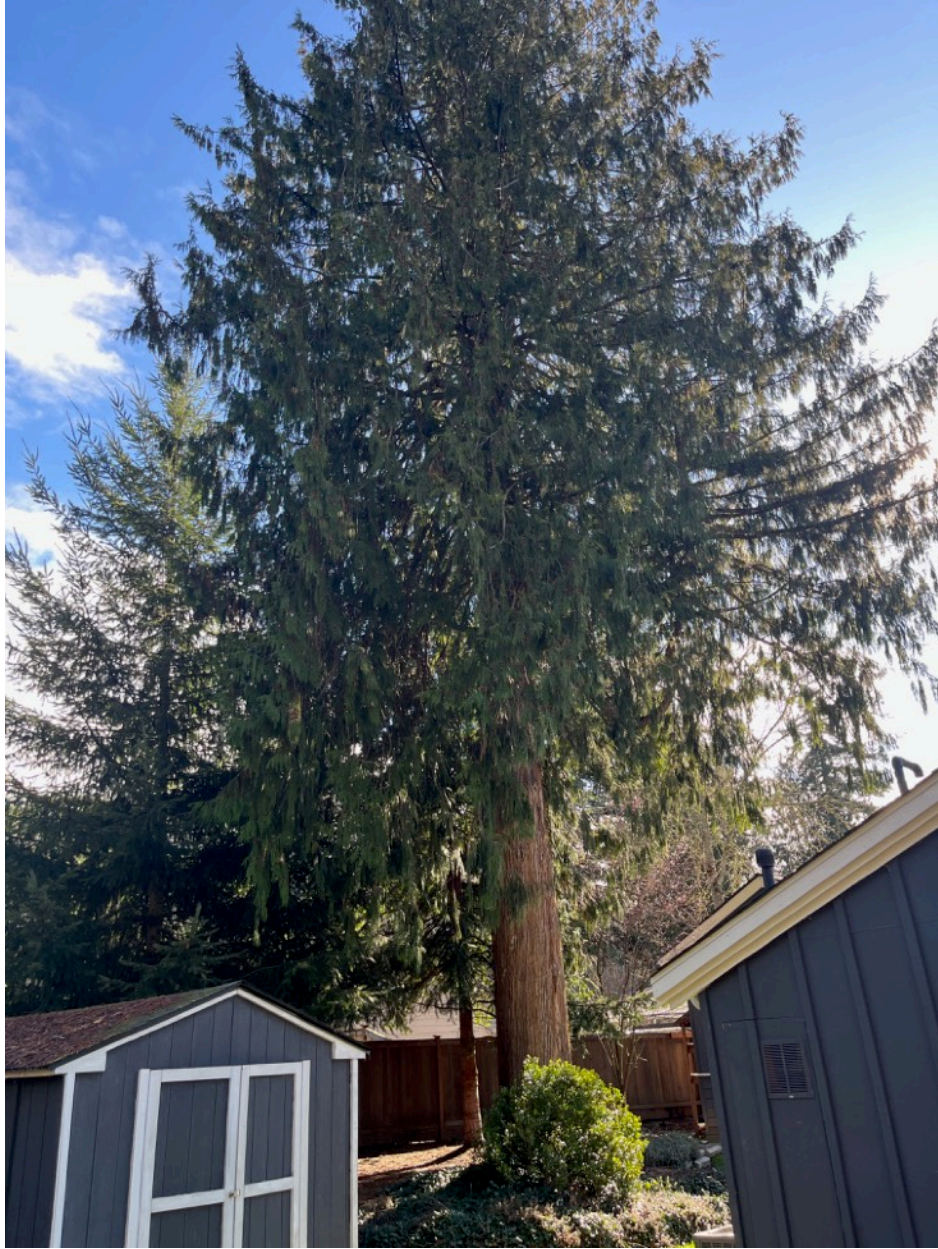
East of the existing one story house at this address and north of the garage building is a specimen of Western Red Cedar (*Thuja plicata*) that is large enough to be considered Exceptional in The City of Mercer Island. To the east of that tree are three Douglas Firs (*Pseudotsuga mensiezii*), one of which was not included on the survey map that I was provided.

**Looking east at 2430**

When making the effort to preserve a tree, you will be required to temporarily fence the tree at the dripline, defined by the outermost leaves on a tree. The area within the dripline contains the most critical roots and should not be disturbed. Remember, the bigger the tree, the further out the dripline and roots extend.

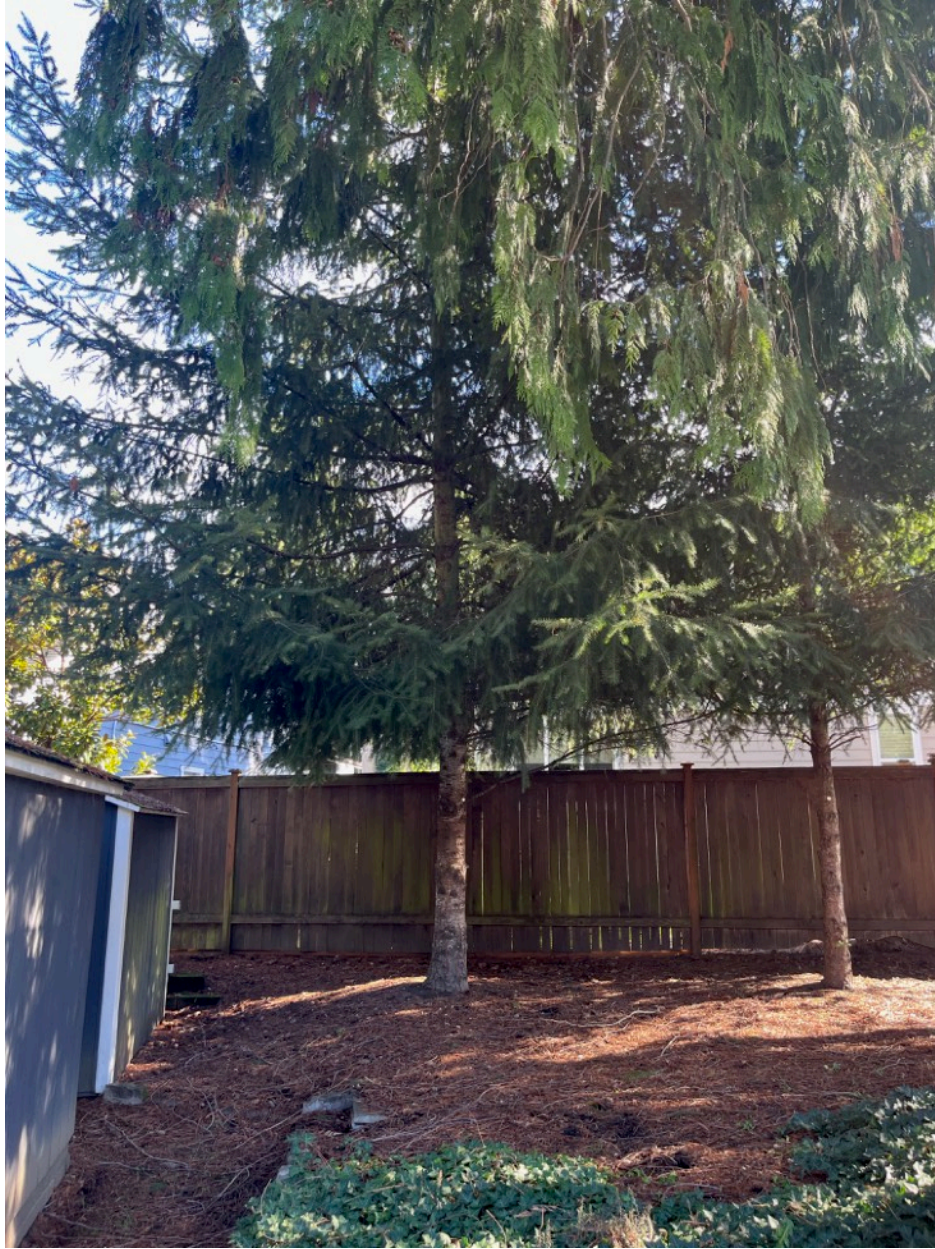
**Looking east at 2431 and 2432**

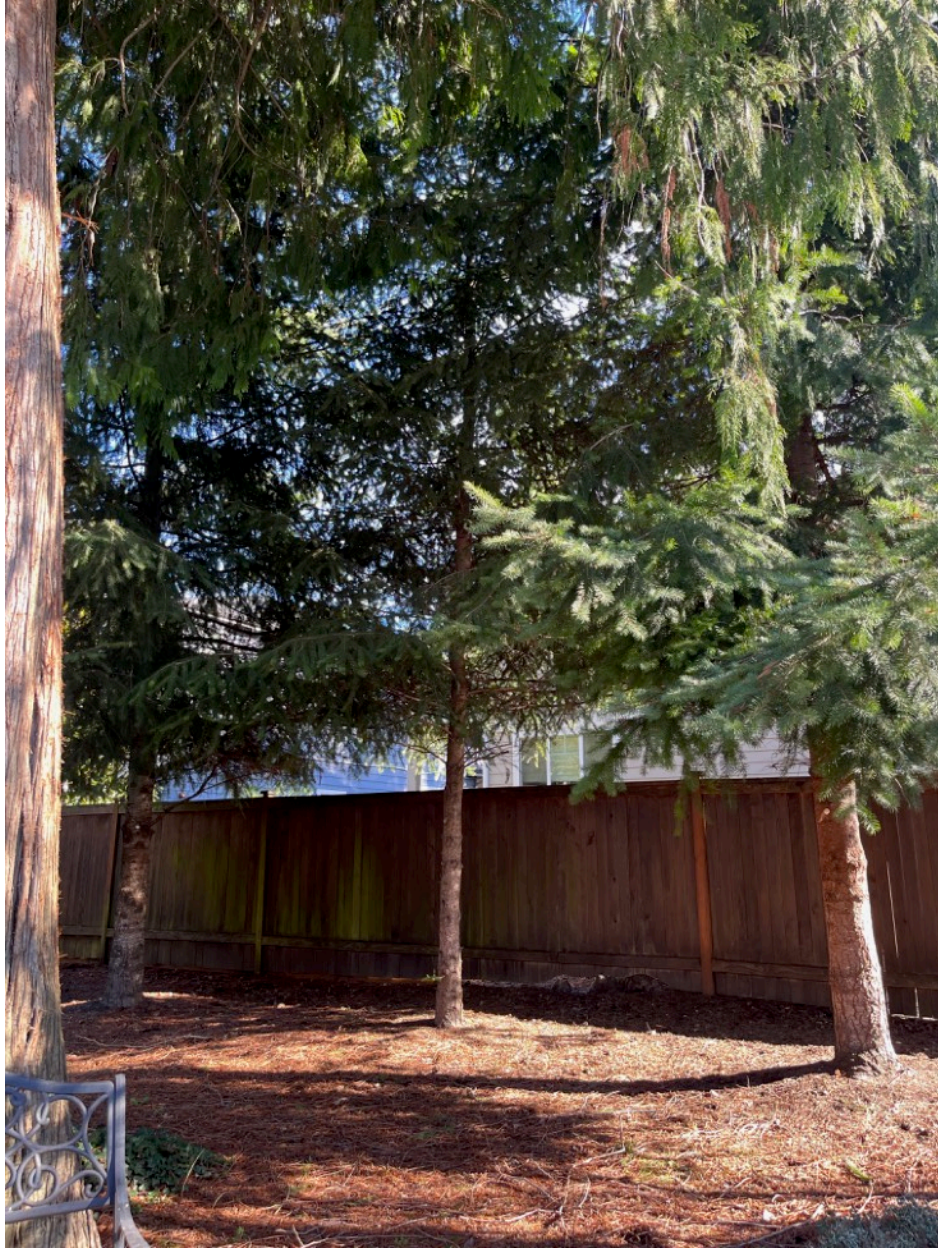
**Looking NE at 2431, 2432, and 2433**

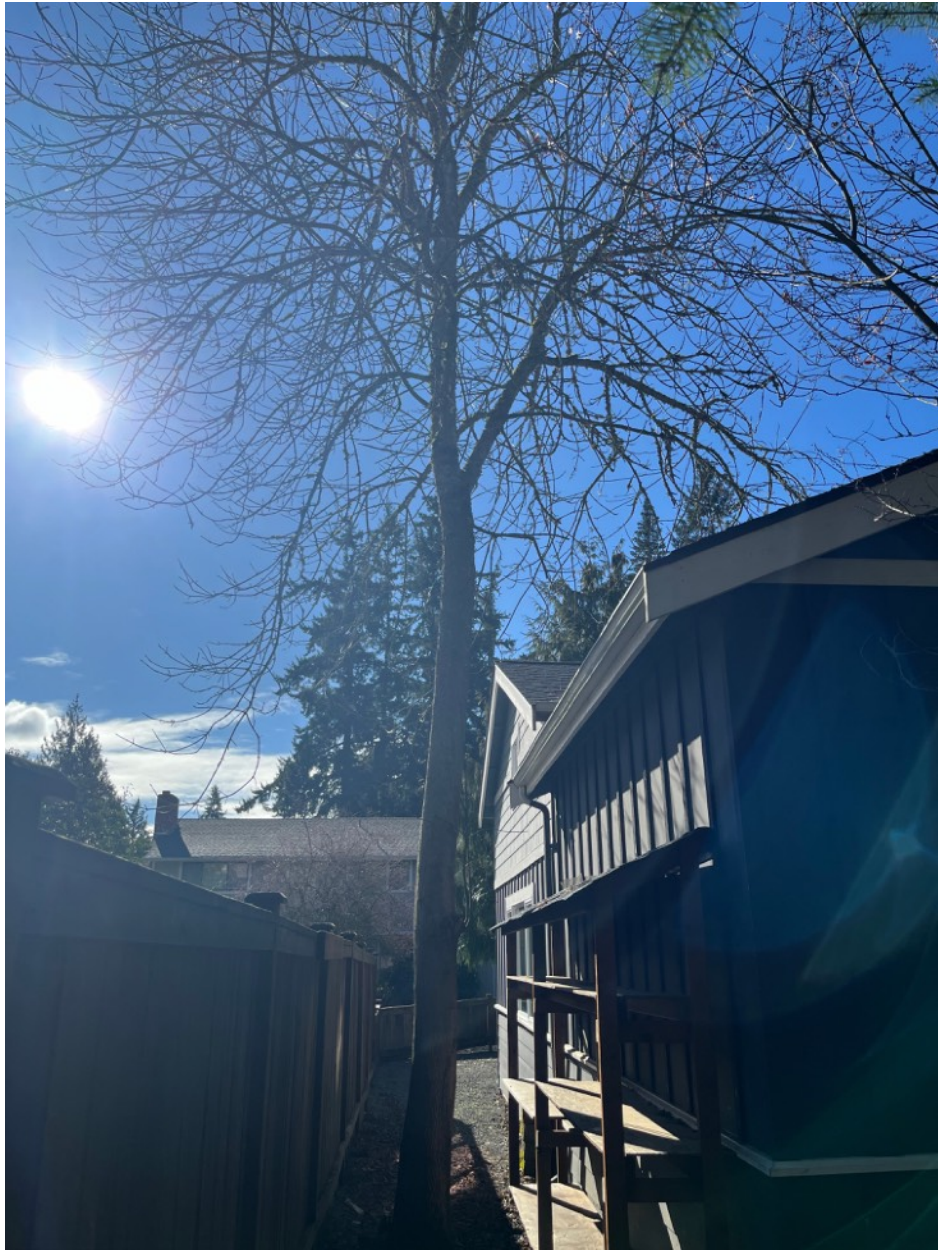
East of the existing garage structure is a native Ash that is very close to the house with a drip line that extends over the existing structure.

**Looking south at 2434**

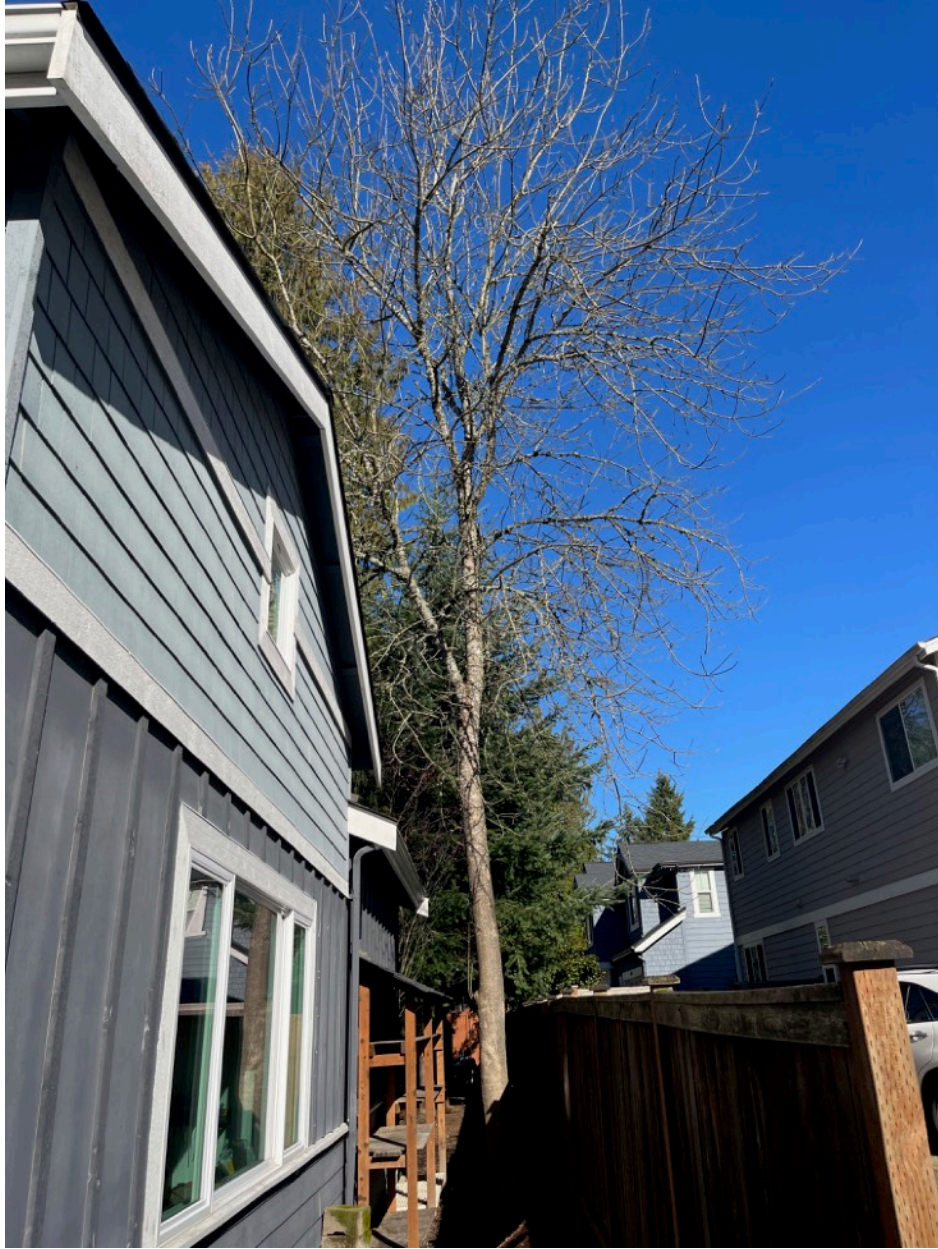
**Looking north at 2434**

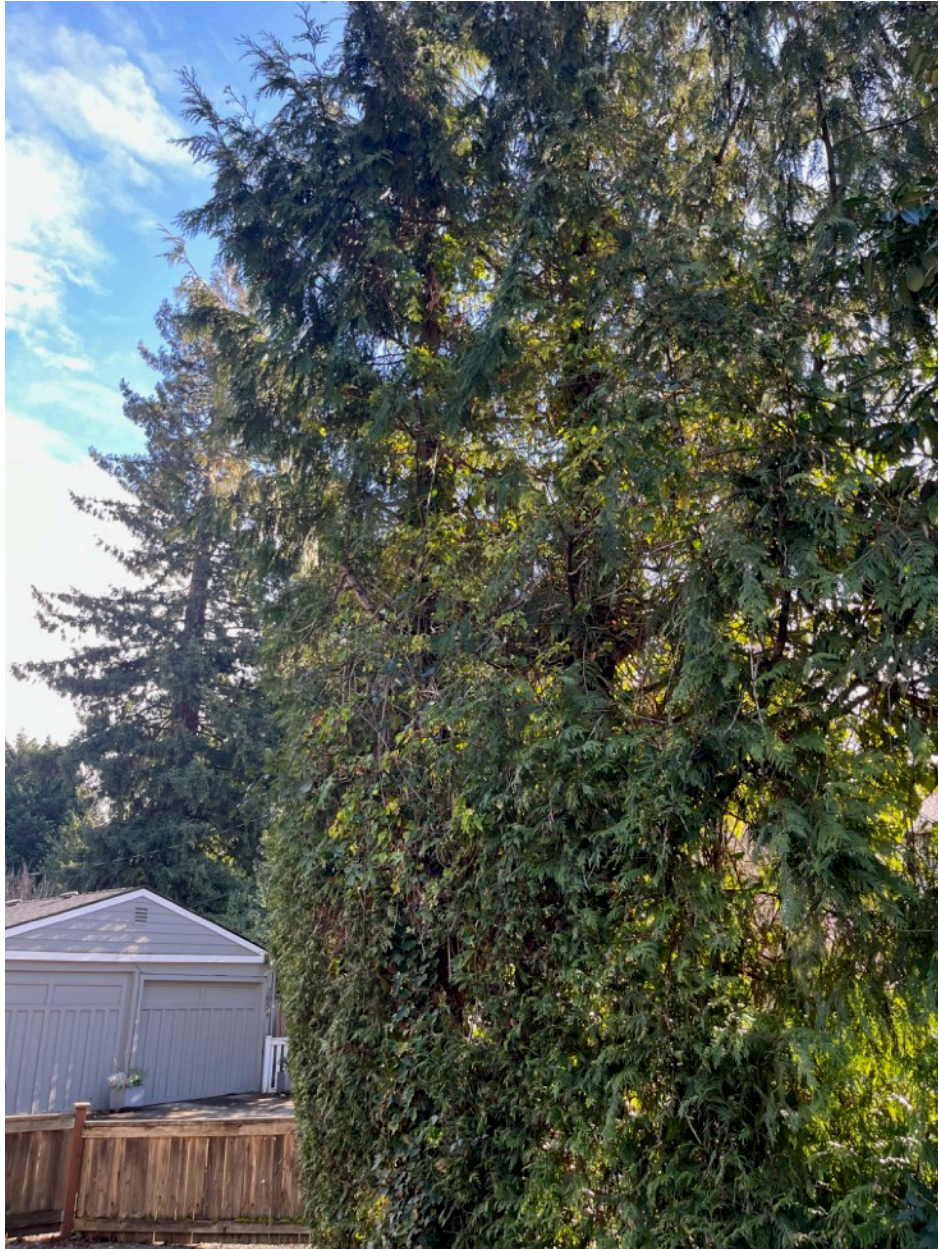
At the southeast corner of the lot there is a two stem Western Red Cedar that is part of a hedge that lines the southern property line that is comprised of multiple species.

**2435 is buried in the hedge**

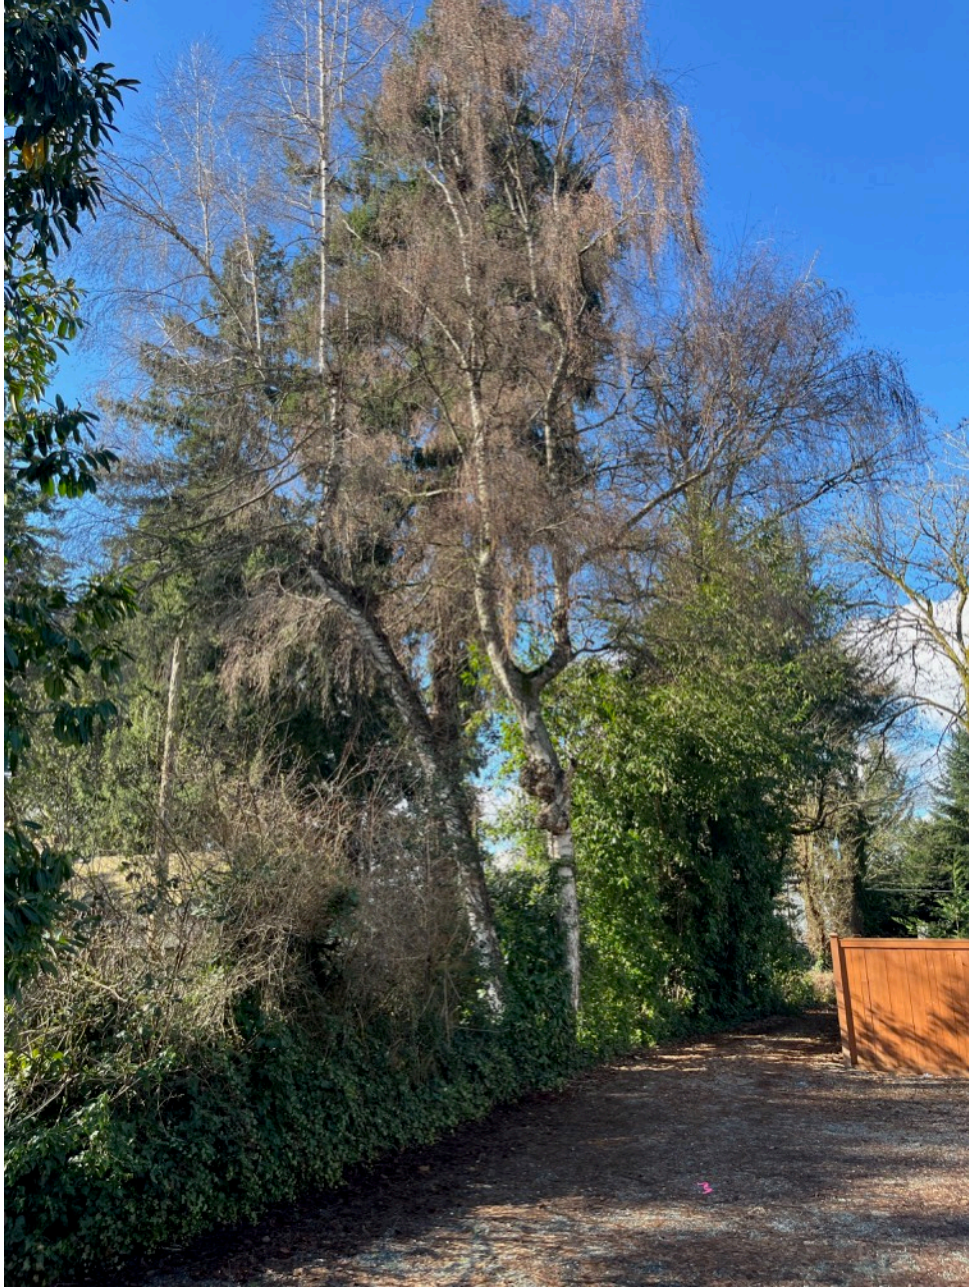
Both of the European White Birch (*Betula pendula*) that are on the south property line are struggling with an infestation of the Bronze Birch Borer and have significant defects in their upper canopies. On the survey map that I was provided, the two birch trees are portrayed as one specimen. These two trees are separated by several feet at the bases and are two distinct systems.

**Looking SW at 2436 and 2437 (distinct trees)**

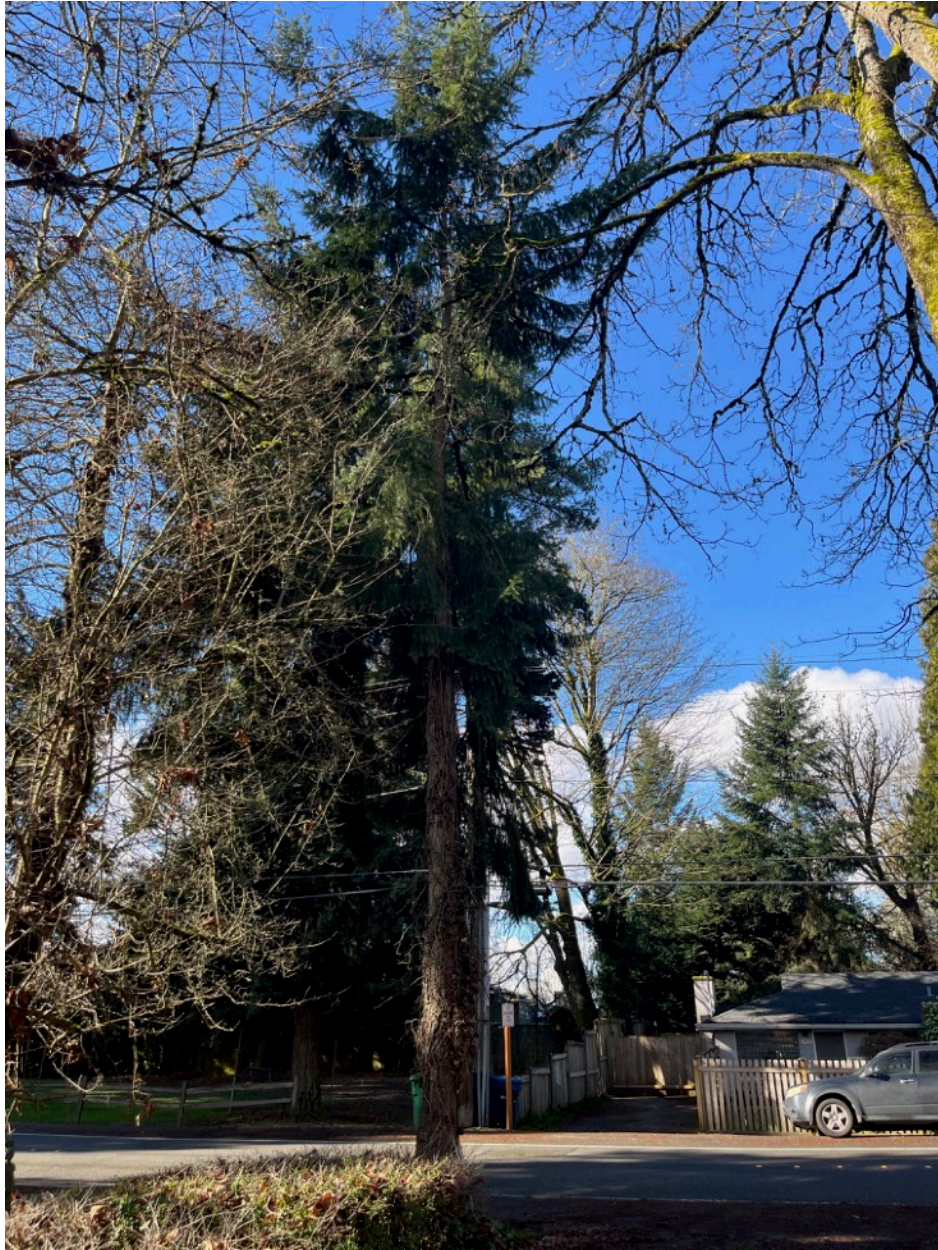
**Looking SW at 2441**

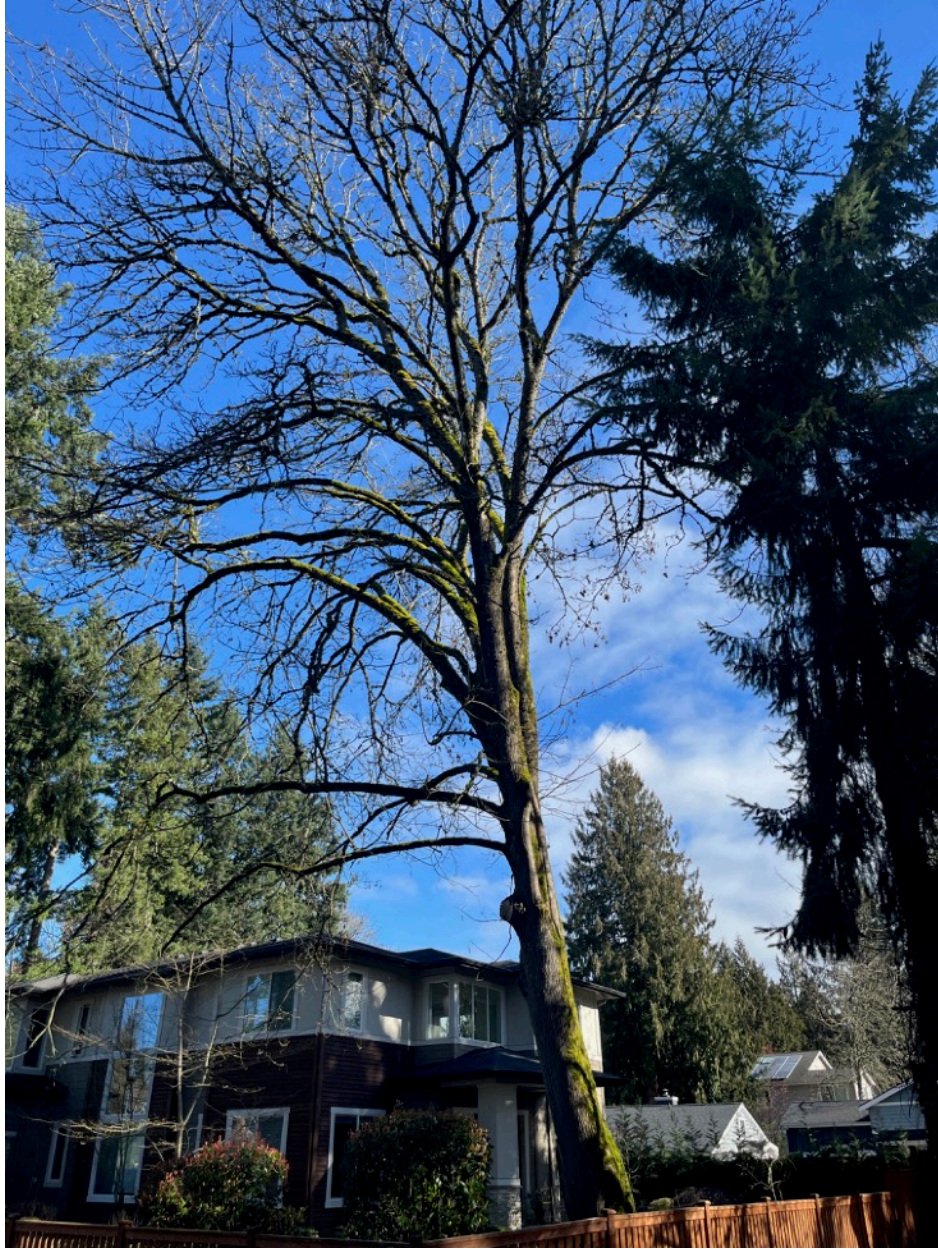
Just north of the driveway entrance is a large specimen of Big Leaf Maple (*Acer macrophyllum*) on one of the neighboring sites that is in excellent condition.

**Looking NE at 2442**

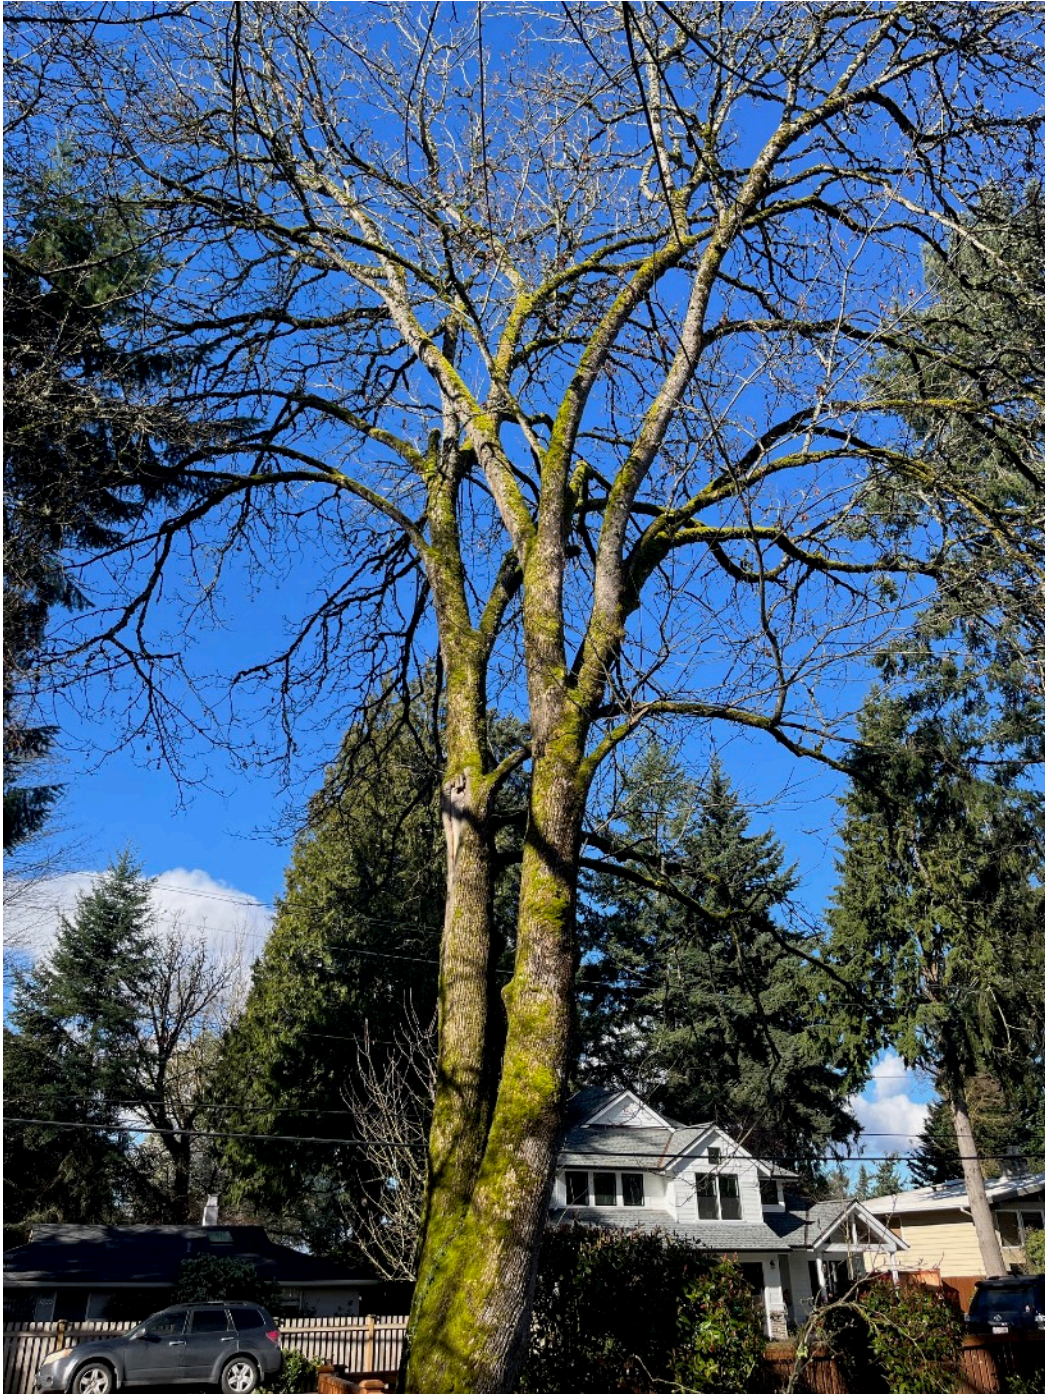
**Looking west at 2442**
