## LEVEL 1 DOWNSTREAM ANALYSIS

Wu / Chang Residence  
2956 72<sup>nd</sup> Avenue SE  
Mercer Island, WA 98040

Tax Map #531510-0744  
March 7, 2024  
CES #2094

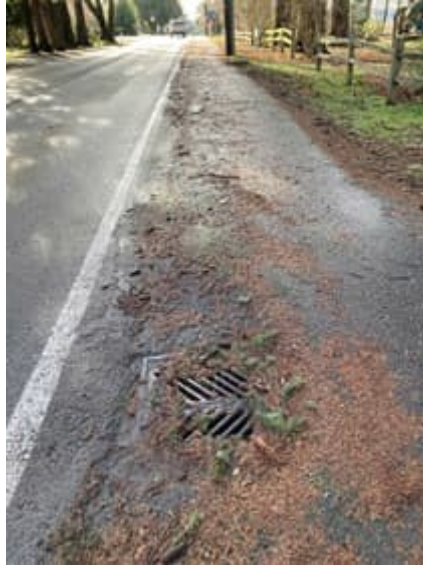
**Picture 1:**

West side of 72<sup>nd</sup> Ave SE at northeast First Hill Park; looking south  
Project proposes to connect into the storm pipe just upstream from here.

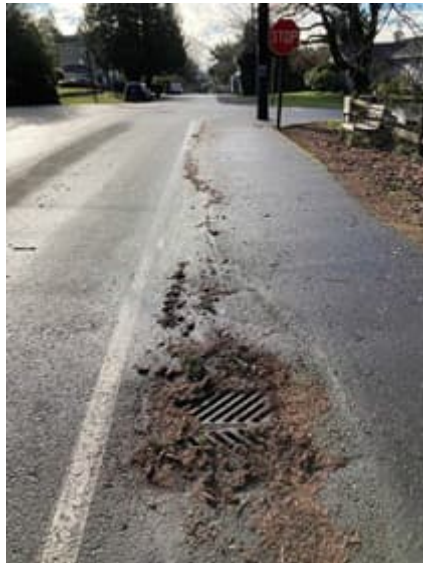
**Picture 2:**

West side of 72<sup>nd</sup> Ave SE at southeast First Hill Park; looking south  
Stormwater continues south in a 12" storm pipe.

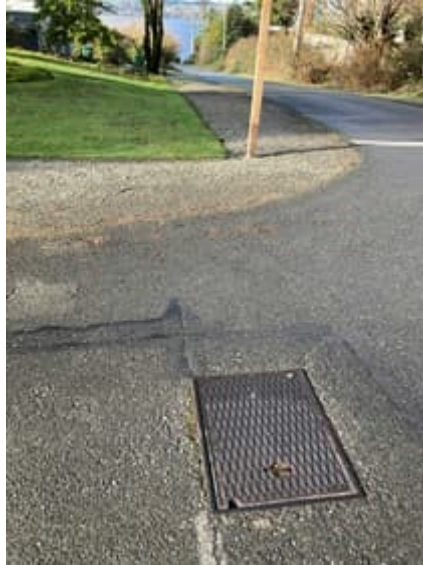
**Picture 3:**

SW corner of 72<sup>nd</sup> Avenue SE and SE 32<sup>nd</sup> Street; looking west  
Stormwater pipe turns 90 degrees at CB below and discharges toward the west.

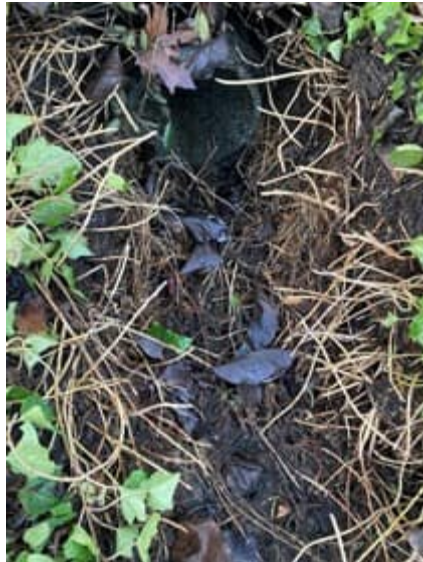
**Picture 4:**

South ROW in front of 7103 SE 32<sup>nd</sup> Street; looking east (upstream)  
Stormwater coming out of a culvert.

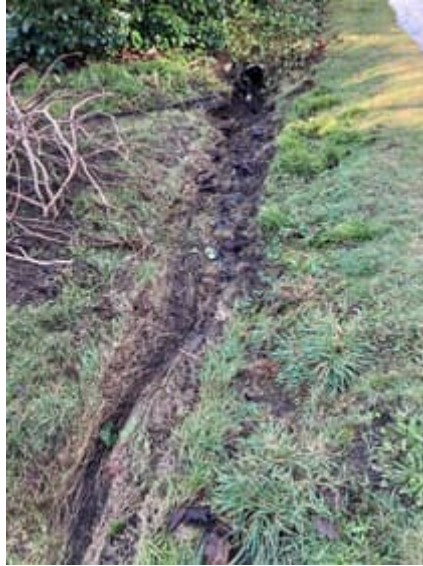
**Picture 5:**  
South ROW in front of 7103 SE 32<sup>nd</sup> Street garden; looking west (downstream)

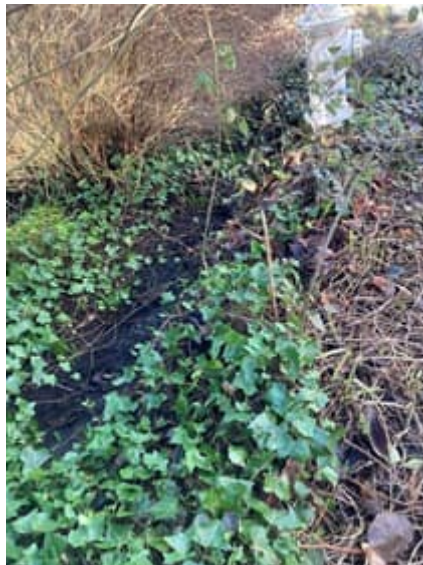
**Picture 6:**  
South ROW in front of 7103 SE 32<sup>nd</sup> Street garden; looking west (downstream)  
This is the next ditch in line. Looks good.

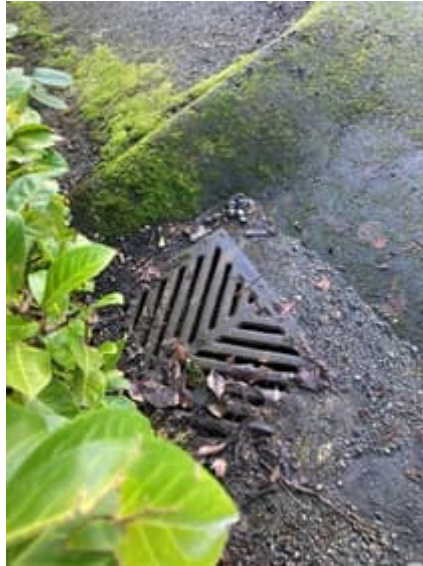
**Picture 7:**

South ROW in front of 7015 SE 32<sup>nd</sup> Street; looking NW  
From here the storm pipe crosses diagonally under SE 32<sup>nd</sup> Street toward the northwest.

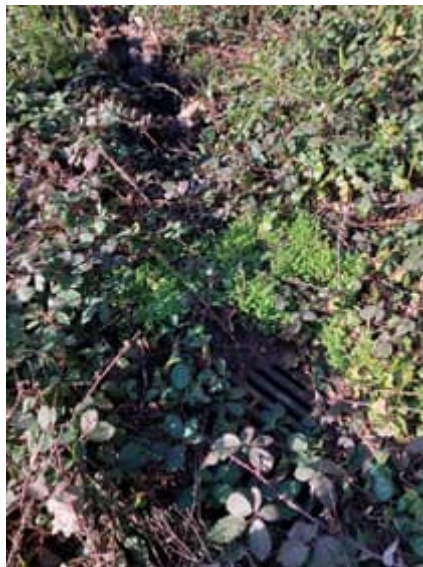
**Picture 8:**

North ROW along 3073 71<sup>st</sup> Avenue SE; looking west  
From here the stormwater discharges into a ditch.

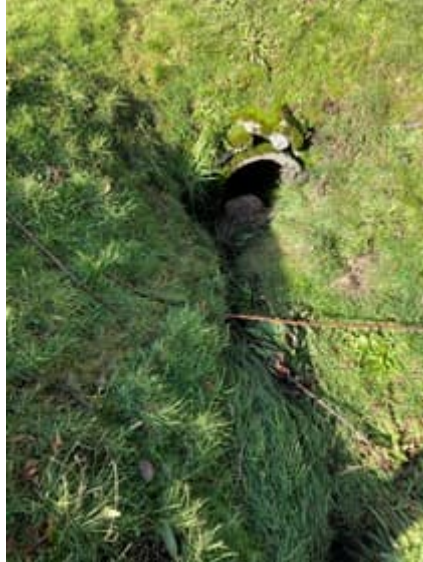
**Picture 9:**

North ROW between 3073 71<sup>st</sup> Avenue SE and 3062 70<sup>th</sup> Avenue SE (looking west)  
Note the rock right at the entrance to the pipe. It is probably doing a good job of slowing down the water entering the pipe.

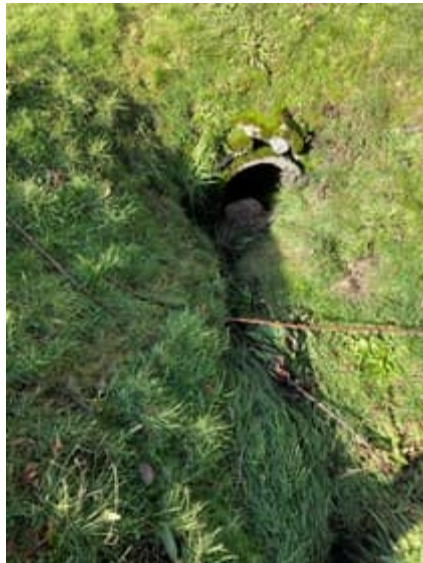
**Picture 10:**

North ROW between 3073 71<sup>st</sup> Avenue SE and 3062 70<sup>th</sup> Avenue SE (looking west)  
Note the rock right at the entrance to the pipe.

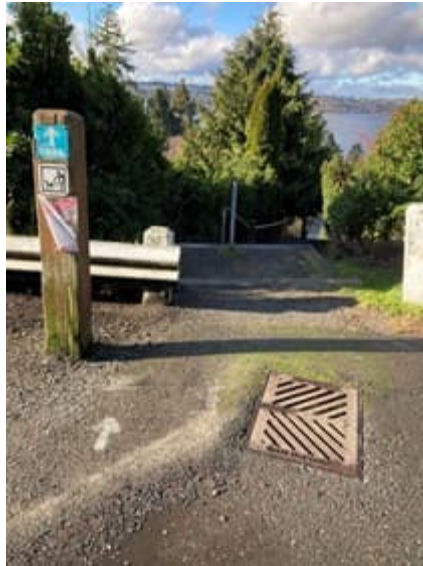
**Picture 11:**

Northwest corner of 70<sup>th</sup> Avenue SE and SE 32<sup>nd</sup> Street; top of trail (stairs)  
Here is the last stop before the hill. No flowing water was heard here.

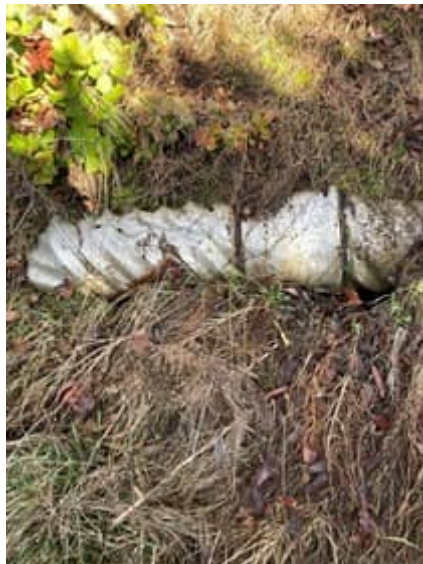
**Picture 12:**

Trail on the south side along 3075 70<sup>th</sup> Avenue SE; looking north  
The map says there is a catch basin along here but engineer could not locate. There is some exposed 12" metal pipe that definitely has water flowing along inside of it.

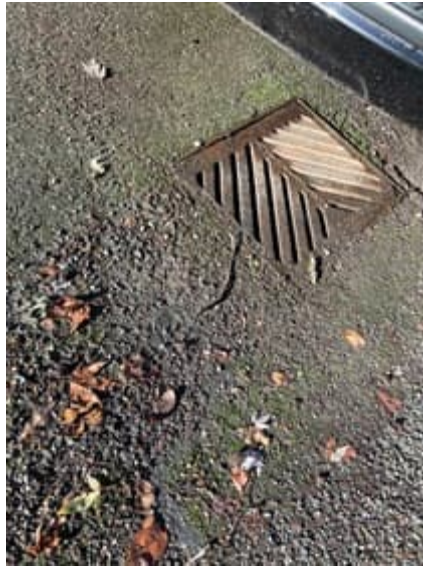
**Picture 13:**

Bottom of the stairs; NE corner of 69<sup>th</sup> Avenue SE and SE 32<sup>nd</sup> Street  
This is the catch basin at the bottom of the stairs.

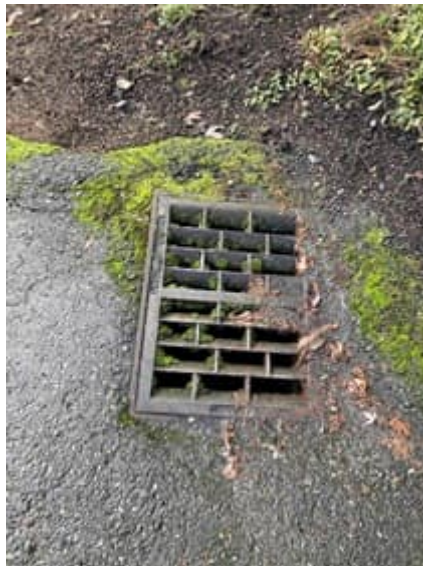
**Picture 14:**

NW corner of 69<sup>th</sup> Avenue SE and SE 32<sup>nd</sup> Street; looking west

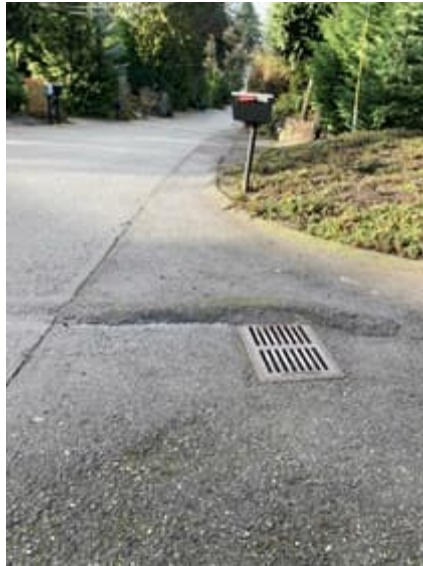
**Picture 15:**  
End of the driveway at 6824 SE 32<sup>nd</sup> Street

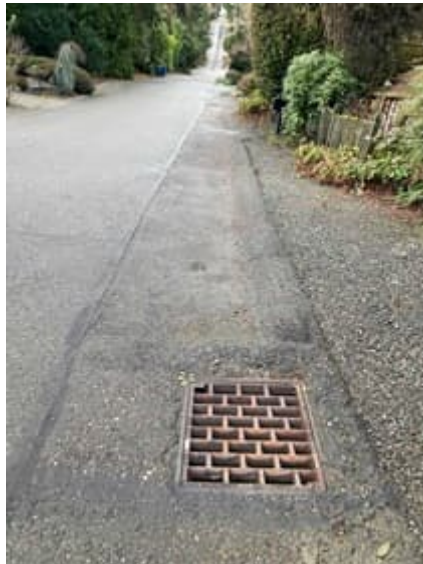
**Picture 16:**  
North ROW in front of 6824 SE 32<sup>nd</sup> Street (looking west)  
Type 2 catch basin. See the next two catch basins downstream of this one.

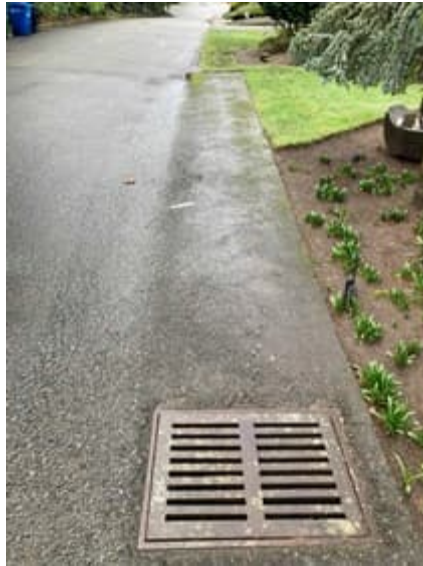
**Picture 17:**

North ROW in front of 3072 68<sup>th</sup> Avenue SE (looking west)  
The next two catch basins in line (2<sup>nd</sup> one is at the beginning of the curb).

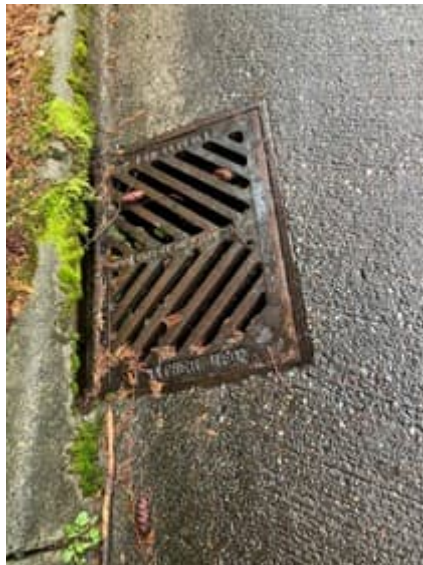
**Picture 18:**

Southeast corner of 68<sup>th</sup> Avenue SE and SE 32<sup>nd</sup> Street  
This is the first of a few catch basins with a flow-thru curb.

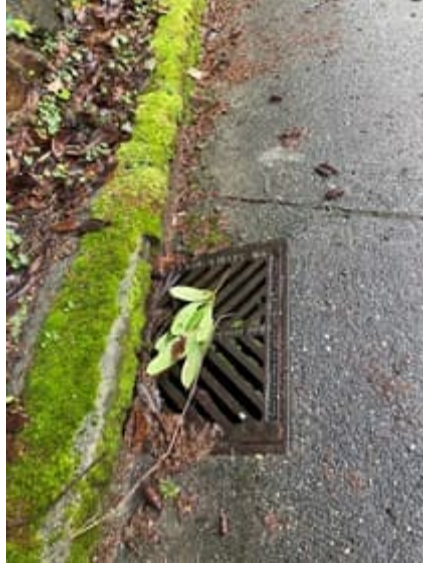
**Picture 19:**  
Southwest corner of 68<sup>th</sup> Avenue SE and SE 32<sup>nd</sup> Street

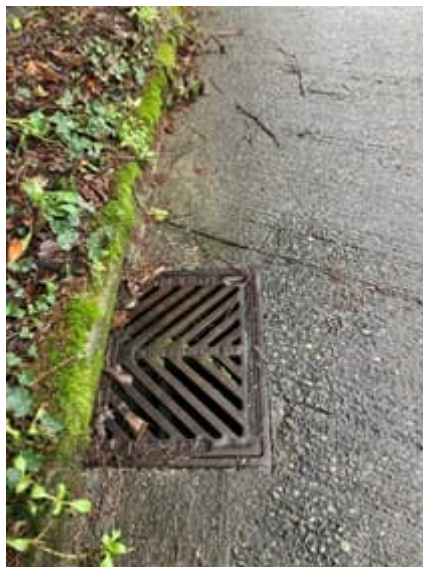
**Picture 20:**  
South ROW of SE 32<sup>nd</sup> Street in front of 3204 W. Mercer Way

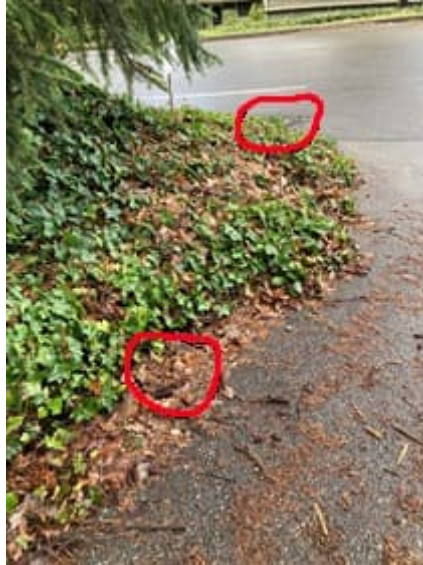
**Picture 21:**

Southeast corner of SE 32<sup>nd</sup> Street and W. Mercer Way (looking west)  
Stormwater rounds the corner here to drain toward the south to Lake Washington.
