DOWNSTREAM ANALYSIS
FOR
SINGLE FAMILY RESIDENCE
3008 70TH AVENEU SE
MERCER ISLAND, WA 98040

March 10, 2024

C2MY Engineers, LLC
P.O. Box 52883
Bellevue, WA 98015-2883
Contact: Choomeng Chin
(206) 451-7856
cmchin.c2my@gmail.com

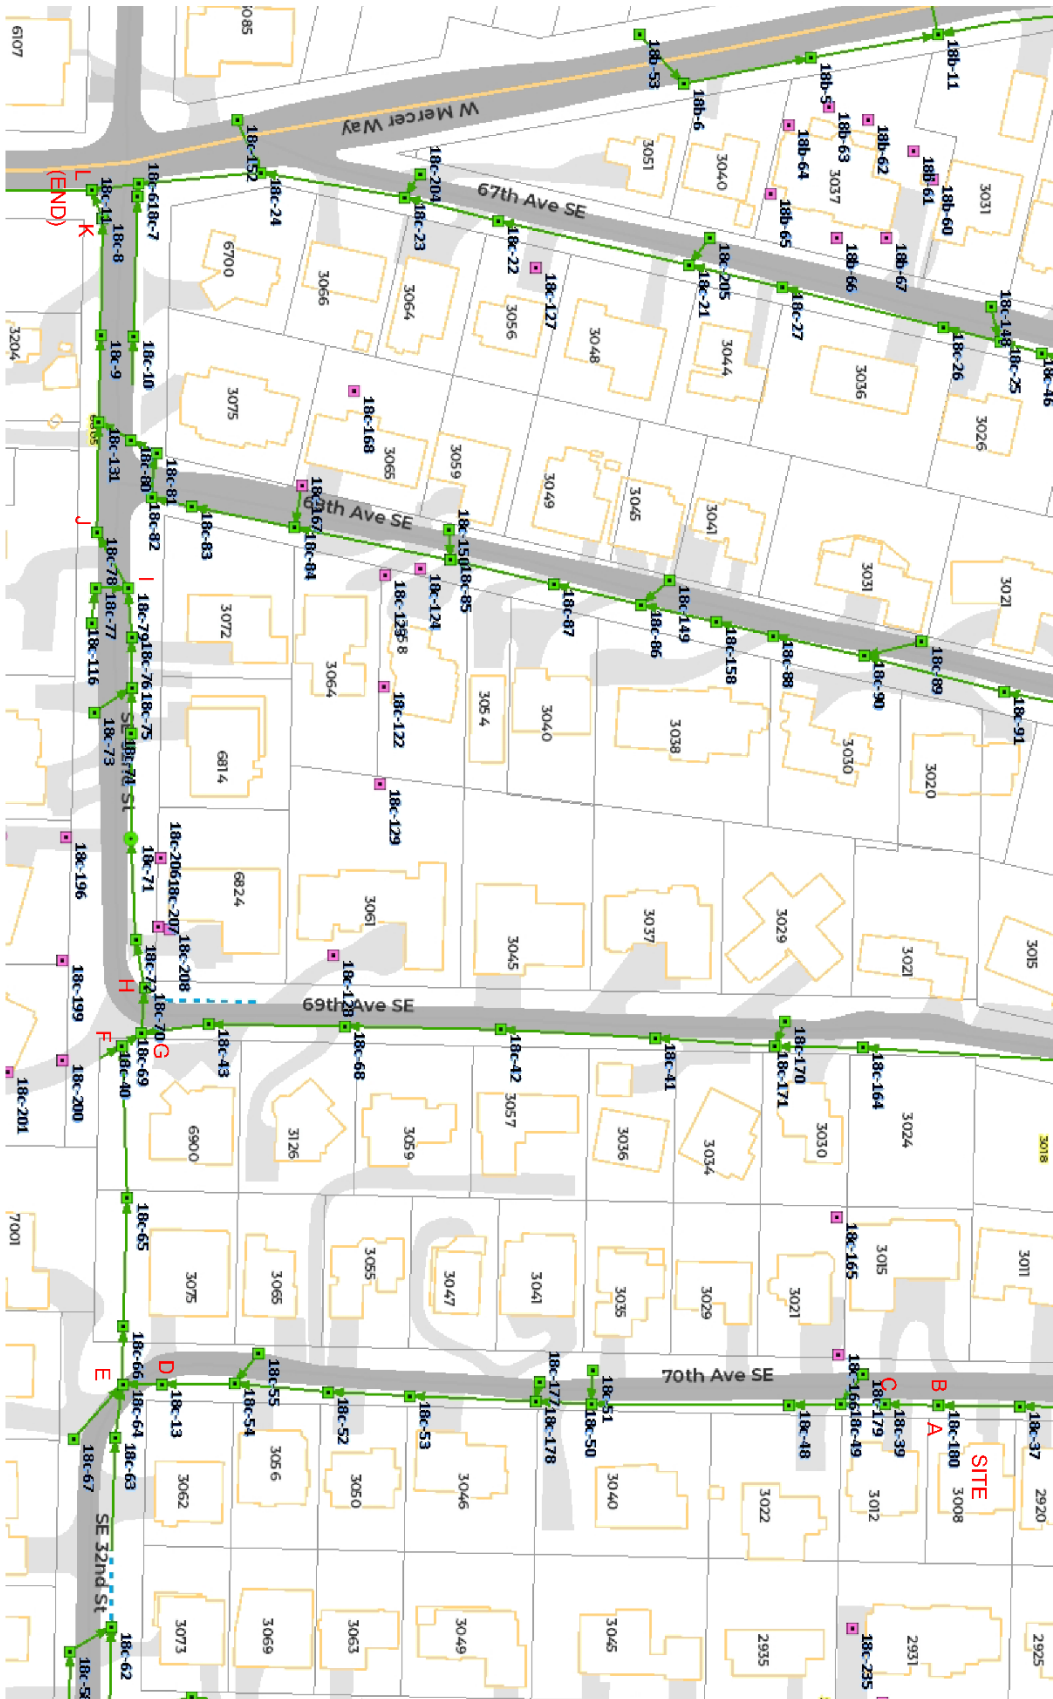
FIGURE 5: DOWNSTREAM MAP (NTS) ↻

- Presently, site runoff discharges at the west property line (**A**) to the street drainage system. Surface flow enters a CB (**B**) approximately 8 l.f. from the property line (See Figure 5, Downstream Map). It continues in a 12” DI pipe on the east edge of the street approximately 38 l.f. under the driveway to another CB (**C**). Then, it continues travels southerly through multiple catch basins at the same street side approximately 495 L.F. in the 12” pipes to another Type 1 CB (point **D**) with vaned grate located at the northeast corner of 70th Avenue SE and SE 32nd Street intersection. From here, it crosses under the street to the south west side to another Type 1 CB (**E**) at the edge of pavement , approximately 27 L.F. at the top of the trail. It then continues westerly along a trail through 2 more catch basins but are not visible on site approximately 230 l.f. to another Type 1 CB (**F**) located at the each of private driveway, end of trail. At this point, it flows northwesterly for approximately 15 l.f. to yet another catch basin (**G**) located at the east edge of 69th Avenue SE and SE 32nd Street intersection. Then, it travels in the 12” pipe crossing 69th Avenue SE approximately 30 l.f. to a catch basin (**H**) located on the west side of the street or northwest corner of the intersection. From here, it continues on the north side of SE 32nd Street through 5 more catch basins approximately 275 l.f. in the 12” pipe to another Type 1 CB (**I**). It then continues down slope crossing under the concrete pavement southwesterly direction approximately 45 l.f. to another Type 1 CB (**J**) located

on the south side of the same street. Runoff continues westerly on the same side of the street approximately 215 l.f. through 2 more catch basins to another Type 1 CB (**K**) located at the south side of SE 32nd Street near the intersection of W Mercer Way. From here it continues for another 22 l.f. to another Type 1 CB (**L**) located at the southeast intersection of W Mercer Way where the analysis is terminated for a total approximately distance of 1,400 l.f. During the downstream drainage field visit, no drainage issues were observed and no areas of any existing or potential major drainage problems were apparent.

The down stream drainage system as described above is not prone to stream bank erosion, siltation, and slide and does not threaten destruction of aquatic habitats. Catch basins as observed are mostly clean and sediment in the catch basins are below the invert of the outlet pipes. No open ditch existed along the route. Due to the fairly steep slope of the analysis route, the conveyance pipes system does not appear to have a capacity problem or show any sign of overtopping in any of the structure.

No off-site mitigation is necessary as there are no observed major drainage issues during the analysis for the downstream portion and runoff discharges from this site will be very minimal to downstream system.

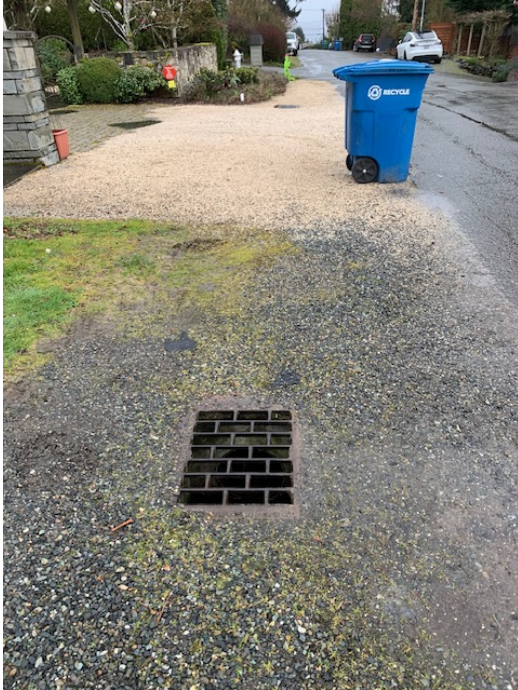
Catch Basin – At point B, Looking Downstream

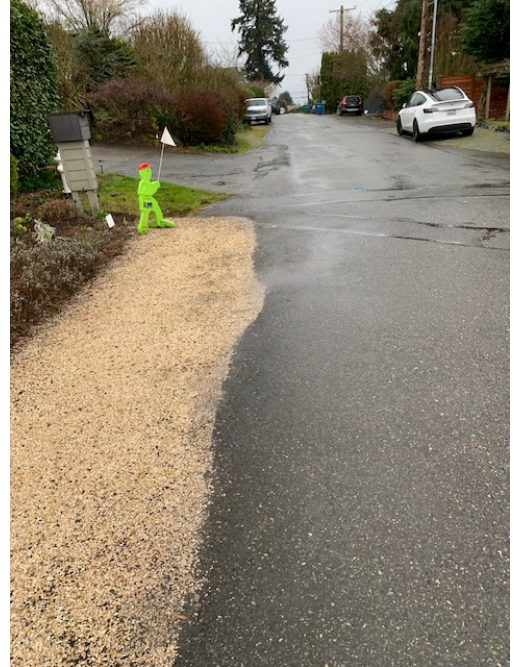
Looking Downstream from Catch Basin – At Point C

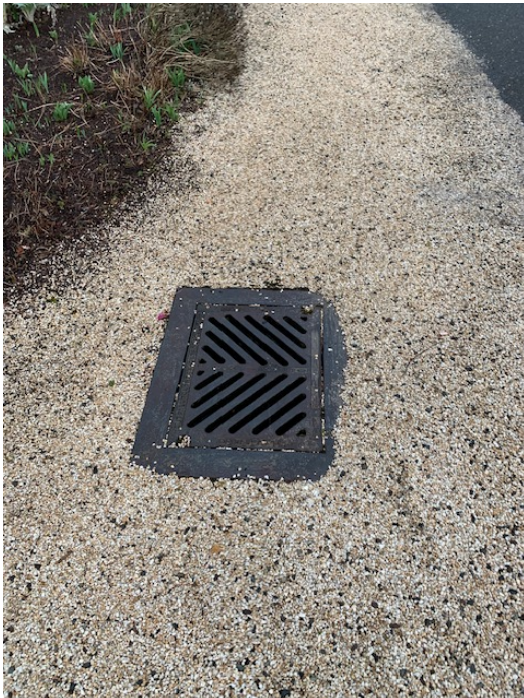
Catch Basin – At Point C

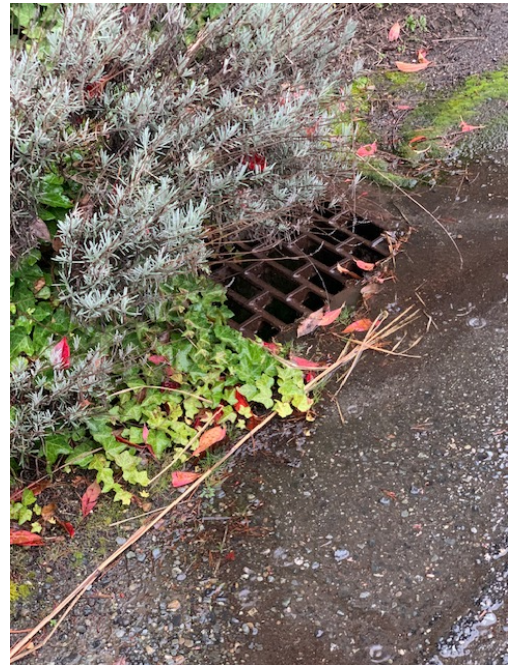
Near intersection East Edge Catch Basin – Point D

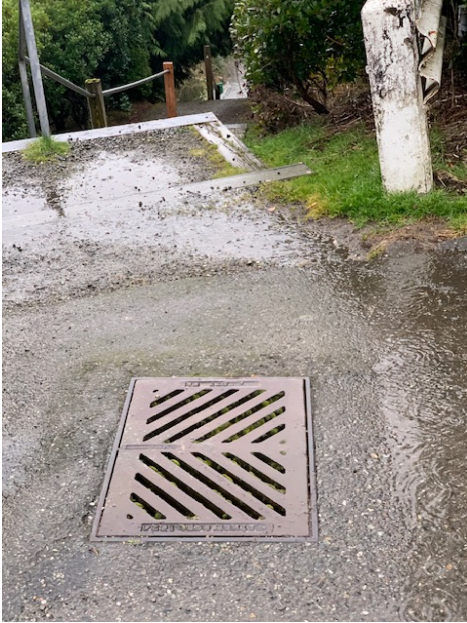
Catch Basin – Point E Top of Trail

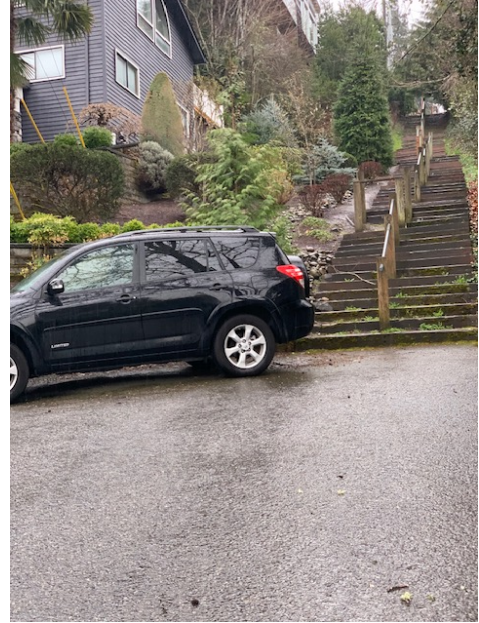
Catch Basin under Car at Point F at end of trail

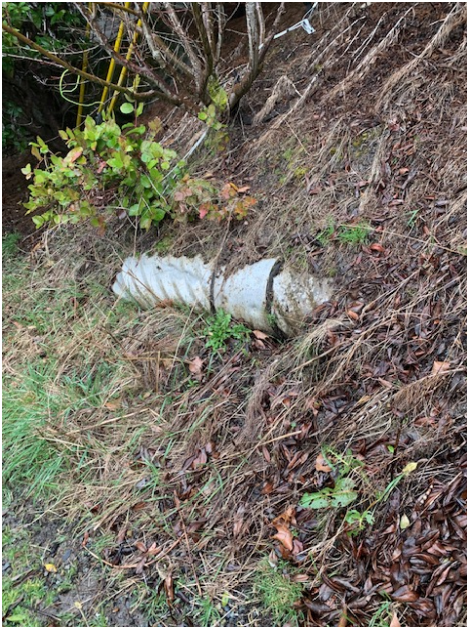
Exposed pipe next to trail near top of trail Point E, no joint leaking

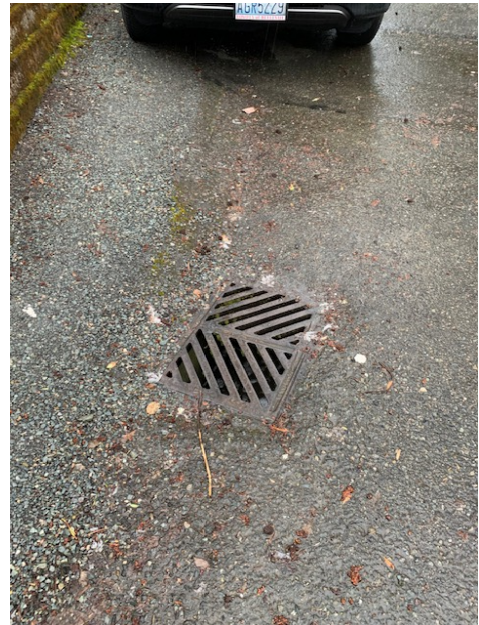
Cath Basin at Point G near end of trail

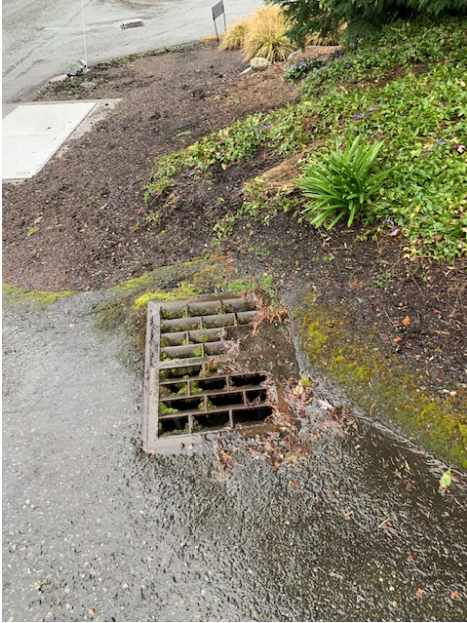
Catch Basin Point H - West of 69th Ave
SE at intersection - Looking West

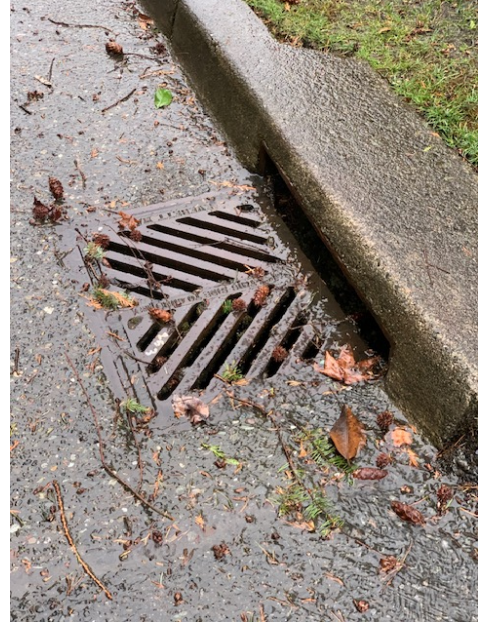
Catch Basin along Noth side of SE 32nd
Street, At Point I

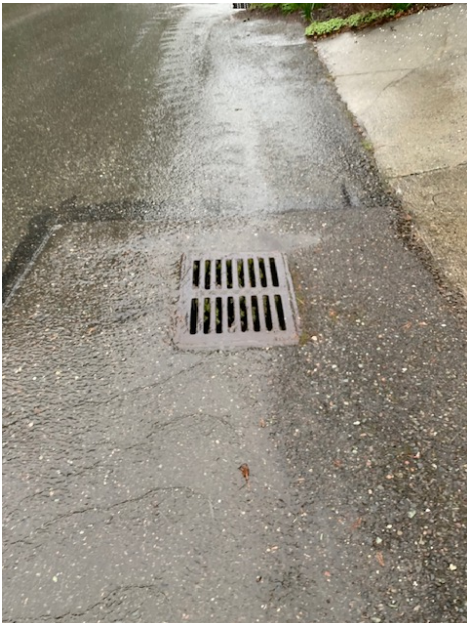
Catch Basin along Noth side of SE 32nd
Street, Downstream of Point H

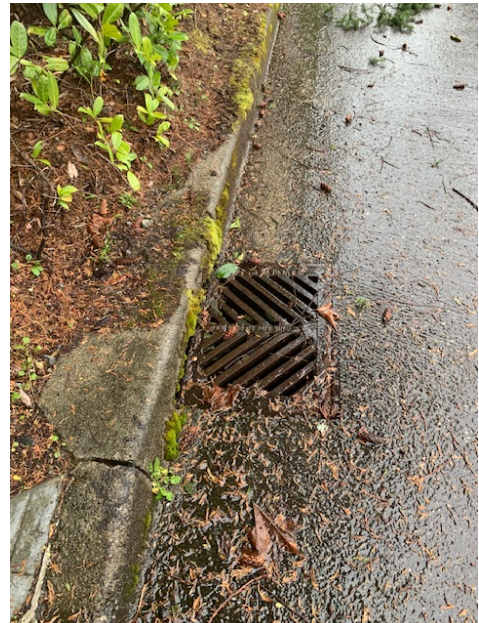
Catch Basin along Noth side of SE 32nd
Street, At Point J

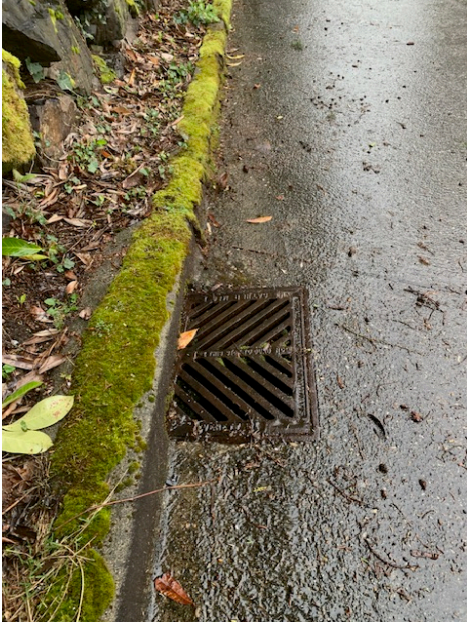
Catch Basin along South Side of SE 32nd Street, Downstream of Point J

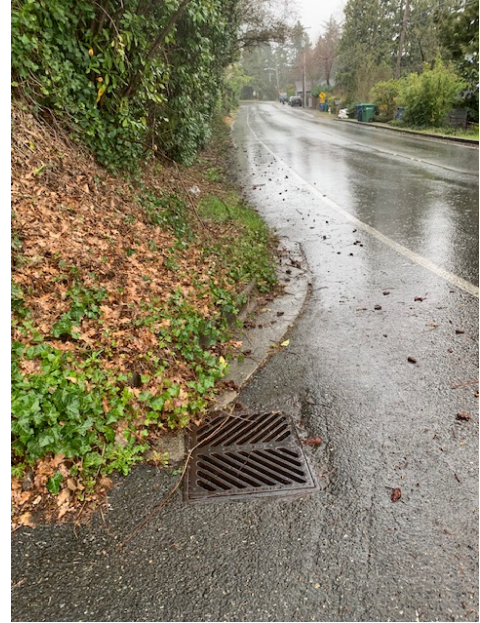
Catch Basin At Eath side of W Mercer Way, At Point L. End of Analysis Looking Downstream

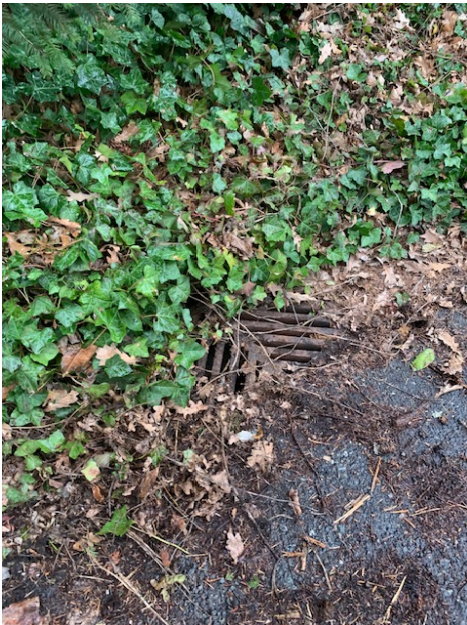
Catch Basin at South Side of SE 32nd Street, At Point K
