Arborist Report

Site: 4332 W Mercer Way, Mercer Island, WA, 98040

Re: Tree Inventory and Assessment

Date: May 9, 2024

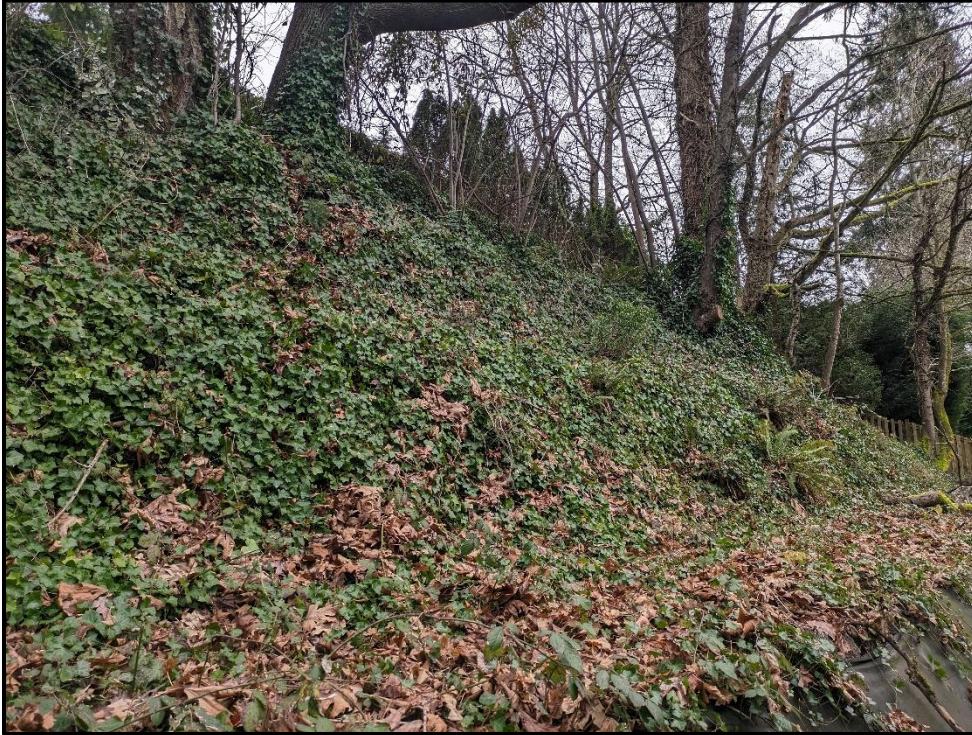
The slope on the eastern boundary of the site had extensive invasive ivy (*Hedera spp.*) that was growing at the base and on the trunk of several of the trees. The combination of the ivy and the steep slope limited my assessment. The ivy should be removed so I can reassess the base of trees prior to construction (Photo 1). Once ivy is removed, I recommend establishing erosion control measures such as jute matts, straw waddles, and planting.

Photo 1. View of the base of trees along the eastern boundary of the site. I observed extensive ivy at the base of these trees and I recommend the ivy is removed prior to construction and for the base of the trees to be reassessed.

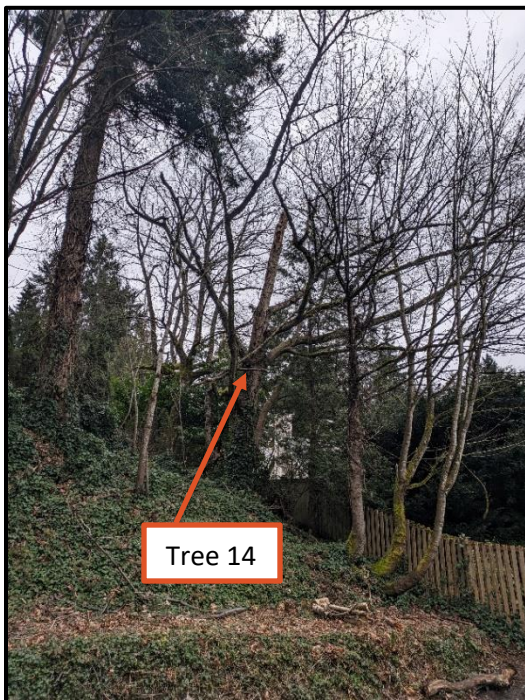
Tree 14 is a 31-inch red alder (*Alnus rubra*) tree that I observed to be in poor health and structural condition. The tree has a dead top that extends 25 feet down the trunk and is in decline. It is a poor candidate for retention (Photo 2). I recommend the dead top is removed prior to construction to mitigate risk to any new targets.

Photo 2. Tree 14 indicated above is a red alder in declining condition and is not a good candidate for long term retention. I recommend the tree is reduced to a wildlife snag.

- Remove wires on trees 38, 39, and 40 to improve the long-term health function of the trees.
- Manage tree 14, which is in poor condition, prior to construction to mitigate risk.

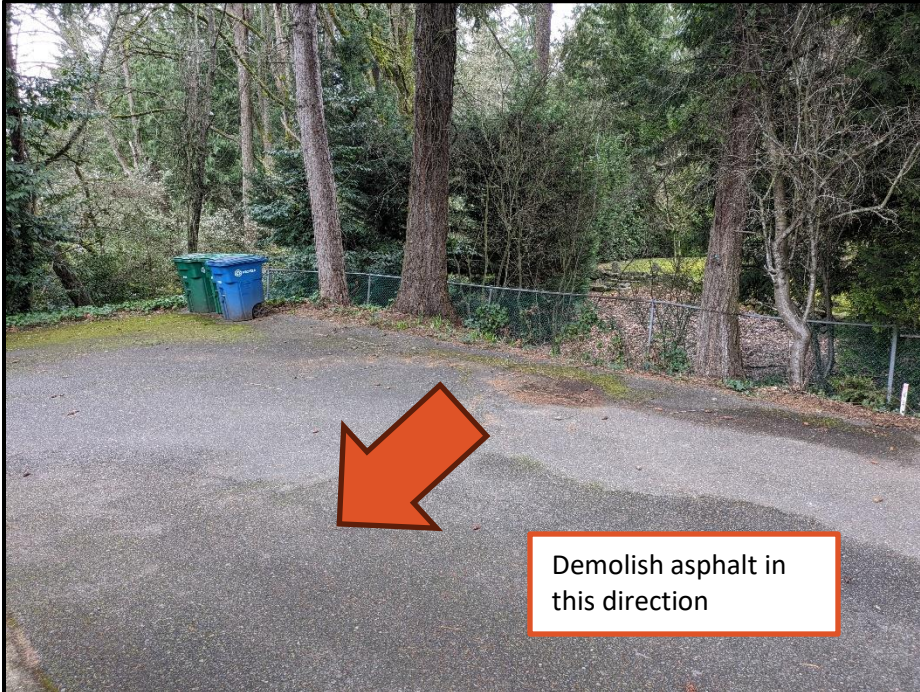
I recommend tree protection is set at the existing hardscape for all trees adjacent to the driveway prior to construction. This includes trees 1, 19, 20, 21, 28, 29, 32, 33, 37, 38, 39, 40. Demolition of the driveway is proposed within the RLOD of trees 1, 38, 39, 40.

Photo 4. Base of tree 38 viewed from the south. The driveway is proposed for removal in this area. I recommend the asphalt removal begins closest to the tree and moves backwards. Once the pavement is removed no machinery traffic or materials are allowed. I recommend the project arborist is called if any large roots over 2-inches diameter are encountered.

Project arborist should be present during driveway demolition to ensure no damage occurs to tree roots. The asphalt should be removed closest to the trees and the machinery should work backwards or south of the trees (Photo 4). No machinery traffic is allowed across exposed soil. No materials may be stored on the uncovered soil once the asphalt is removed.

Once demolition is completed I recommend tree protection fencing for trees 1, 37, 38, 39, and 40 to be set at the new hardscape limits. I recommend a 4-inch layer of arborist woodchip mulch to be spread over the uncovered area immediately. This will both provide a visual indicator of tree protection with the tree protection fencing and help mitigate any health impacts to the trees during demolition.

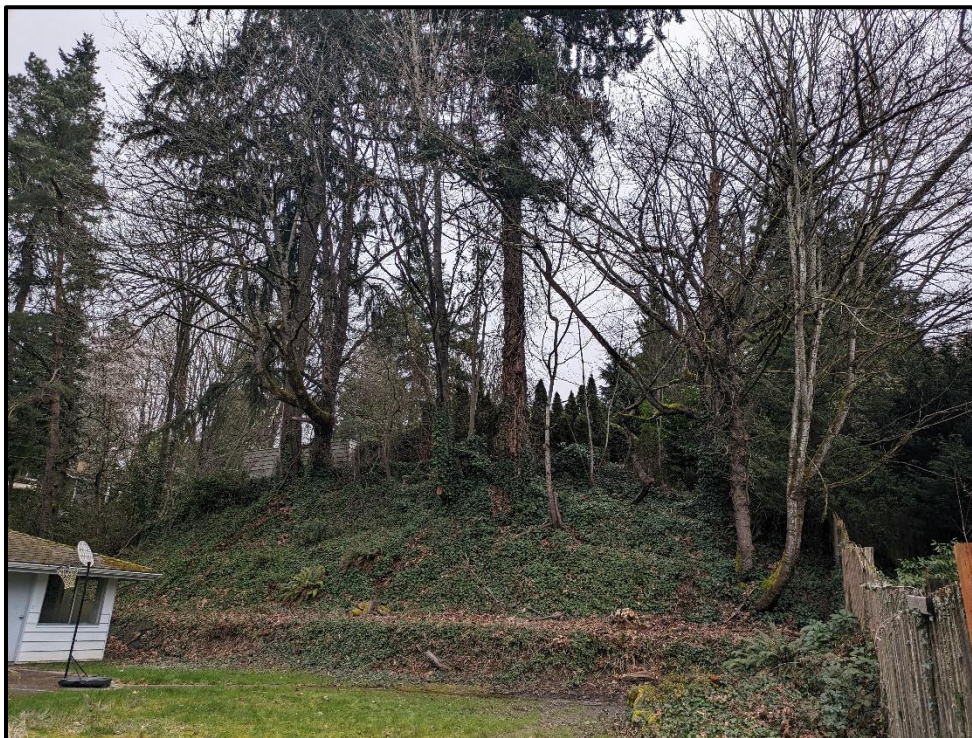
The plans propose the installation of a catchment wall on the east side of the property. The limits of disturbance to install the catchment wall are proposed within the RLOD of trees 10, 11, 12, 13, and 14 and within the MLOD of tree 13 (Photo 6).

Photo 6. View of trees 10, 11, 12, 13, 14, and 17 viewed from the west. A catchment wall is proposed within the RLOD of the subject trees and I recommend the footings for the walls are installed by hand or air excavation.

In discussion with the project team, I understand that the catchment wall is proposed to be constructed with a foundation of 2-inch pin piles with helical anchors. If impacts within the MLOD of tree 13 are limited to pin piles, I believe the wall can be constructed as proposed if the following measures are utilized within the RLOD of trees 10, 11, 12, 13, and 14:

- Tree protection fencing is set along the RLOD of trees 10, 11, 12, and 13 prior to any construction

- When construction of the catchment wall is to begin tree protection can be moved to the location shown on the TESC plan.
- No machinery is allowed within the RLOD of these trees without tree protection.
- Any excavation within the RLOD must be approved and monitored by the project arborist.
- Excavate the location of the pin piles either by hand or air-excavation with the arborist present to assess locations of roots and assess impacts to the trees.
