ARBORIST REPORT

April 6, 2024

8440 SE 82nd St Mercer Island, WA 98040 / Lot # 3625600120

Kim Ettari - ISA Certified Arborist PN1301A / TRAQ

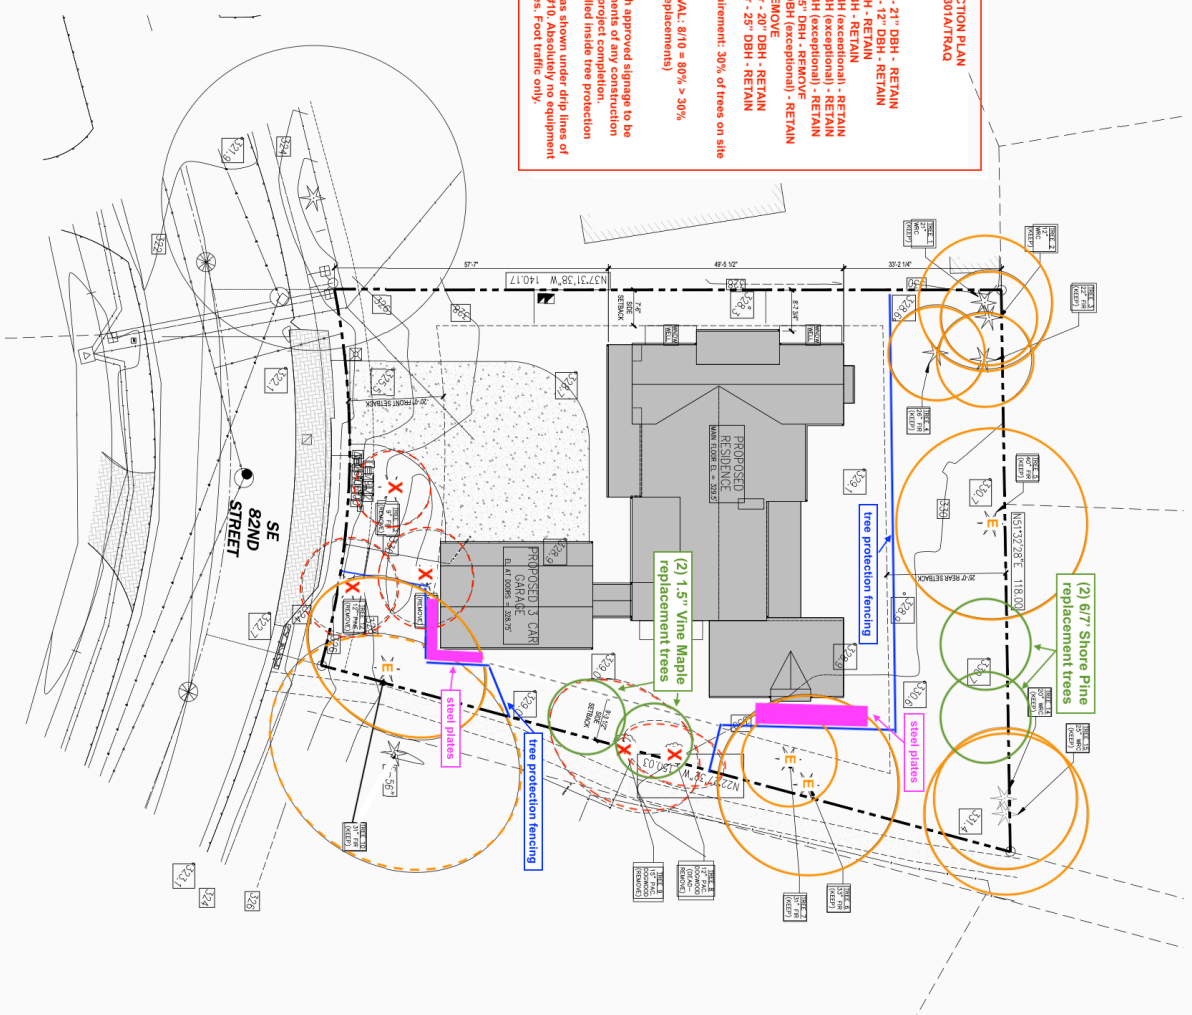
1 SITE PLAN
 SCALE: 1" = 10'-0"

TREE RETENTION & PROTECTION PLAN
 Kim Ehart - ISA Adaptor PN1301A17RAQ
 Landscaping Trees Landscapes

- ARBORIST NOTES:**
1. Tree protection fencing with approved signage to be installed prior to commencement of any construction.
 2. 3.4" bark mulch to be installed inside tree protection areas.
 3. Steel plates to be installed as shown under drip lines of exceptional Trees #s. #7 and #10. Absolutely no equipment traffic permitted on steel plates. Foot traffic only.
