Arborist Report and Inventory

March 19th, 2024

3029 62nd Ave SE
Mercer Island, Wa

Arborist notes for Aspen homes at 3029 62nd Ave. SE., Mercer Island Washington. Time of site visit: Thursday, March 14, 2024. 1:30 PM.

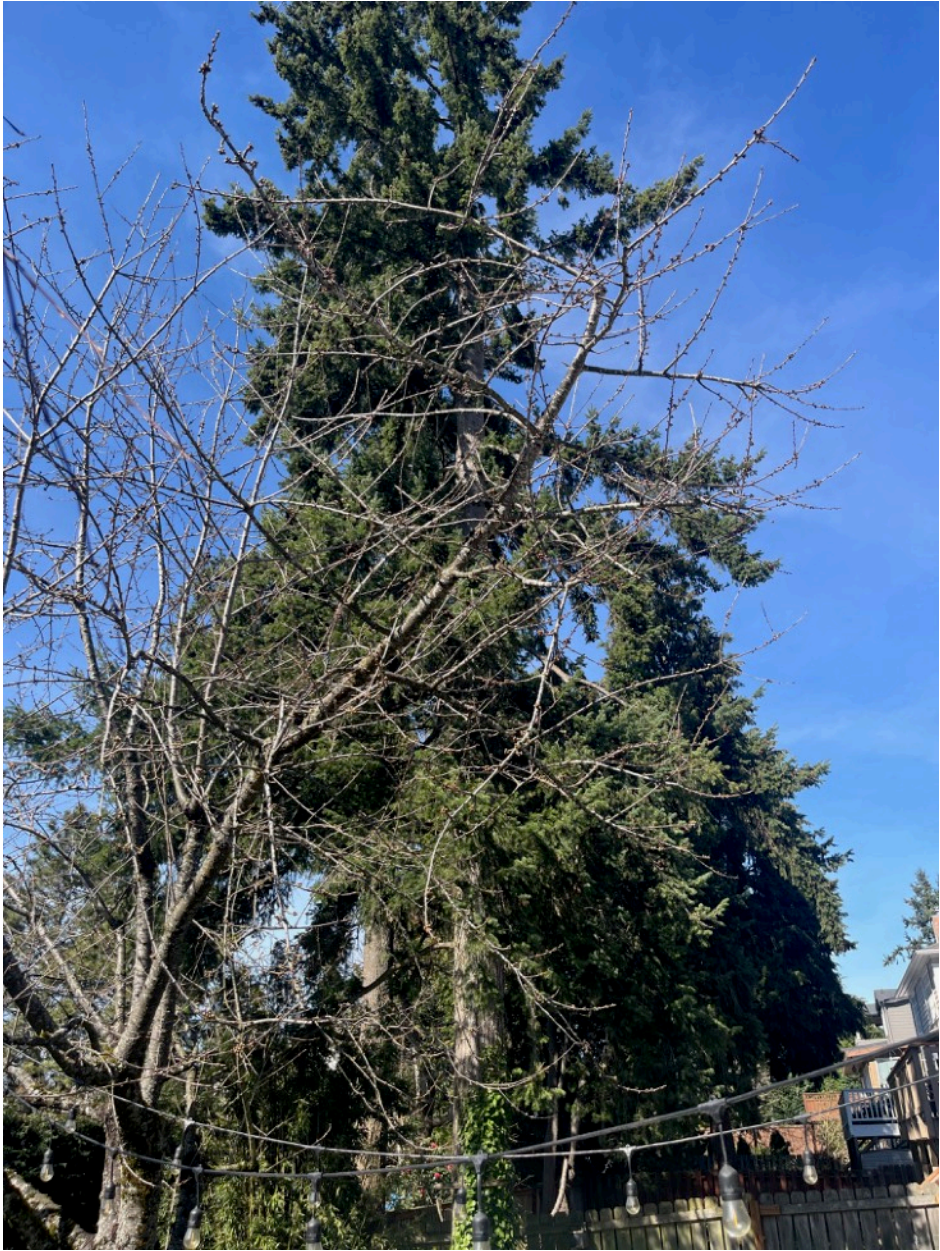
Tree #2477 On the north property line in the backyard there is a Douglas Fir (*Pseudotsuga mensiezii*) tree with excurrent structure and which is in good condition. This tree has a live crown ratio of approximately 80% and is not presenting any hazards, nor does it seem to be in need of any pruning at this time.

Looking north at 2477 (fir in the background)

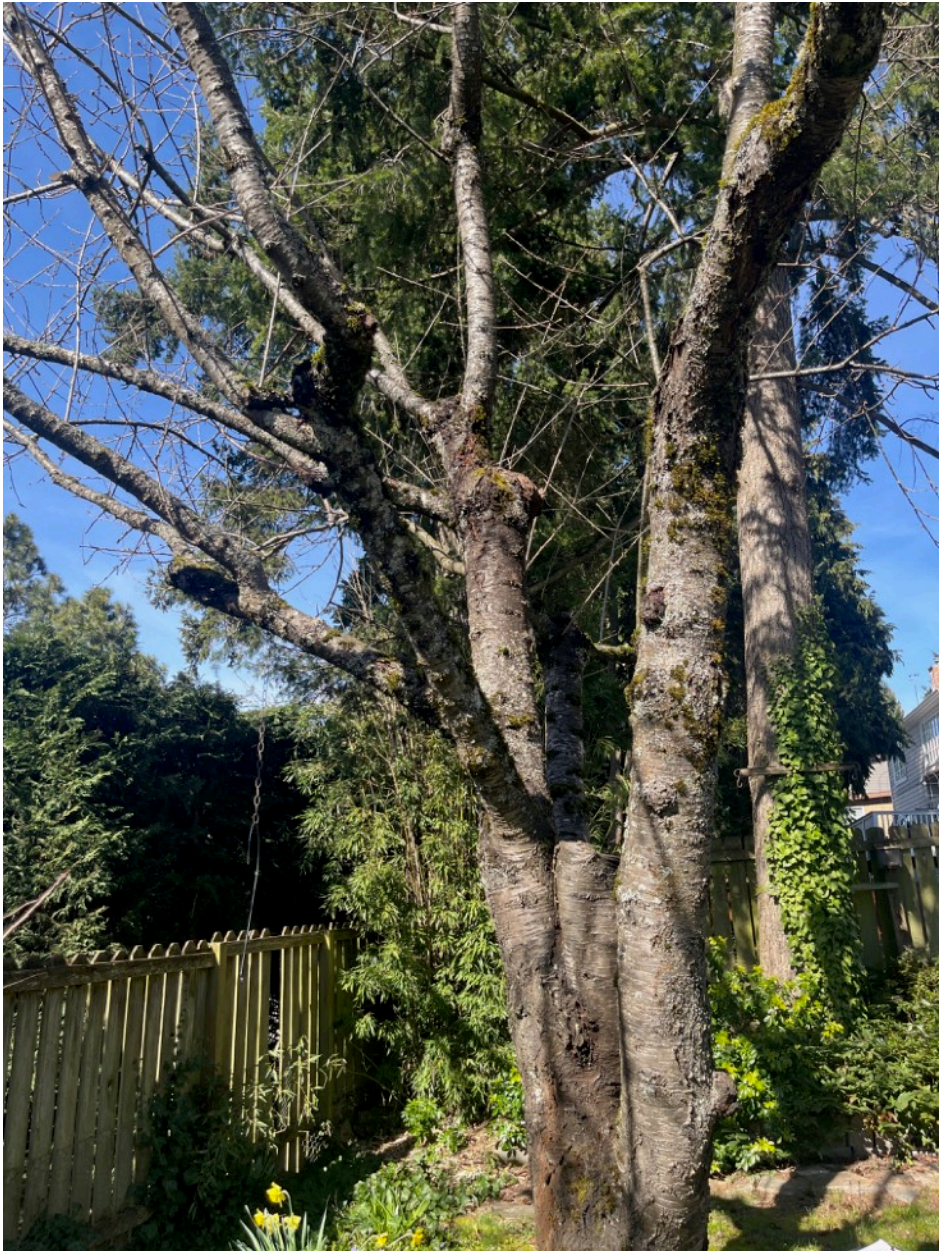
Tree #2478 Just to the south of the Douglas Fir tree is a decurrent (spread out canopy) specimen of Flowering Cherry (*Prunus* sp.) that is in fair condition. This tree seems to have been height reduced several times throughout its existence and there is apparent decay in the pedestal region as well as in the upper canopy of this tree. This tree is large enough to be considered Exceptional on Mercer Island and despite some of its defects, it is not presenting any hazards.

Looking north at the pedestal and structure of 2478

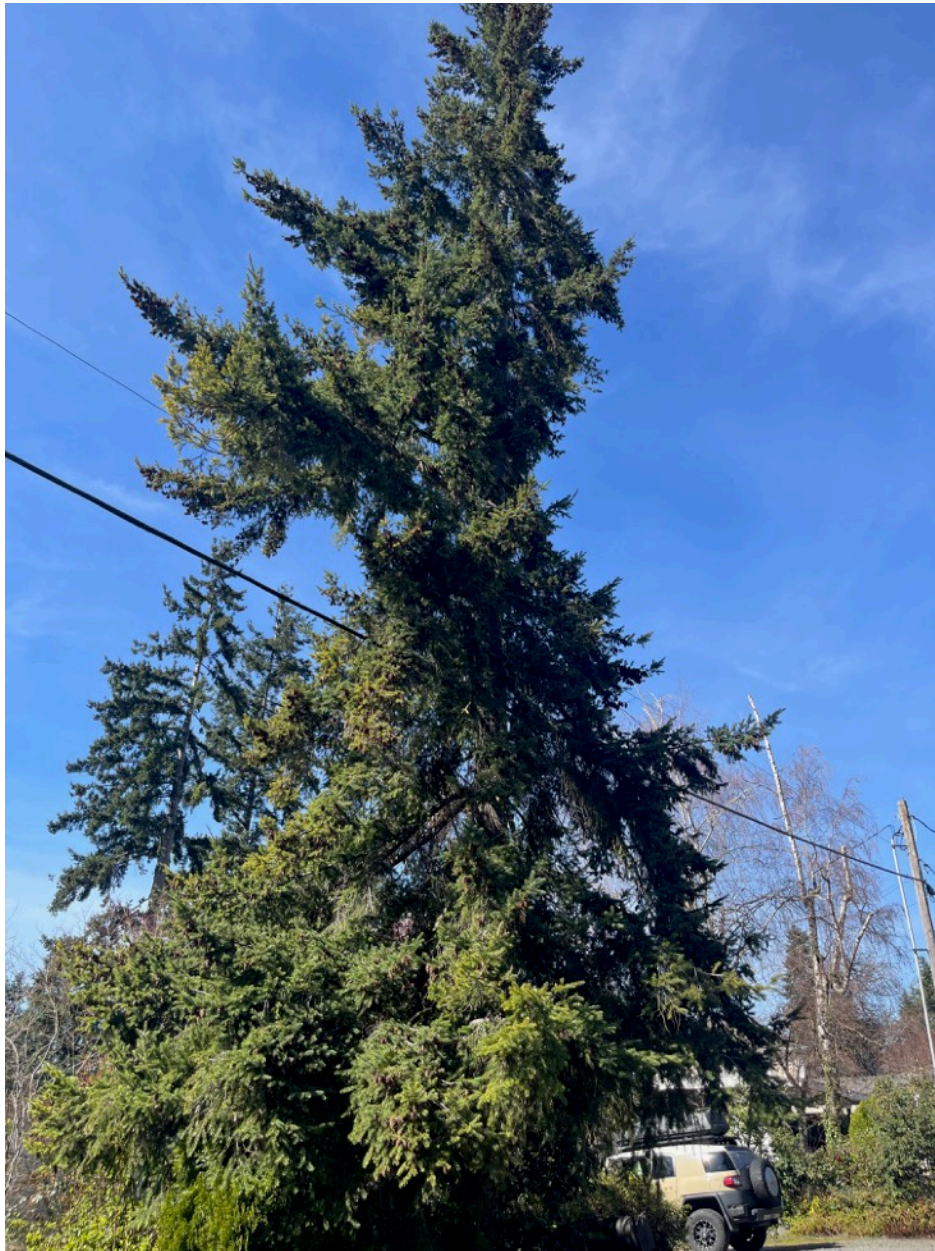
Tree #2479 Close to the southeast corner of this lot, on the east side of the fence that protects the front yard, is a specimen of Douglas Fir with an 18 inch diameter standard height. This tree also has excurrent structure and is in good condition. There are some communication and power lines that run through the low canopy of this tree. This tree is exposed to the prevailing winds and there are some areas on the trunk where it is apparent that limbs of broken off in the upper canopy.

Looking north at 2479 with the power lines running along the east side of the tree
