**ARBORIST REPORT
FOR
8383 & 8375 E Mercer Way
Mercer Island, WA**

September 3rd, 2014

The proposed 2-Lot short plat encompasses the properties located at 8383 & 8375 E Mercer Way. Our assignment is to prepare a written report on present tree conditions, which is to be filed with the short plat permit application.

Date of Field Examination: August 29th, 2014

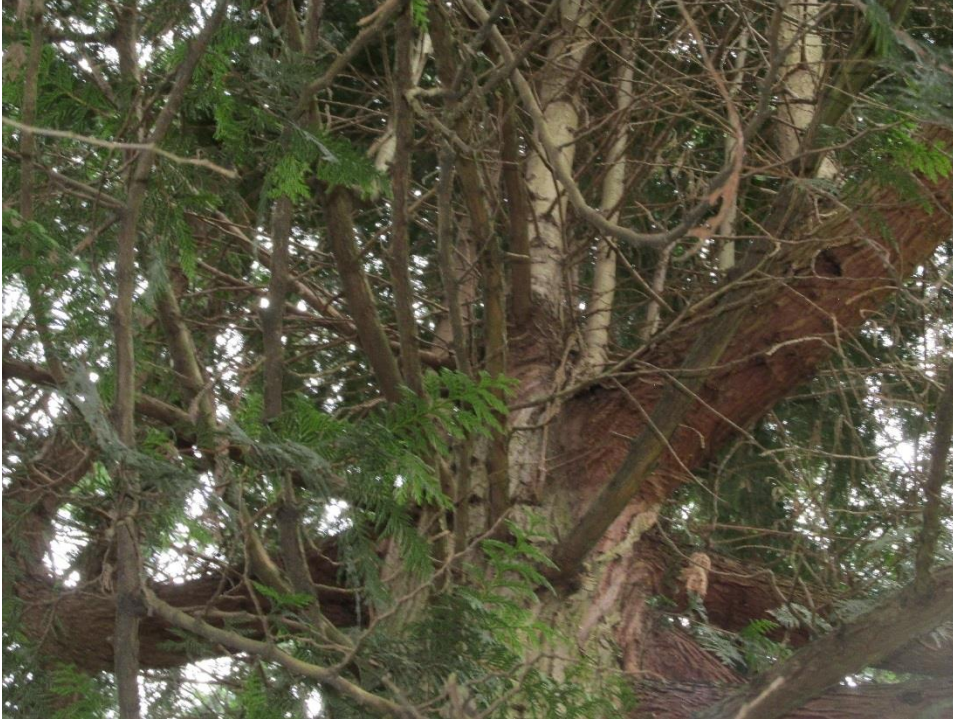
Tree #8538 and 422 are two 55' tall western red cedars on the west edge of 8383. Both trees were topped and now have multiple new leaders. These new leaders are weakly attached and prone to breaking. Both trees are in fair-poor condition and are borderline viable.

Tree #8538, western red cedar, previously topped, many new leaders

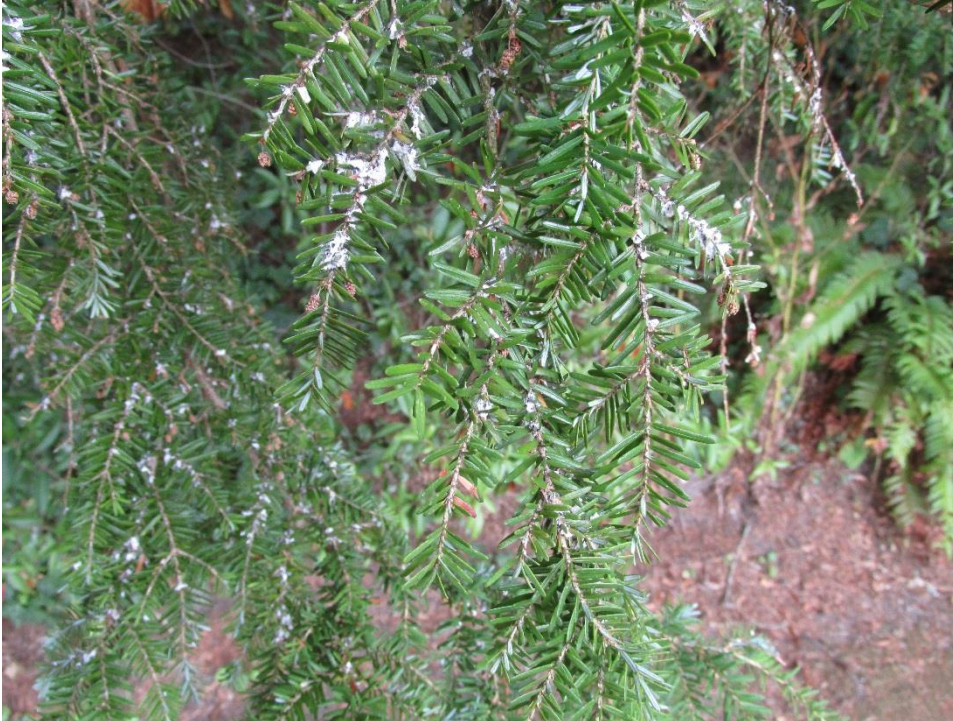
Tree #508 is a 22" dbh western hemlock. The subject tree is infected with a leaf defoliator, hemlock woolly adelgid. Hemlock woolly adelgid is not known to cause serious damage in western hemlocks. This tree has no other concerning defects and is in fair condition.

Tree #508, western hemlock with hemlock woolly adelgid

All of the viable trees, if construction will remain outside the limits of disturbance, would be well suited for retention. Tree #540 (big leaf maple, 22"), #8432 (big leaf maple, 38"), and #508 (Western Hemlock, 22") are all healthy, viable trees located on the perimeter of the property and would be very good options for retention.

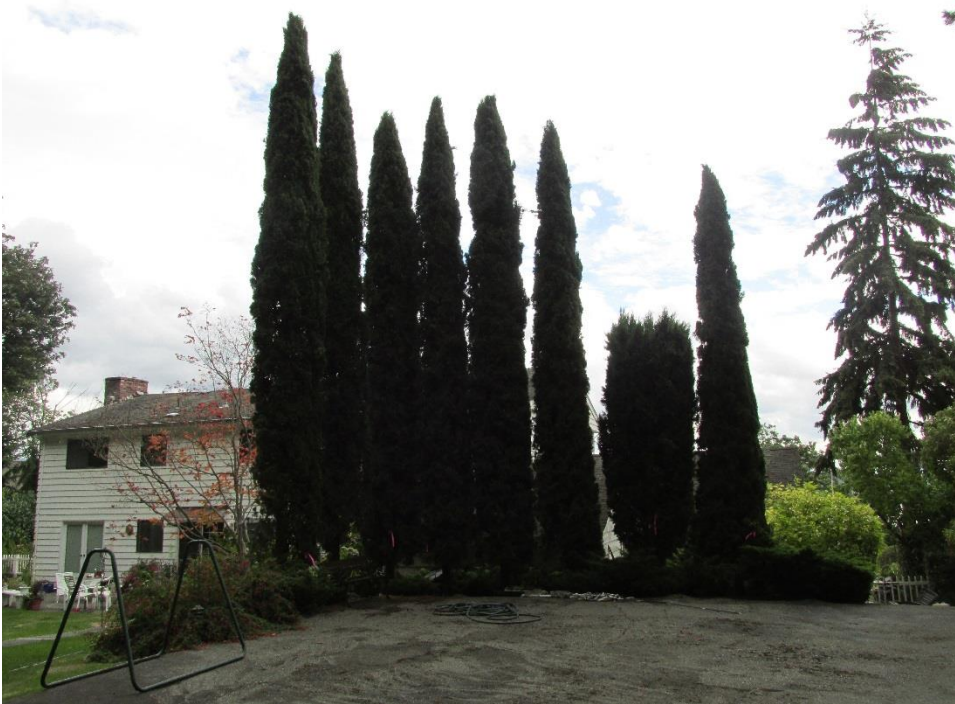
The row of *Pyramidalis arborvitae* (#839, 8497, 841, 842, 843, 8498, 845 and 846) in the middle of 8375 range from 15' to 35' tall. All of the trees are in fair condition except for tree #8497 which is in fair-poor condition and was topped.

Pyramidalis arborvitae's

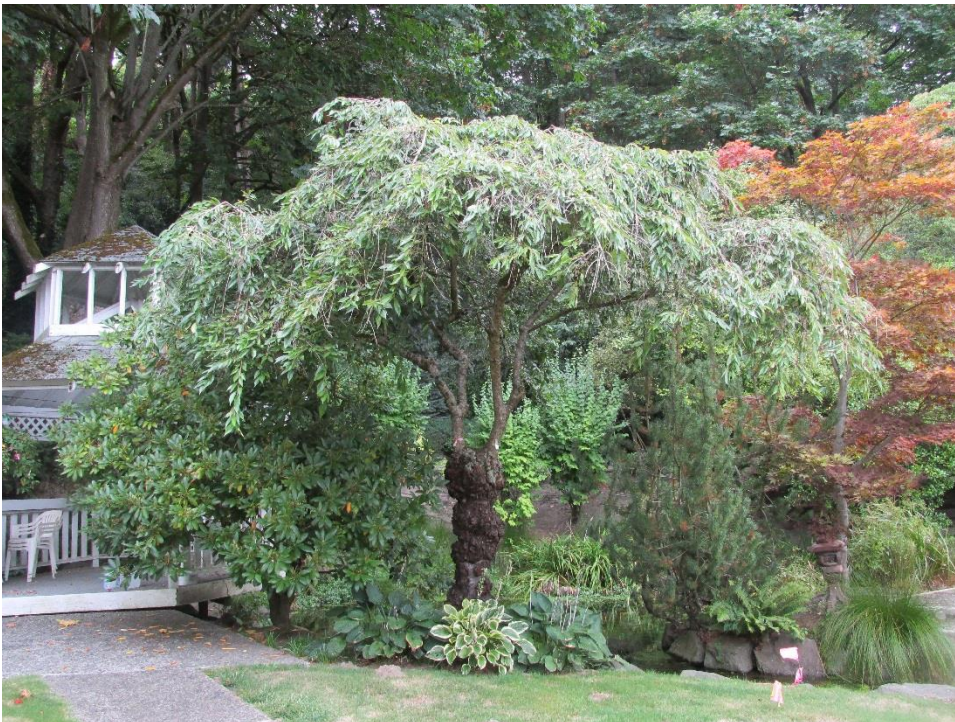
Tree #787

The fruit and cherry trees (#787, 835, 833, 819, 818 and 820) on the east side of 8375 are fair condition. The subject trees have typical form (widespread crowns, leaning, pruned) and are in fair condition.

The two non-viable trees on the property (#787 and #8280) should be removed to reduce risk. The two borderline trees (#8497 and #8100) are in decline and unlikely to contribute long term to the health of the forest. There are multiple large standing dead trees on the 8383 property. These should be removed to abate risk.

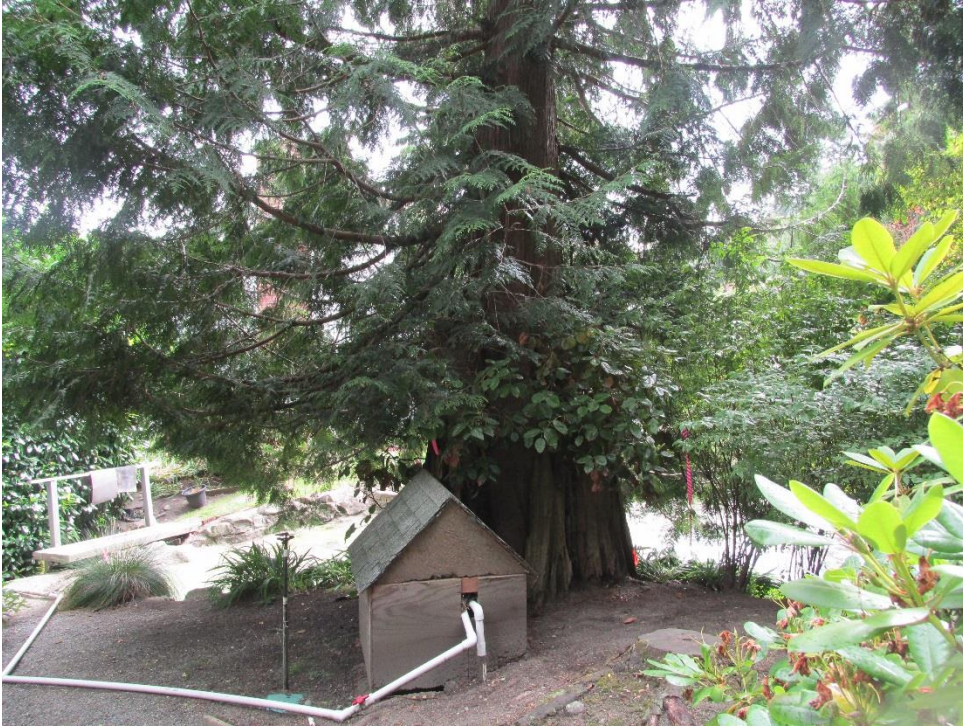
Tree #798 is a western red cedar on the east edge of 8375, adjacent to the pond. The tree is growing on a 4' tall stump. The tree has excellent form and a full crown.

Tree #798, western red cedar growing on a stump

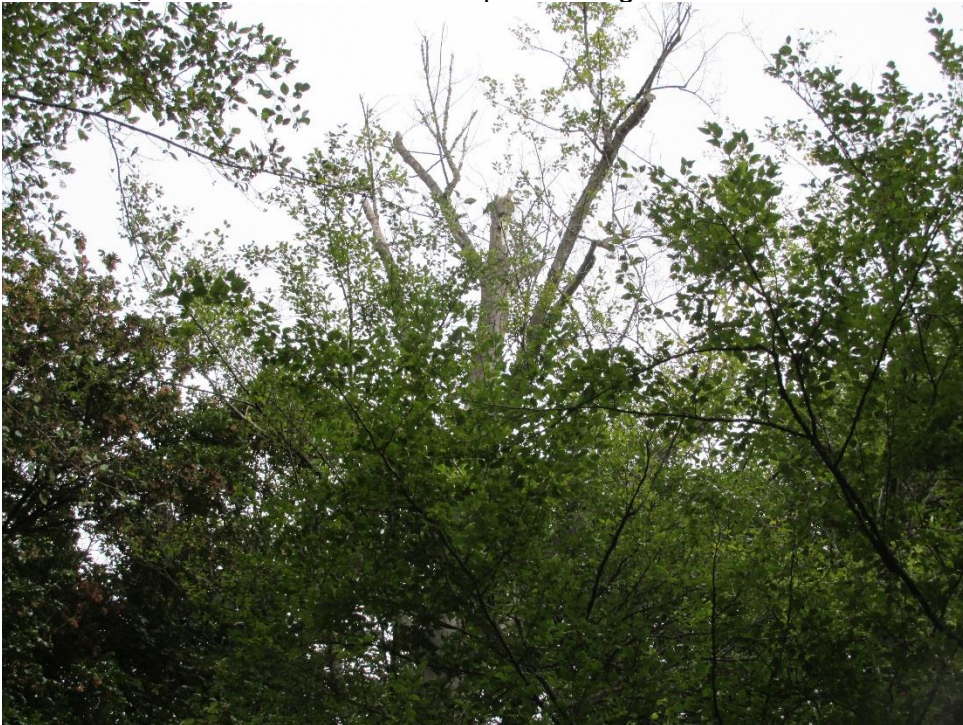
Tree #576 is an over mature red alder north of 8375. The subject tree is an over mature alder in severe decline. The subject tree has a small live crown, and leaf discoloration. This tree additionally has pockets of decay and past branch failure. The subject tree is in poor condition and is non-viable.

Tree #576, red alder with a broken top and foliage dieback

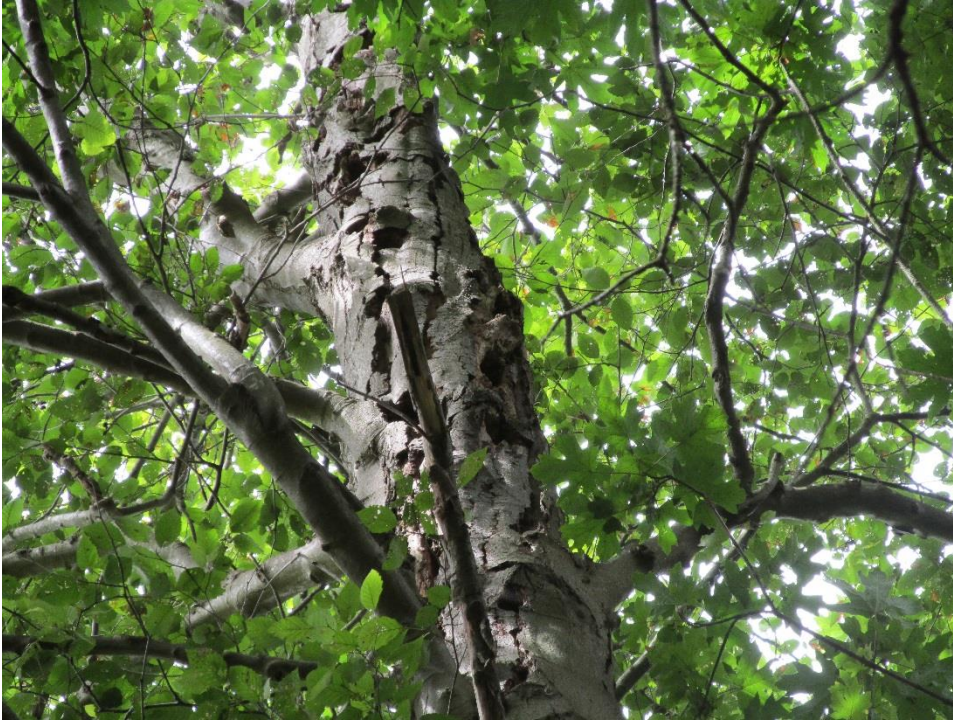
Tree #574 is an over mature red alder north of 8375. The subject tree leans SE and has co dominant stems with included bark. There are pockets of decay throughout the trunk and ivy covering the lower trunk. The subject tree is in fair-poor condition and is borderline viable.

Tree #574, red alder with decay
