Project: Pre-construction assessment for lot re-development at 8110 SE 70th Street, Mercer Island, WA. Parcel number 5452800465.

Objectives: Evaluate health of existing trees and establish criteria for the preservation of those to be retained.

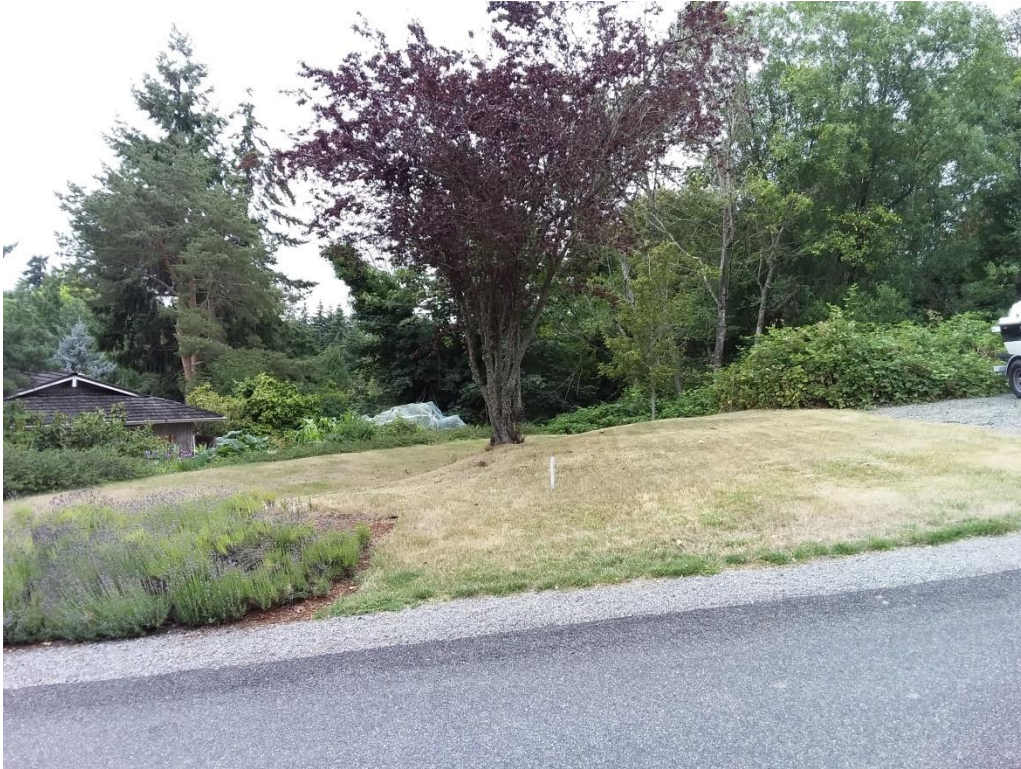
- 1) Flowering Plum (*Prunus xxx*) 18” Cal, 14’ tall, 7’ spread standing 5’ W of the property line near the SW corner of the property (Figure 4). The tree separates into 7 leaders 12” above grade all less than 6” diameter. It is in weak condition with limited new growth and poor color.
- 2) English Oak (*Quercus robur*) standing 55’ SW of the current house’s foundation and 30’ NW of the edge of the asphalt on 70th. The tree separates into two main stems 6.5” and 8” DSH at the 12” mark. There are five smaller stems which come off low on the south side of the stem. Their diameters are between 1.5” and 2.5”. The tree is in excellent condition with great color and abundant new growth. It reaches 28’ tall and has a 9’ radial spread.

Figure 4. Photo showing the #1 Flowering plum and the SW corner marker.

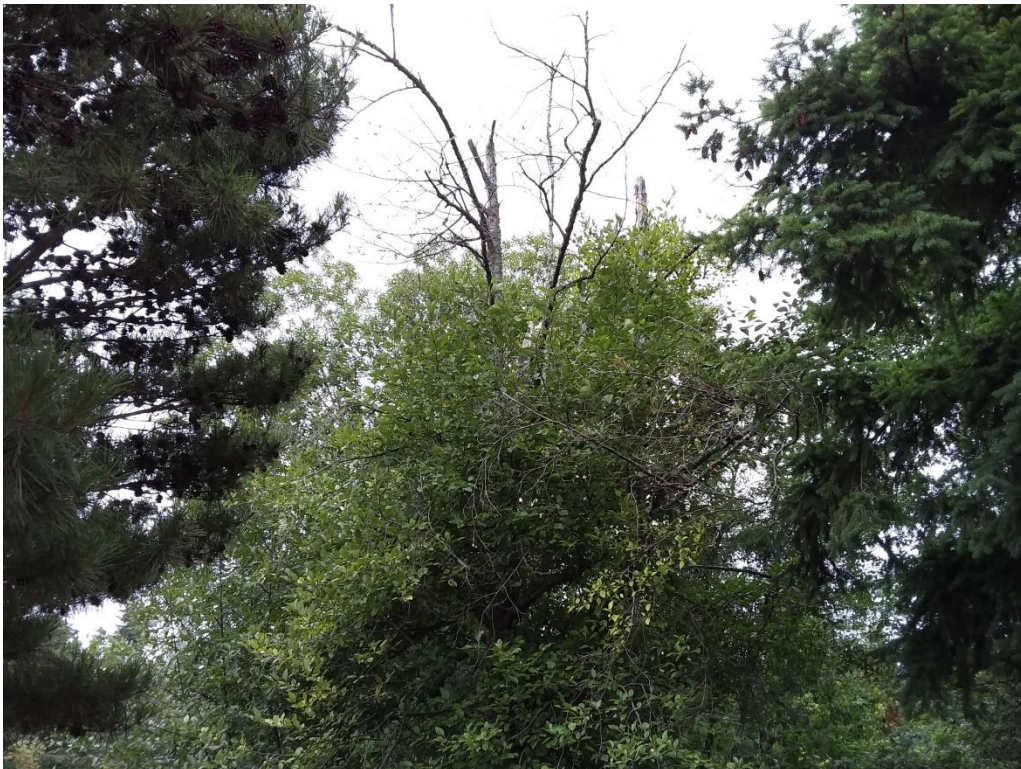
- 5) Tanyosho Pine 10" DSH, 10' tall, 6.5' spread standing 15' SW of the back left corner of the 8110 home. It is in good condition.
- 6) Red Alder (*Alnus rubra*) 16.5" DSH, 35' tall, 12' spread standing 25' W of the back left corner of the home. The upper half of the tree's canopy is dead as shown in Figure 5. There are multiple epicormics coming off the lower stem.

Figure 5. Photo showing the #6 alder's canopy.

Recommendations: The #6, #9, #10, and #11 alders should be removed during the clearing and grading period for the project. None of these trees are viable long term and due to their quite poor conditions should not be included in the tree calcs for the site.

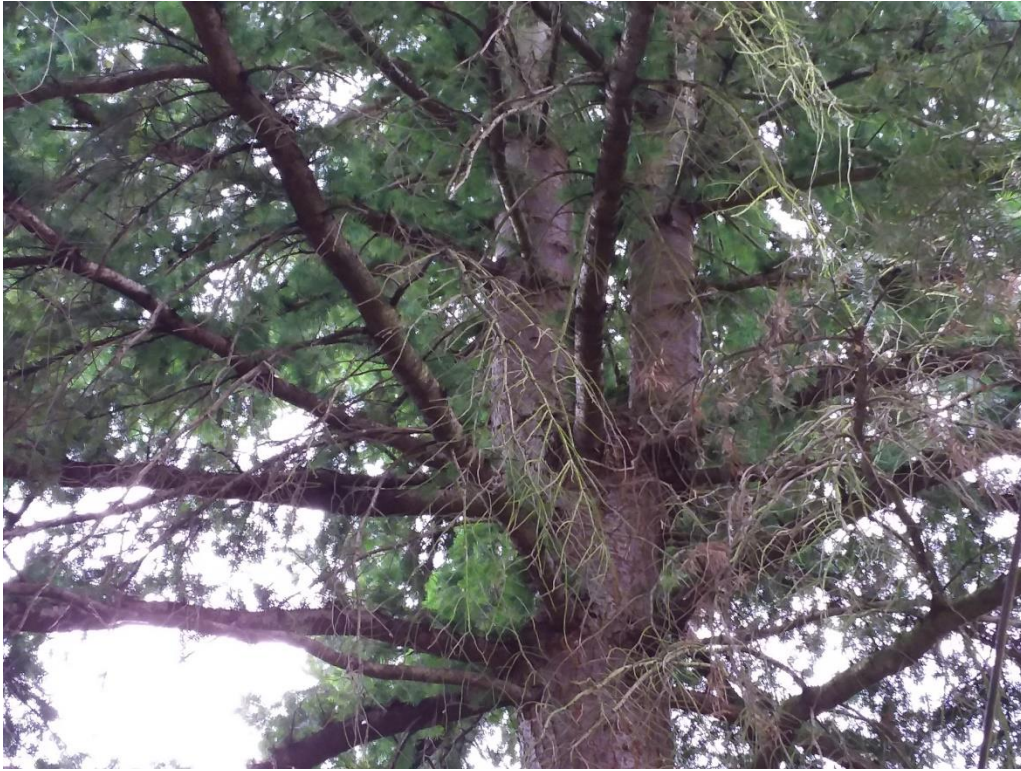
- 7) Douglas Fir (*Pseudotsuga menziesii*) 22" DSH, 65' tall standing 20' WNW of the back left corner of the house. The tree bifurcates at the 25' mark (Figure 6) with the stems oriented broadside to the prevailing wind pattern. It does not exhibit a fracture plane and has average new growth and color. The fir has uplifted the existing patio all around its base which is approximately 18" above grade.

In the case of the #7 fir mentioned above, the excavation for the proposed foundation could come as near as 14' to the base of the tree. From Figure 13 the Structural Root Plate for a 22" DSH tree is given as 9' so the foundation demolition should be well outside this tree's SRP.

Using the #7 fir again as the example, with the foundation excavation being 14' from the tree's base and it having a 22" DSH, there will be impact at a linear distance equal to 64% of the fir's CRZ (14'/22'). The chart shows that this roughly equates to a 27% loss of the fir's Critical Root Area (CRA) putting it just within the maximum recommended impact guideline. However, if more than 8" of fill is placed over the fir's roots on its west side it will have an additive impact effect which could result in the tree's early decline.

Risk Assessment: The #7 and #14 Douglas Firs are not so much at risk of falling over but rather of their large codominant spars breaking free. The spars on the # 7 tree have **possible likelihoods of failure** as an apically dominate species such as a fir with a bifurcated main stem becomes less able to dissipate wind loads. As the existing and proposed homes are just 20' from the tree, up wind of it, and the two tops are more than 20' tall, the spars are **somewhat likely to fail and impact**. The spars are less massive than an entire tree but the failure of either one of them could still cause **significant consequences**. Therefor the #7 fir would be characterized as having a **moderate risk** component.

Figure 6. Photo showing bifurcation of #7 Douglas Fir.

Whether the #7 fir is suitable for retention is debatable. While it stands far enough from the actual work zone that it will not outright lose too much of its root system it is also in an area which is slated to be filled to raise the grade. If the ground is leveled to the west of the tree it will likely result in atrophy of the roots on that side. So a significantly large section of the upper terrace would have to be left with a large 'divot' to protect the tree's roots. This doesn't make a great deal of sense.

Currently the fir only has a Moderate Risk level but as it grows the force loads on the two stems will increase exponentially. It could have reduction pruning completed with a mindset to maintain the tree near its current height but that will force lateral growth and, as the tree will end up just 5-8' off the back deck of the new house, continued branch encroachment will be an issue for the life of the tree.

Because of its proximity to the new home, the #7 fir's lower canopy will have to be pruned back and some limbs removed entirely. This will change the dynamics of the tree, shifting its center of gravity higher on the column (destabilizing it) and significantly reducing the ballast/harmonic dampening effect these limbs provide.

This arborist feels, on a balance of the issues, that the tree is best removed and a more suitable one installed at a proper distance from the home. A pair of Weeping Alaska Cedars would be good choices.

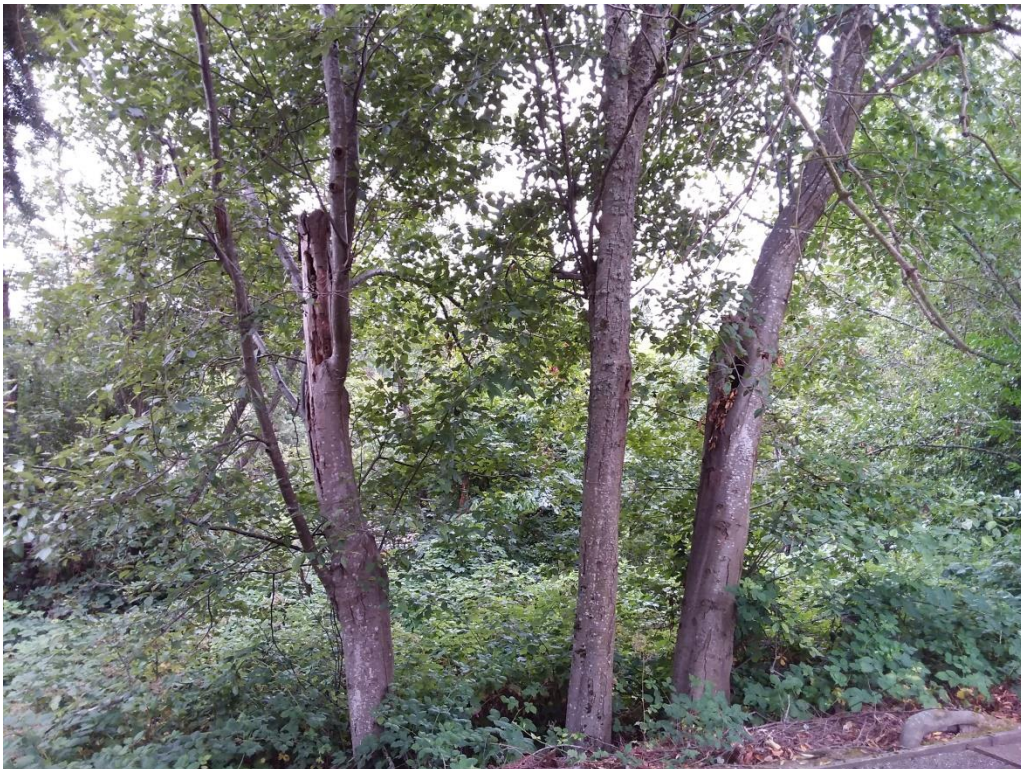
- 9) Red Alder 15" DSH, 40' tall, 10' spread almost entirely to the west. The tree broke out at the 14' level and has advanced decay extending down from this point on the west face of the main stem (Figure 7). There is some retrenchment low on the column. The tree leans to the west and into the green space on the neighboring property. It is standing 16' WSW of the #8 pine at the top edge of a small slope.

- 10) Red Alder 11" DSH, 45' tall, 8' spread mainly to the west. It is standing 6' N of the #9 tree. The uppermost branches of the alder are dying back. There is some epicormic growth along the mid-column. The tree leans slightly to the north.

- 11) Red Alder 17.5" DSH, 50' tall, 18' spread only to the NW quadrant. The tree stands 3' N of the #10 tree and 10' W of the #8 pine. It leans noticeably to the NW and has a large decay point at the 9' level (see Figure 7).

Figure 7. Photo showing the #9-11 alders. Note their poor conditions.

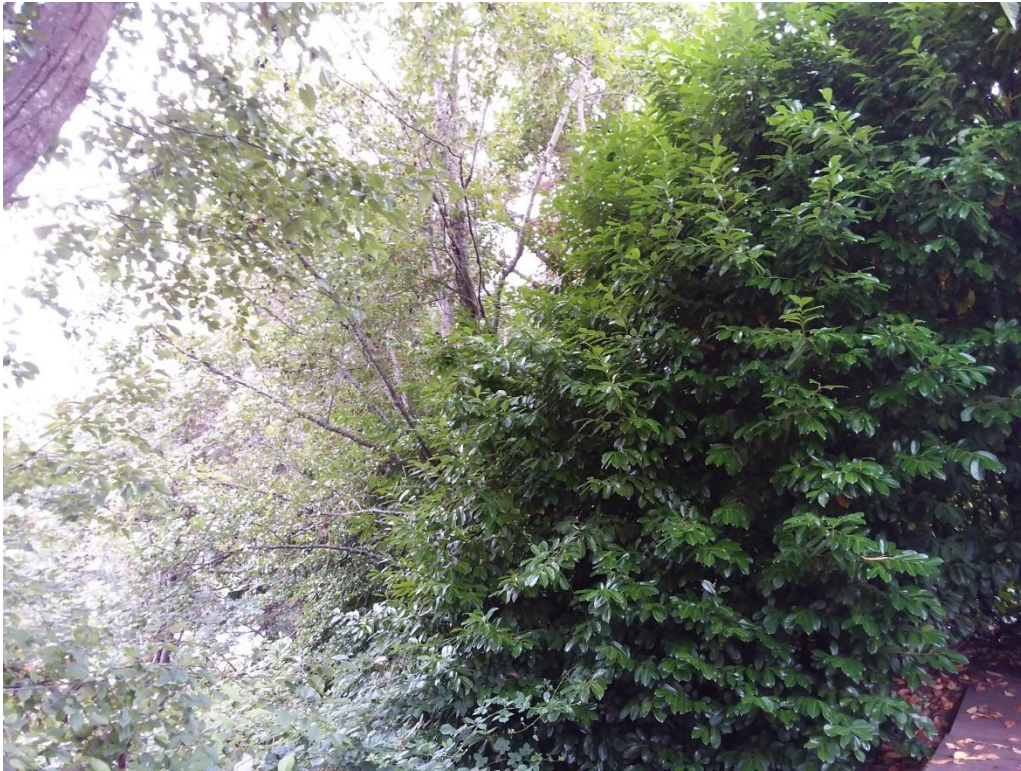
- 12) Red Alder standing close to the NW corner of the property, 18-20' below the top of the bank (edge of the backyard proper). Not measured or tagged. It appears to be about 50' tall with a 14' spread and is in below average condition (Figure 8). It was estimated as having a 14" DSH.

There are a number of other smaller trees and shrubs scattered about the lot. A large English Laurel hedge which has gone feral runs along the NW corner of the property and into the neighboring ones (see Figure 8). It reaches 20' tall and 25' wide in places. None of the stems are greater than 9" in diameter at the standard height.

The NW corners of the west side retaining walls will cross into the CRZ for the #12 alder. From the plan sets it appears that the nearest corner will come no closer than 10' to the base of the tree. This will result, at the extreme, in a 10% loss of rooting material for the alder, well within its tolerance level.

Figure 8. Photo showing the upper canopy of the #12 tree and the large laurel hedge in front of it.

Some attention will have to be paid to the areas around the #12 and #13 trees as it was not possible to determine their exact placement in relation to the proposed work. Once the blackberries are removed and the layout for the west retaining walls fully determined the degree of impact and mitigation required for them can be better resolved.

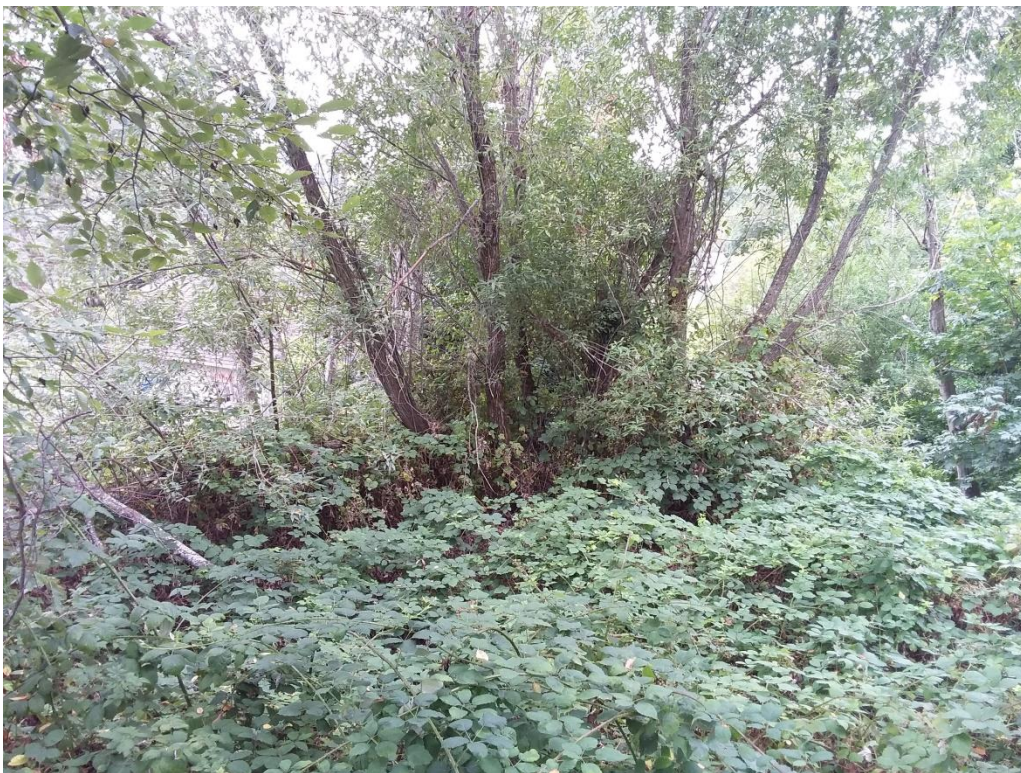
- 13a) Pacific Willow (*Salix lucida*) with four main stems between 6" and 10" DSH as shown in Figure 9. It stands near the west side of the parcel. The tree reaches 45' tall and, together with the #13b tree, has a 30' wide overarching canopy. It is in good condition for the species.

- 13b) Other half of the Pacific Willow stand. It contains at least one 10" stem and a handful of others in the 6-8" range. Good condition in native form (see Figure 9).
- 14) Douglas Fir 30.5" DSH, 75' tall standing in the City ROW 7' NE of the NE corner marker. The tree was topped or damaged near the 60' mark and now has one dominant and multiple subordinate tops (Figure 10). It has abundant new growth and good color.

Figure 9. Photo of the #13a and #13b willows looking WNW across the blackberry patch.

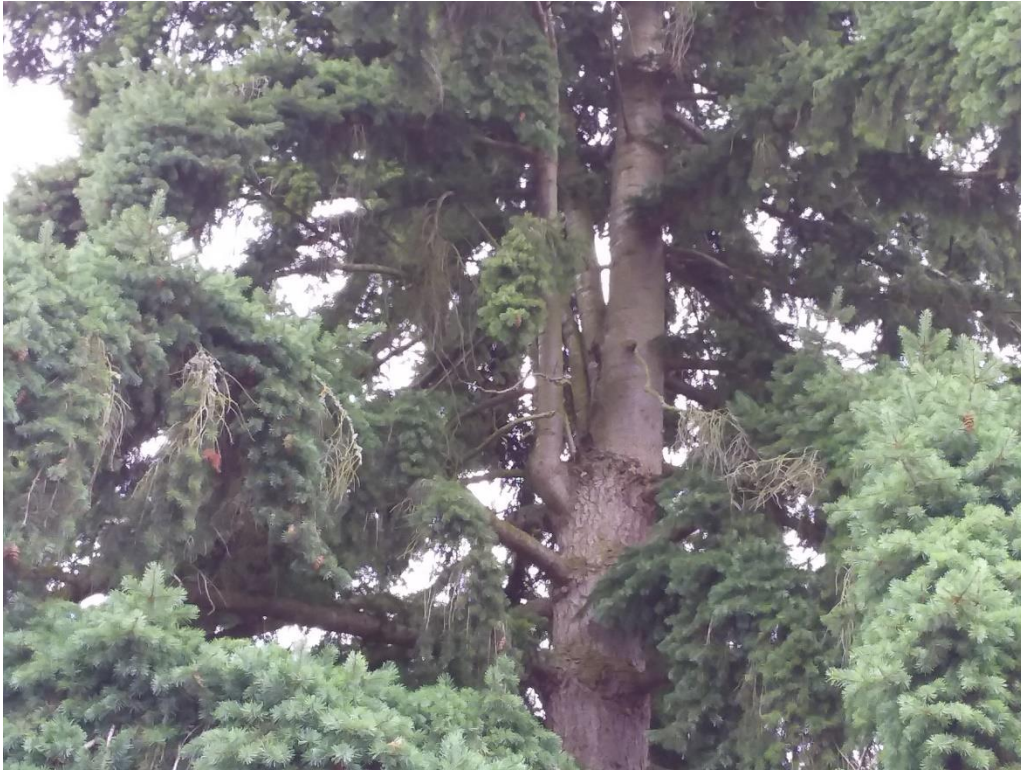
The #14 tree stands far enough from and upwind of both homes in its area. It does however stand at the intersection of 82nd Avenue and 70th Street where auto and pedestrian traffic has to pause before proceeding. The formation of this tree is less strong than that of the #7 tree. Its spars have **probable likelihoods of failure** but only **medium likelihoods of striking** a person or vehicle. This relegates it the **somewhat likely to fail and impact** row in the second matrix. Like the #7 tree failure of a spar could still cause **significant consequences** and it would be characterized as having a **moderate risk** component.

Figure 10. Photo taken of the #14 fir damage point looking up from the street.
