October 24, 2020

**Project:** Pre-construction assessment for garage renovation at 4602 East Mercer Way, Mercer Island, WA. Parcel number 7558700045.

**Objectives:** Evaluate health and suitability for retention for 6 trees near the garage.

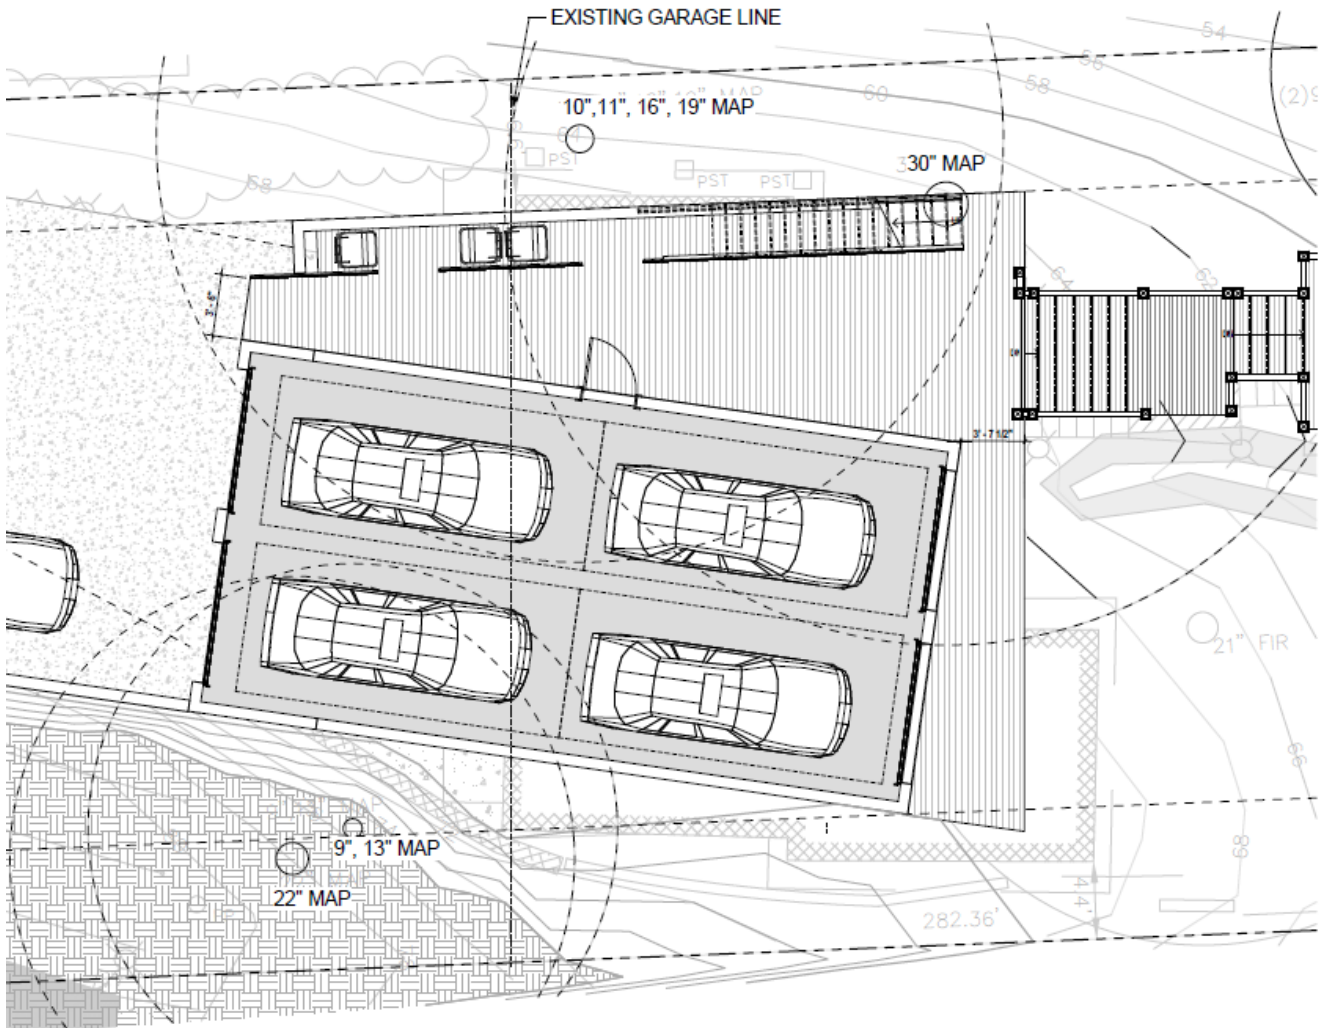
The proposed south side foundation/retaining wall will cut across the existing one no more than 6' west of #1 maple's base. On the north side the existing foundation will have to be removed and probably the area will be excavated to create space for the forms for the new one. And it is likely that the existing foundation on the east side will be demolished as the new garage east side is set 5' further to the west. Typically all trees within the primary zone are removed during the clearing and grading period of the project. In this case each tree will be analyzed individually.

Figure 2. Excerpt from proposed plans showing layout of new garage. Note foundation/retaining wall intersecting the existing one on the south side.

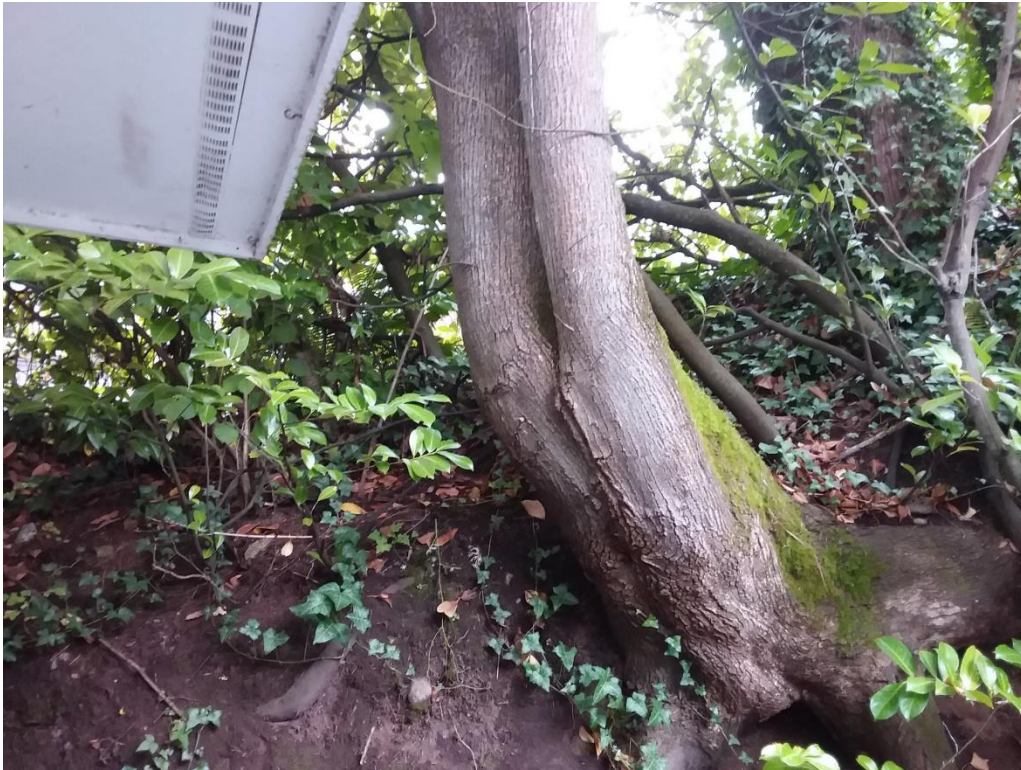
- 1) Bigleaf Maple (*Acer macrophyllum*) dual stem 6.5” and 15” DSH separating from the base but not fully until the 48” level (Figure 4). The base of the tree is 7 feet on center from the southwest corner of the existing. It growing out of the side of a small embankment and its closest structural roots are 22” off of the stone retaining wall running along the south side of the driveway. The tree stands roughly 32” on center from the wall but is at least 20 inches above the top of the wall. The smaller stem bends slightly to the NE in a rather crooked manner reaching about 20’ where it kinks over more noticeably into the NE quadrant stretching as much as 20 feet over the top of the garage. The larger stem bifurcates again 7’ above the main separation point. It goes nearly vertical up to 22’ level where it branches off into a main scaffold and some sub scaffolds. The main goes nearly vertical to 65’ and the other stems reach out to the east crossing against each other. Fair health, weak structural condition.

The #1 maple would be expected to have a 7' SRP based on its calculated 16" diameter. As it is already constrained by the retaining wall on its north side it is more likely than not to have compensated by extending east and west parallel to it. The excavation for the proposed south side foundation could come as near as 6' to the base of the tree and will likely cut through structural elements.

Figure 4. Base of #1 maple showing the separation point and proximity to the SW corner of the existing garage.

**Recommendations:** The #1, #3, and #4 maples should be removed during the clearing and grading period for the project. Each of these trees has structural and locational issues preventing them from becoming viable full grown trees currently. Each will also experience significant impacts to their Root Plates which will create catastrophic failure concerns.

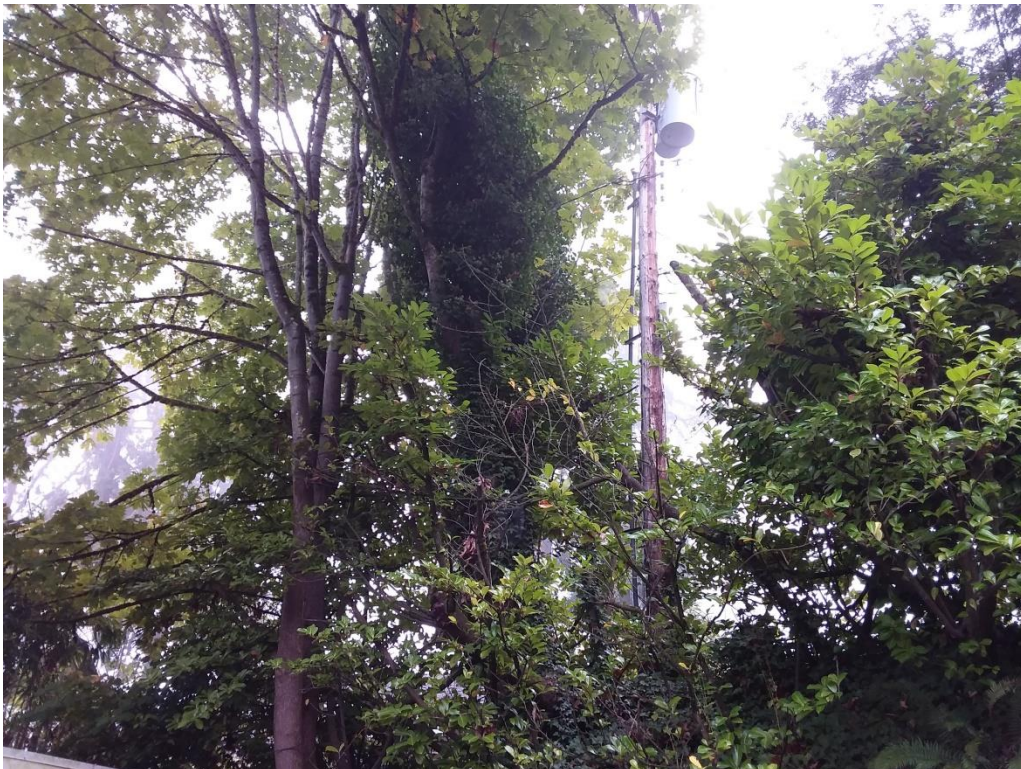
- 2) Bigleaf Maple bifurcates at 44" mark, 12" and 16" DSH standing 5' on center southwest of the #1 tree and 40" above it on the bank. The smaller stem on this tree separates again and one of its scaffolds goes out east, crooks multiple times as it bends slightly to the south. The canopy on this section extends entirely into the SE quadrant. The larger stem bends slightly to the north, separates a couple more times and the majority of its canopy reaches out north. The mass of the tree is significantly off center of its base. This is most likely due to clearance pruning for the transformer on the utility pole 8' SSW of the base of the tree (Figure 5). The drop lines for both homes run through the lower canopy of this tree and the middle of the #1 maple's. Fair health, weak structure, and full of ivy.

The #2 tree has a 20" calculated diameter and would be expected to have an 8' radial SRP. The cut for the south side foundation appears to be right at the 8' mark so this tree should not have its SRP impacted to a great degree.

Figure 5. The utility pole standing next to the #2 maple.

The #2 maple stands just far enough away from potential impact that it can be retained but the ivy has to be severed at its base. A swath at least 36" tall should be completely cleared of the vine on the trunk of the tree to ensure it does not continue to grow. This tree may require some degree of remedial pruning to address weight loads on over extended branches, crossing elements, and clearance for the power drops.

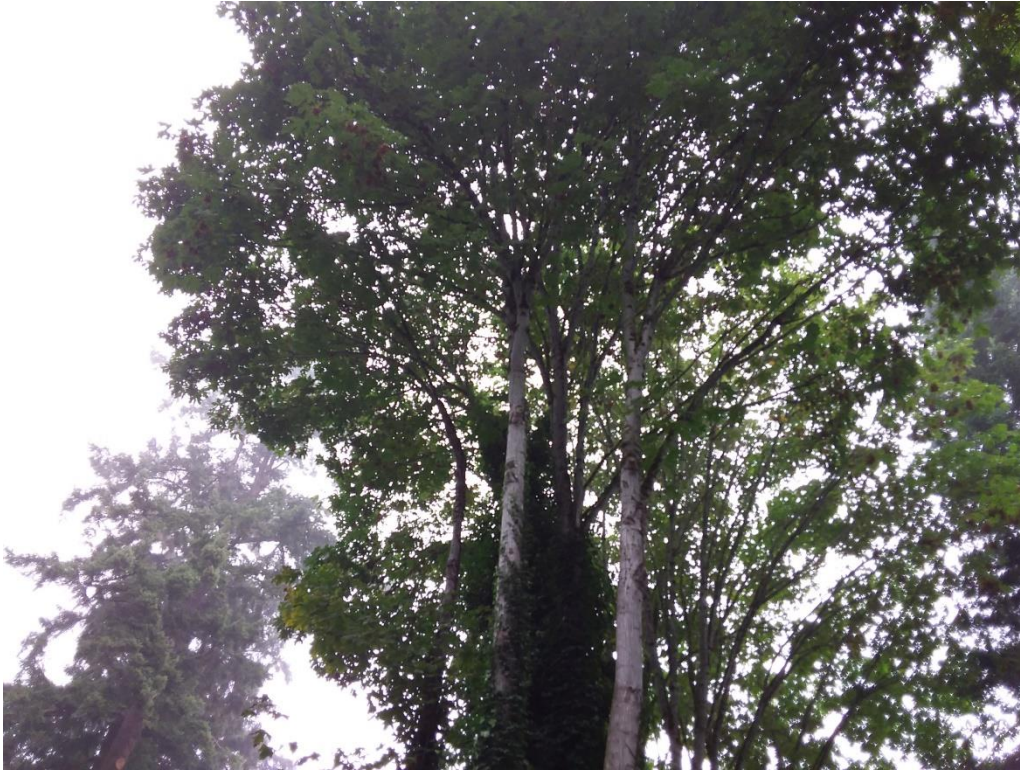
- 3) Bigleaf Maple with four trunks from the base (likely is a stump sprout) measuring 17.5", 13", 10.5", and 19" DSH and all four have been pruned to the vertical to get them off of the subject garage and the neighbor's garage (Figure 6). The tree is growing in a narrow strip 8.5' wide between the south wall of the neighbor's garage and the subject garage's north wall (Figure 7). Its base is 5' S of and 5' vertically above the corner of the foundation for the neighbor's garage (Figure 8). It is 30" N of the existing garage foundation wall (Figure 9). It is close to 30" below the level of the floor of the garage.

Figure 6. Looking up at the canopy formation of the #3 maple. Note the lack of lower branches which creates instability in these small diameter stems.

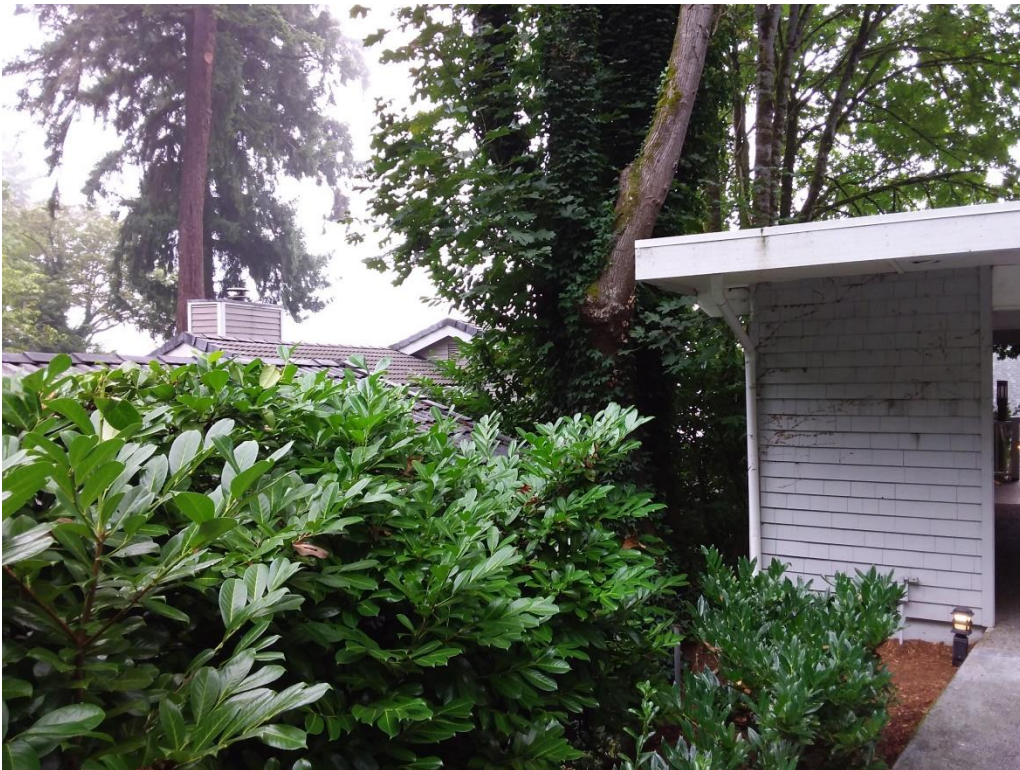
The #3 tree has a greater than 24" diameter and should have a 10' radial Structural Root Plate. It obviously doesn't based on the proximity of the garages (unless it does grow under the subject one). Any structural roots it does have are rather tightly constrained and have to be pressing into the existing foundation walls. The demolition of the existing garage alone will damage this tree's SRP let alone if further excavation is necessary for the forms.

Figure 7. Showing where the #3 maple stands between the subject garage on the right and the neighbor's garage whose roof is just visible on the left.

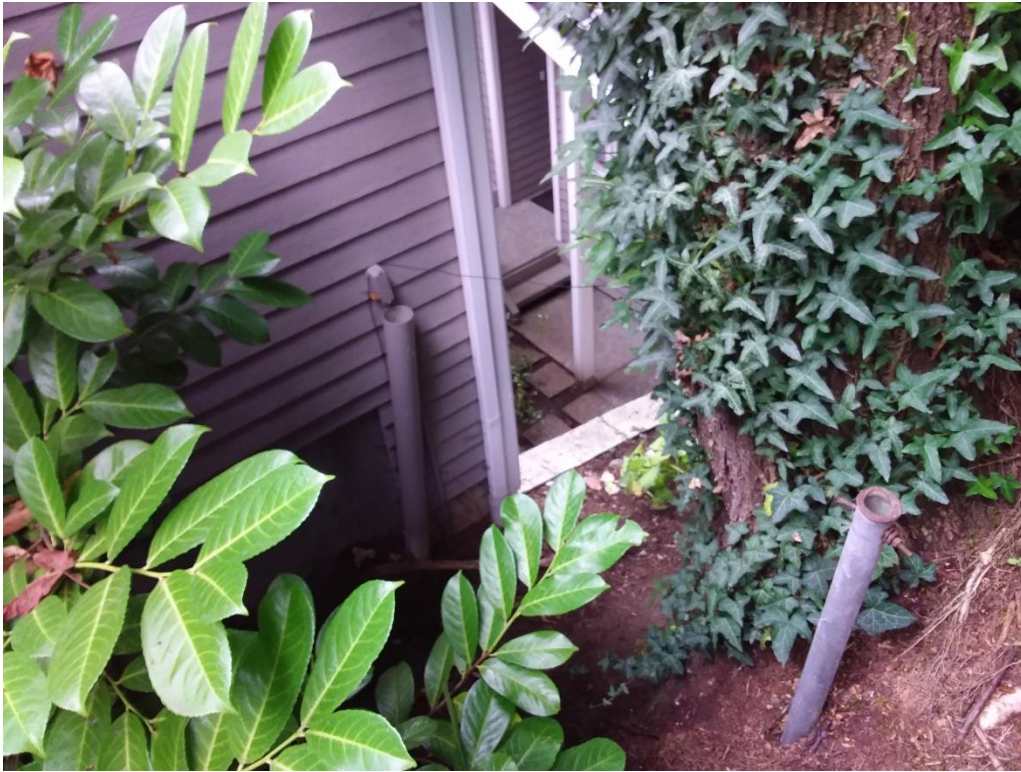
Figure 8. Looking past the base of the #3 tree at the corner of the neighbor's garage.

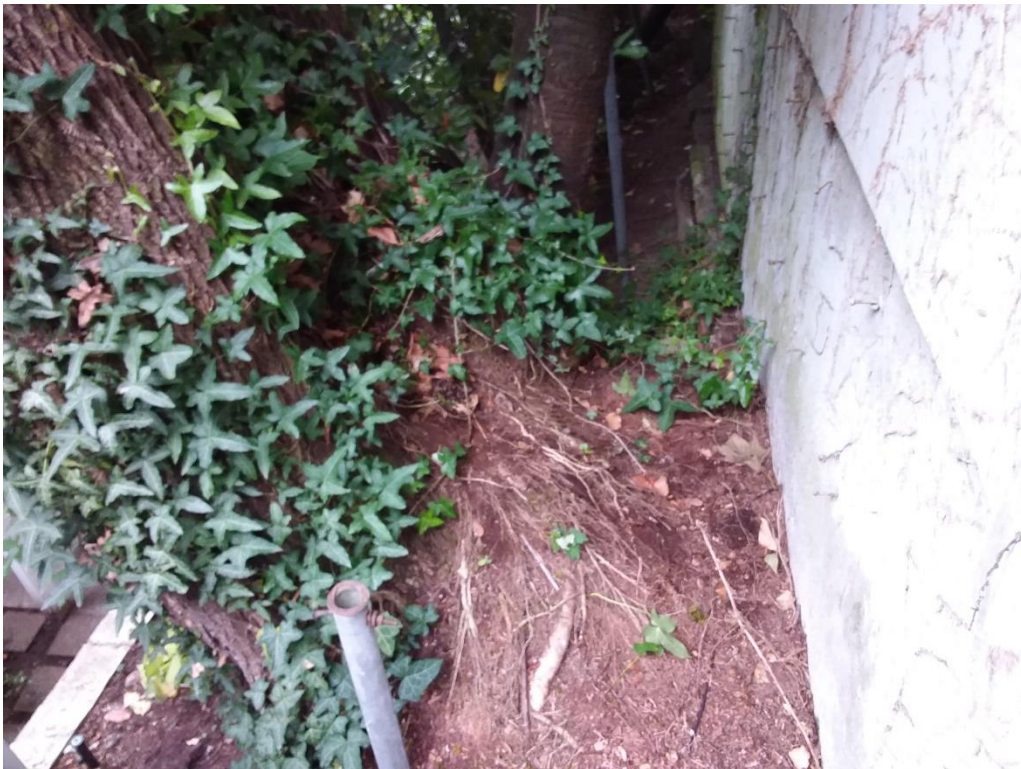
Figure 9. Showing the proximity of the subject garage to the base of the #3 tree.

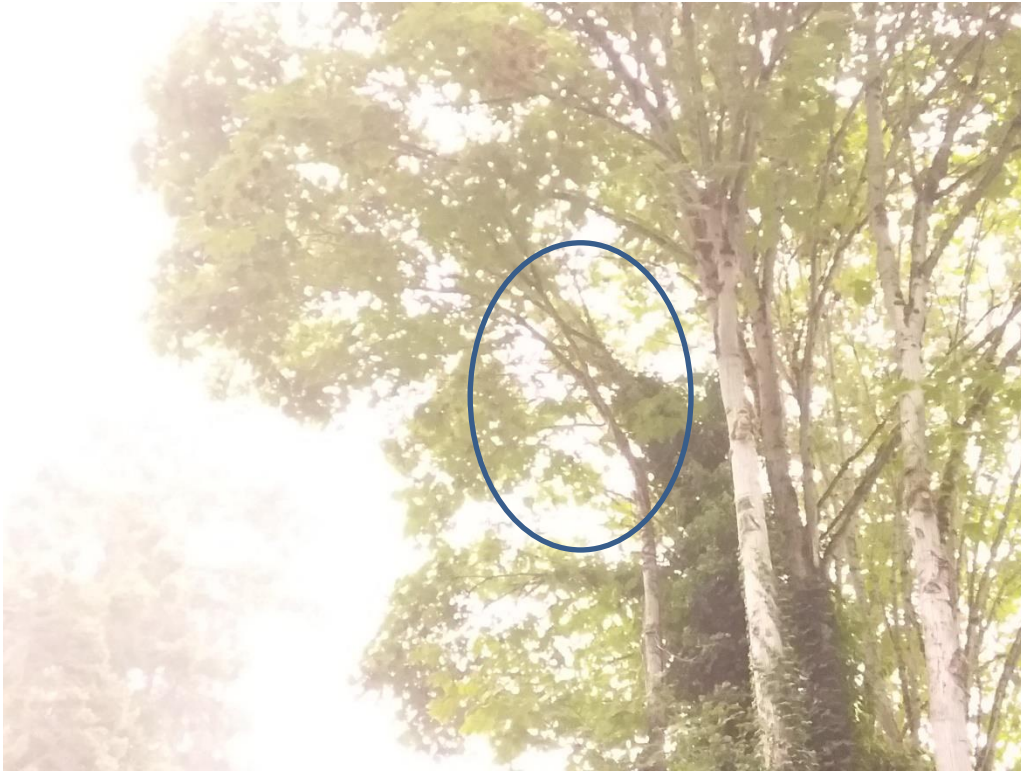
Figure 10. Showing the formation of the canopy at the top of the 10” stem on the #3 maple.

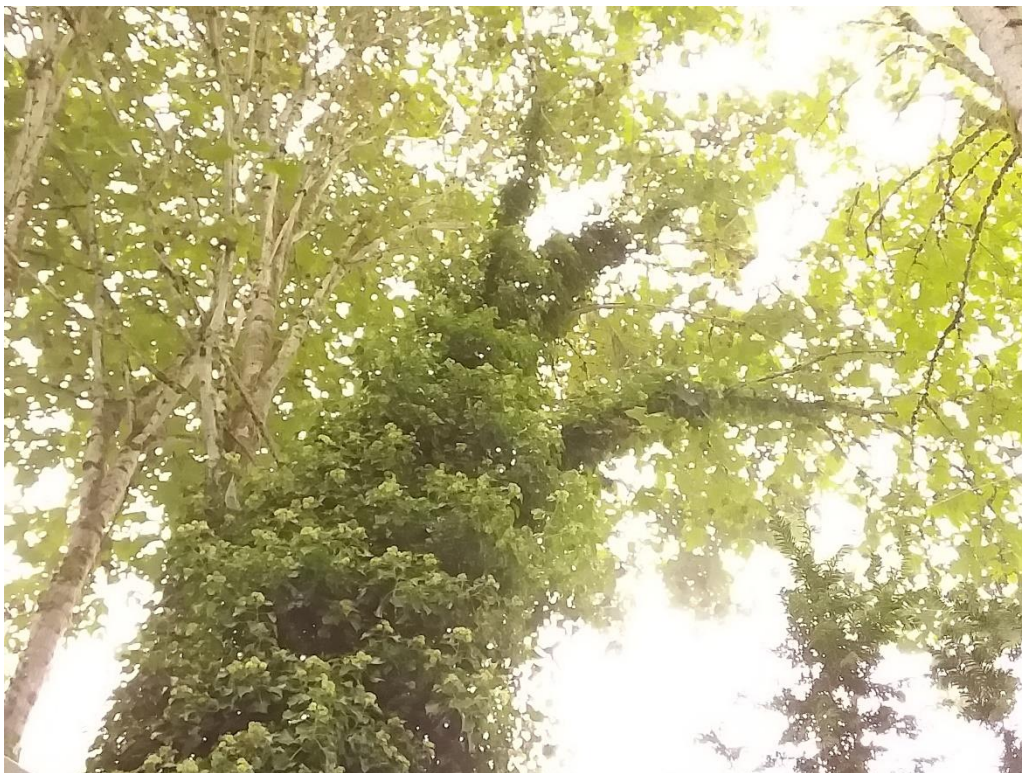
Figure 11. Showing the ivy inundating the 19” stem on the #3 tree.

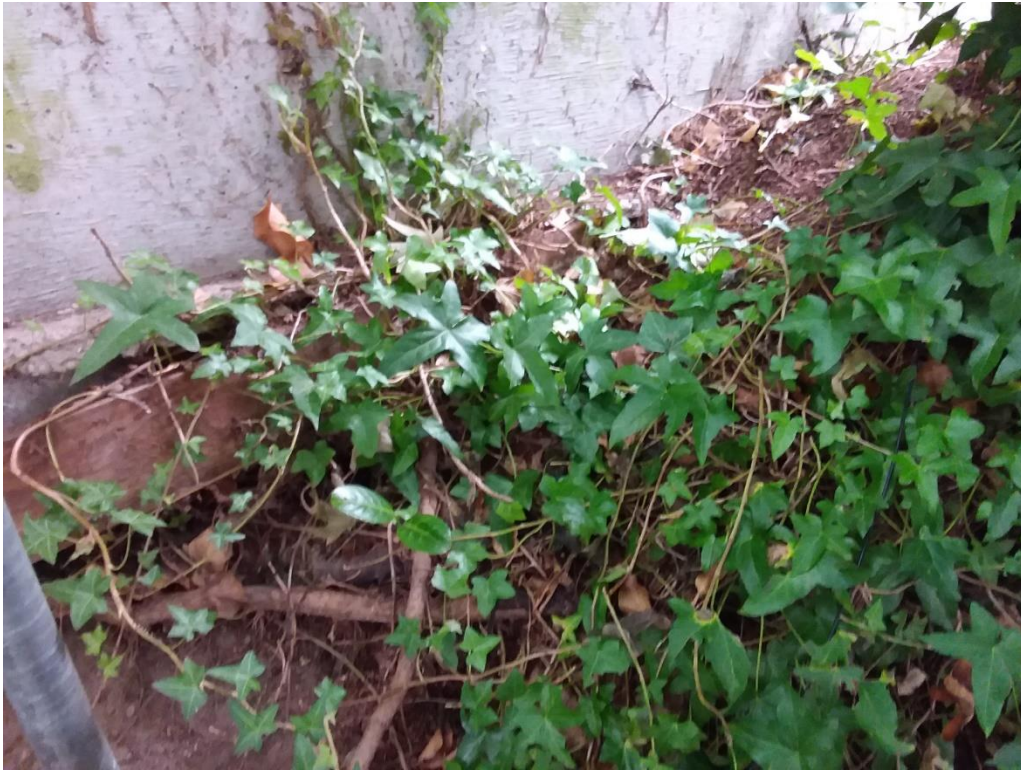
The tree has some structural roots heading north and down the slope but not a great deal and does not appear to have many lateral roots going east and west. Its base is actually slightly below what looks like the lower footing for the subject garage north wall (Figure 12). It could very well be that it has roots extending beneath this wall and is using it as a counterbalance. There was a cherry growing to the north side of the maple's base which has been stubbed off (Figure 13). Most likely it grew into the existing garage.

Figure 12. Looking at the base of the north side foundation/retaining wall of the existing garage. There is evidence that the #3 tree has roots growing under this section.

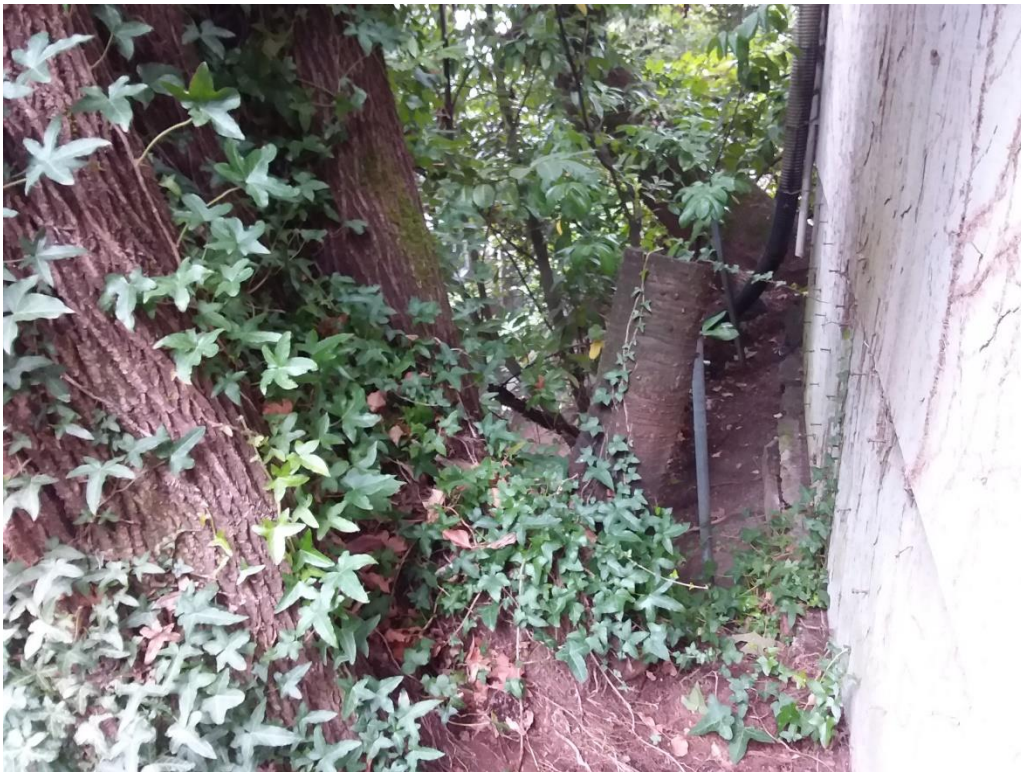
Figure 13. The cherry stub at the base of the #3 tree.

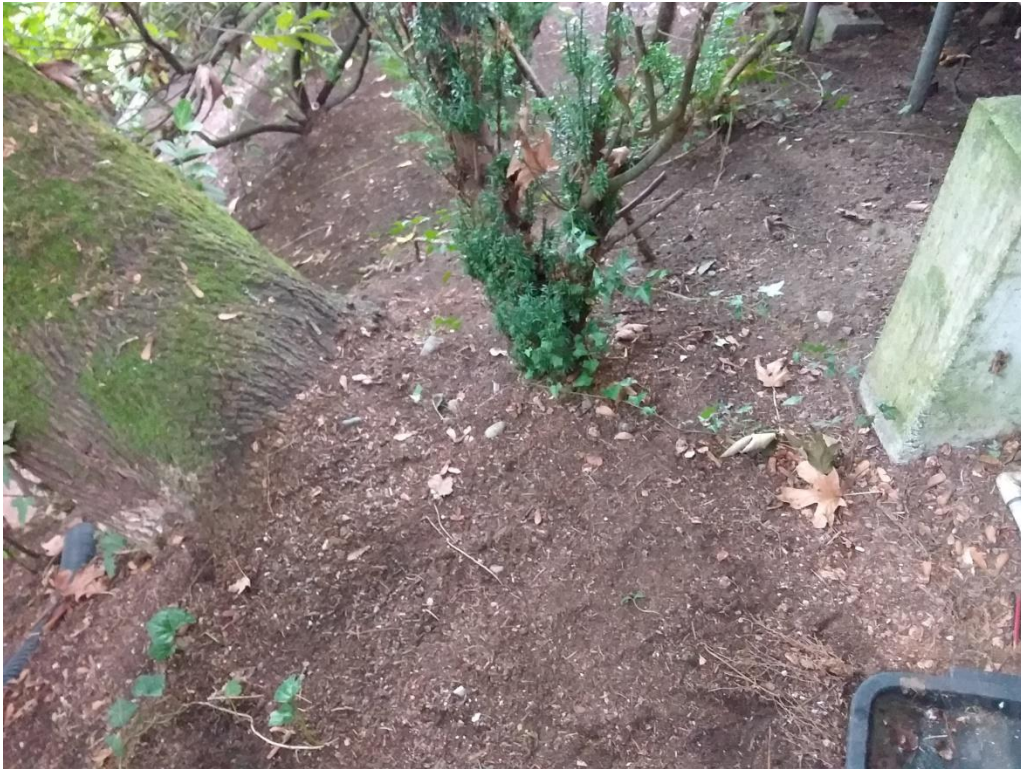
- 4) Bigleaf Maple whose base is 7' E of the northeast corner of the existing garage foundation and 5'N of a support post for the northeast corner of its roof (Figure 14). The tree grows at a 45 degree angle to the north from its base (Figure 15) and at 8 feet out it sprouts into 5 stems that go nearly vertical (Figure 16). The ground drops off just about even with the north side of the base of the tree, probably as much as 16 feet (Figure 17). The knuckle where the tree goes to vertical is six feet south of the gutter line of the neighbor's house. At 54" out from its base the tree measured 29" in diameter. The stems are estimated at 7", 8", 10.5", 12", and 12" caliper.

The stairs on the north side of the proposed garage cut right through the base of the #4 tree.

Figure 14. Looking at the base of the #4 maple and its proximity to the NE corner of the existing garage.

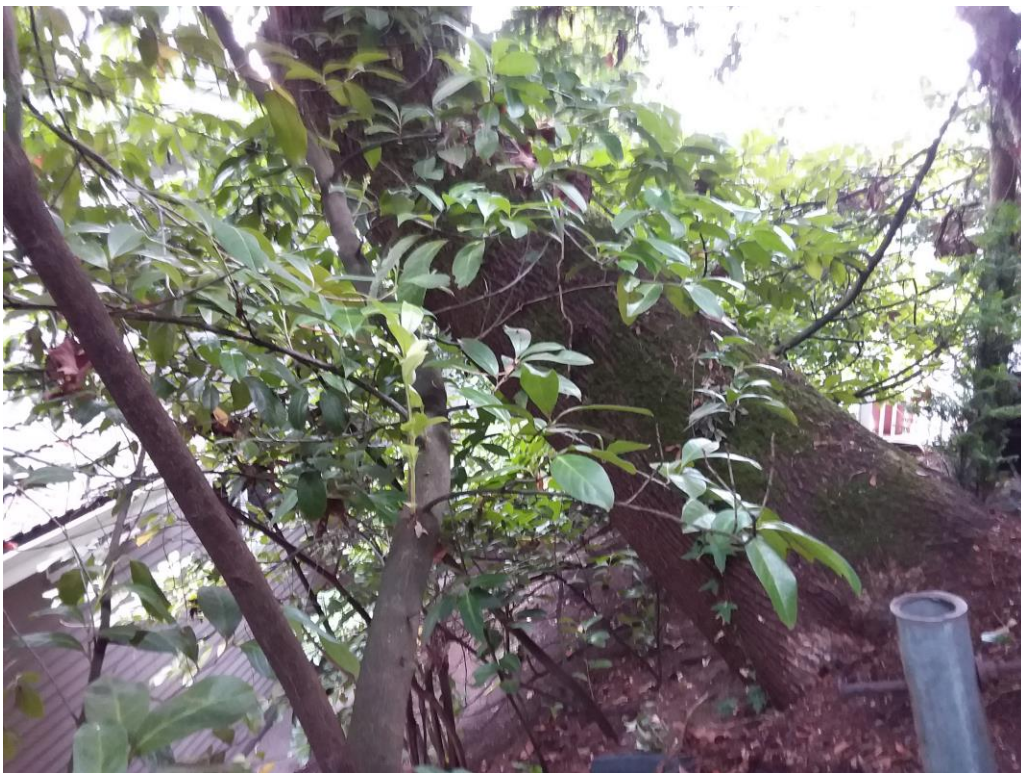
Figure 15. Looking east at the base of the #4 maple.

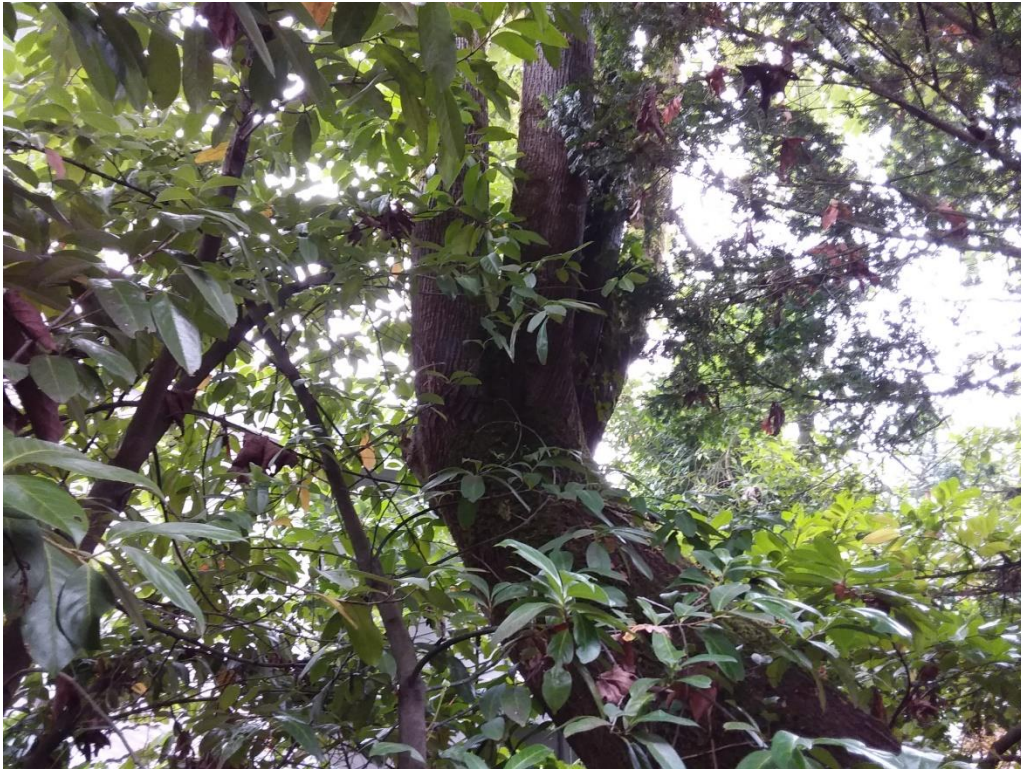
The smaller two extend into the NE quadrant and bend increasingly over to the east. The smallest one's canopy is in a narrow column in the NE quadrant. The canopy on the 8" stem is in a narrow quadrant on the east side. Both reach out closes to 30 feet. The larger two go vertical to 65'tall. The north side one spreads to the north 25' and the south side one spreads 30' into the SW quadrant. The center stem leans slightly south as it rises and then increasingly bends to the horizontal as it turns into a set of scaffolds reaching at least 30' over the existing garage area. The branches and scaffolding within the tree are conflicting at many points. Fair health and weak structural formation.

Figure 16. Looking NE at the point where the stems rise off of the #4 maple. It is highly likely that the mainstem was severed at this point many years ago and the existing stems were formed in epicormic response.

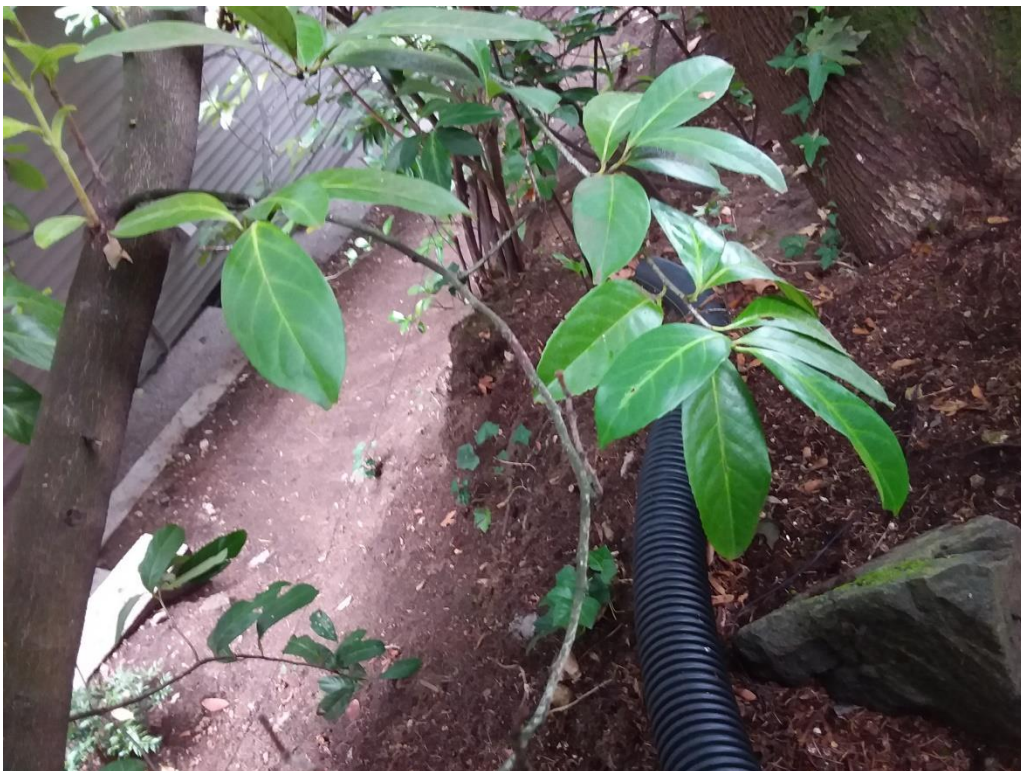
Figure 17. Looking down past the base of the #4 maple. The narrow path shown at the left side of the image is a 36" wide walkway for the north side neighbor's house.
