ARBORIST REPORT FOR

8005 SE 34th Place
Mercer Island, WA 98040

November 24, 2021

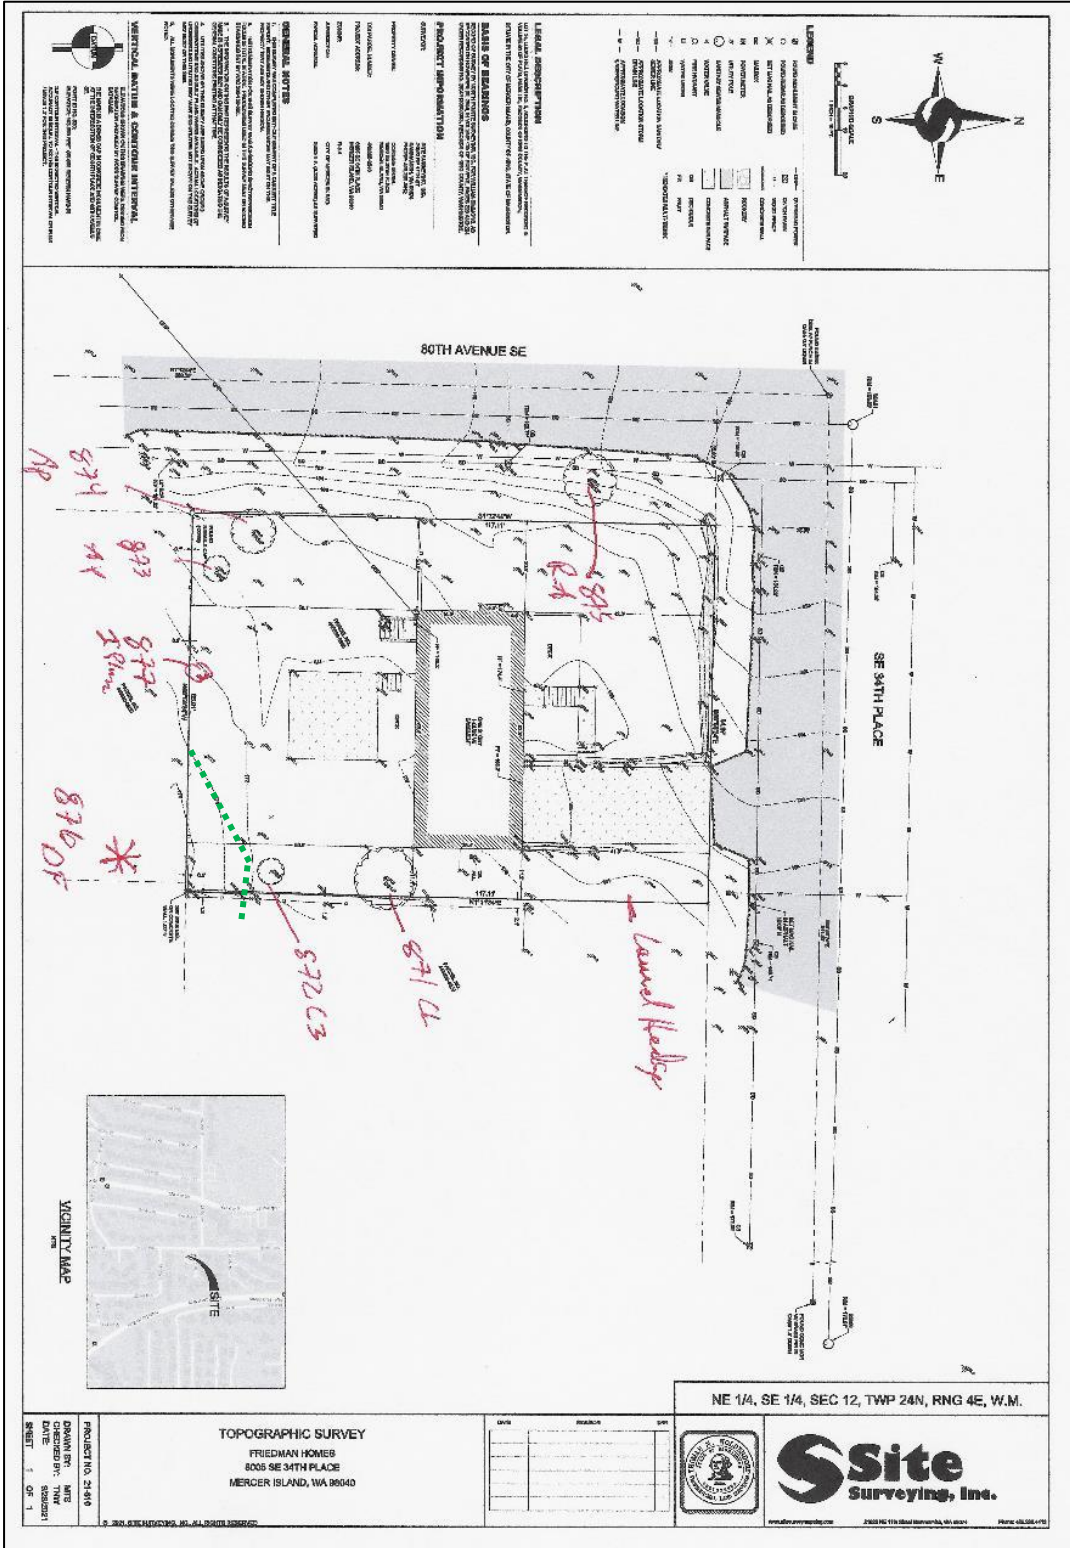
Approximate Tree Protection Fencing Locations

Tree # 876 is a large Douglas Fir on the adjacent property to the south. The diameter is estimated to be 38 inches measured at the standard 4.5 feet above the average ground level. It is in *Very Good condition*.

It is worthy of retention and can be adequately protected during demolition and reconstruction. The canopy extends over the subject property by approximately 10 feet. It will be easy to install tree protection fencing in the back of the lot to protect this tree.
