## Arborist Report

To: Sturman Architects  
Site: 4603 89<sup>th</sup> Ave SE, Mercer Island, WA 98040  
Re: Tree Inventory for Development  
Date: June 17, 2022  
Project Arborist: Joseph Sutton-Holcomb  
ISA Certified Arborist #PN- 8397AM  
Municipal Specialist; ISA Qualified Tree Risk Assessor  
Referenced Documents: Lanctot Residence: Permit Set (Sturman Architects, dated 6/9/2022)  
Attached: Table of Trees  
Tree Site Map

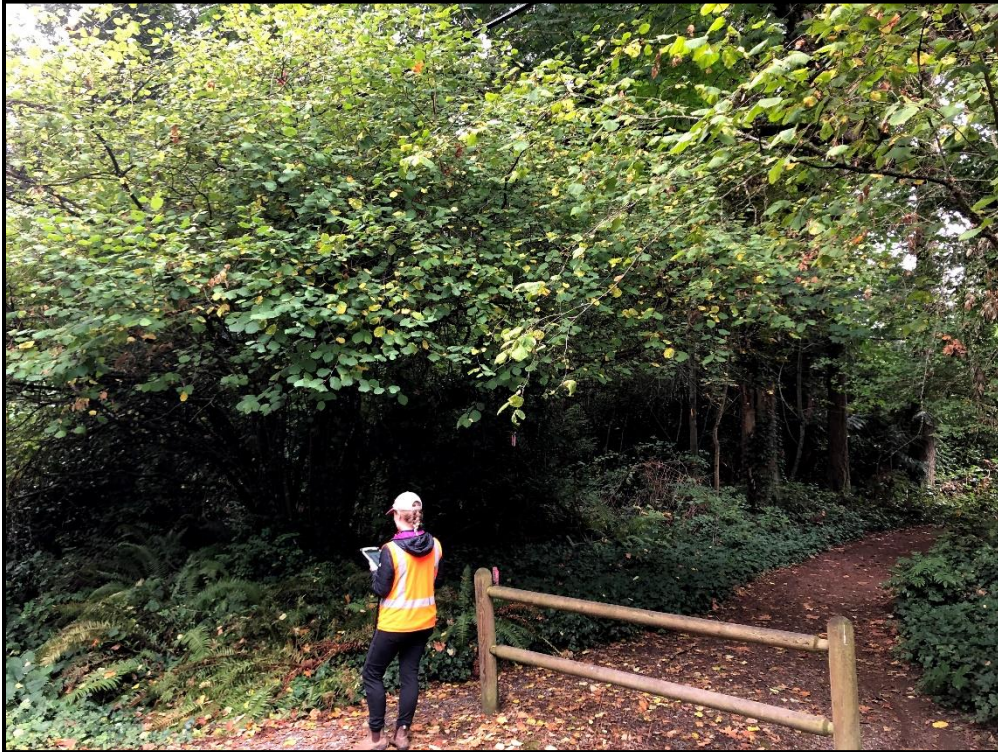
Photo 1. Looking southwest into the site. Walkway on the right is a public path adjacent to the site.

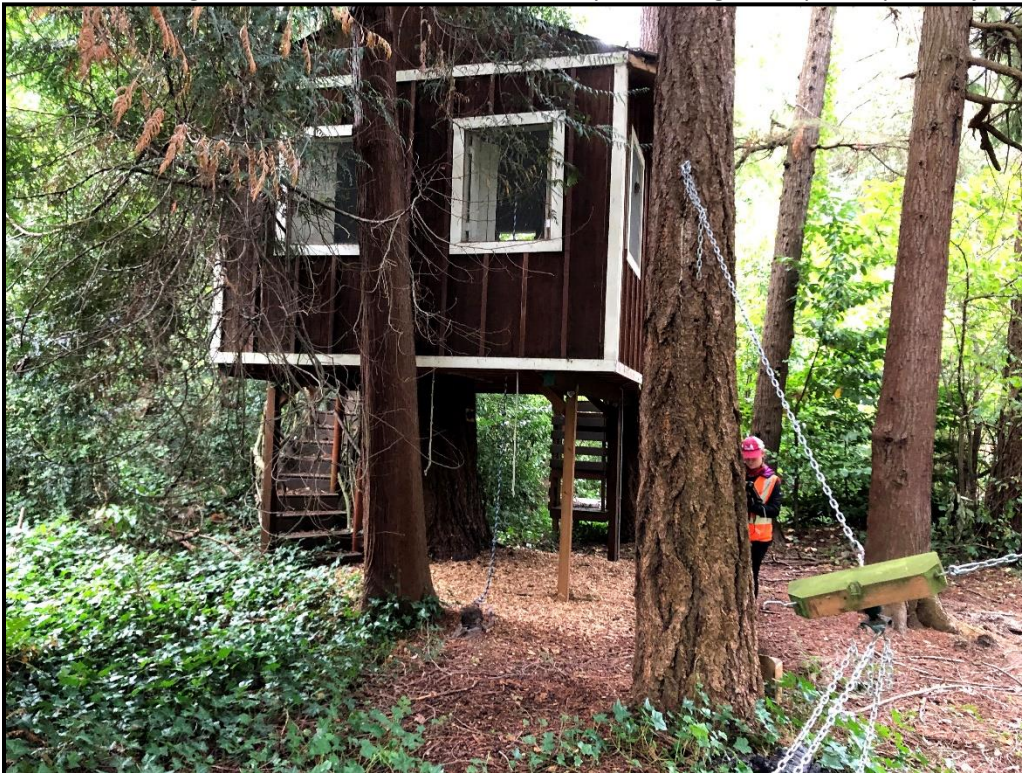
Several trees are used as attachment points and supports for a tree house and adjacent zipline. These trees are 1806, 1810 and 1813.

Photo 2. There is a treehouse and associated recreation apparatuses attached to trees near the center of the site.

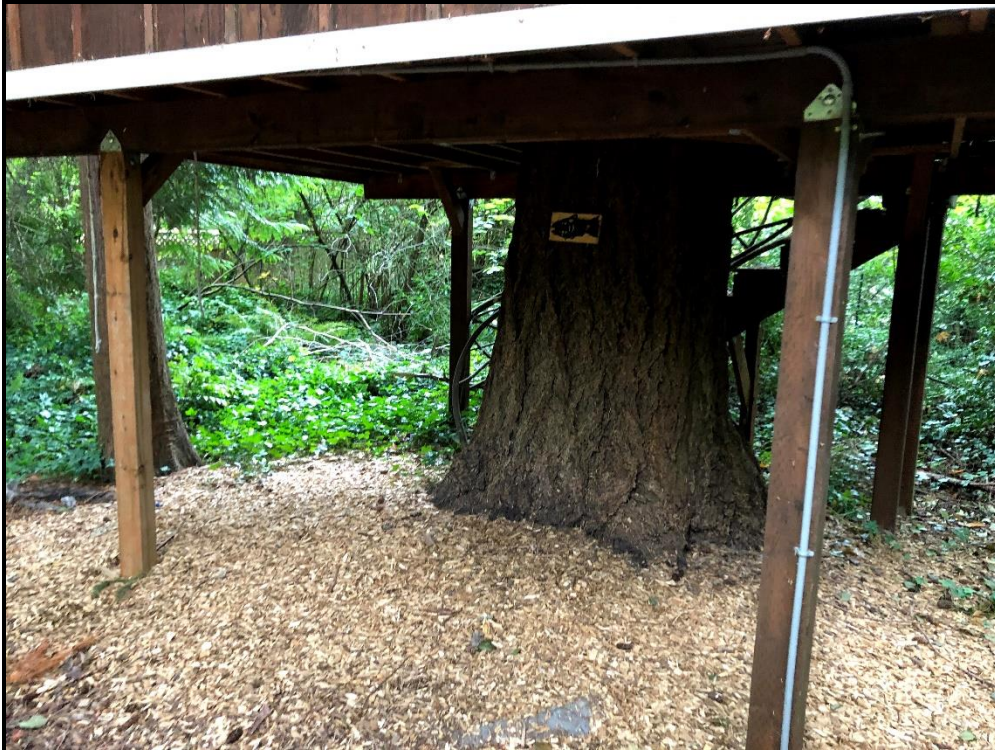
Photo 3. Tree 1806 is not serving as a primary support but is in the center of the treehouse with small attachment hardware. Large diameter surface roots are just below landscape fabric and mulch layer.

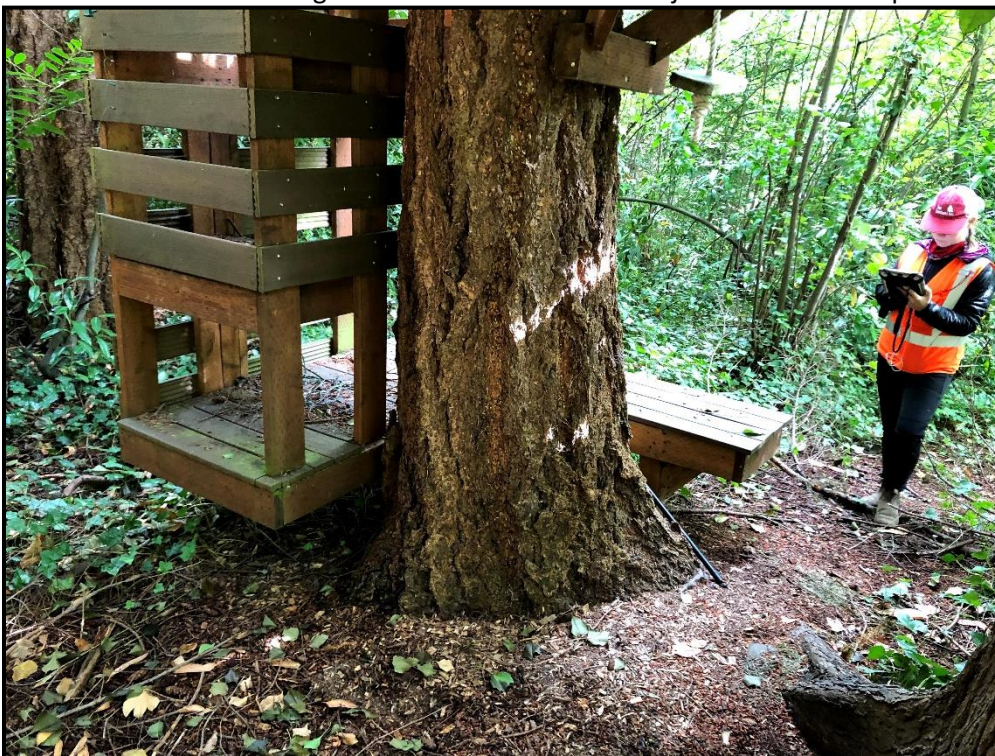
Photo 4. Tree 1810 has a platform and ladder with swing and zipline attachments; it is a primary support for the structures.
