Arborist Report

To: Ross Murray, Thomas Quigley
Site: 4803 Forest Ave SE, Mercer Island, WA 98040
Re: Micro-resistance drill testing of bigleaf maple 746
Date: Jan. 19, 2022
Project Arborist: Joseph Sutton-Holcomb
ISA Certified Arborist #PN-8397AM
Municipal Specialist, ISA Qualified Tree Risk Assessor
Reviewed By: Connor McDermott,
ISA Certified Arborist #PN- 8704A
ISA Qualified Tree Risk Assessor
Attached: Micro-resistance drill test results

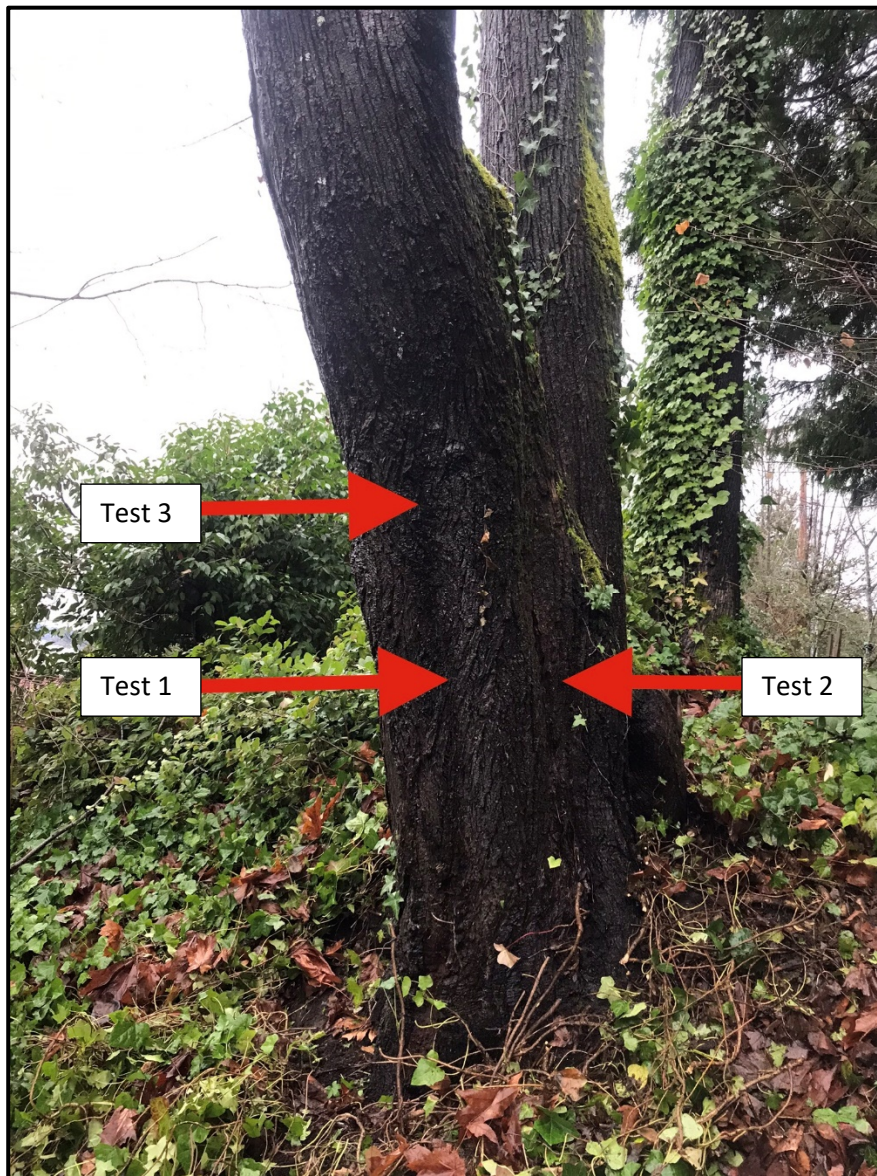
I conducted four micro-resistance drill tests on this tree. Three of the tests assessed the southern stem due to the structural defects observed in the visual tree assessment. The results of the tests with accompanying analysis are attached to this report. The tests found significant internal decay in the south stem, and decay to a lesser extent in the north stem.

Photo 1. A view looking north at the tree in question. The approximate locations of the Tests 1, 2 and 3 in the south stem are indicated.

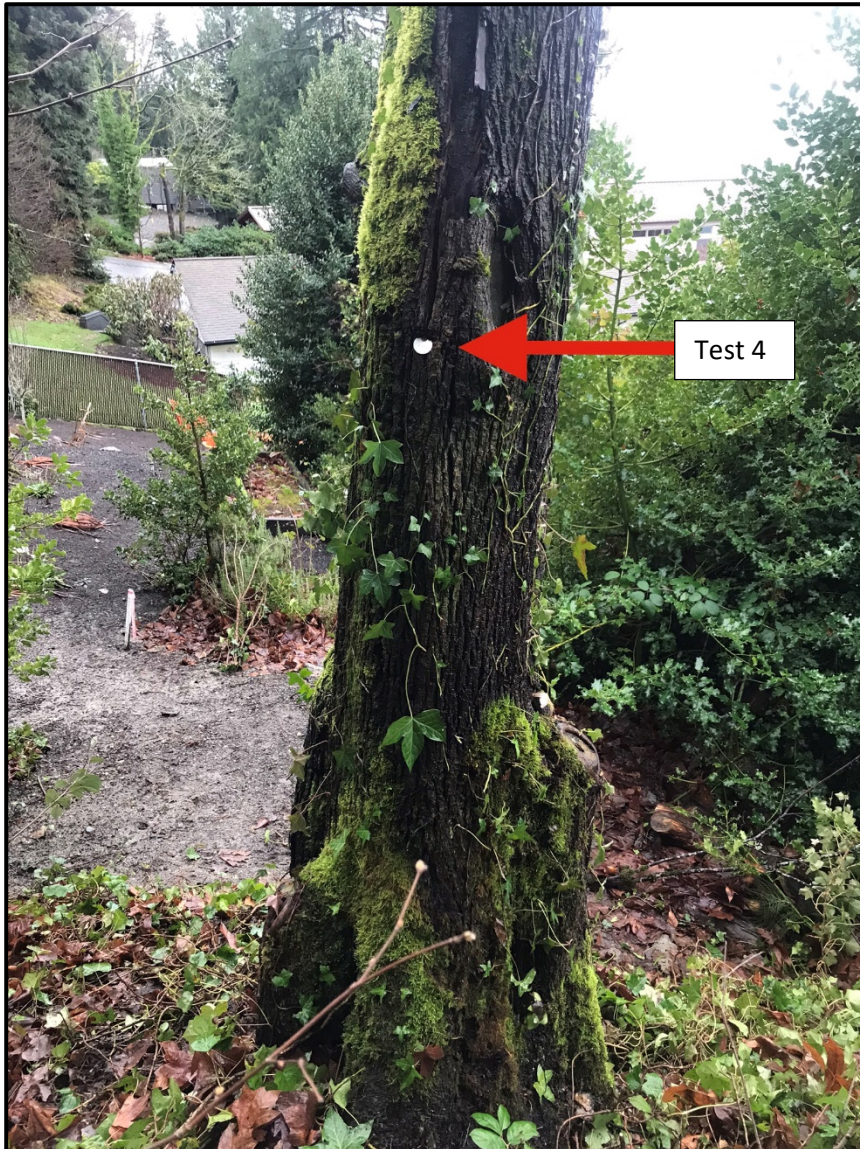
Photo 2. A view looking south at the tree in question. The approximate location of test 4 on the north stem is indicated.

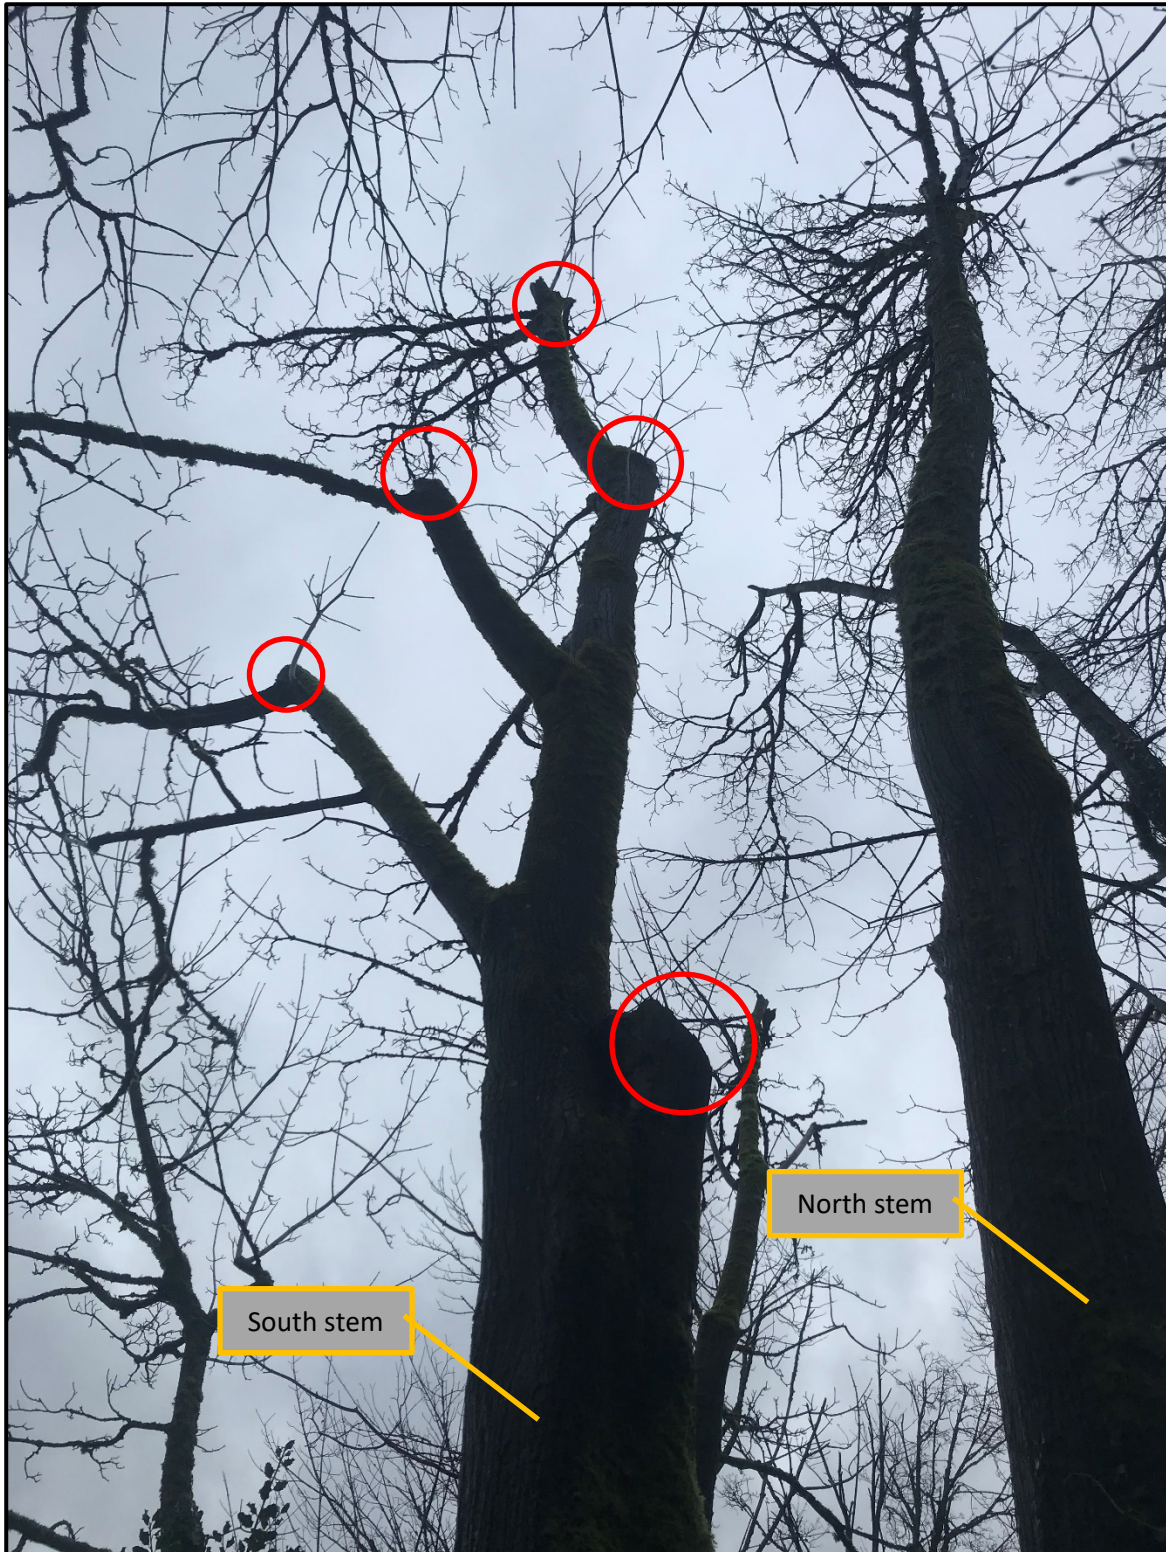
I noted that the south stem was cantilevered downslope to the south. I observed that several branches have been pruned out of the south’ stem’s upper canopy in the past. This reduction pruning appears to have contributed to the cantilevered form of this stem by encouraging lateral growth downslope to the south.

Photo 3. A view of the crown of the tree in question with the two stems indicated. The red circles indicate past pruning cuts, which has resulted in the southern stem having a cantilevered form to the south.

- If the new garage is permitted for construction downslope to the south of tree 746, reduce the south stem of the tree to a 20' wildlife snag to mitigate the risk of stem failure onto the garage.

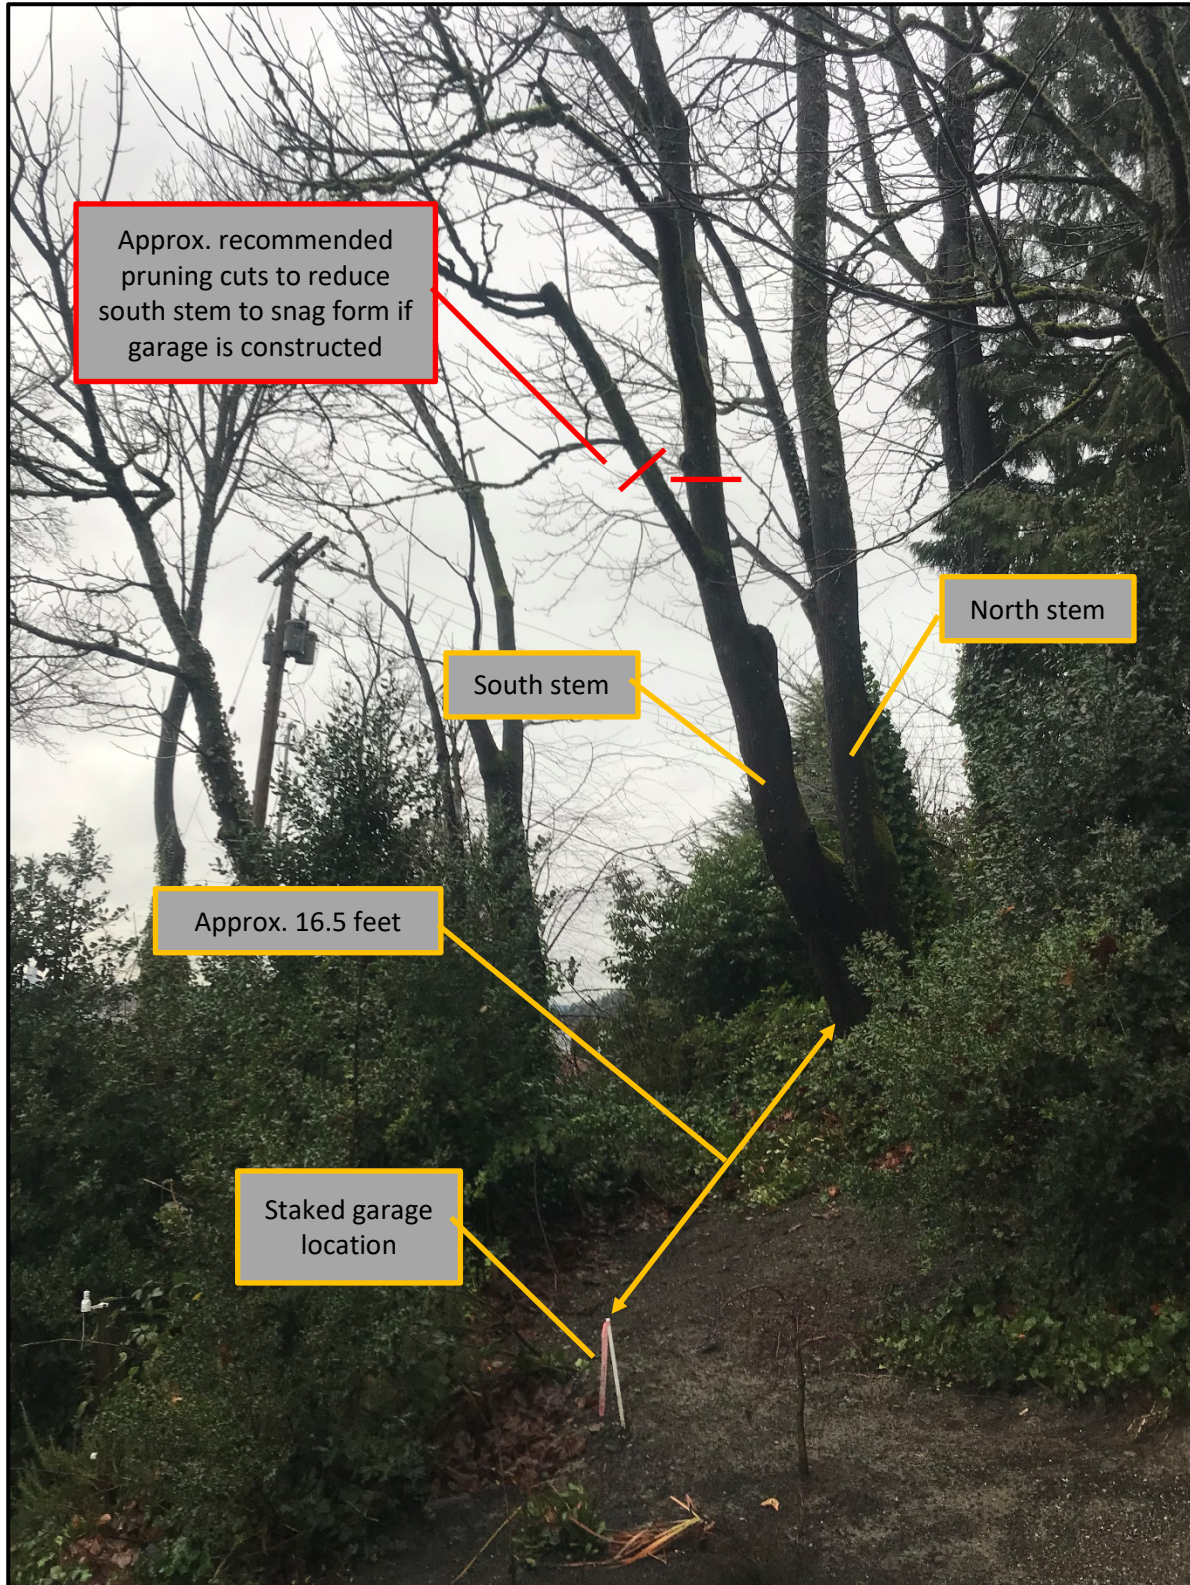
I measured the newly constructed house to be 20-feet to the east of the trunk of the maple tree in question. I measured the staked location of the proposed new garage to be 16.5-feet to the south of the trunk.

Based on visual tree assessment and micro-resistance drill test assessment, I believe the likelihood of the southern stem failing in a 3-year time period to be probable. In my opinion, the stem is likely to fail downslope, which makes the likelihood of the stem impacting the house to the east low. However, if the new garage is constructed at the staked location on site, the south stem would have a high likelihood of impacting it with severe consequences. If the garage is permitted for construction, I recommend

Photo 4. A view looking northwest at tree 746 and the staked location of the proposed garage.

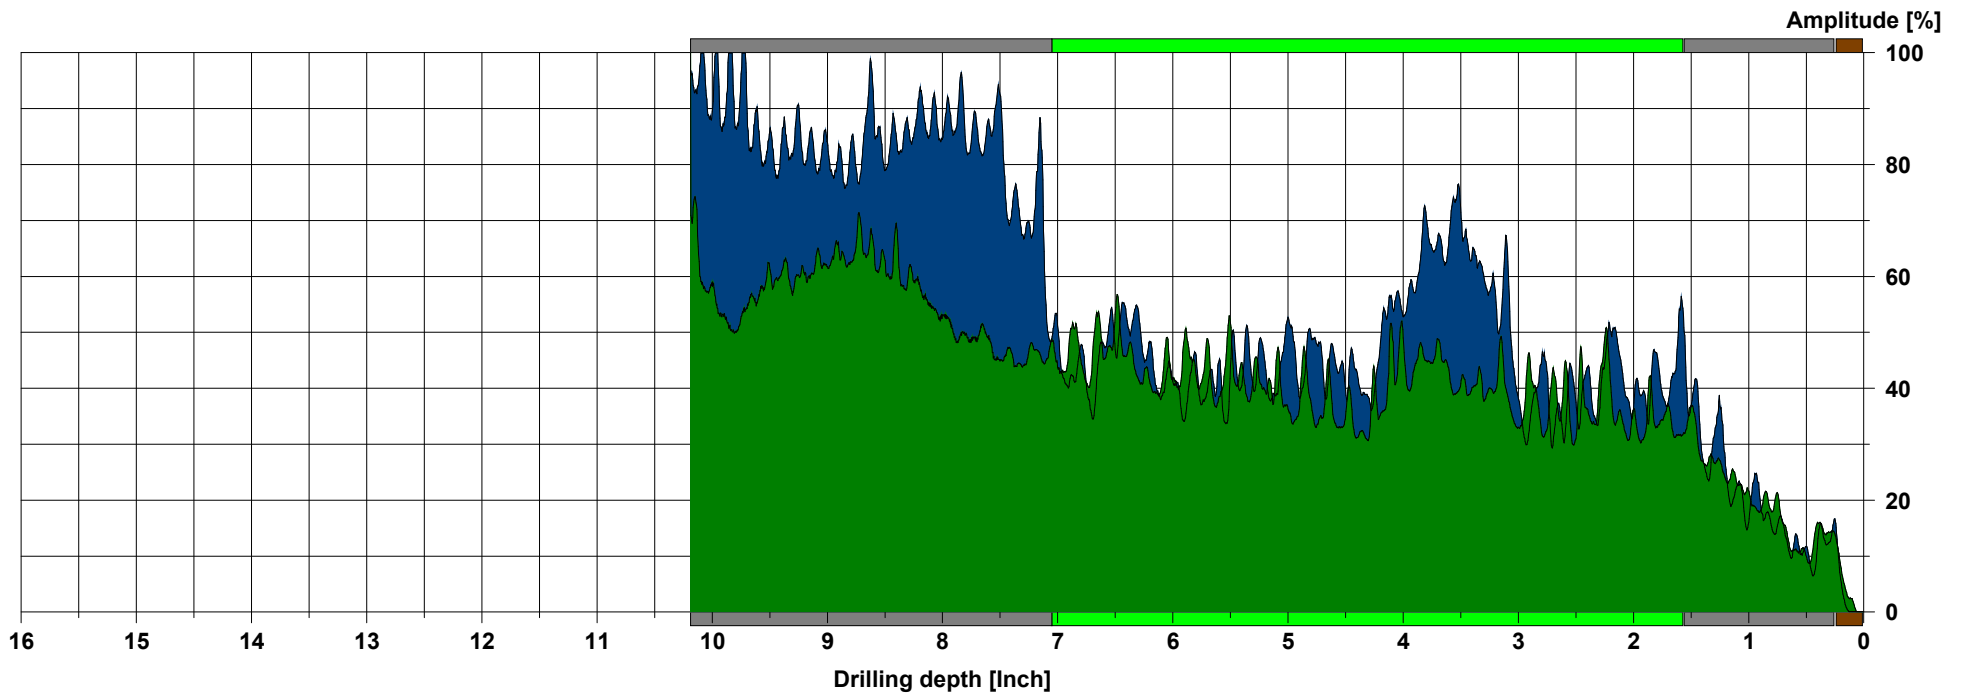
From 0,01 in to 0,24 in	: Air/Bark
	From 0,26 in to 1,56 in	: Unusual Pattern
	From 1,57 in to 7,05 in	: Sound Wood
	From 7,05 in to 10,19 in	: Unusual Pattern

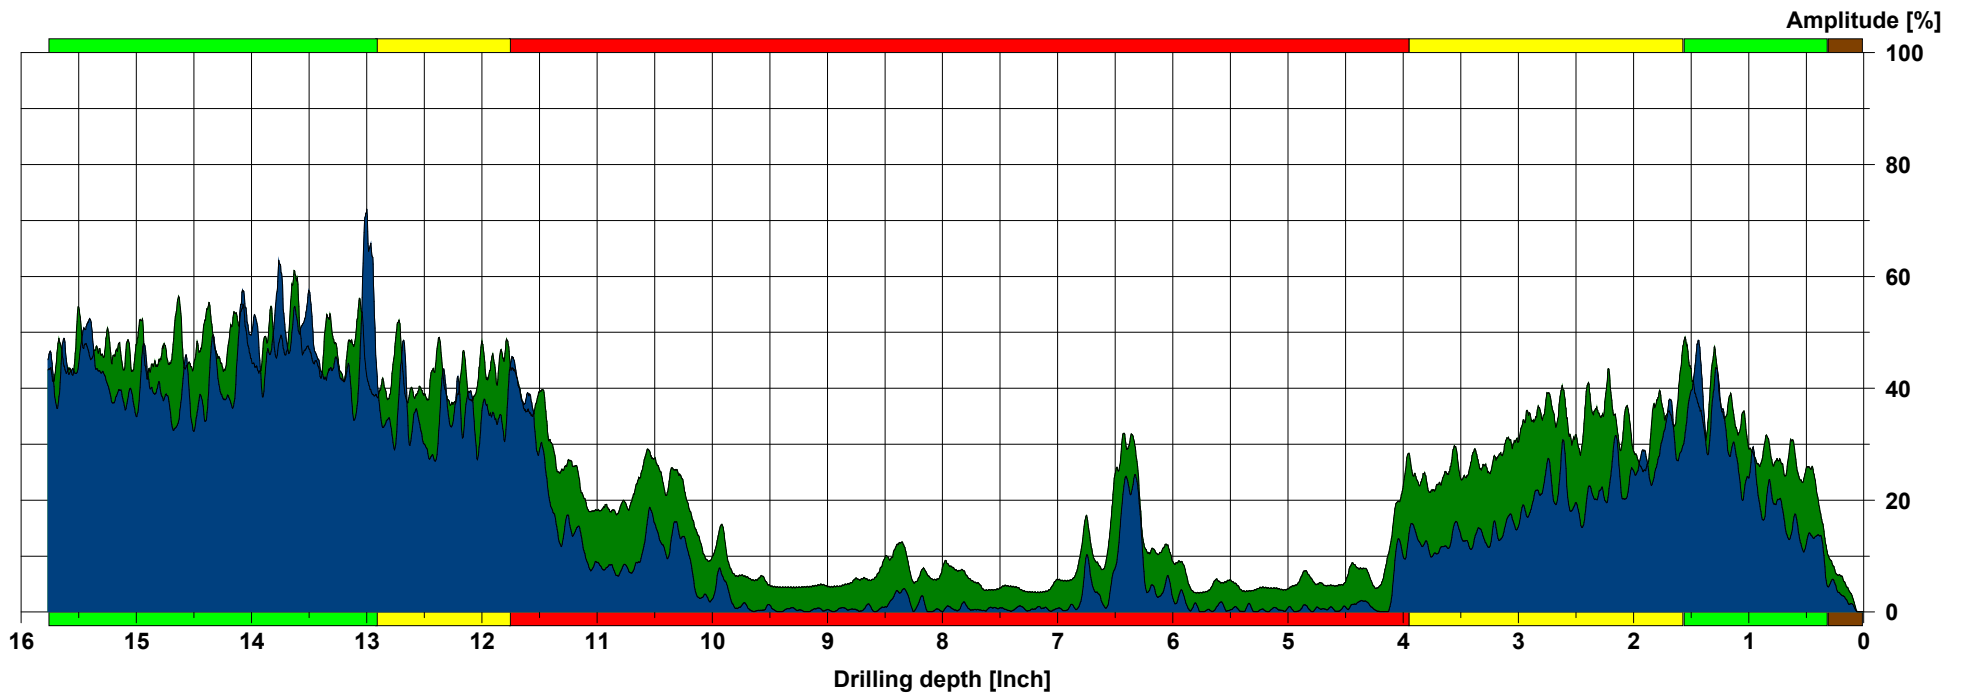
■	From	0,01 in	to	0,31 in	:	Air/Bark
■	From	0,32 in	to	1,56 in	:	Sound Wood
■	From	1,57 in	to	3,95 in	:	Early Decay
■	From	3,95 in	to	11,76 in	:	Decay/Hollow
■	From	11,75 in	to	12,92 in	:	Early Decay
■	From	12,91 in	to	15,76 in	:	Sound Wood

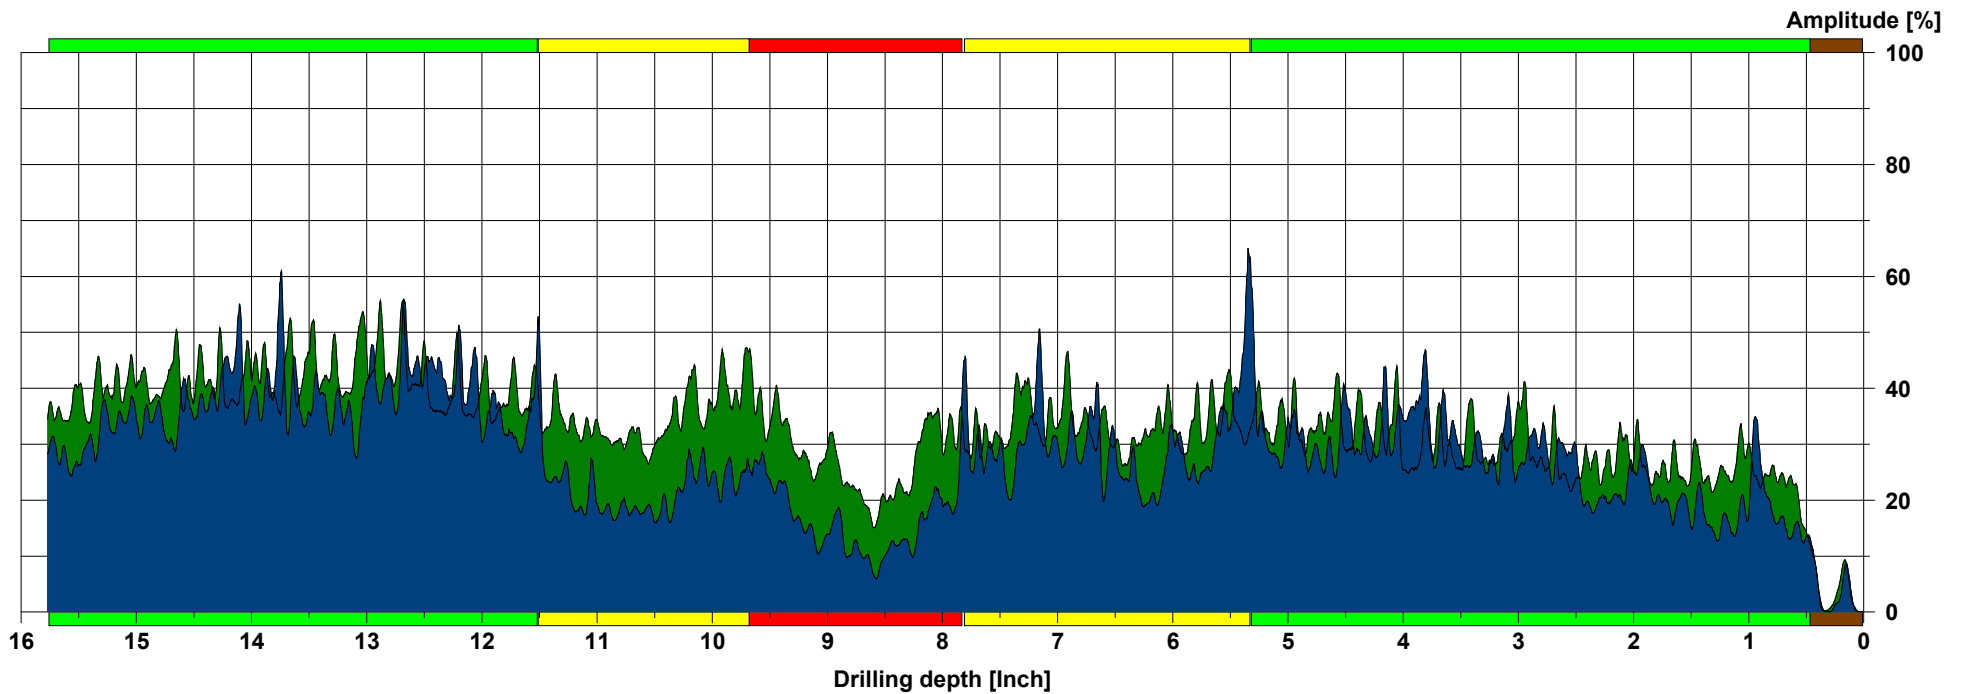
■	From	0,01 in	to	0,47 in	:	Air/Bark
■	From	0,47 in	to	5,32 in	:	Sound Wood
■	From	5,33 in	to	7,81 in	:	Early Decay
■	From	7,83 in	to	9,68 in	:	Decay/Hollow
■	From	9,68 in	to	11,51 in	:	Early Decay
■	From	11,52 in	to	15,76 in	:	Sound Wood
