PRELIMINARY SOIL INVESTIGATION

LOTS 3, 4 AND 5

7600 BLOCK WEST MERCER WAY

MERCER ISLAND, WASHINGTON

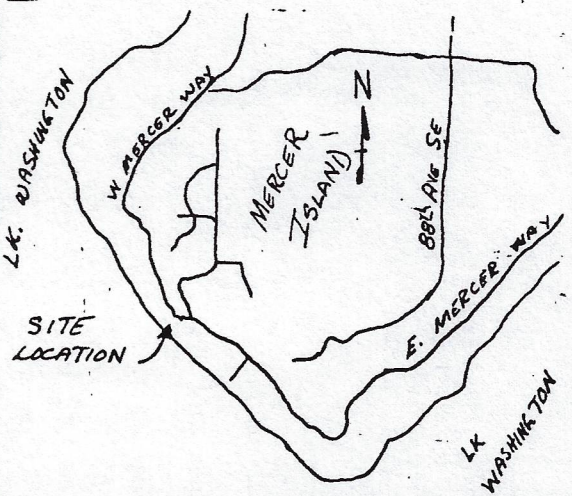
The locations of the test pits are shown on the Site Plan, Plate 1, with the test pit logs presented on Plates 2 through 5.

Groundwater was encountered in Test Pit No. 1 at a depth of 6-1/2 feet below the surface flowing downhill toward the west. Some springs were noted emanating from the slope just above Test Pit. No. 2.

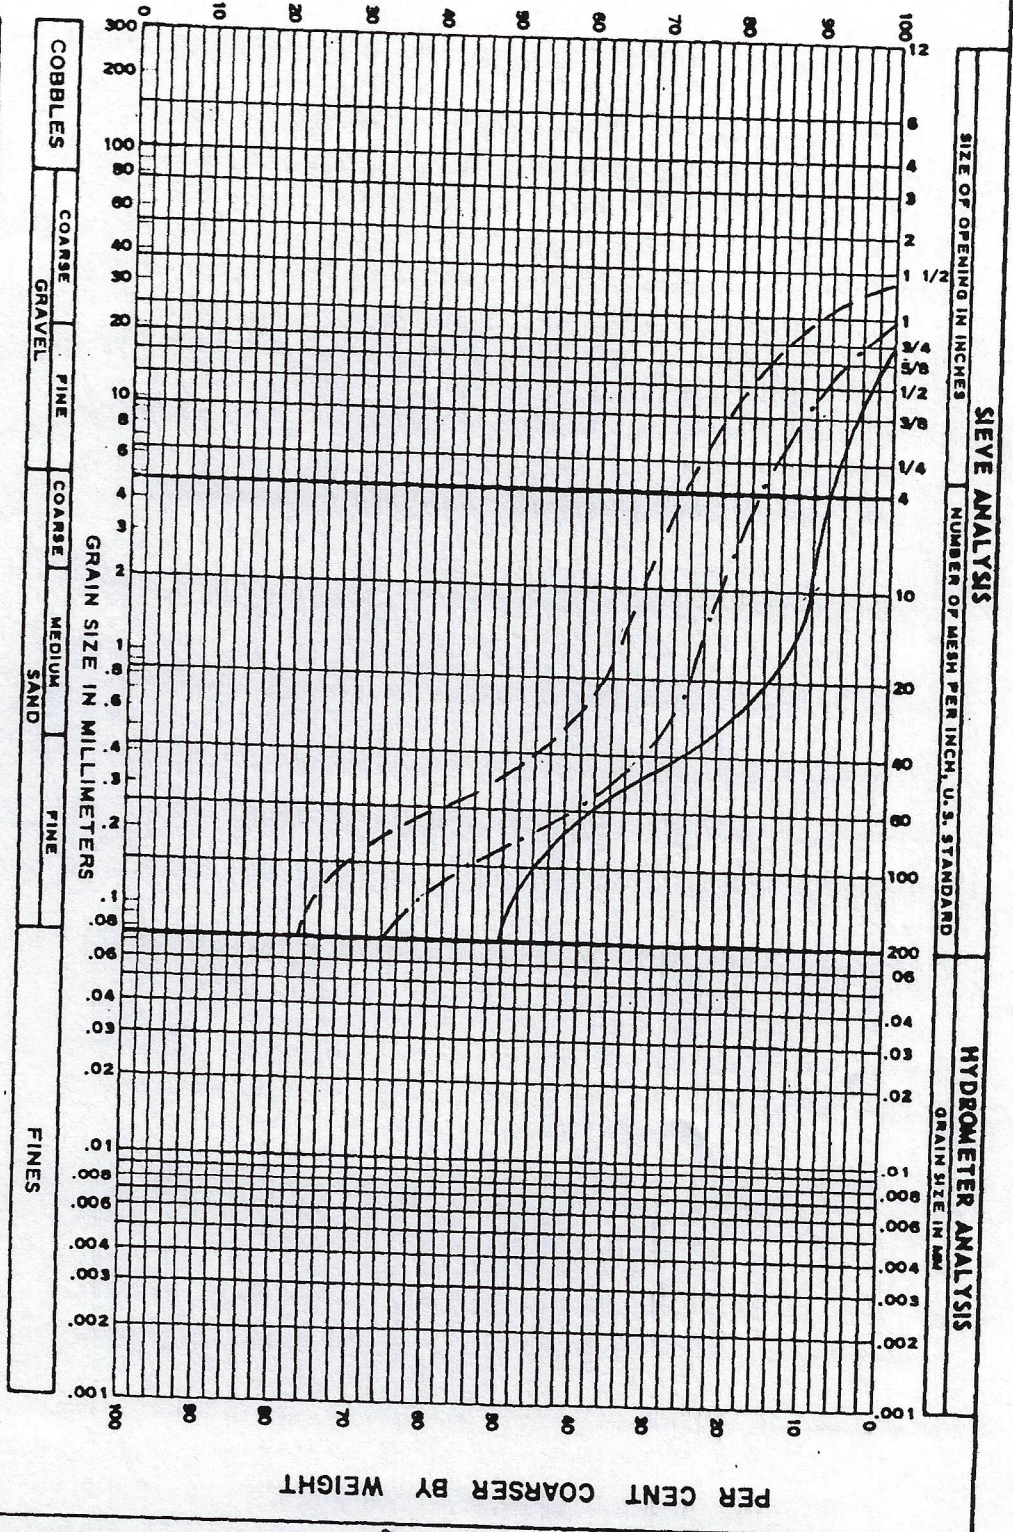
Test Pit No.	DEPTH -FT.	U.S.C.	DESCRIPTION	NAT. W.C. %	LL	PL	PI
5	4.5	SM	silty gravelly SAND	11.1		NP	
6	1.0	ML	sandy SILT with some gravel	11.6			
7	8.0	SM	gravelly silty SAND	8.0		NP

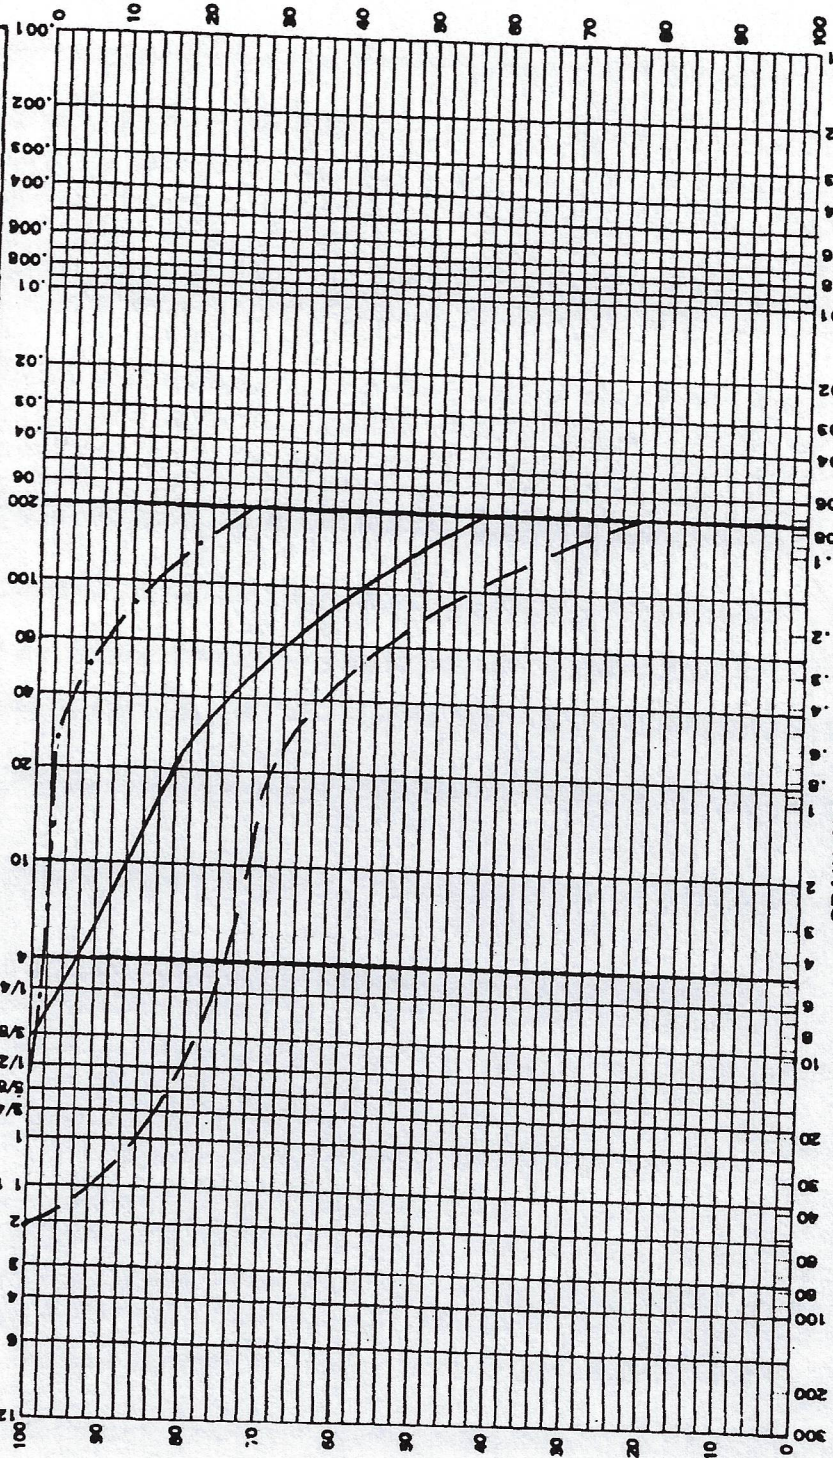
PLATE 7

Test Pit NO.	DEPTH -FT.	U.S.C.	DESCRIPTION	NAT. W.C. %	LL	PL	PI
1	1.5	SM	silty SAND with some gravel	17.6			
1	7.5	ML	fine sandy SILT	16.7			
2	5.0	SM	silty gravelly SAND	7.5
