June 22, 2001
91P-15269

**Subject: Geotechnical Reconnaissance Report
Coson Residence
7709 West Mercer Way
Mercer Island, Washington**

GEOTECHNICAL INVESTIGATION REPORT

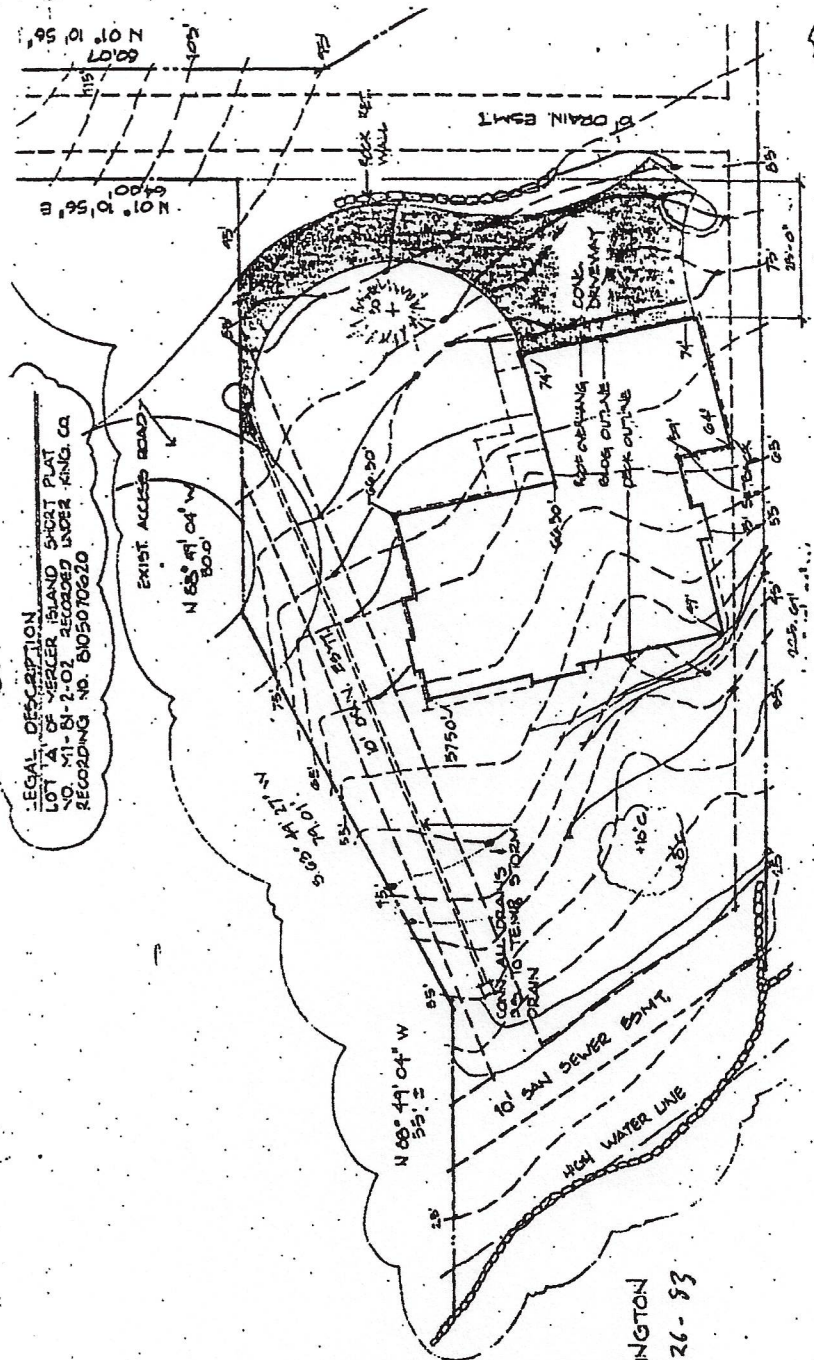
Enclosure: October 26, 1983 Topography and Grading Plan

We also reviewed a letter and attached drawing dated October 26, 1983, from George Lewis to City of Mercer Island, entitled *Landscaping Plan of Lewis Home*. This plan indicated the landscaping of the area to the west of the house was to consist of four terrace areas, separated by 1.5H:1V slopes. Hand-drawn grading contours suggest this area was filled by about 10 to 12 feet.

In our opinion, based on our surface observations and geotechnical research, the primary cause of the recent landslide was the infiltration of large quantities of water into the ground, stemming from the break in the water line above the residence. A contributing cause to the water line break may have been the February 28, 2001 earthquake. It appears that the soils involved in earth movement are the fill soils, which were emplaced atop the relatively dense native soils. The shape and direction of earth movement appears to be down the axis of the former swale area (see attached sketch from October 26, 1983 letter referenced above).
