February 27, 2020

RE: SIDE SEWER SETTLEMENT AT 7701/7703 WEST MERCER WAY,  
MERCER ISLAND, WASHINGTON

Side Sewer Line Break at 7701/7703 West Mercer Way  
Photographs

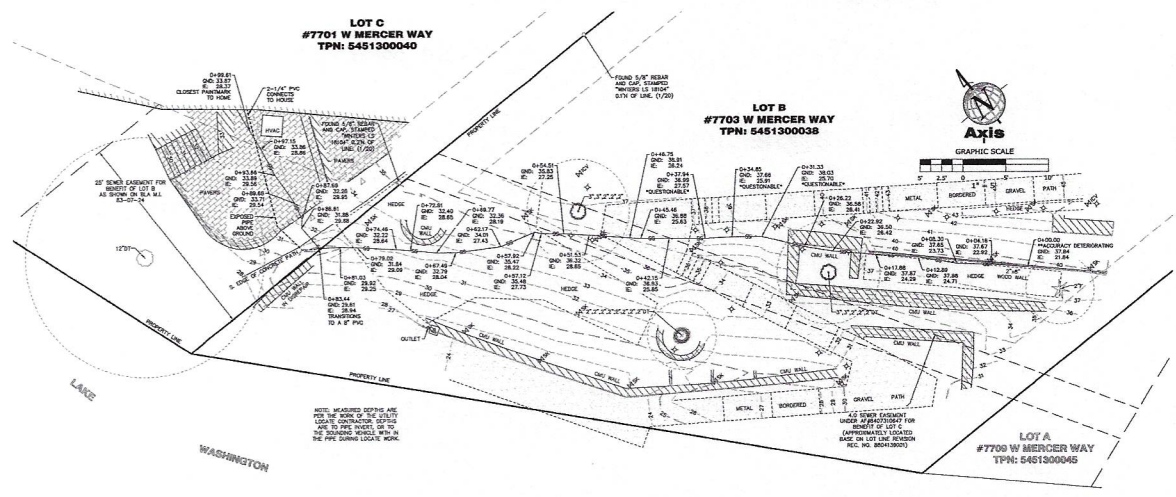
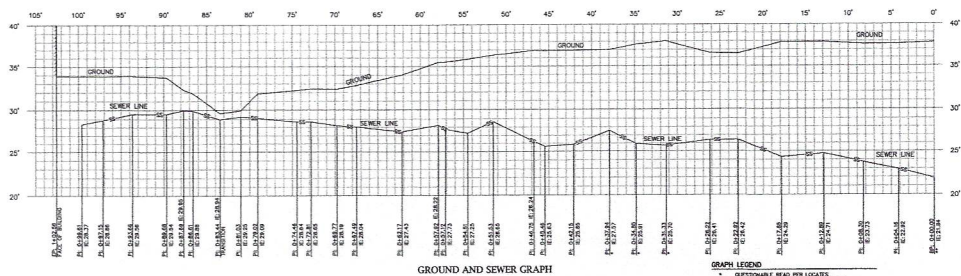
Figure 2 - January 7, 2020 Survey  
 SE 1/4, SW 1/4, SEC. 25, TWP. 24N., RGE. 4E., W.M. CITY OF MERCER ISLAND, KING COUNTY, WASHINGTON

measurements made for the side sewer segment on the Lewis property show the plan location varies substantially from the projected line. The depths apparently increase from south to north, i.e., the opposite of the likely pipe grade. Therefore, we recommend not using the pipe position measurements to judge pipe grades and plan. The measurements could be used for gross estimates of pipe depth for planning purposes. We estimate the error in position could be on the order of +/- 2 feet. The error could be greater where the side sewer is deeper than 6 to 10 feet below ground surface.

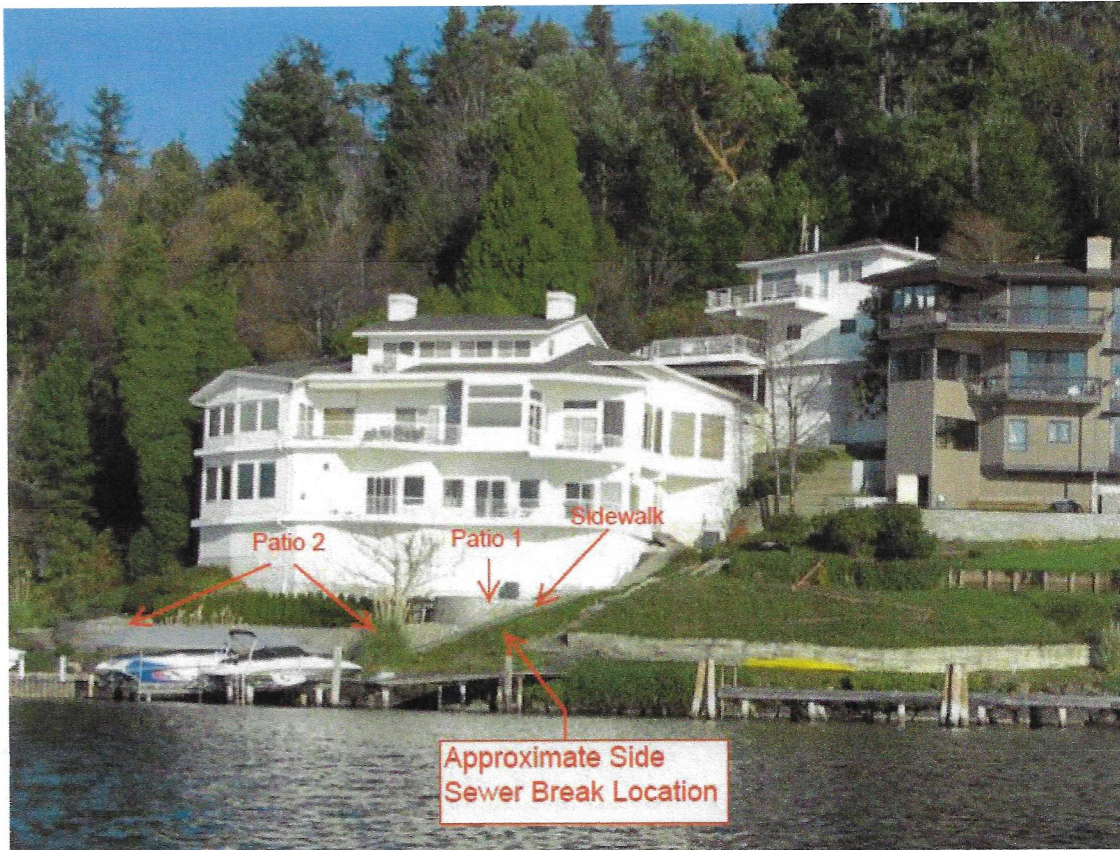
- (1) **December 2009 Overview.** White house is 7701 West Mercer Way. Light brown house to the right (south) is the Gartz Residence at 7703 West Mercer Way.

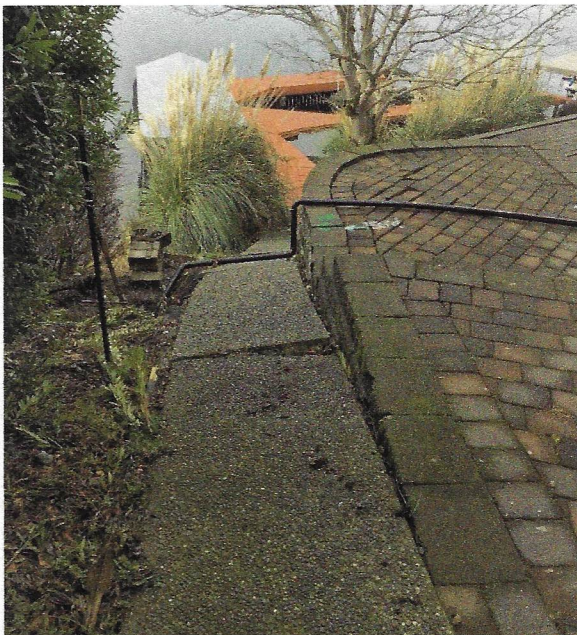
- (2) **7701 Sidewalk Near the Property Line.** January 5, 2019. Looking west to Lake Washington. Note:

- Temporary 2-inch diameter black ABS sewer line crossing over Patio 1, sidewalk and into excavation to connect to the side sewer line.
- Sidewalk panels displaced to the left (south) and displaced vertically at joints.

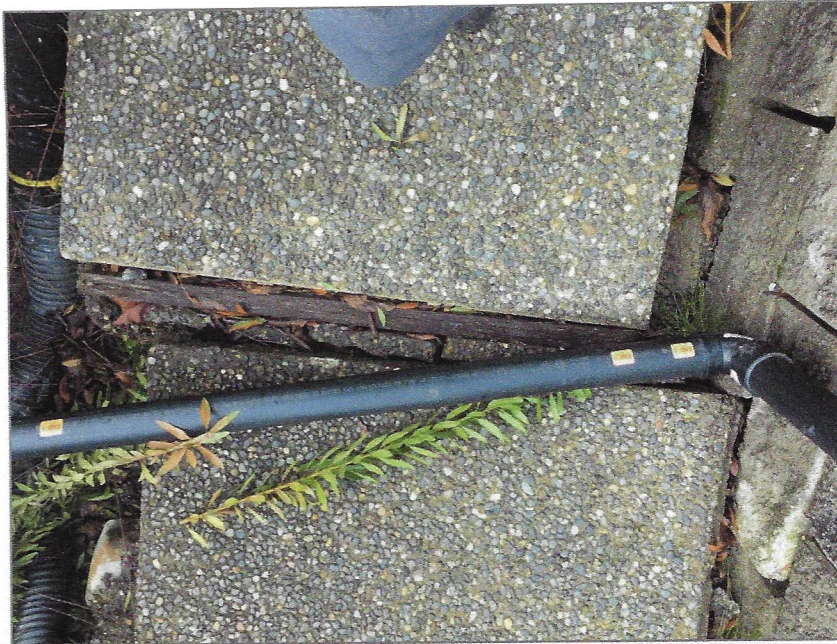
(3) **Closeup of 7701 Sidewalk.** January 5, 2019. The top of the photograph is towards the lake (west). Note the temporary sewer line. The downhill panel is offset 6 inches to the south and about 5<sup>3</sup>/<sub>4</sub> inches to the west.

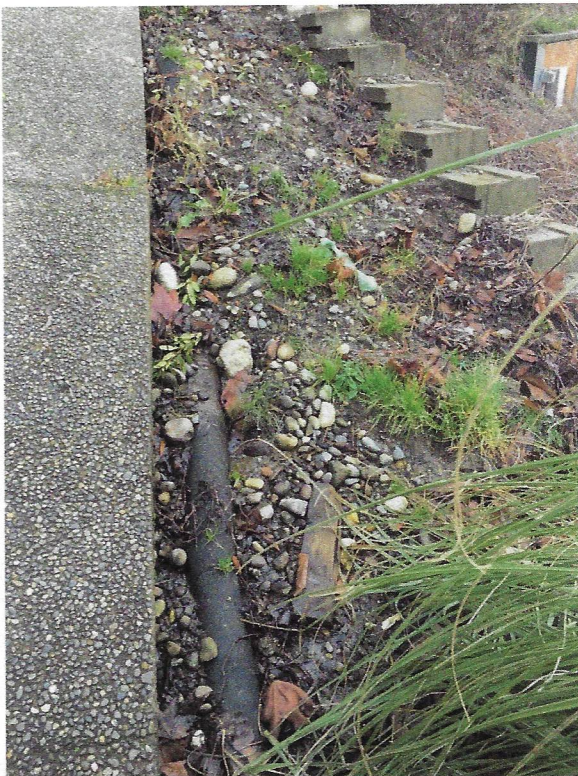
(4) **Subsurface Drain Line next to 7701 Sidewalk.** January 5, 2019. Looking east. Note:

- Geotextile wrap directly around pipe.
- Subsurface drain is exposed at the surface.
- No drainage backfill around pipe.
- Ground is wet with slight seepage near the bottom of the picture.

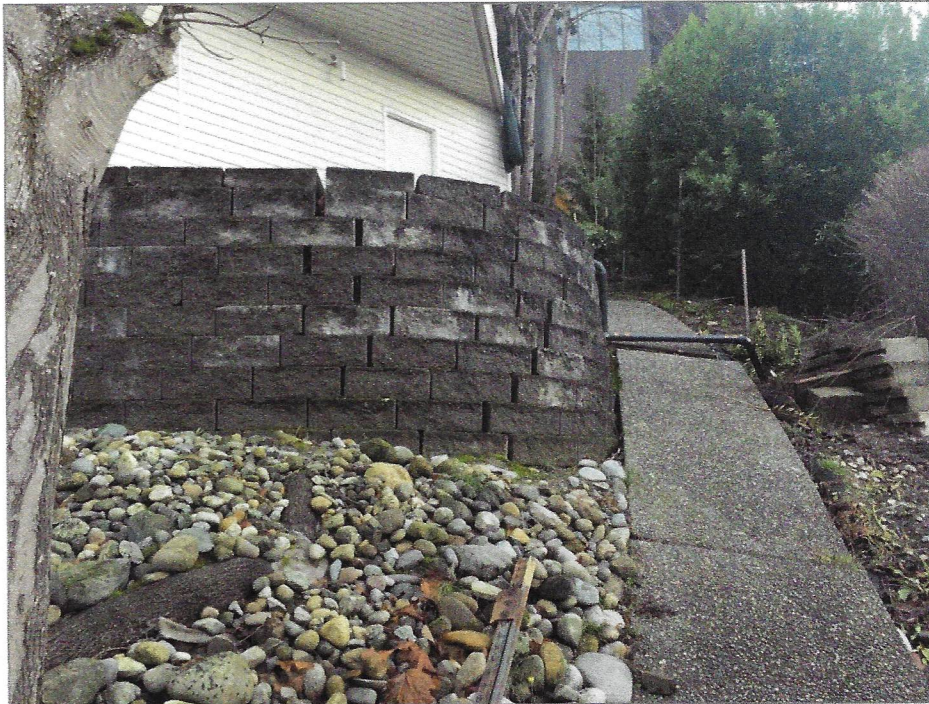
In our opinion, fill for your neighbor's Patio 1 that is above his side sewer line is moving downslope. This movement severed the side sewer on his property and caused his side sewer line to sever on his property and to settle mostly on his property and extending about 10 feet on to your property. As described above, that patio wall probably has settled at least 5.5 inches and moved laterally at least 5 inches. As described in the Site Observation Section, we could not see evidence that the Patio 1 walls were properly designed and constructed using conventional geotechnical practices, such as drainage and geosynthetic soil reinforcement. We understand the patio construction was not permitted by the City of Mercer Island.

(5) **Patio 1 CMU Wall.** Looking east. Note openings between blocks caused by settlement and movement downslope. The wall has pushed the sidewalk to the right (south).

We anticipate Patio 1 on the Lewis property will continue to slump and move downslope. This ground movement would affect a new side sewer. Therefore, we recommend that Mr. Lewis replace Patio 1 with a new patio that is designed, permitted, and constructed in accordance with City Mercer Island codes. We anticipate this will require geotechnical studies to provide design recommendations.

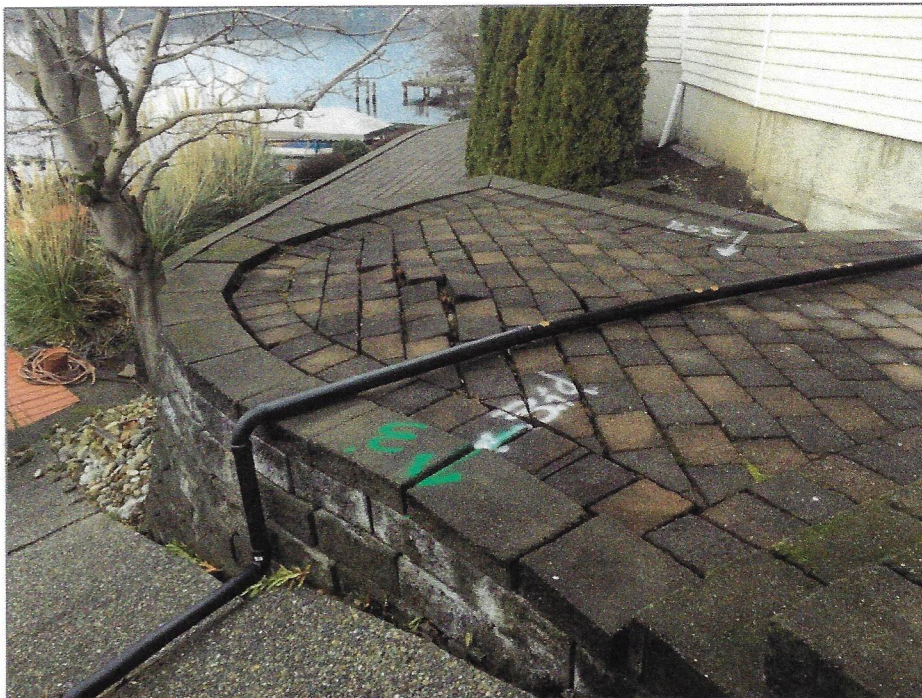
(6) **Patio 1 Pavers.** Looking west. Note the settlement relative to the wall and the openings between the pavers caused by lateral movement.

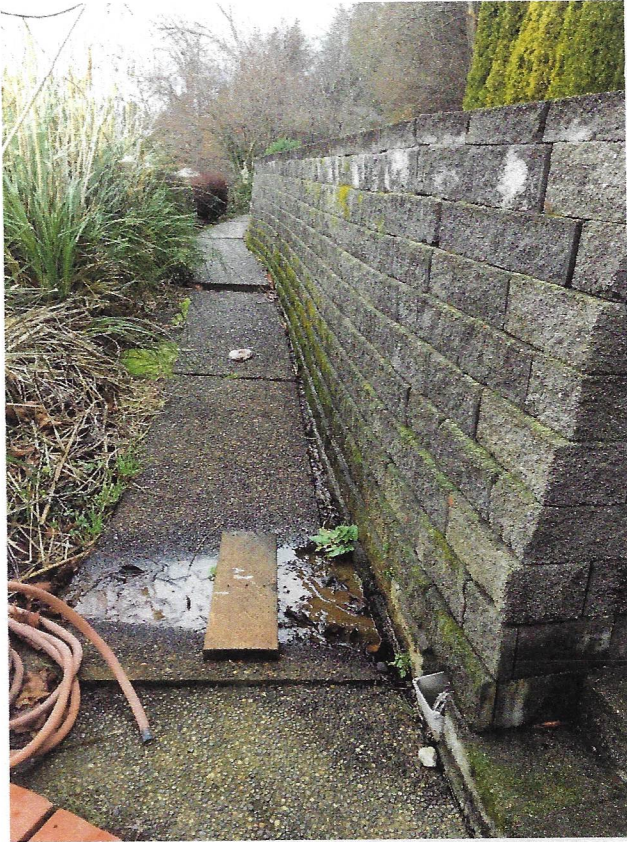
Patio 2 that is parallel to the lake and downslope from your neighbor's house shows evidence of landslide movement. That movement caused settlement and lateral movement of the sidewalk below the Patio 2 retaining wall. Patio 2 may have been constructed over Holocene Lake silt and clay, which is a weak and settlement prone soil. The Patio 2 movement may have reduced support for the toe of the smaller Patio 1 retaining wall that is over your neighbor's side sewer line. If so, it would have exacerbated the slope movement caused by the Patio 1 fill and retaining wall. As described in the Site Observation Section, we could not see evidence that the Patio 2 walls were properly designed and constructed using conventional geotechnical practices, such as drainage and geosynthetic soil

(7) **Patio 2 CMU Wall.** Looking North. Note apparent sidewalk settlement close to the photographer, curved wall face, and groundwater seepage. In addition to visible seepage in the foreground, the moss along the bottom tiers of the wall indicate moisture for seepage.

Patio 2 on the Lewis property may be contributing to the slope between Patios 1 and 2 moving downslope, i.e., it may be reducing support at the toe of Patio 1. Therefore, we recommend that Mr. Lewis design, permit and perform repairs or a replacement for Patio 1 in accordance with City of Mercer Island codes.

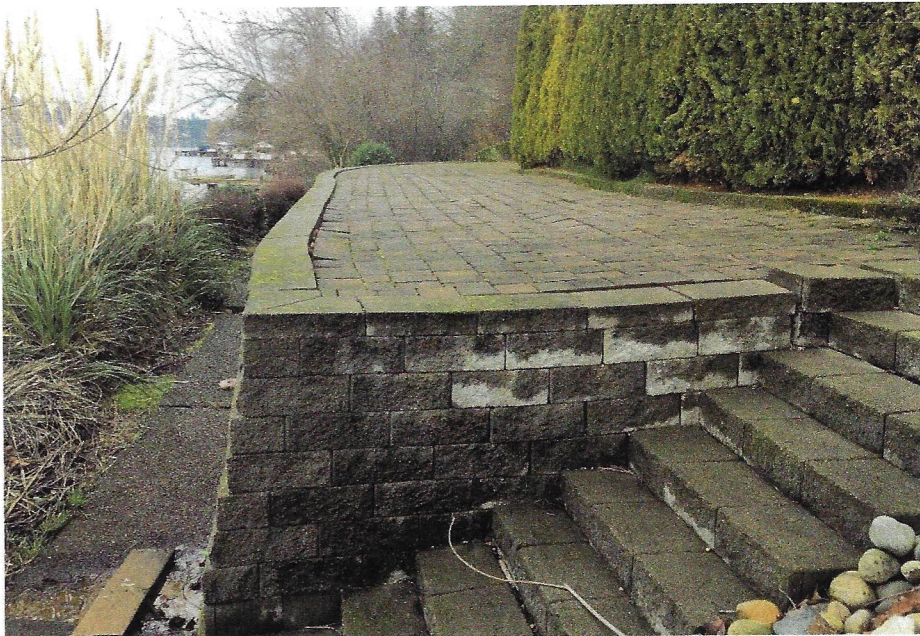
(8) **Patio 2 Pavers.** Looking North. Note curved CMU wall top, and pavers that have settled relative to the wall. Gaps between pavers indicate lateral movement toward the lake.

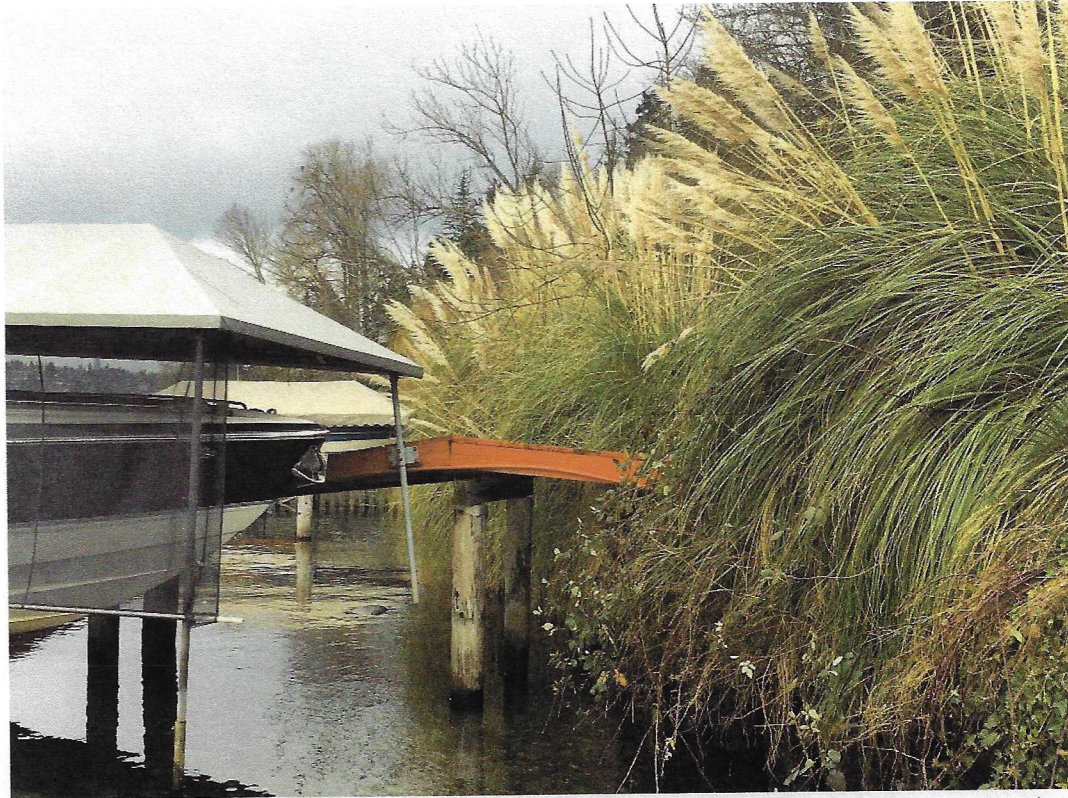
- The first bent supporting the pier appears high, which could have been caused by uplift at the toe of rotational landslide movement. See Photographs 7 through 9.

- (9) **7701 Pier.** Note that the deck has buckled upwards because of lateral movement for the abutment towards the lake. The piles may have heaved because of rotational landslide movement.
