## 77 Central HVAC repair timeline

2022/2023

# 77 Central Indoor Coils

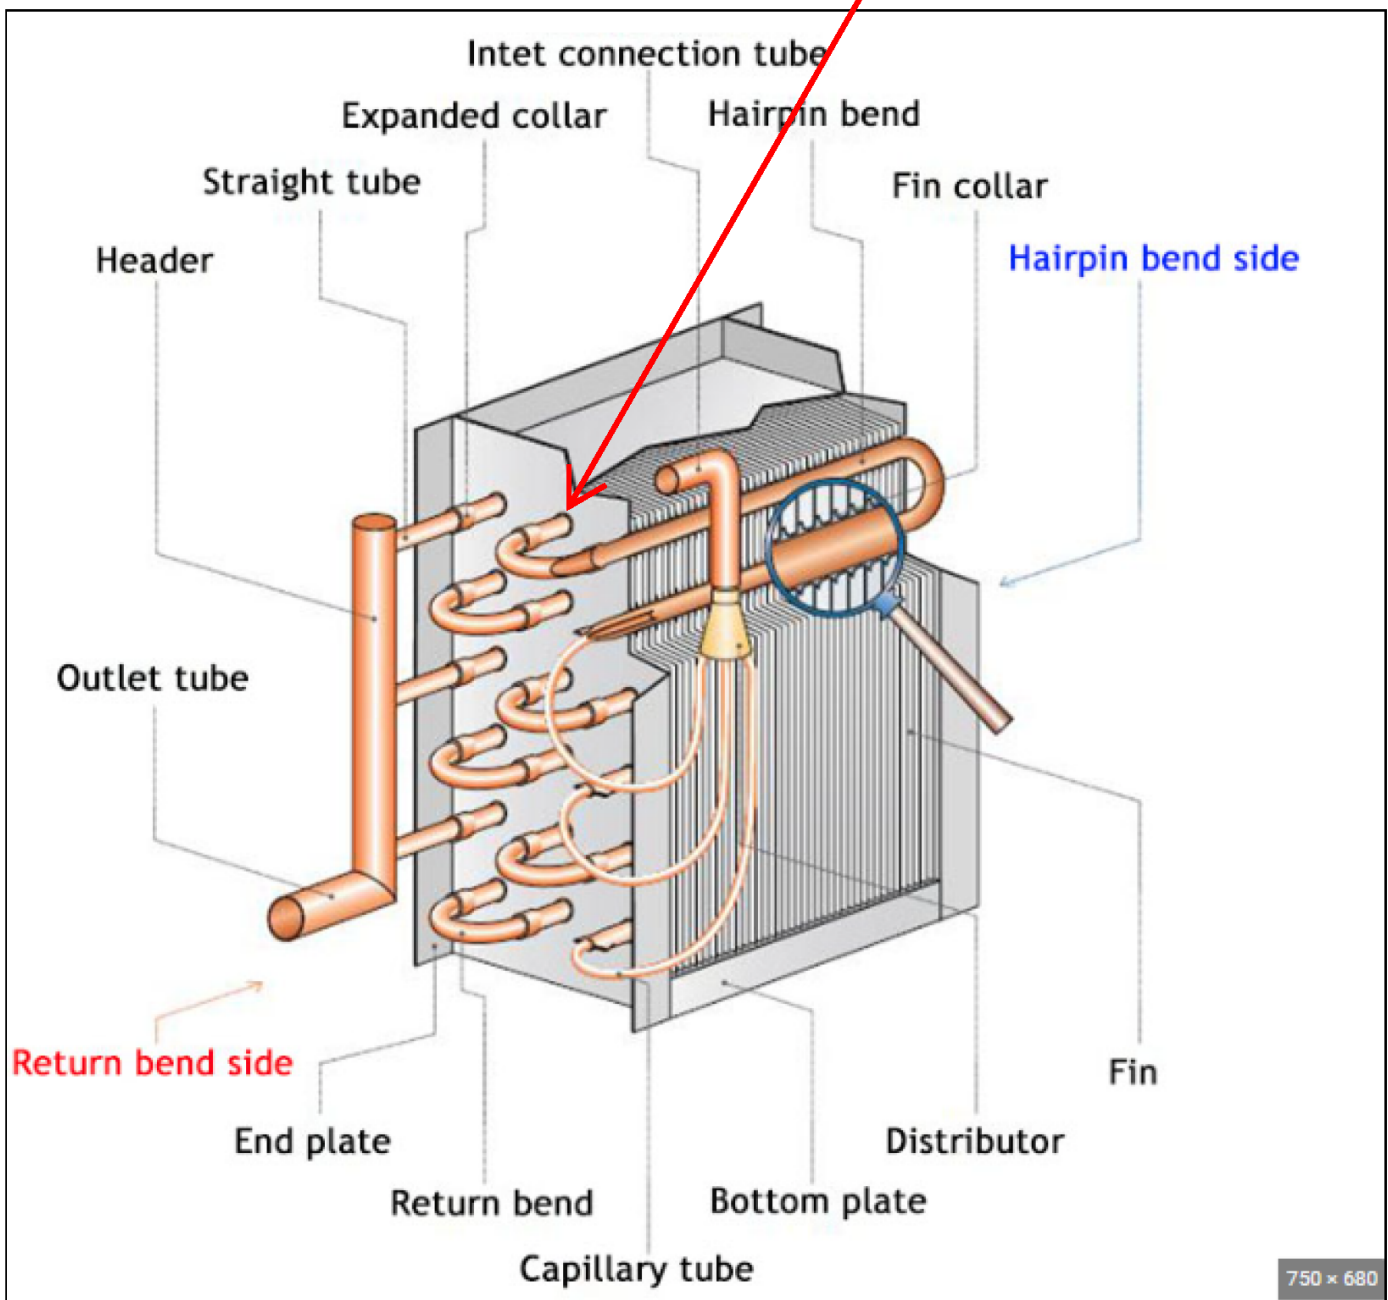
The leaks that are appearing on the indoor coils are in a very hard place to repair between the steel header end plates and the copper tubes. At the factory, the tubes are expanded to create a tight fit between the tubes, steel end plates and the aluminum fins.

The problem with the coils at 77 Central is that there are several small leaks on several tubes on both ends of the coils, and there's really no way to fix this problem other than replacement.
