**TO:** Dan Grove  
**SITE:** 3515 72nd Ave SE Mercer Island  
**RE:** Tree Health Assessment  
**DATE:** October 21, 2023  
**PROJECT ARBORIST:** Scott Selby  
ASCA Registered Consulting Arborist #749  
ISA Board Certified Master Arborist #PN-1775B  
ISA Qualified Tree Risk Assessor  
**ATTACHMENTS:** Map  
Photos  
References  
Glossary  
Assumptions and Limiting Conditions  
Certification of Performance

### **INTRODUCTION and SCOPE of WORK**

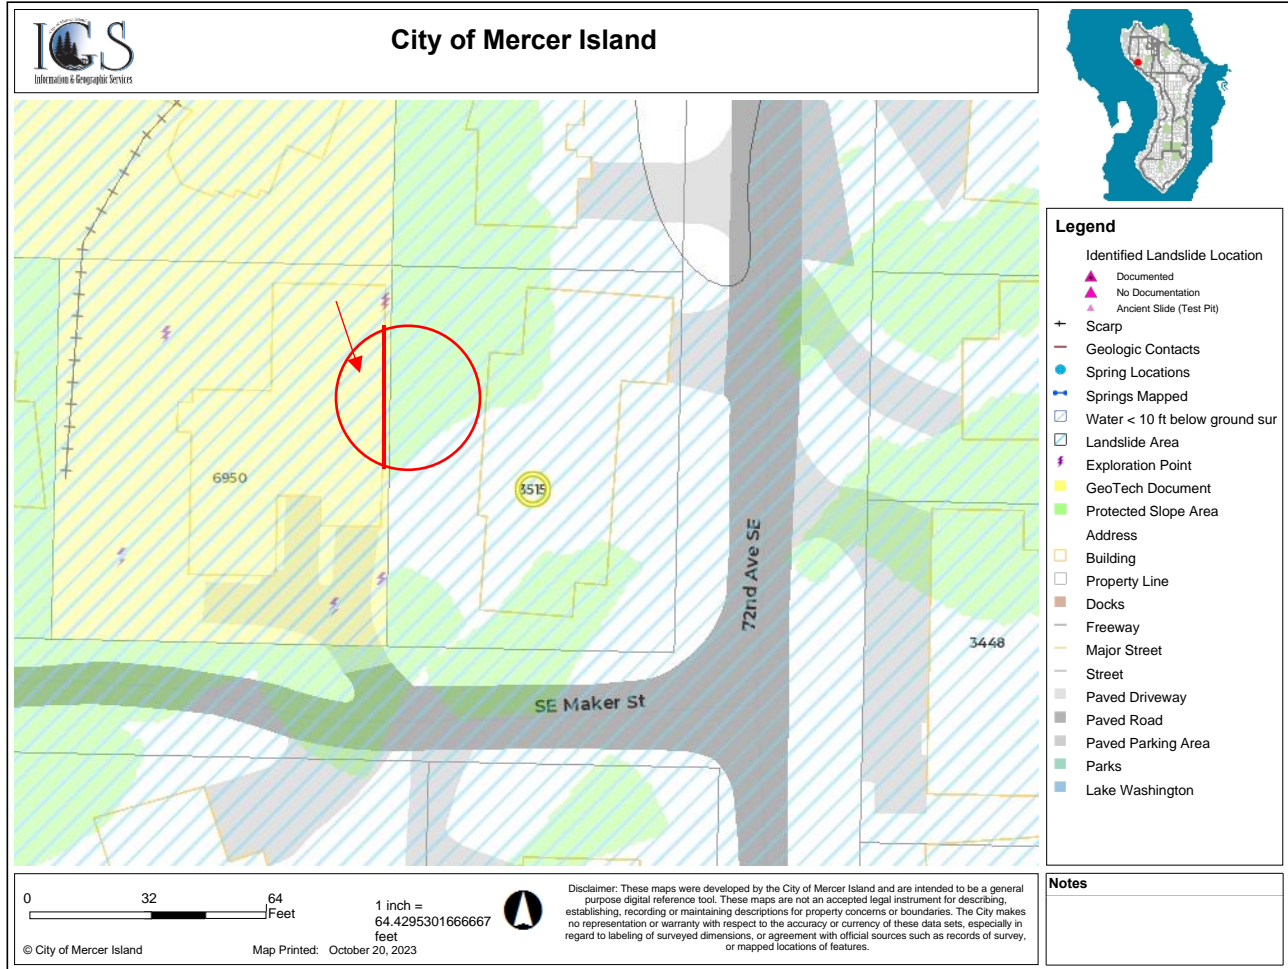
Image 1: Mercer GIS map showing approximate area of tree removed by topping (arrow).

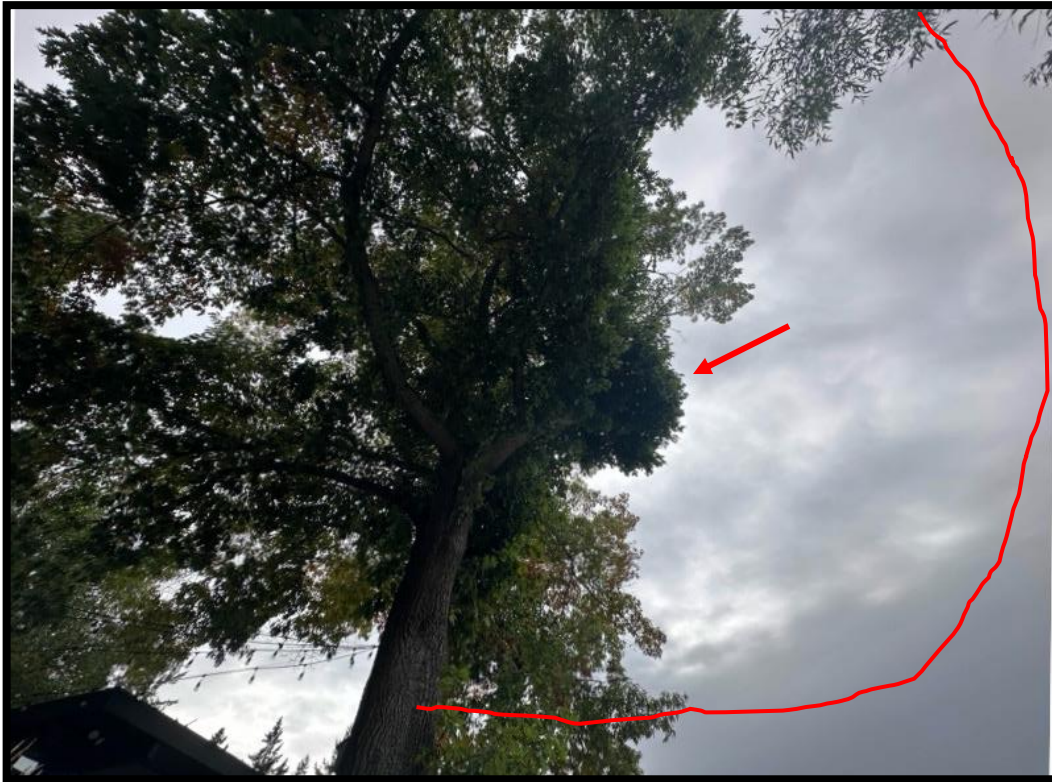
The tree in question is a 45-inch DSH (141-inch circumference) red oak (*Quercus rubra*). A large west stem of the tree was cut in 2021 to approximately a 12-foot stump. While difficult to determine because of excessive adventitious growth along the length of the remaining stump, diameter of the final cut appears to be approximately 18 inches. The volume of the tree removed appears to be approximately 30 percent of the total biomass of the crown. Some decline of the crown was observed during my site visit, but it was difficult to distinguish between seasonal dieback and potential stress of the tree. The skirt (lowest level of branches of the tree) is approximately 18 feet on the east side (area opposite the cutting) and approximately 50 feet where the cutting was conducted.

*Photo 1: Red outline shows approximate area occupied by the topped stem. View is looking south. Image taken looking up from base of tree. Arrow points to end of stem that was topped close to the property line and is re-sprouting.*

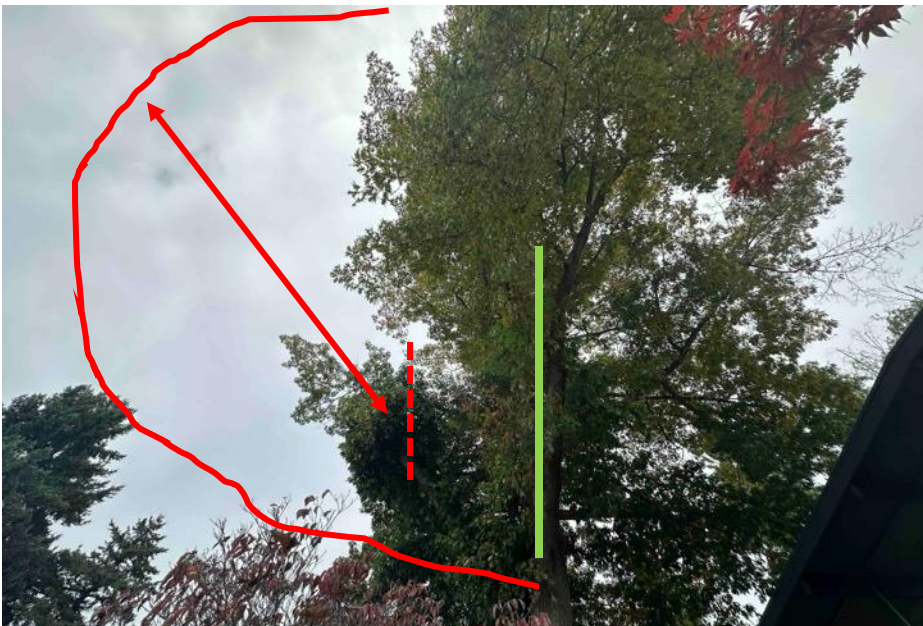
3. **Tree Health.** Prior to the cutting that occurred, tree health was identified by an arborist as being “excellent.”
4. **Cutting.** The management activity carried out on November 10, 2021 by a tree care company hired by the adjacent land owner resulted in a topping cut to a huge stem removed nearly the entire section of crown overhanging the adjacent property – constituting a loss of approximately one-third of the entire tree crown.

*Photo 2: Red outline shows approximate area occupied by the topped stem. View is looking north. Image taken from the street. Red dashed line shows how far back the topped stem was cut. Arrow indicates the approximate distance from the trunk the stem was topped. Green line identifies the main trunk for reference.*
