August 16, 2022

Project: Pre-construction assessment for lot re-development at 6950 SE Maker Street, Mercer Island, WA. Parcel number 9350900620.

Objectives: Evaluate health of existing trees and establish criteria for the preservation of those to be retained.

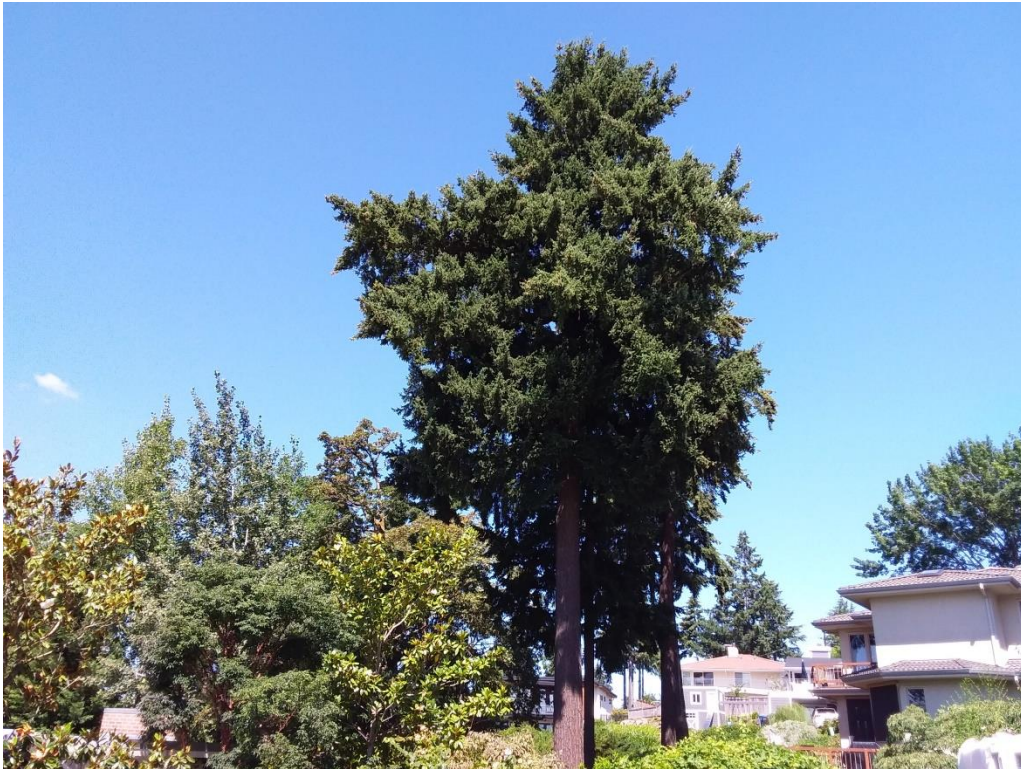
4. Douglas fir (*Pseudotsuga menziesii*) 36" DSH (may be less as it appears to have heavy bark), reaches in the neighborhood of 75' tall. It appears to have been topped multiple times and regrown (Figure 5). Exhibits good new growth and color with a full radial canopy down below the halfway point. Base of the tree is 9.5' N of the northwest corner of the subject property. There is a significant drop off in this area of the yard. The plan sheet indicates a negative 12' grade change.

According to the plan set the nearest construction impact to the fir will come from trenching for the drain lines. This will occur 40-45' out from the tree at the closest, well outside its potential rooting space.

The fir tree is also deemed to be under little to no risk of disturbance from the proposed construction project.

Figure 5. Looking NNW at the #4 fir and showing its conformation.

Ideally the protection fencing will be set up prior to the demolition. Along the east side it can just follow the top of the Keystone wall as there are no roots west of it. Technically a fence could be erected along the top of the west retaining wall but the trees to that side are not large enough to have penetrated into the subject property. Out of an abundance of caution a section of fence could be set between the north and west property lines at a radial distance of 25' out from the base of the #4 tree. This should ensure that no accidental impact will occur within the potential root zone of the Douglas fir.

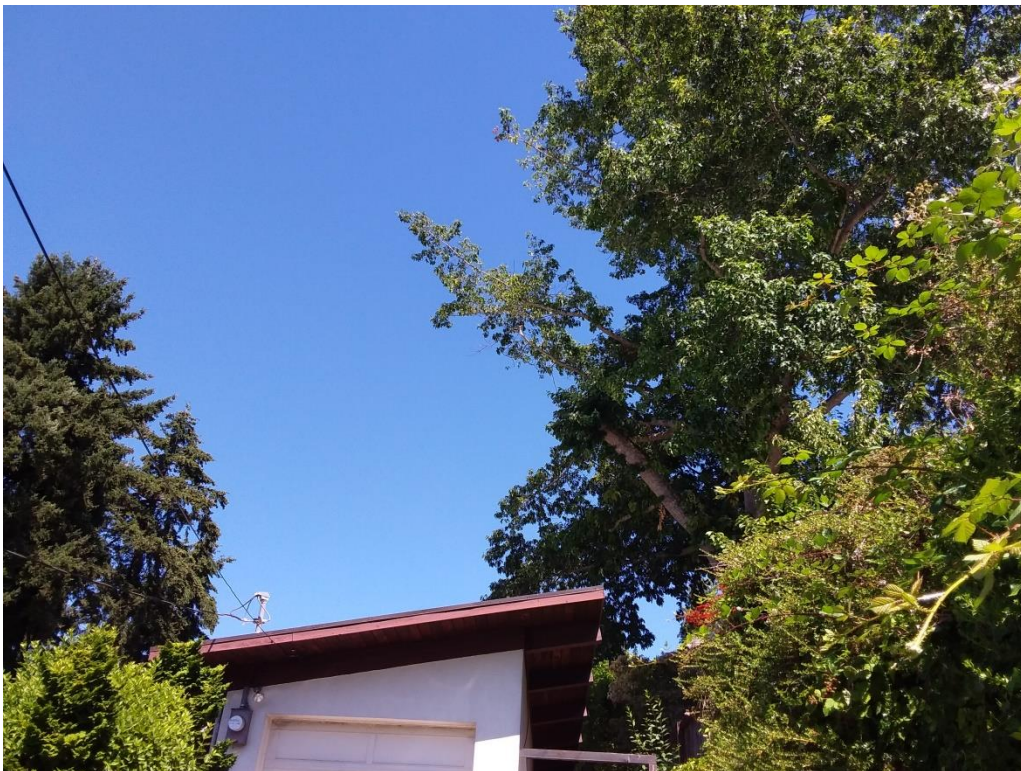
5. Red oak (*Quercus rubra*) easily 40" DSH, 50' tall in the highest reaches, spreads as much as 45' north and south, around 35' east, but was cut back quite hard on the west and extends no more than 18' to that side (Figure 6). The base of the tree is 25' S of the NE corner and 10' on center east of the east line. It sits on top of a large stone retaining wall that is near 5' tall and fully on the neighbor's lot (Figure 7). The stone wall sits above a Keystone block retaining wall that is 5.5' tall and runs along the whole east side of the existing house and 5' E of it (Figure 8). The roots from the oak have interwoven with the stones and likely have entered the soil beneath but primarily they have to have spread toward the east side neighbor's house. There are no indications that the oak's roots have disrupted the Keystone blocks. The oak appears to be fair condition overall but is exhibiting signs of stress in the upper canopy. Heavy epicormic response growth is present in the lower canopy.

Figure 6. Looking up and north at the west side of the #5 oak's canopy. It was pruned back as to not extend over the roofline of the existing house. This was likely done in anticipation of selling the home.
