August 16, 2022

Project: Pre-construction assessment for lot re-development at 6950 SE Maker Street, Mercer Island, WA. Parcel number 9350900620.

Objectives: Evaluate health of existing trees and establish criteria for the preservation of those to be retained.

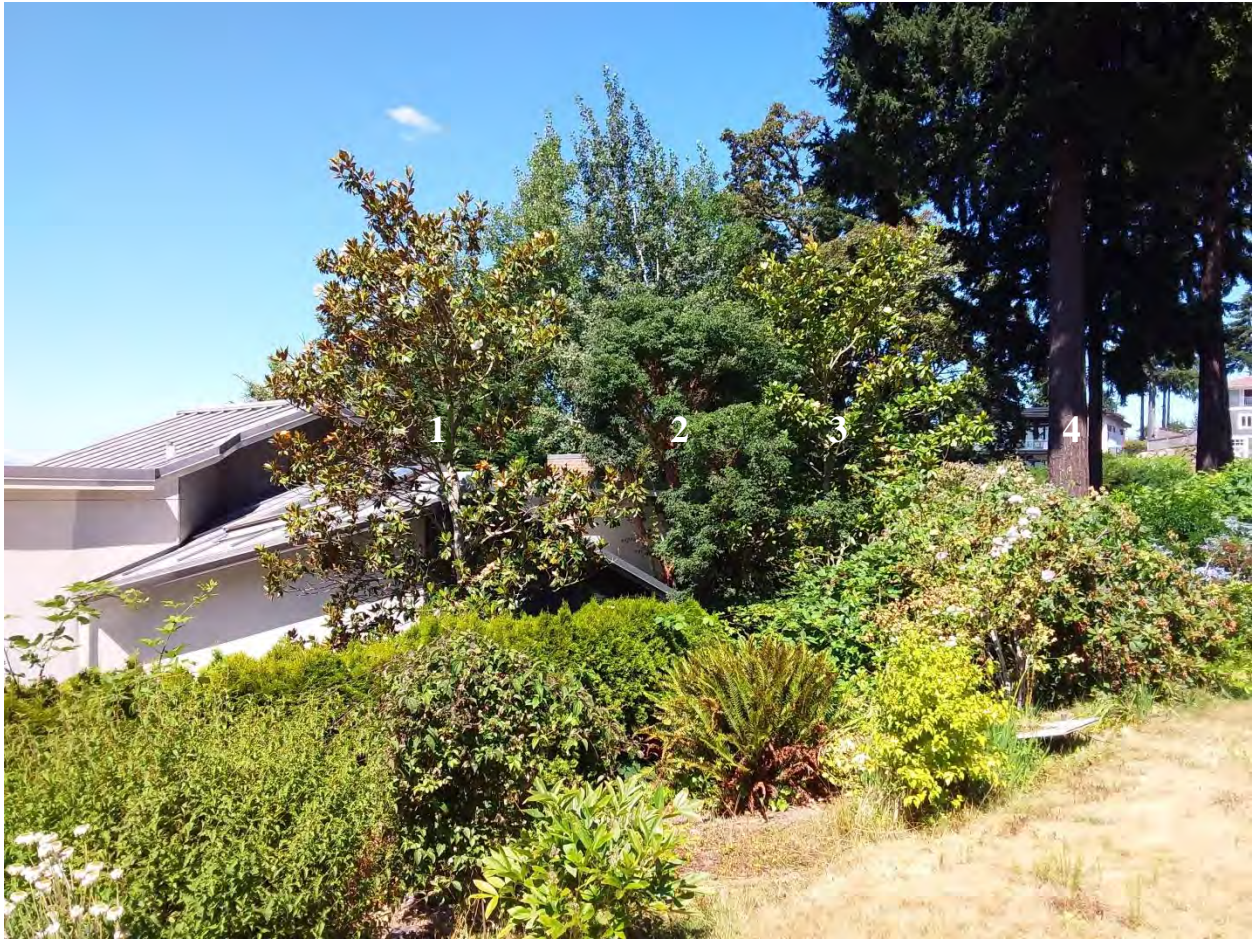
1. Likely a Teddy Bear Magnolia (*Magnolia grandiflora* 'Teddy Bear') about 8" DSH, 22' tall with a 6' radial spread. The tree stands 10' W of the west property line and close to 40 N of the SE corner (Figure 4). Fair condition with average new growth and color.

2. Paper Bark maple (*Acer griseum*) 10" DSH, 24' tall with an 8' radial spread. Tree stands close to 15' W of the west line and 25' N of the #1 magnolia. Good condition.

3. Southern Magnolia (*Magnolia grandiflora*) about 10" DSH, 28' tall with a 12' radial spread. The tree stands 12' W of the west line and about 20' S of the NW corner. Tree is in fair condition.

Figure 4. Looking NW at the #1-4 trees.

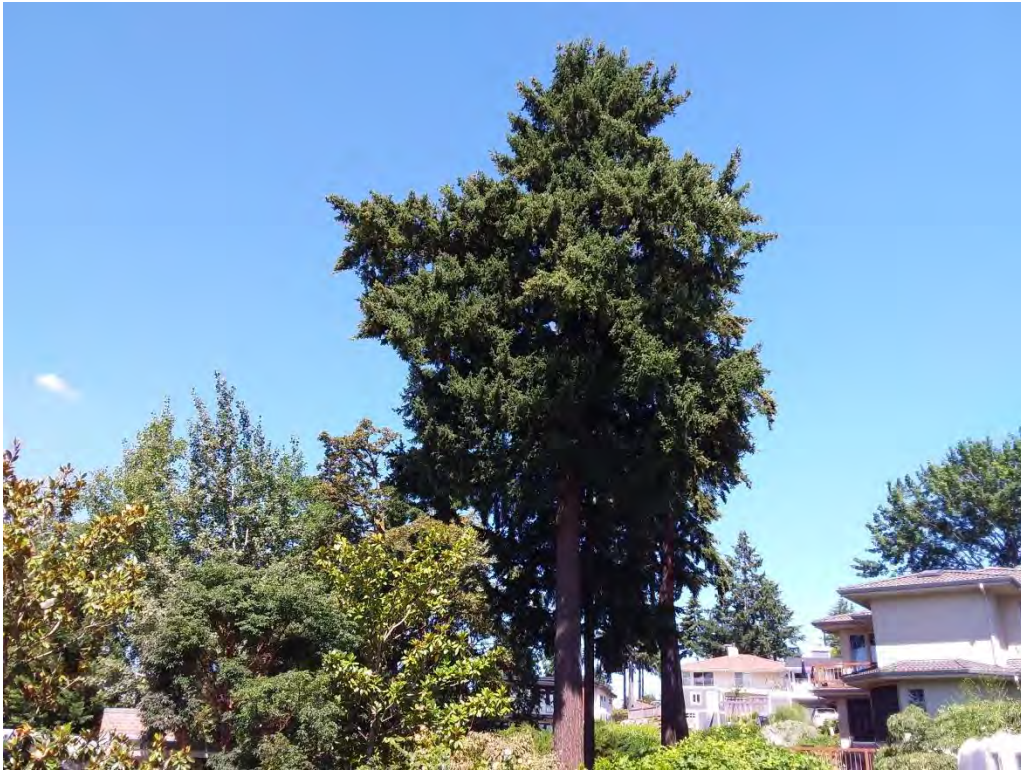
4. Douglas fir (*Pseudotsuga menziesii*) 36" DSH (may be less as it appears to have heavy bark), reaches in the neighborhood of 75' tall. It appears to have been topped multiple times and regrown (Figure 5). Exhibits good new growth and color with a full radial canopy down below the halfway point. Base of the tree is 9.5' N of the northwest corner of the subject property. There is a significant drop off in this area of the yard. The plan sheet indicates a negative 12' grade change.

According to the plan set the nearest construction impact to the fir will come from trenching for the drain lines. This will occur 40-45' out from the tree at the closest, well outside its potential rooting space.

The fir tree is also deemed to be under little to no risk of disturbance from the proposed construction project.

Figure 5. Looking NNW at the #4 fir and showing its conformation.

Ideally the protection fencing will be set up prior to the demolition. Along the east side it can just follow the top of the Keystone wall as there are no roots west of it. Technically a fence could be erected along the top of the west retaining wall but the trees to that side are not large enough to have penetrated into the subject property. Out of an abundance of caution a section of fence could be set between the north and west property lines at a radial distance of 25' out from the base of the #4 tree. This should ensure that no accidental impact will occur within the potential root zone of the Douglas fir.

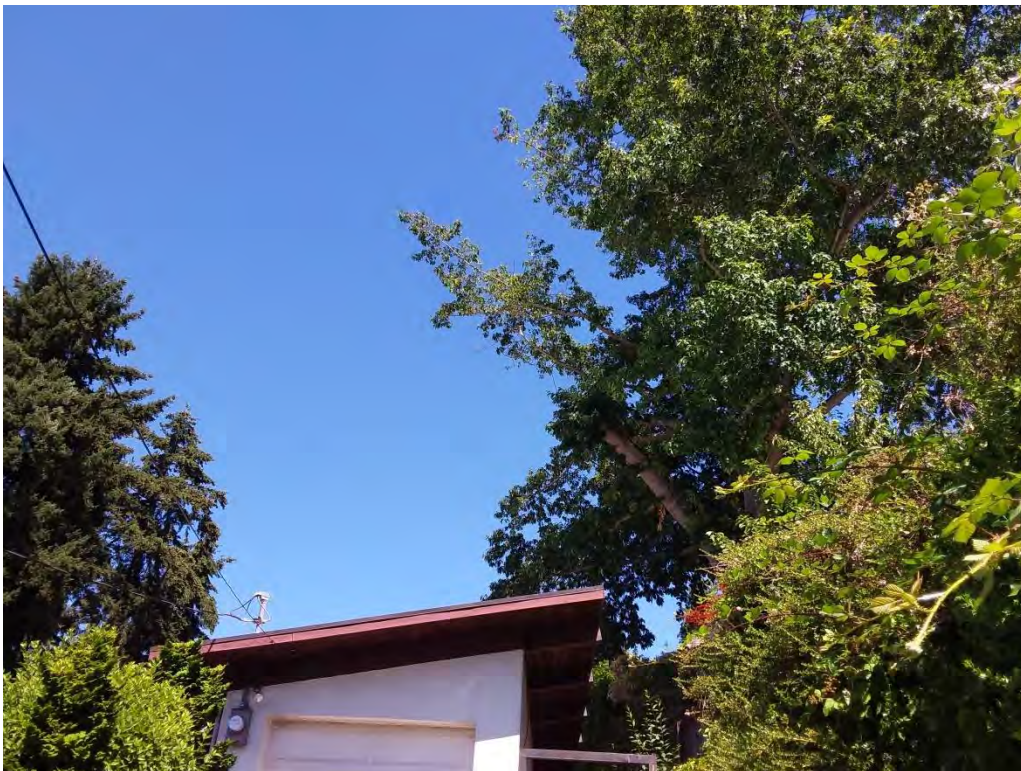
5. Red oak (*Quercus rubra*) easily 40" DSH, 50' tall in the highest reaches, spreads as much as 45' north and south, around 35' east, but was cut back quite hard on the west and extends no more than 18' to that side (Figure 6). The base of the tree is 25' S of the NE corner and 10' on center east of the east line. It sits on top of a large stone retaining wall that is near 5' tall and fully on the neighbor's lot (Figure 7). The stone wall sits above a Keystone block retaining wall that is 5.5' tall and runs along the whole east side of the existing house and 5' E of it (Figure 8). The roots from the oak have interwoven with the stones and likely have entered the soil beneath but primarily they have to have spread toward the east side neighbor's house. There are no indications that the oak's roots have disrupted the Keystone blocks. The oak appears to be fair condition overall but is exhibiting signs of stress in the upper canopy. Heavy epicormic response growth is present in the lower canopy.

Figure 6. Looking up and north at the west side of the #5 oak's canopy. It was pruned back as to not extend over the roofline of the existing house. This was likely done in anticipation of selling the home.

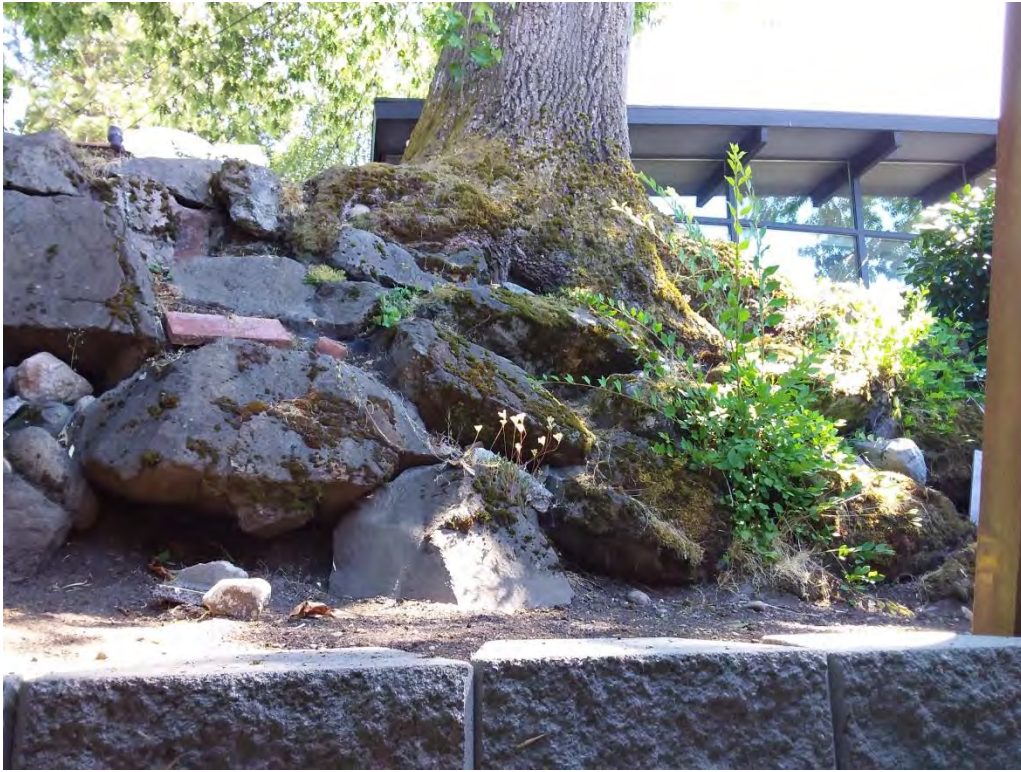
Discussion: The demolition of the existing home theoretically, based on the linear distances, has the potential to create root disturbance in the CRZ of the #5 oak. The Keystone block wall is to be retained though. As a rule of thumb it is rare to find roots from trees more than 4' below their bases in areas of sudden grade change. Roots have to have aerated soils to function properly. While oak trees are known to be rock breakers and large ones like the subject tree have the power to crack concrete and affect other types of hardscaping there are no indications that this tree has any roots on the 6950 property.

The oak tree is deemed to be under little to no risk of disturbance from the proposed construction project.

Figure 7. Looking up and east at the base of the #5 oak. The concrete blocks at the bottom of the photo are the top or the Keystone wall shown in Figure 8.

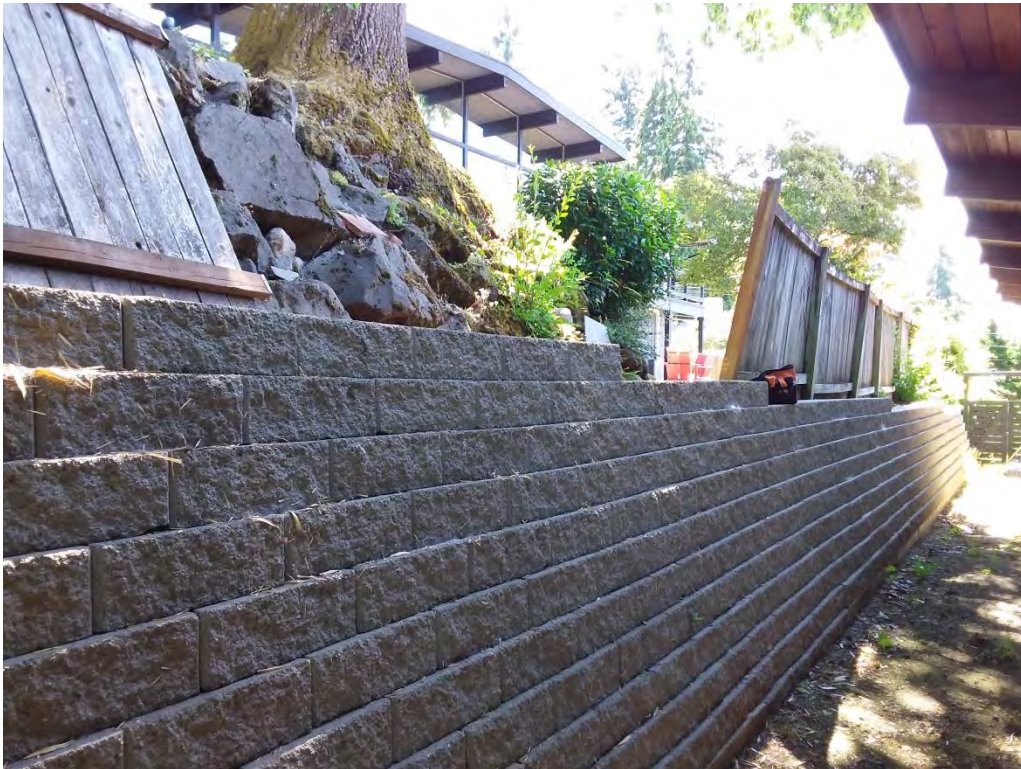
Figure 8. Looking SSE down the length of the Keystone block retaining wall running along the east side of the existing house. Note the base of the #5 oak at top center of the photo, The edge of the existing roof is visible in the top right corner of the image.
