Mercer Island Treehouse

LEVEL 1 DOWNSTREAM ANALYSIS

City of Mercer Island, Washington

Issued: June 23, 2015
Revised: October 5, 2015

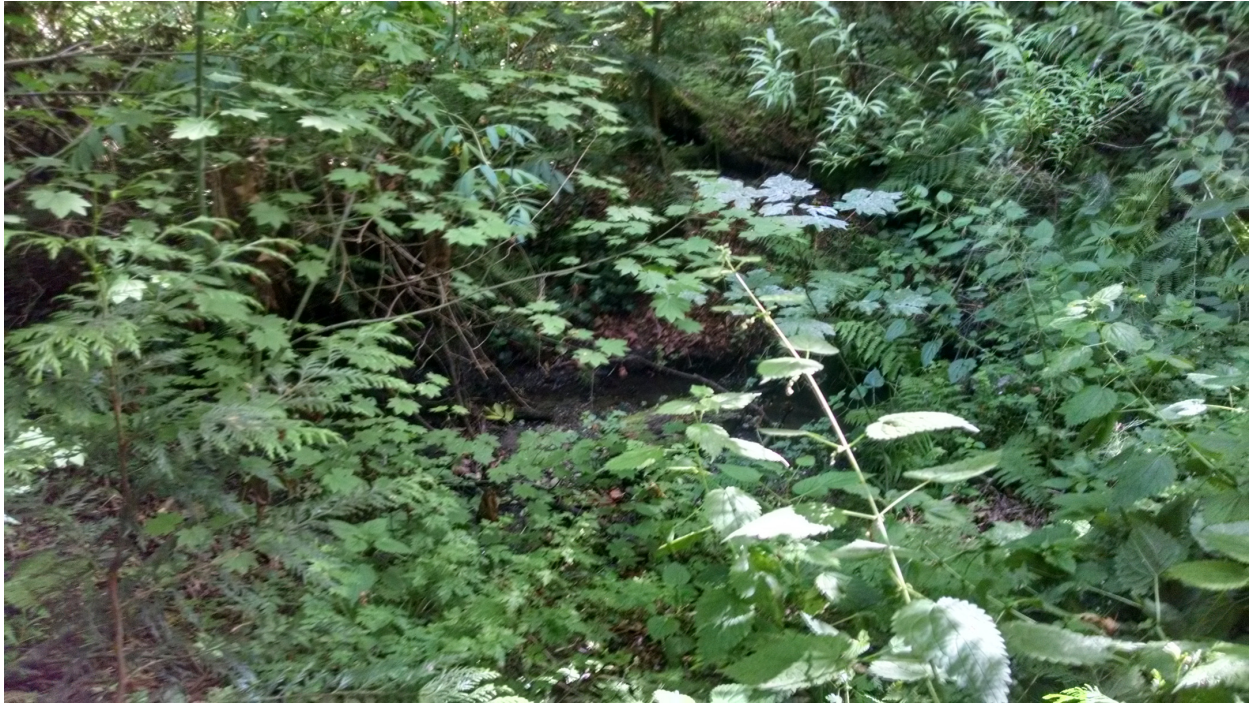
During the site visit, the vegetation in the stream channel appeared to be well established. Many of the installed logs and the rockery were overgrown, indicating that the plantings conducted during the project had become established. The stream channel near the site displayed minimal visual signs of erosion. A pedestrian trail which runs parallel to the stream channel to the north of the project parcel appeared to be in good shape and showed no sign of sluffing towards the stream. The improvements to the stream channel appear to have been successful in limiting the erosion problems within the improved section of Stream A. It is likely that the noted erosion problems come from the unimproved sections of Stream A, downstream of the site.

Photo: Stream A observed from the pedestrian trail, approximately 50-feet west of East Mercer Way. Note the established vegetation on the stream bank.

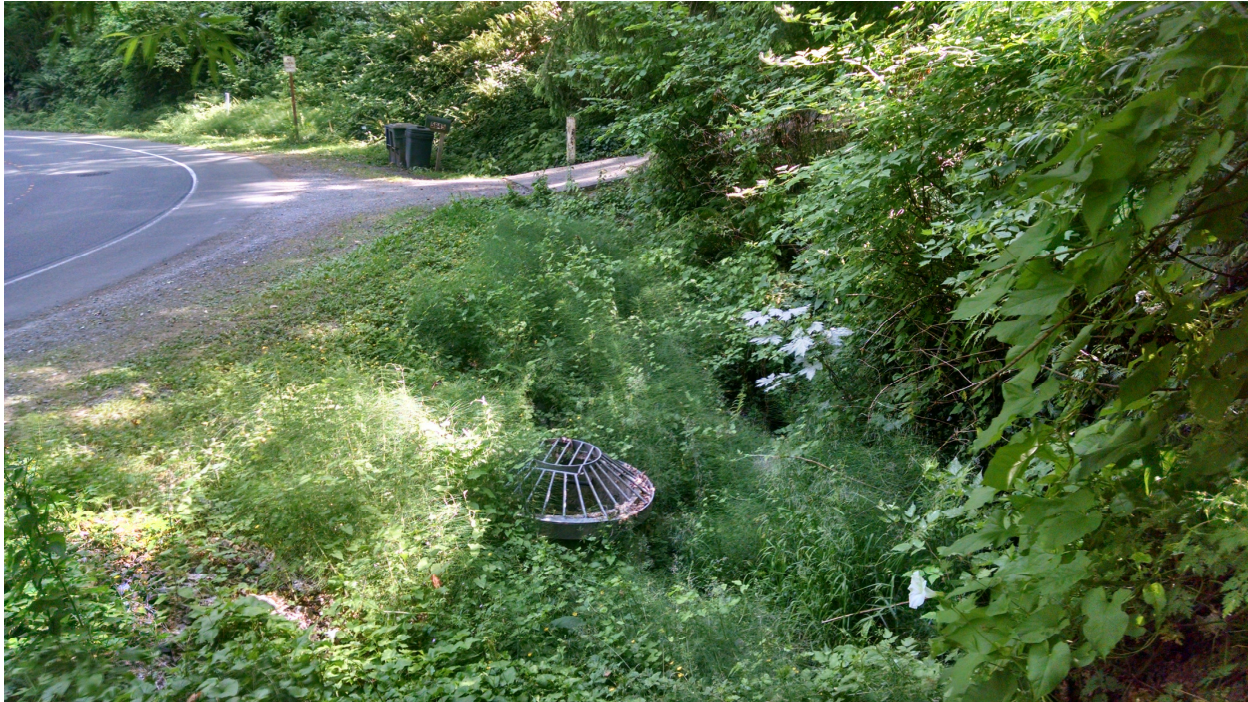
A Type-2 catch basin with a beehive overflow grate collects Stream A within this depression and conveys the stream under East Mercer Way via a 16-inch HPDE pipe. This system discharges to the continuing stream channel to the east of East Mercer Way. An As-built drawing obtained from the City of Mercer Island titled *Schedule 'B' Culvert dated July 30, 2012* shows this system and is attached to Appendix B.

Photo: Type-2 catchbasin with beehive grate overflow conveys Stream A across and beneath East Mercer Way.

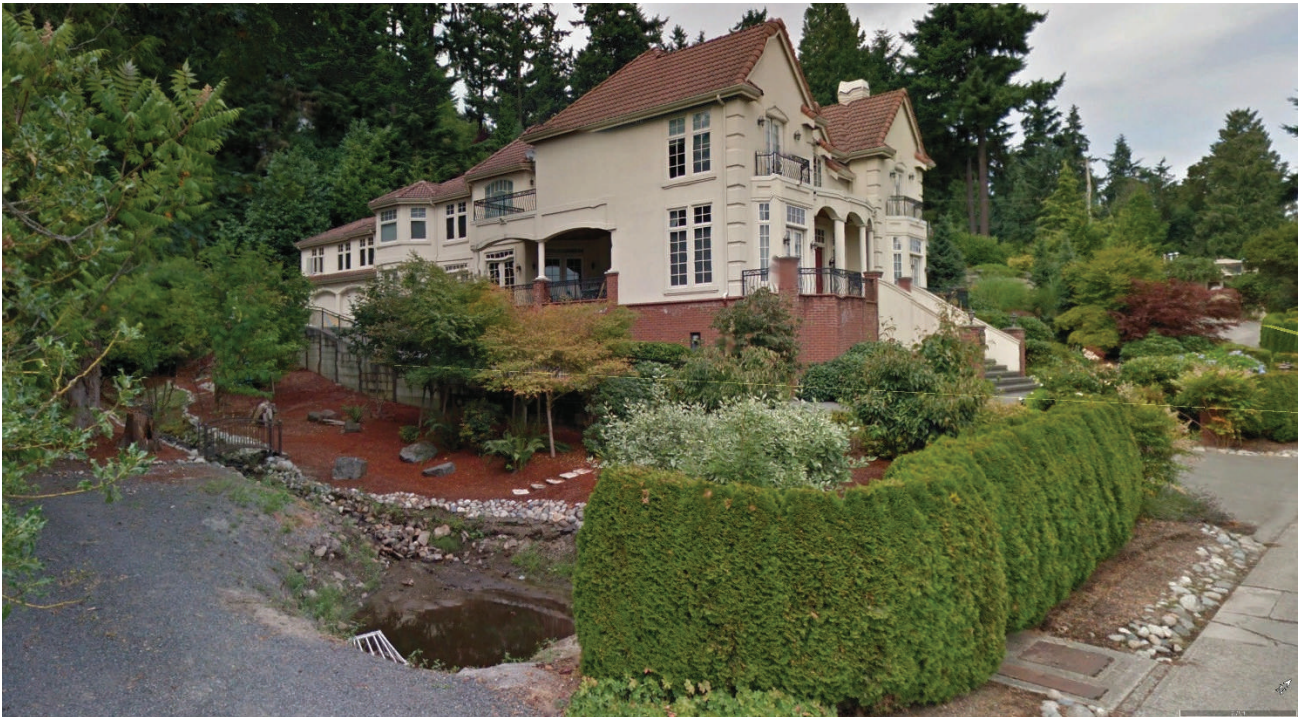
The Glenhome Sediment Pond

Five of these complaints, between October 2009 and April 2014 are reports of a catch basin being clogged. Although not explicitly stated, the catch basin is likely the outlet of the small sediment pond (the Glenhome Pond) that collects Stream A, before the stream is conveyed to the Lake. On April 22, 2014 the outlet structure to the sediment pond was modified. The previously installed 6" diameter vertical standpipe was replaced with a 12" standpipe. This modification was intended to prevent fouling of the pond outlet by debris.
