EVALUATION OF SELECTED TREES AT

**5637 E Mercer Way
Mercer Island, WA 98040**

July 14, 2015

GILLES CONSULTING

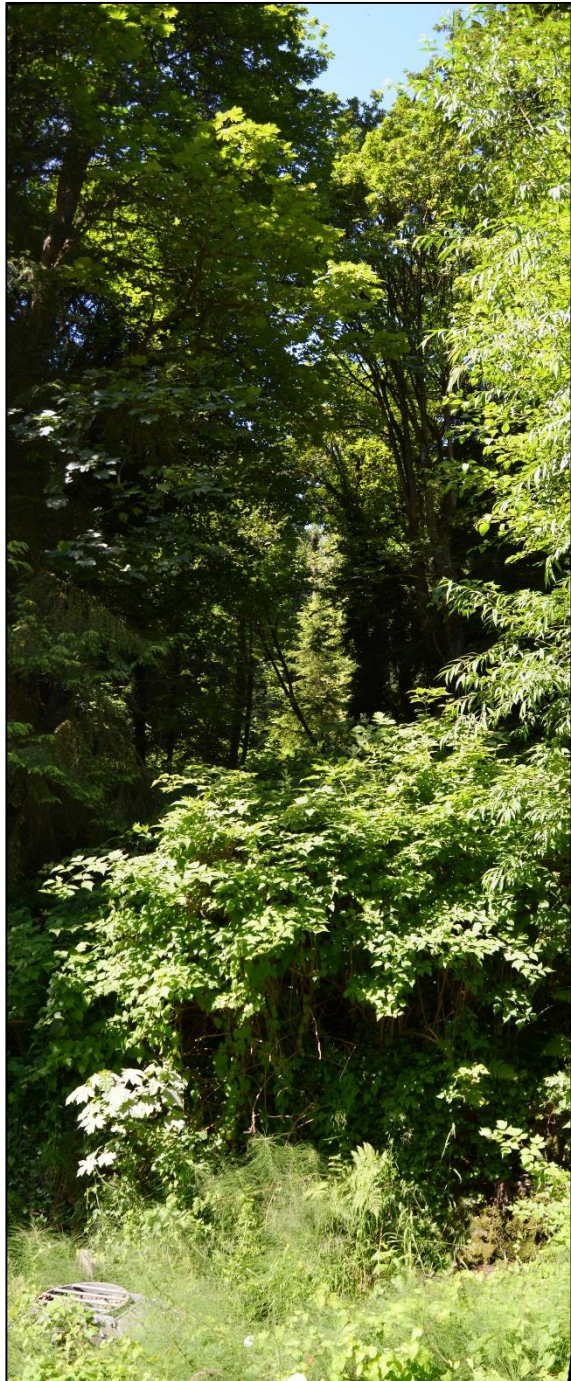
Photo # 2: A view from the shoulder of E Mercer Way looking up into the wooded lot that is 5637.

Note the storm drain cover in the lower left of the photo at the bottom of the ditch.

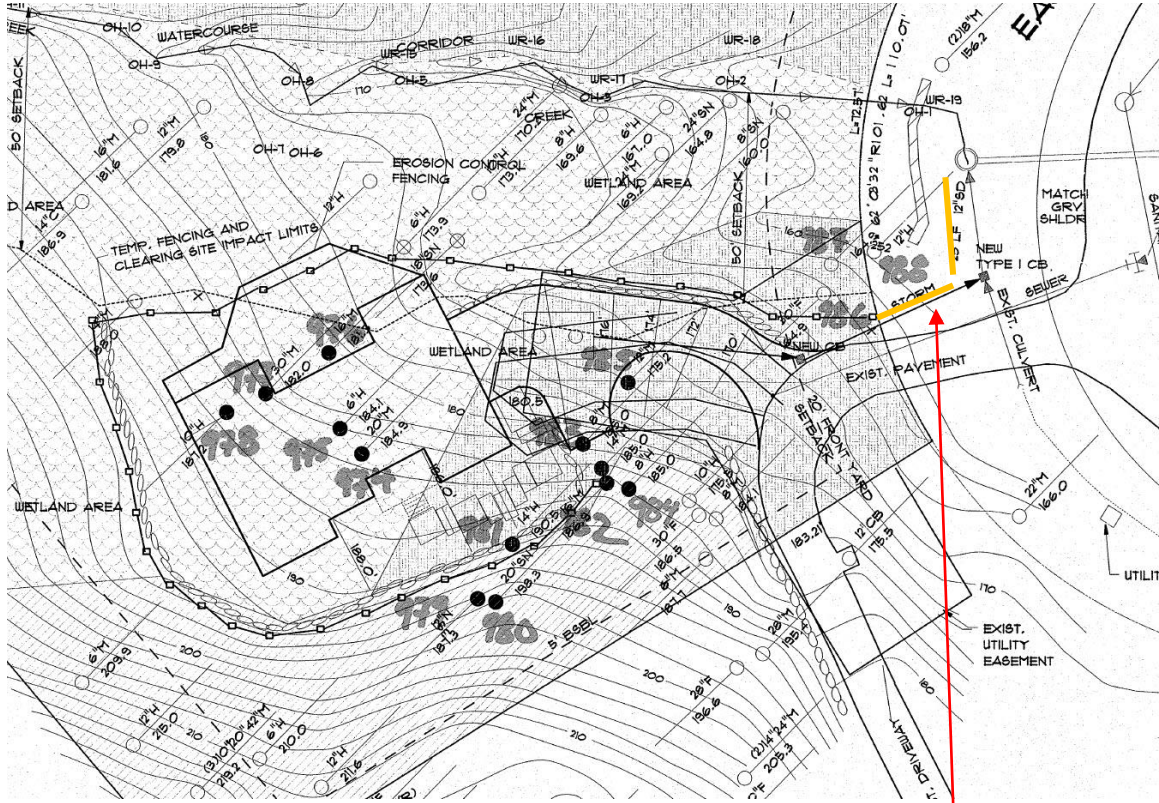
There is one right-of-way tree impacted by the project. It is tree # 988. It is a 15.4-inch Diameter Western Hemlock in Good Condition. It can be adequately protected by having the “*Limits-of-Disturbance*” fence extend east from the property line to the road shoulder and extend slightly north above the Storm drain inflow device.

I agree that trees 974 through 985 should be removed for safety and for the construction of the new home. I recommend extending the "*Limits-of-Disturbance*" fencing to protect tree # 988 in the East Mercer Way right-of-way. The remaining trees will be adequately protected by the "*Limits-of-Disturbance*" fencing.

Extend the "Limits-of-Disturbance" fence to the edge of the shoulder
