REVISED TREE REPORT AT

**5637 E Mercer Way
Mercer Island, WA 98040**

January 15, 2021

Brian K. Gilles, Consulting Arborist

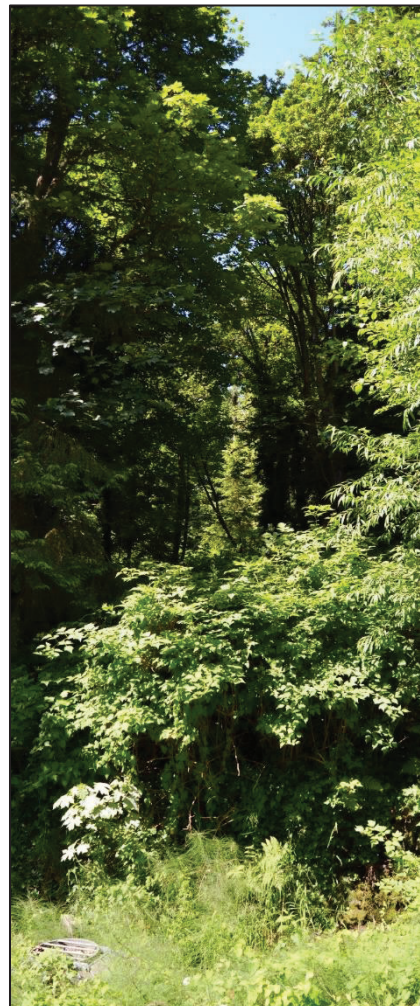
Photo # 3: A view from the shoulder of E Mercer Way looking up into the wooded lot that is 5637.

Note the storm drain cover in the lower left of the photo at the bottom of the ditch.

There is one right-of-way tree impacted by the project. It is tree # 988. It is a 16.1-inch diameter Western Hemlock in Good Condition. It can be adequately protected by having the “Limits-of-Disturbance” fence extend east from the property line to the road shoulder and extend slightly north above the Storm drain inflow device.

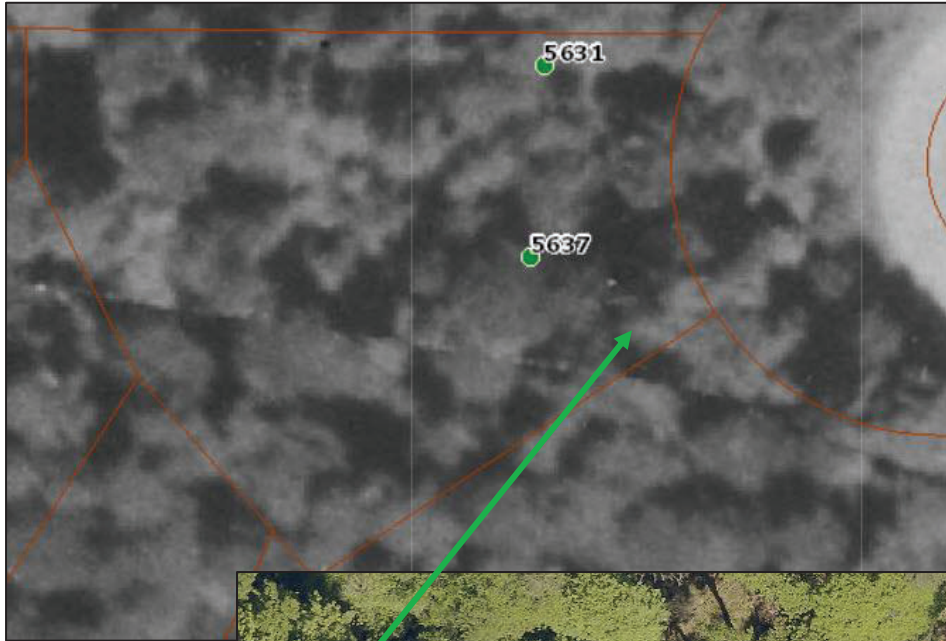
Photos # 3 & 4:
A 1936 aerial photo of the property in black and white. And, a 2019 color photo of the property.

Tree # 986 appears to be this tree.

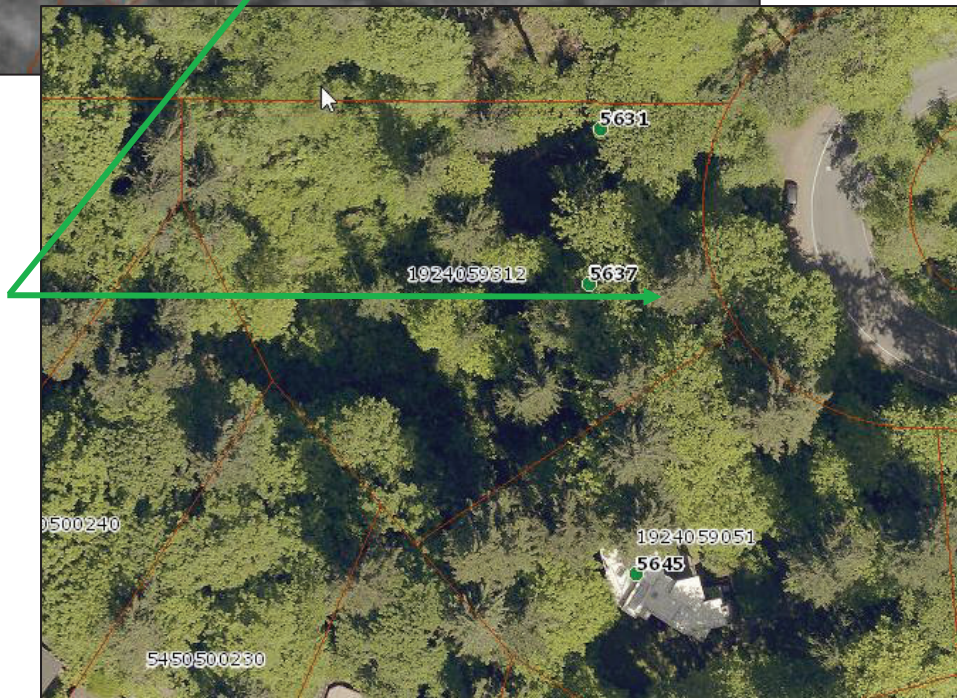
The proposed driveway to access the proposed new house at 5637 is within a small portion of the dripline of this tree.

- This can be accomplished by suspending the driveway over an aeration system and then excavating as normal for the rest of the driveway construction up the slope to the new home.
