October 28, 2017

Project: Pre-construction assessment for lot re-development at 6025 77th Avenue SE, Mercer Island, WA. Parcel number 4097100075.

Objectives: Evaluate health of existing trees and establish criteria for the preservation of those to be retained.

Anthony Moran, BS
ISA Certified Arborist
Qualified Tree Risk Assessor
#PN-5847A

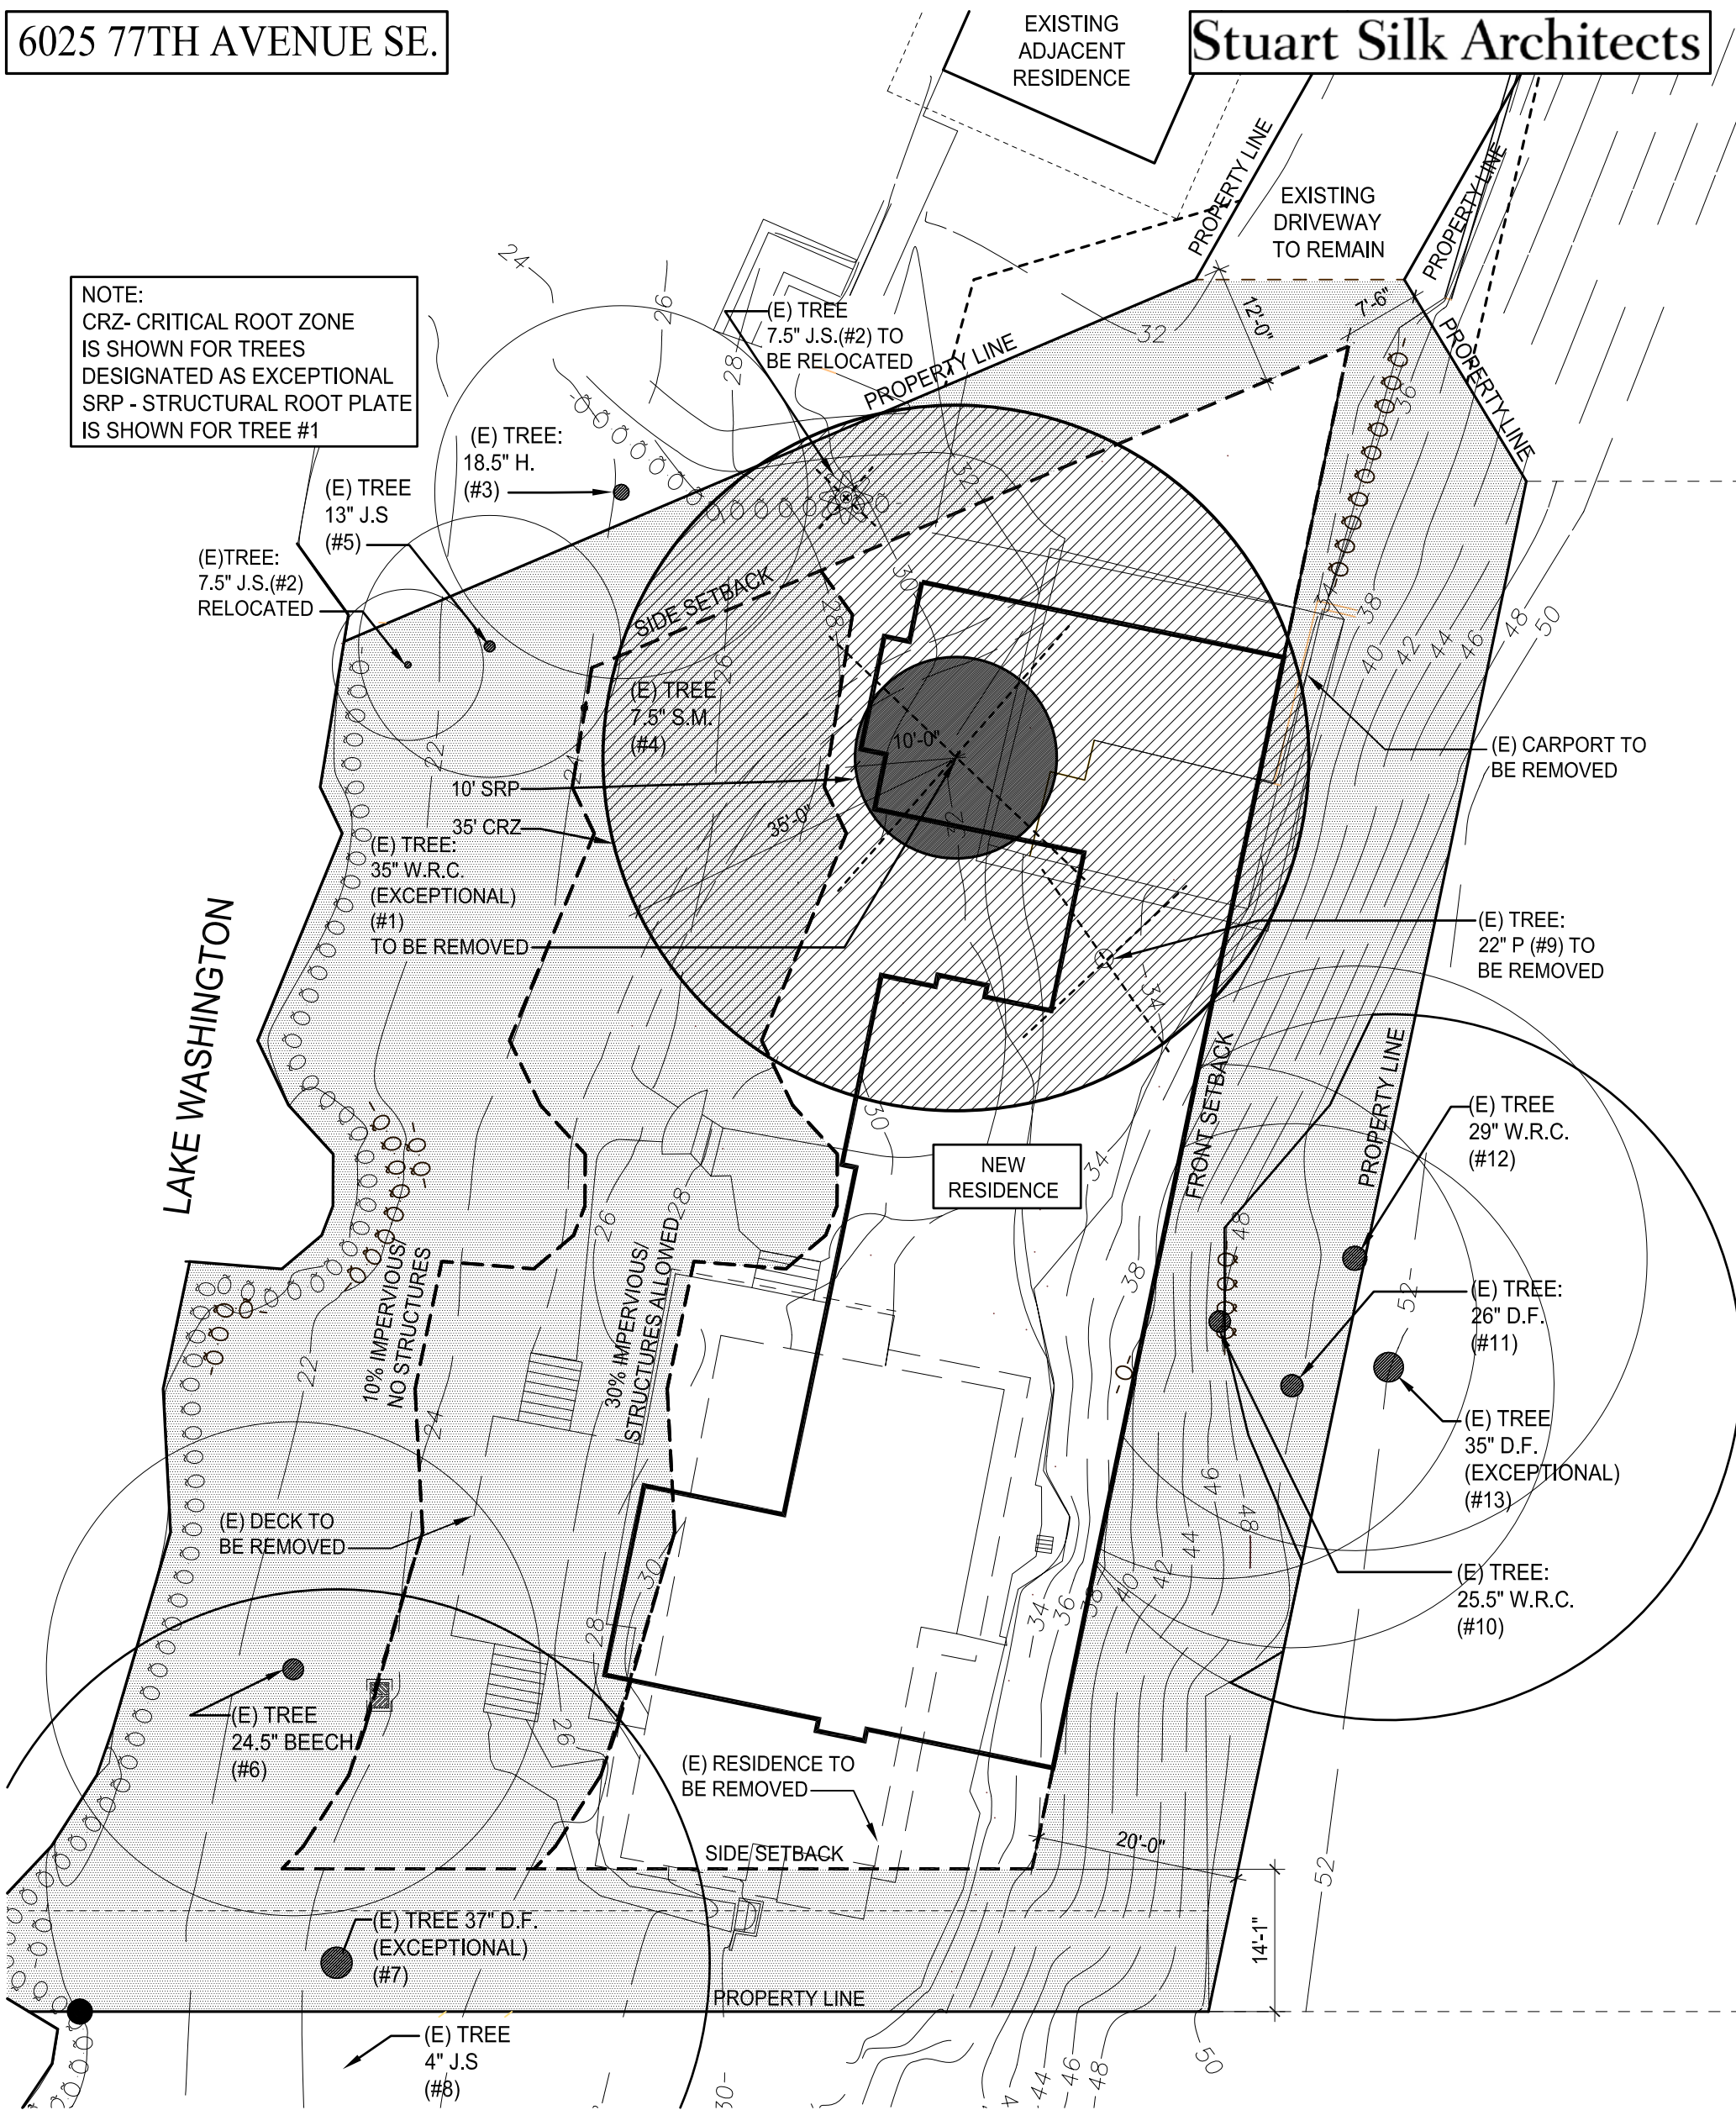
SETBACK DIAGRAM

The first diagram, Setback Diagram, illustrates the narrow and only buildable area of the property. Tree #1 is located at the only entry to the buildable area. Its CRZ covers the entire possible entry area to the site. Any construction on this site will send the tree into rapid decline and create an unavoidable hazardous situation. For this reason, MICC 19.10.060.A.3 permits this tree to be removed.

THE LOCATION OF TREE #1 WITH A CRZ OF 35' CREATES A SITUATION IN WHICH ANY CONSTRUCTION ACCESS AND HOUSE LOCATION ON THE SITE WILL UNDOUBTEDLY HARM THE TREE. PER THE ARBORIST REPORT, ANY CONSTRUCTION ON THE SITE WILL DISTURB THE TREE ROOTS AND SEND IT INTO RAPID DECLINE.

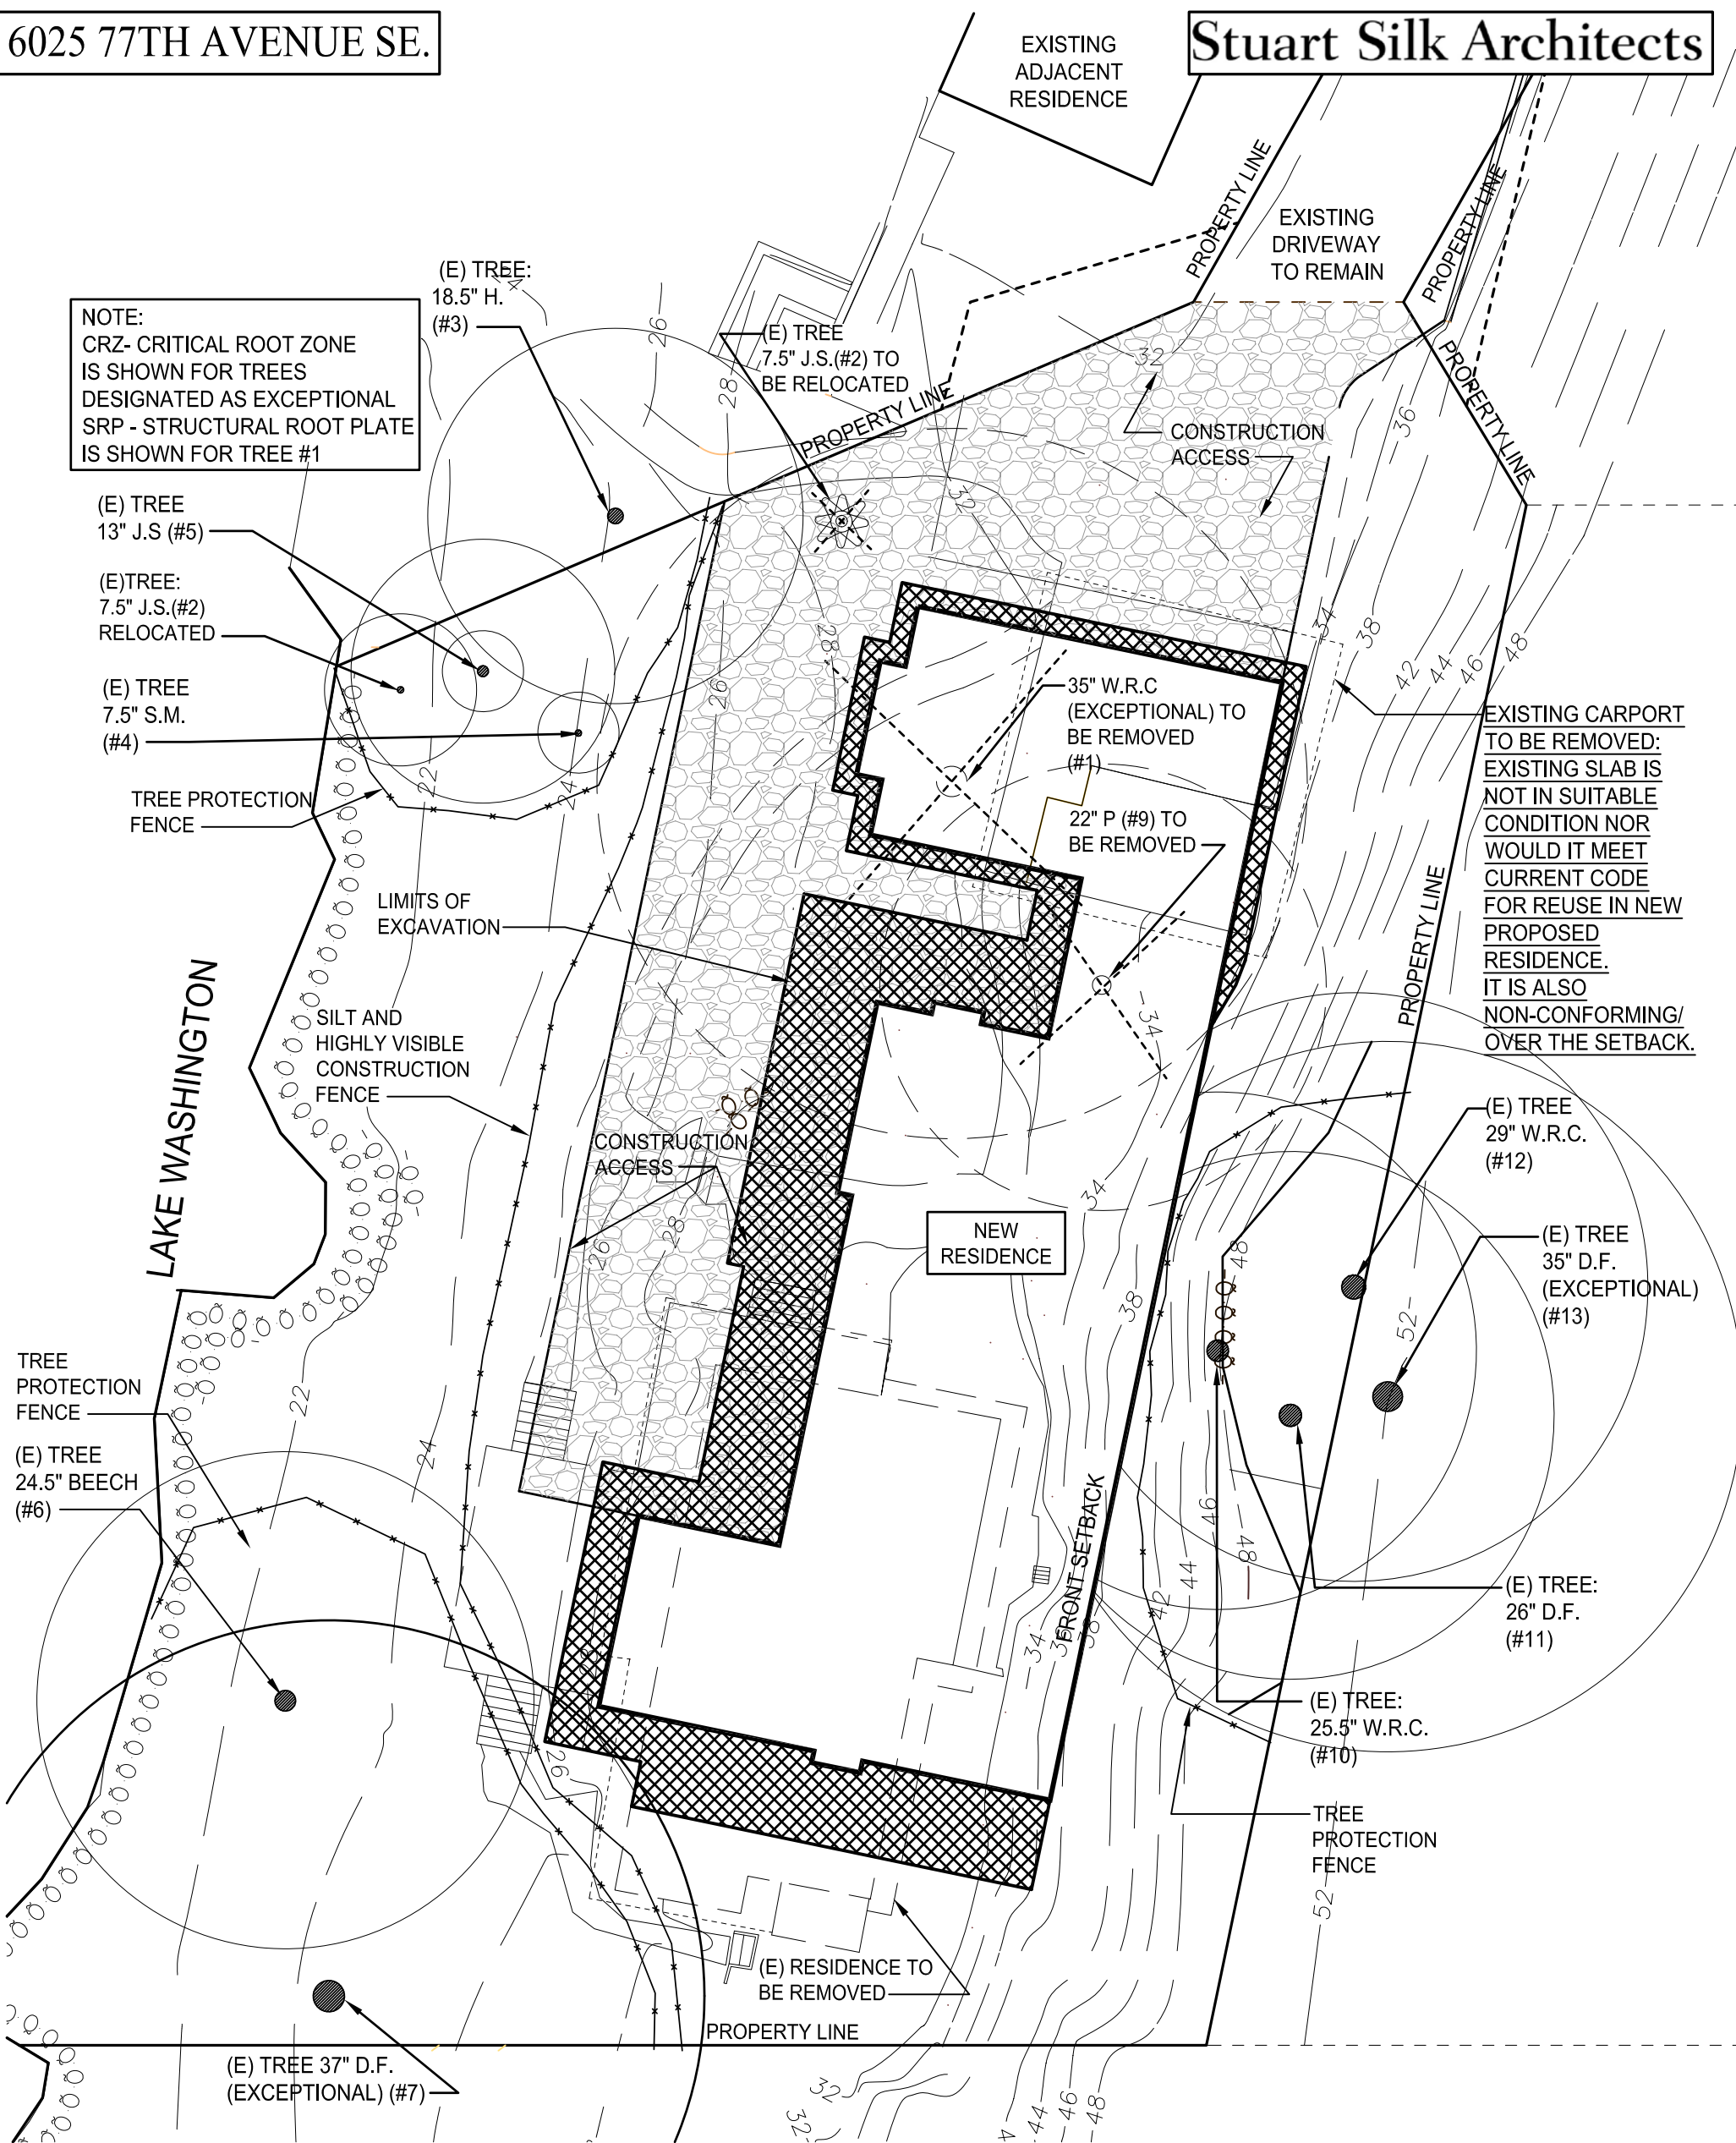
EXISTING CARPORT
TO BE REMOVED:
EXISTING SLAB IS
NOT IN SUITABLE
CONDITION NOR
WOULD IT MEET
CURRENT CODE
FOR REUSE IN NEW
PROPOSED
RESIDENCE.
IT IS ALSO
NON-CONFORMING/
OVER THE SETBACK.

8 NEW TREES WILL BE PLANTED PER MICC 19.10.070 TREE REPLACEMENT. NEW TREES ARE LABELED WITH LETTERS A - H .

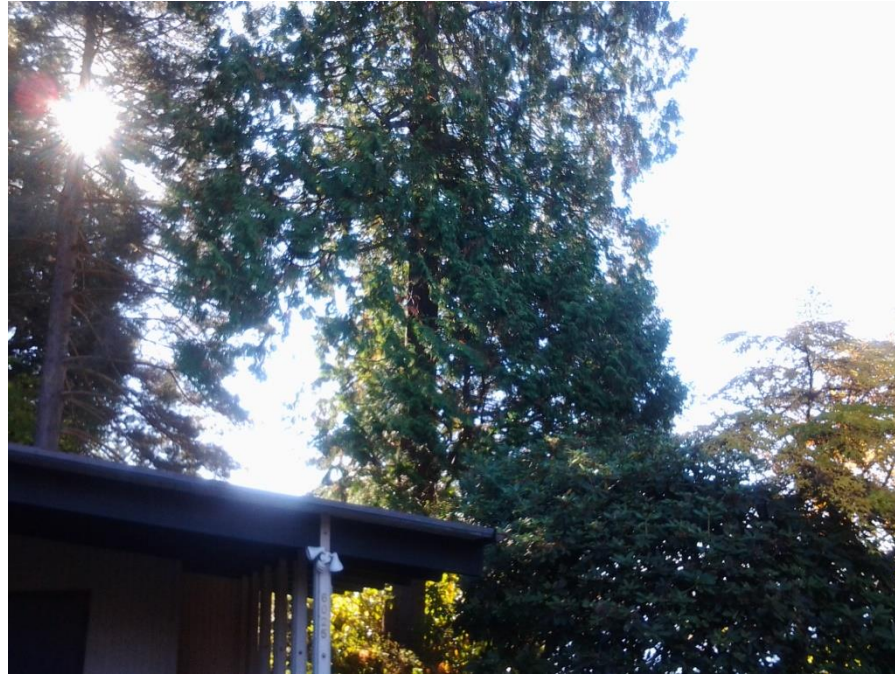
- 1) Western Red Cedar (*Thuja plicata*) 35" DSH, 70' tall standing 6' W of the carport foundation and 7' N of the SW corner of the shop. It has large subordinates starting low on the west side which curl to the vertical (Figure 5). The densest part of its canopy is in the lower half of the column. There is evidence of root uplift under the entrance walk which runs between the tree and the garage. The tree exhibits below average new growth and poor color in the upper canopy, close to average in the lower. It bifurcates E/W near the 50' level as shown in Figure 6.

Looking at the #1 cedars situation, even though the existing carport slab is just 6' to its east and could be acting as a root barricade, the uplift of the walkway suggest that the tree is sending out structural roots in that direction. The demolition of the existing concrete could disrupt its SRP significantly. If the slab has been acting as a barricade than the structural roots for this cedar will most likely extend significantly further north and south than expected.

The #1 cedar is worrisome because its feeder roots most likely fill to the north and south of the existing car port. They are probably concentrated to the south as the north side nutrient source is limited by the paved driveway and contained drainage of runoff water. While the original house is close to 60' away from the tree, giving it ample space for its roots, the foundation for the new one is just 16' south of the base of the tree. This cedar starts with an inherent 35% limitation because of the proximity of the slab. It loses another 10% due to the driveway cutting across the north side. If the new house is built as designed the tree would lose another 23% of its CRA which in reality would be closer to 35% because of the probable feeder root concentration to that side.

Even if the new garage is built exactly in the same footprint as the carport slab and the new house is pushed as much as 40' away, just the construction traffic of dump trucks and excavators would severely damage if not fully destroy the cedar's roots in the southern sector. There are no means to prevent further impact to this tree if a construction project is going to occur on the site. And any impact will be severely detrimental to this tree.

Figure 5. Photo of the #1 cedar showing the proximity to the carport and the density of the lower canopy.

Recommendations: The #1 cedar should be removed during the demolition stage of the project. There is no possible way to preserve this tree with any expectation that it will survive more than five years post construction. While core tests taken did not show advanced center decay they did reveal quite limited new wood formation. This combined with the stunted new growth in the upper canopy suggests a tree that is well into its decline cycle. The additional stress of any degree of construction impact will most likely result in this tree going into a rapid degeneration.

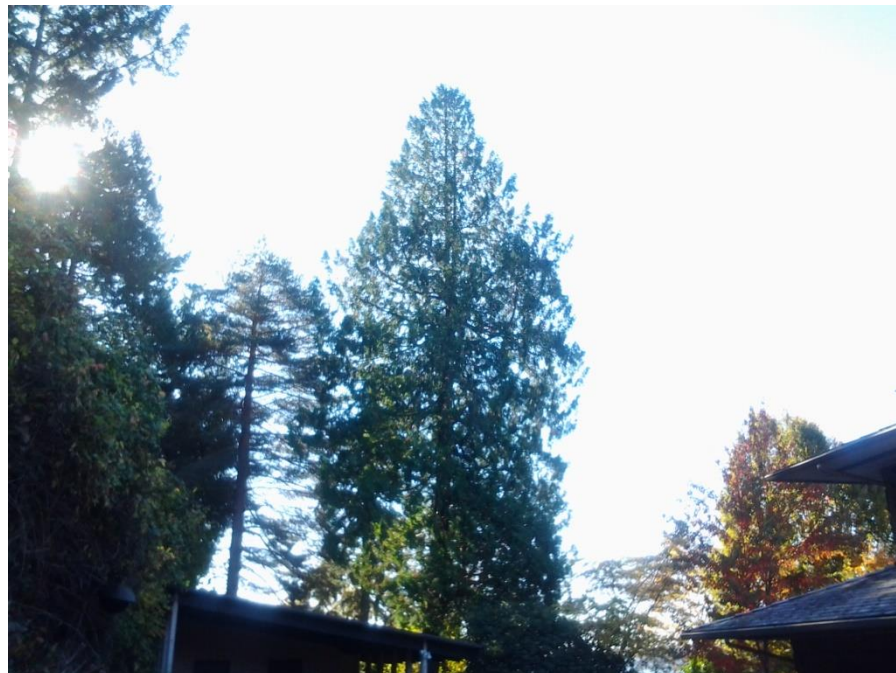
Figure 6. Photo of the #1 cedar showing the sparse upper canopy and the bifurcated top.

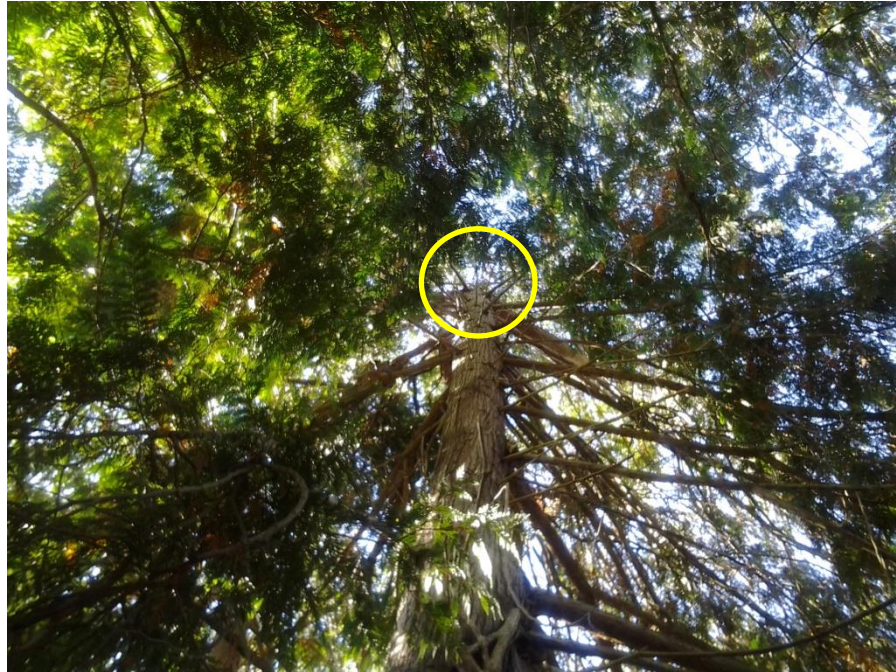
- 10) Western Red Cedar 25.5" DSH, topped or damaged near the 40' level, and has several spars rising 15-20' above this point (Figure 7). It has large (16" caliper) spar which comes off the south side near the 8' mark and extends out to the SW as shown in Figure 8. All its canopy is on the west side of the tree. It stands at the top of a double, stone, retaining wall system about 18' NE of the NE corner of the existing house (Figure 9 and 10). The first wall is around 8' east of the house foundation and rises 4-5' above grade. There is an 8-10' somewhat level area above it before the second rock wall rises another 6' or so. The upper wall is breaking down (Figure 11) and the roots from this tree have pushed through in a number of places as shown in Figures 12.

Figure 7. Photo looking up from the base of the #10 cedar. The main stem was damaged near the 40' mark (yellow circle) and several spars grow up and out from this point at least two of which broke and are hanging in the tree.

The #10 cedar can be retained but the retaining wall work around it will have to be monitored by a Certified Arborist as the work is occurring well within its CRZ. This tree also requires pruning mitigation to remedy the weakly attached upper spars and overweight subordinate. The spars should be cut back to near the original damage level and the subordinated should be headed back at least 15'. The hangers and deadwood also need to be extracted from the tree.

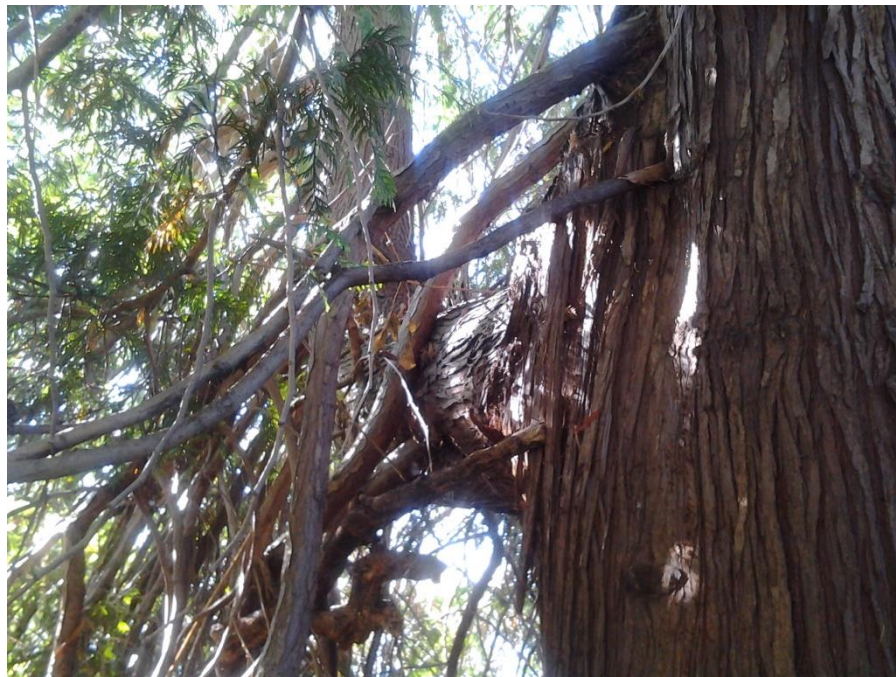
Figure 8. Photo showing large subordinate extending south from near the 8' level. This spar forms close to a third of the tree's biomass.

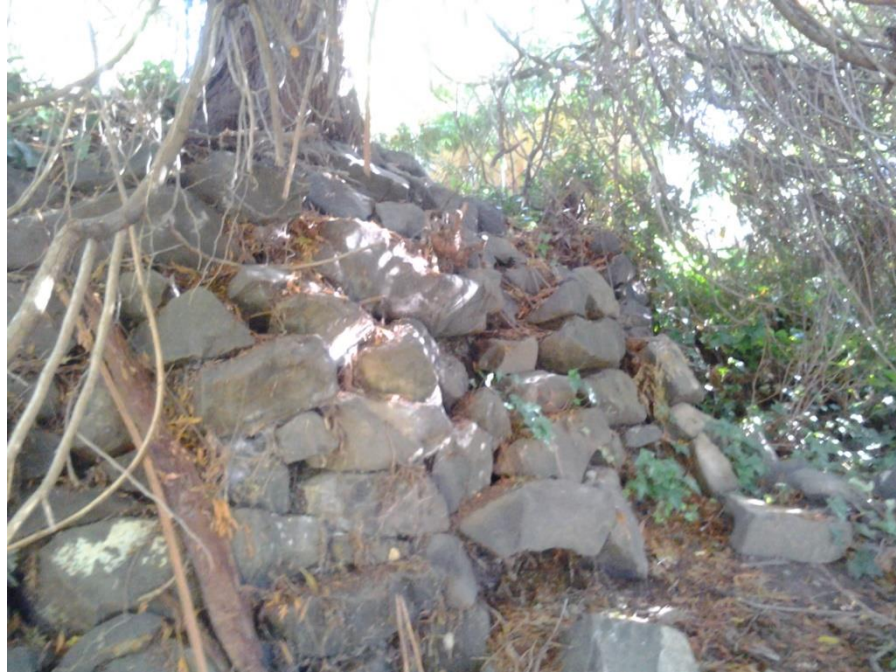
Figure 9. Photo showing the location of the #10 tree at the top of the second rock wall. Note the loose stones scattered at the base of the wall.

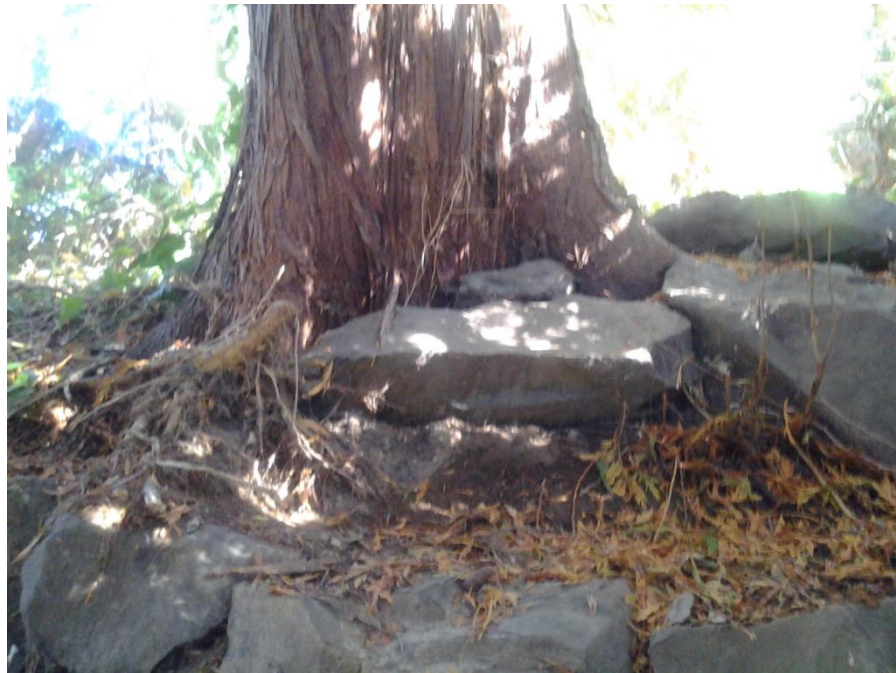
Figure 10. Photo showing close up of base of #10 cedar.

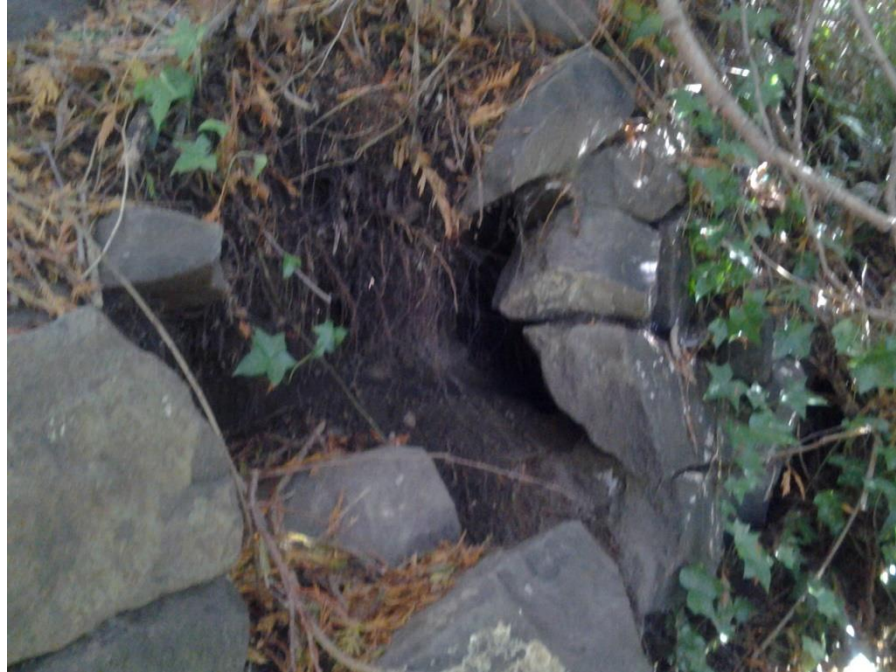
Figure 11. Photo showing one of the locations where the wall is breaking down.

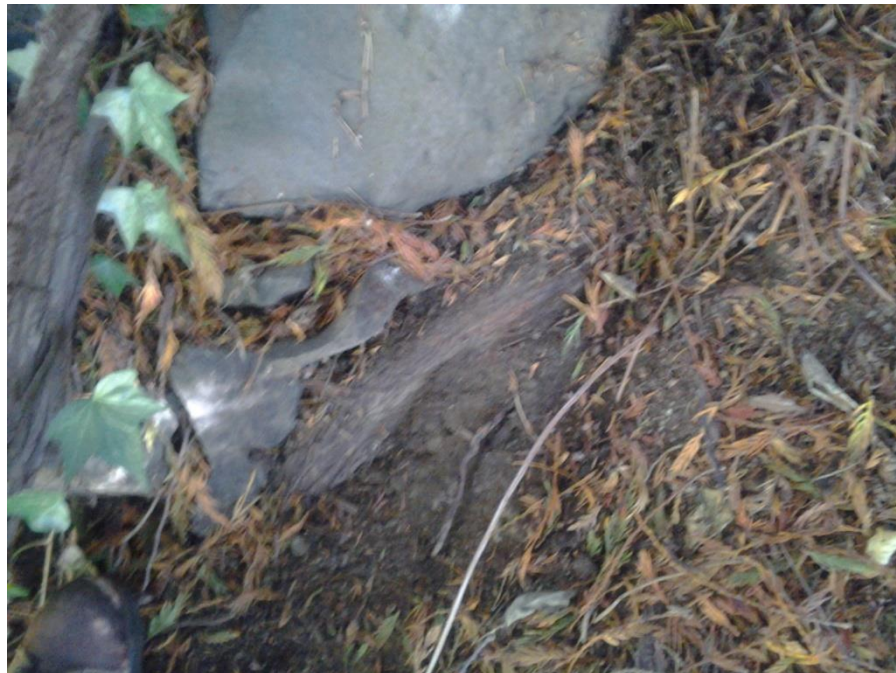
Figure 12. Photo of one of the #10 cedar's roots coming through the wall.

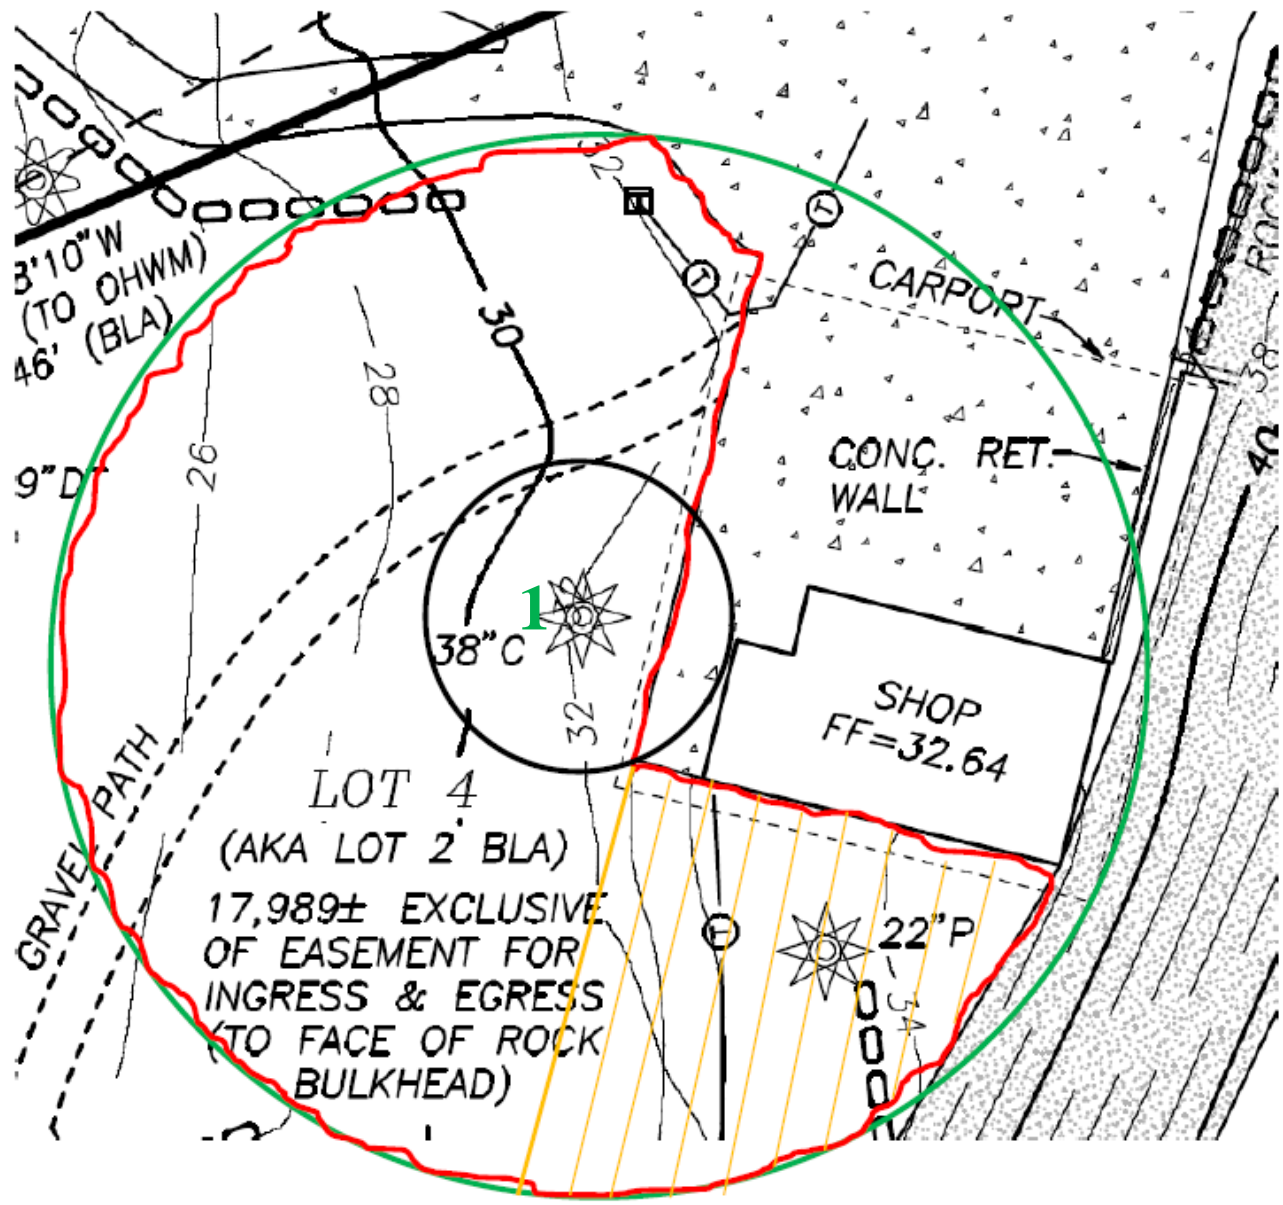
RE: #1 Cedar Infographic

This infographic shown on the following page was built to elucidate the case of the #1 cedar in the Hart arborist report. The tree in question is shown in the center of the image. The small black circle around the tree represents the tree's Structural Root Plate (SRP) and extends 10' radially. Note that the carport's slab impedes the SRP 6' out from the base on the east side of the tree. The larger green circle is the tree's theoretical Critical Root Zone set at a radial distance 35' out from the tree. The region designated by the red line shows the expected area in which the cedar's roots should be found. Roots may or may not exist below the slab, they are lifting the concrete pavers between it and the tree. The yellow striped region is the minimum expected construction impact which will occur during the proposed demolition and construction to the known viable section of the cedar's CRZ. There is no way to work around this tree within the constraints of this sight. The tree is in distress and has limited rooting space. Disturbing it in any way will more likely than not result in the tree going into rapid decline. Just removing the existing slab will disturb the SRP. Building the footings for the new garage will damage even more critical roots. Driving through the yellow zone with construction equipment will damage close to 30% of the cedar's viable existing roots which will definitely push this tree over the edge.

Referring to MICC 19.10.06(3)(a) the cedar in question meets the criteria for removal because attempting to retain it will create an unavoidable hazardous situation. It should be removed during the demolition portion of the project.
