October 11, 2018

Re: 8100 Retaining Wall Project – Tree Impact Report

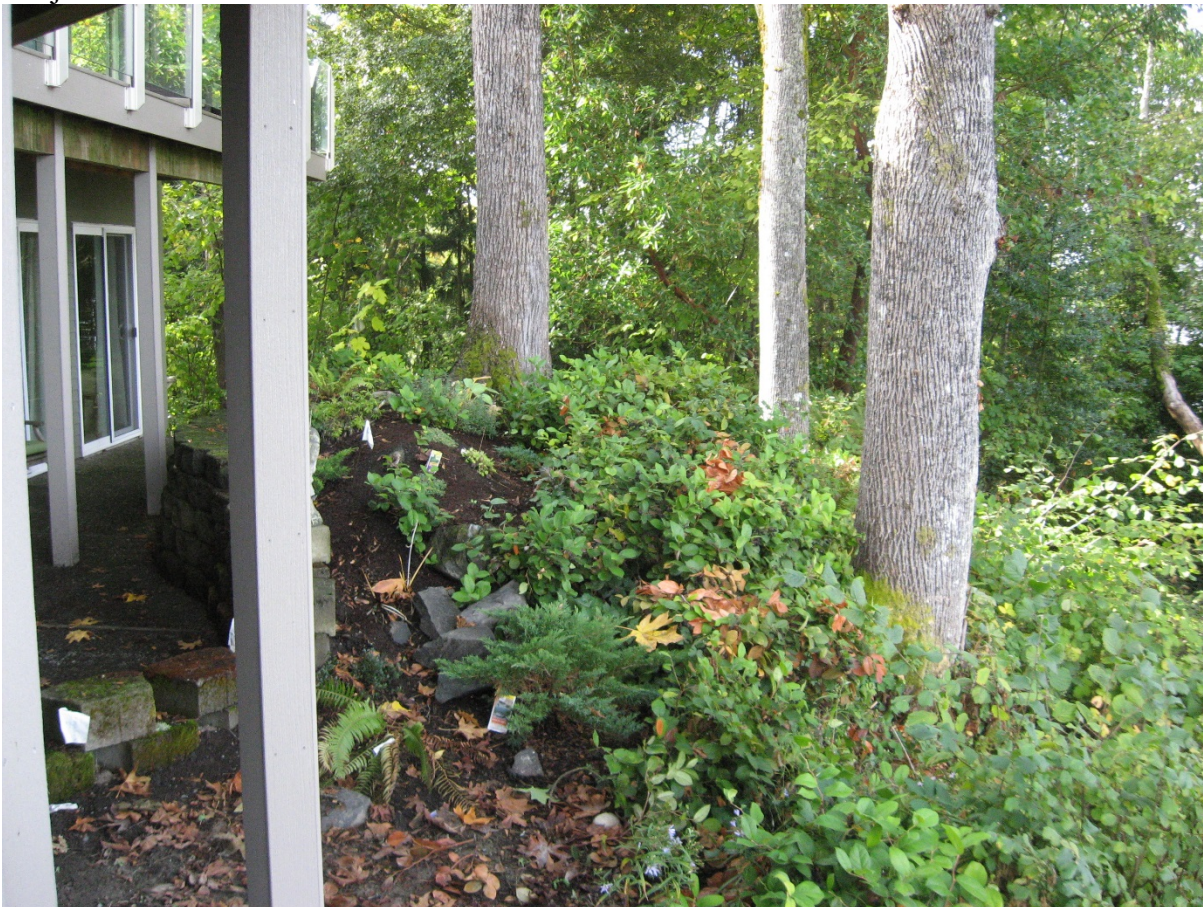
New retaining wall to tie in with existing wall northeast of subject trees

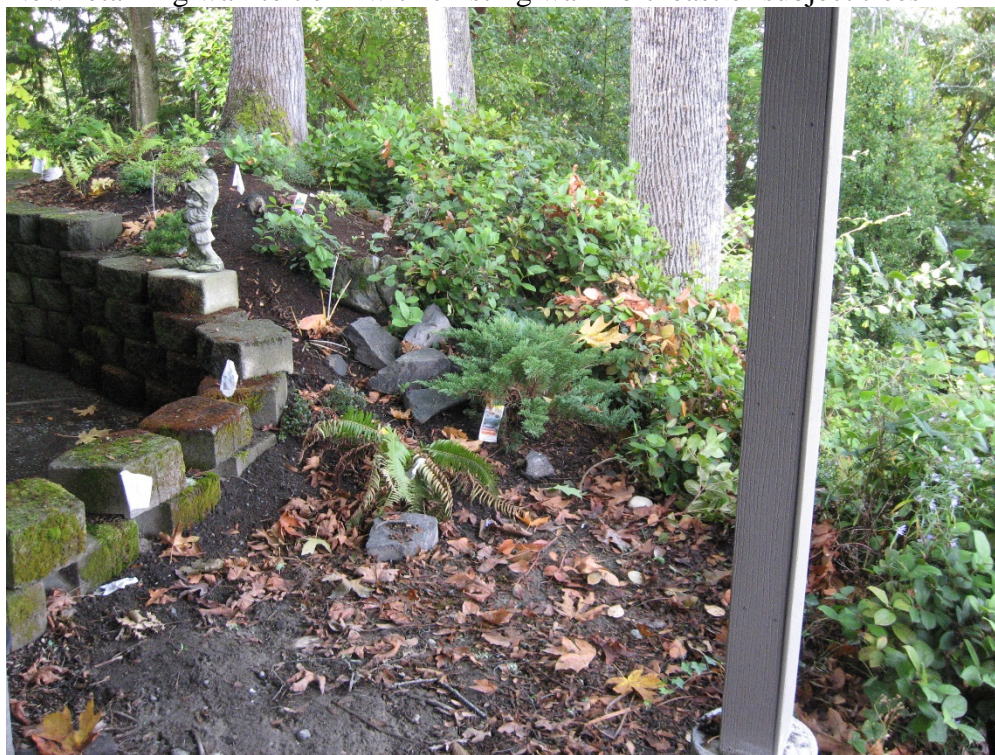
Subject trees #2 and #3 looking south

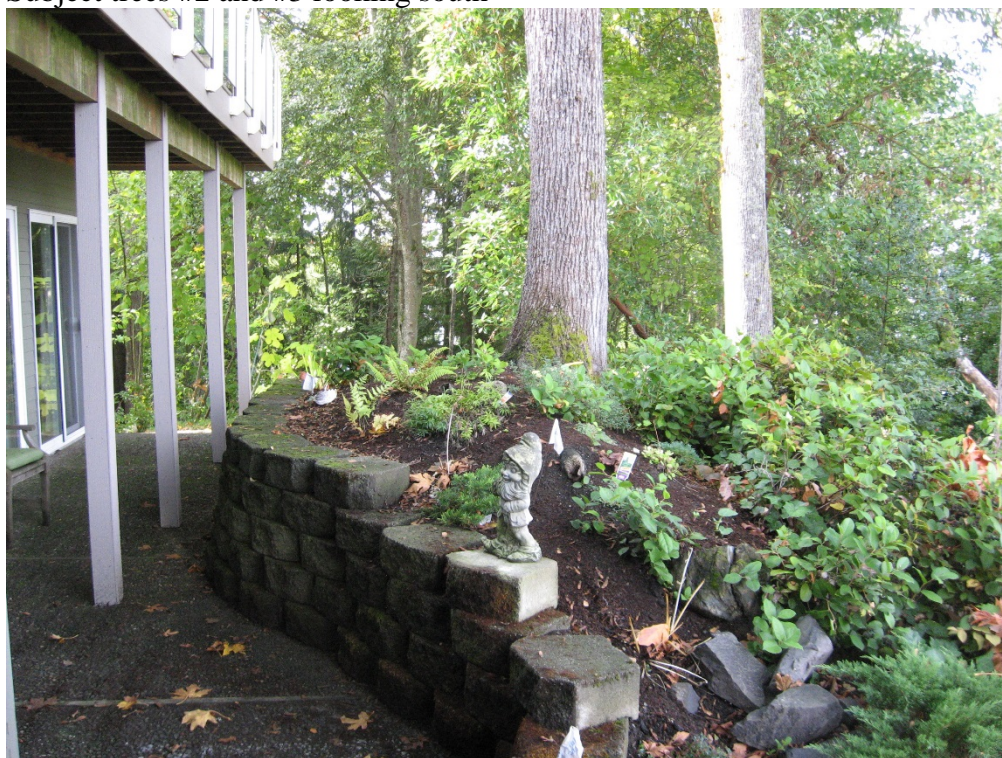
Subject trees looking north

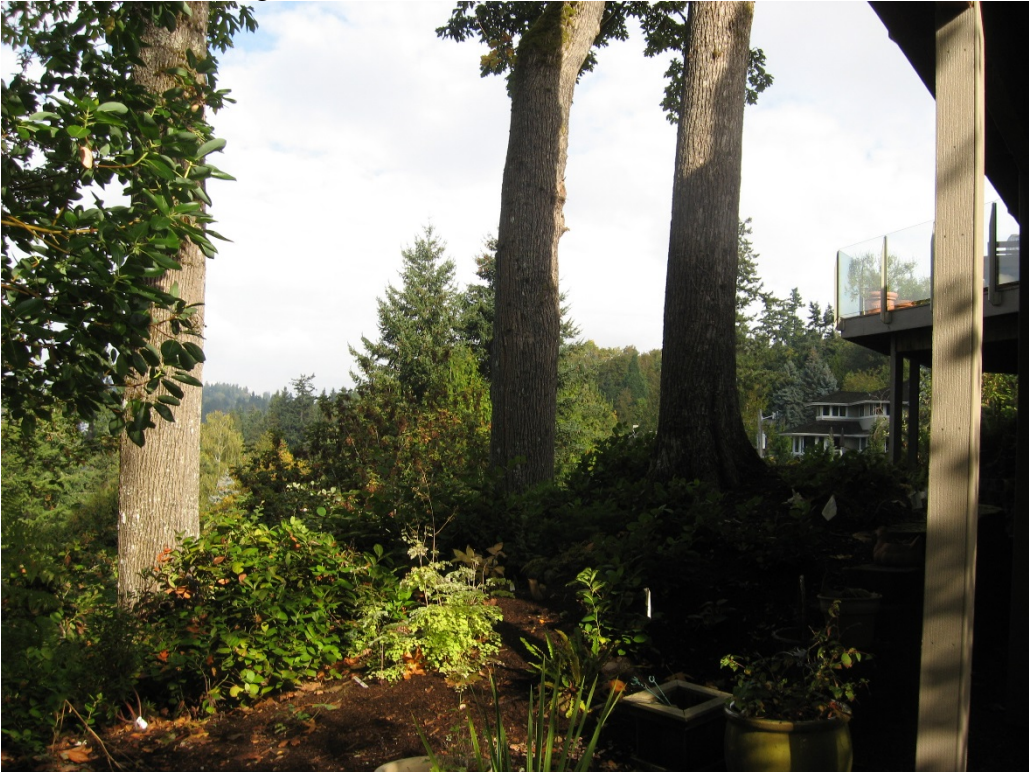
Upper crowns of subject trees
